RE: Thrifty Oil Co. Station #49
3400 San Pablo Avenue
Oakland, CA 94608

SUBSURFACE ASSESSMENT
SERVICE STATION 49
OAKLAND, CALIFORNIA

DECEMBER 4, 1986

Woodward-Clyde Consultants
100 Pringle Avenue
Walnut Creek, CA 94596

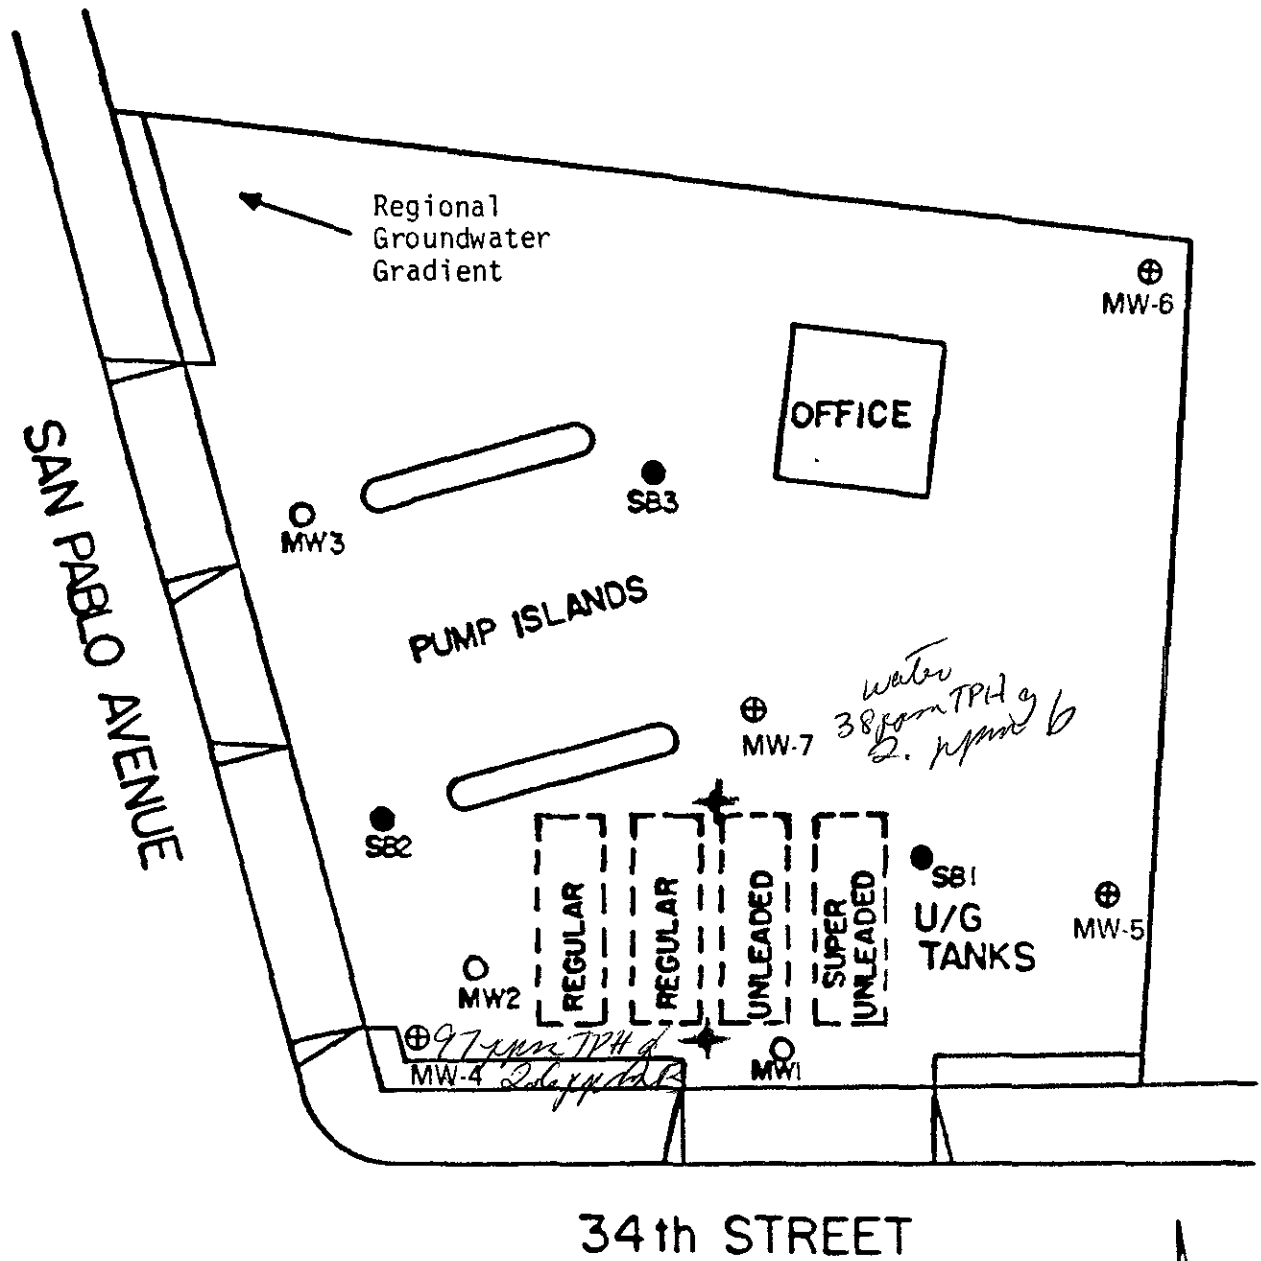
Figure 1. MONITORING WELL AND BORING LOCATIONS

The initial site assessment was conducted by Groundwater Technology in August of 1986 and consisted of advancing six borings and installing three 2-inch monitoring wells. Boring and well locations are shown in Figure 1. Soil samples were taken at 5-foot intervals in all borings and field analyzed for volatile organic vapors using a photoionization detector. The samples taken at a depth of 9.0 in Borings SB-1, MW-1 and MW-2 and 4.0 feet in Borings SB-2, SB-3 and MW-3 were submitted to a lab for analysis. Only the samples from SB-1 and MW-3 were found to contain detectable hydrocarbons (67 and 22 ppm respectively). Groundwater samples were also taken from each well and analyzed for hydrocarbons. Total hydrocarbons in MW-1, MW-2 and MW-3 were 85.3, 93.7 and 2.1 ppm, respectively. Respective benzene, ethyl benzene, toluene and xylene (BTEX) levels in the three wells totaled 54.1, 52.4 and 0.75 ppm.

The relative well casing elevations were surveyed to enable calculation of the local groundwater gradient. Calculations indicated that the gradient was to the east northeast. A closer analysis of the data revealed a mound or ridge in the water table near the tank pit area and more specifically between wells MW-7 and MW-4. Although the reason for the mounding is uncertain, it is not unusual in urbanized areas where pavement or buildings cover most of the ground surface and open areas available for groundwater recharge are sporadic. In addition, the region is known to contain old buried stream channels and subsurface faults which will influence local gradients. Other contributing factors could be leaking water, sewer or storm drain piping. There is a storm drain inlet adjacent to MW-4 which could be a source of recharge if it contains water and is leaking. It would not, however, be expected to influence water levels in MW-7 due to the distance from the source.

The presence of the mound has resulted in the groundwater gradient below the site sloping in two separate directions. Gradient calculations using wells to the north of the mound indicate that it slopes to the west northwest whereas the use of wells to the south of the mound results in the gradient sloping to the south southeast. Free product measuring 0.3 feet was discovered in MW-1, which is to the south of the storage tank area. All measurements are listed in Table 1.

The laboratory results and observations made during drilling and sampling indicate that subsurface contamination does exist in both the soil and groundwater at the site, although it does not appear to be extensive. The product storage tanks and pipelines were reported to have been tested and found to be tight, which suggests that the contamination is the result of occasional tank overfills. The location of the existing groundwater contamination does appear to be centered around the tank pit area and is generally migrating to the west or northwest. It is probable that some free product is present within the tank backfill but has been relatively well contained by the surrounding silty clay substrate.

You will note that the testing results seem to indicate some contamination in the area of the tank pit. We propose to recover all free product from the existing wells and to install two additional wells in the tank backfill (see figure 1). The purpose of the additional wells is to facilitate product removal and to provide a means to add surfactants to flush backfill and remove any residual contamination.

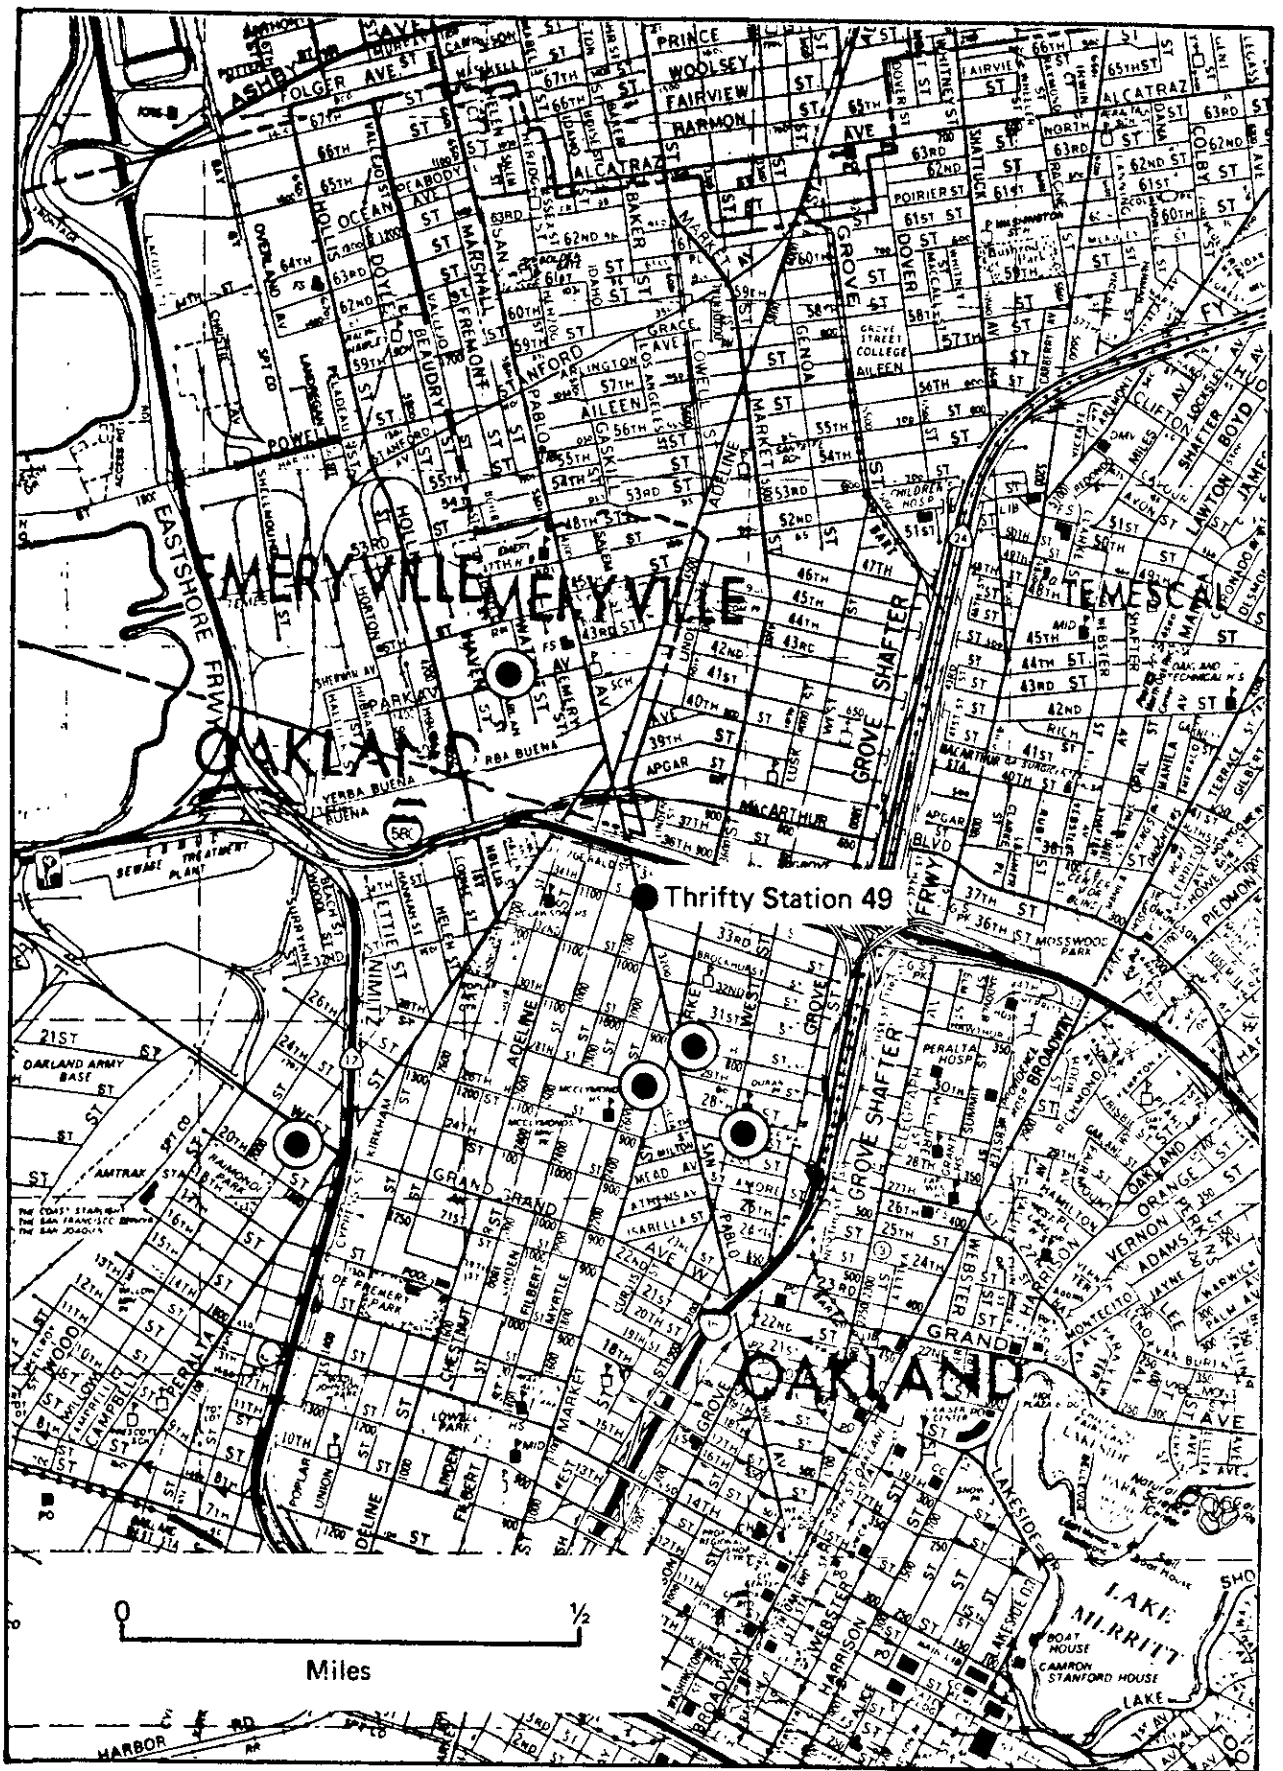
Figure 2. LOCATIONS OF INDUSTRIAL AND IRRIGATION WELLS

The records on active wells in the area appear to be complete but outdated, and very little data is available on well construction. The records indicate that approximately five wells exist within a 1-mile radius of the site. This information, however, is rarely updated unless the well owner contacts the ACFC&WCD which means the wells may or may not currently be in operation. Four of the wells in the area are, or were, used for industrial purposes with the other being an irrigation well. No municipal or domestic wells were identified anywhere near the site. The closest well is an industrial well located approximately 1/2 mile to the south. The locations of the wells are shown in Figure 2.

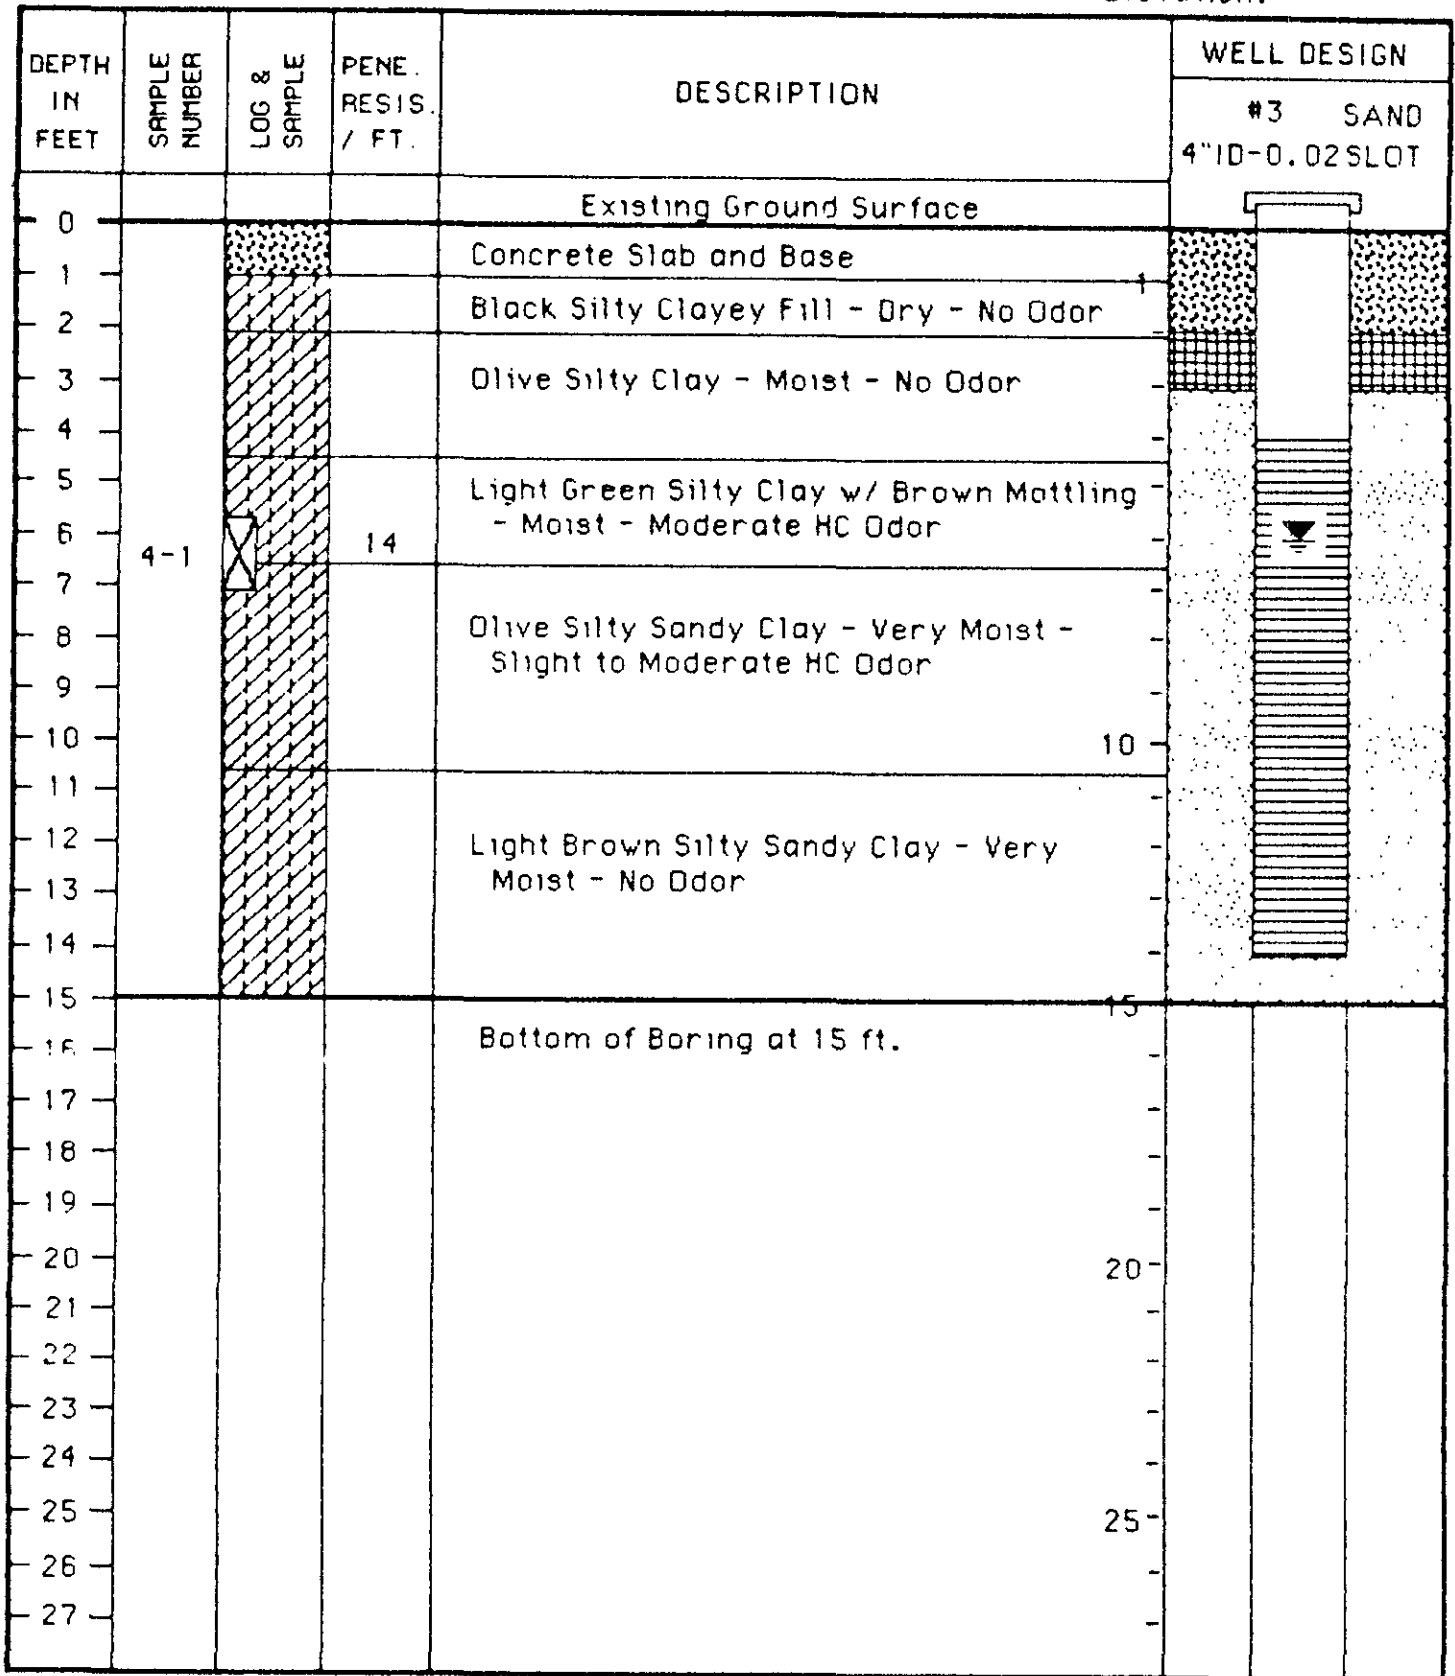
Figure 2 - Test Boring Log No. B-1
 - Monitoring Well No. MW-4

Based on the findings of the previous investigation, soil contamination was not considered to be a problem and, as such, no soil sampling was proposed. However, because moderate hydrocarbon odors were detected in the cuttings in the first boring (MW-4), a sample was taken at the approximate location of the water table in that and each subsequent boring. At the time of drilling, the water table was about 6 feet below grade as measured in MW-2. Samples were obtained using a modified California sampler containing three brass tubes measuring 2.5 inches in diameter by 6 inches long. The sampler was driven ahead of the augers by a 140-pound drop hammer. After each sample drive, one tube was extruded into a plastic bag in the field, and a headspace analysis was performed using a flame-ionization organic vapor analyzer. Samples from both MW-4 and MW-7 resulted in headspace readings of >1,000 ppm while the MW-6 sample contained only 20 ppm in the headspace. No soil was recovered in the MW-5 sample after three attempts. Due to the high headspace readings, one of the adjacent tubes from the MW-4 and MW-7 samples was sealed at each end with aluminum foil, PVC end caps and tape and submitted to Brown and Caldwell Laboratories in Emeryville for analysis.

Past WCC spill experience in clayey, low permeability materials such as these suggest that free product may typically migrate slowly downgradient along the water table and be distributed vertically through the substrate from seasonal water table fluctuations. The high retention capacity of the fine-grained materials rapidly immobilizes the free product prior to migrating any great distance. The relatively high hydrocarbon contamination in the soil in MW-4 and the absence of free product in the well would appear to support this.
