RE: Thrifty Oil Co. Station #63
6125 Telegraph Avenue
Oakland, CA 94603

Subject: Subsurface Assessment Report
Thrifty Oil Company
6125 Telegraph Avenue
Oakland, California

SUBSURFACE ASSESSMENT
SERVICE STATION 63
OAKLAND, CALIFORNIA

December 15, 1986

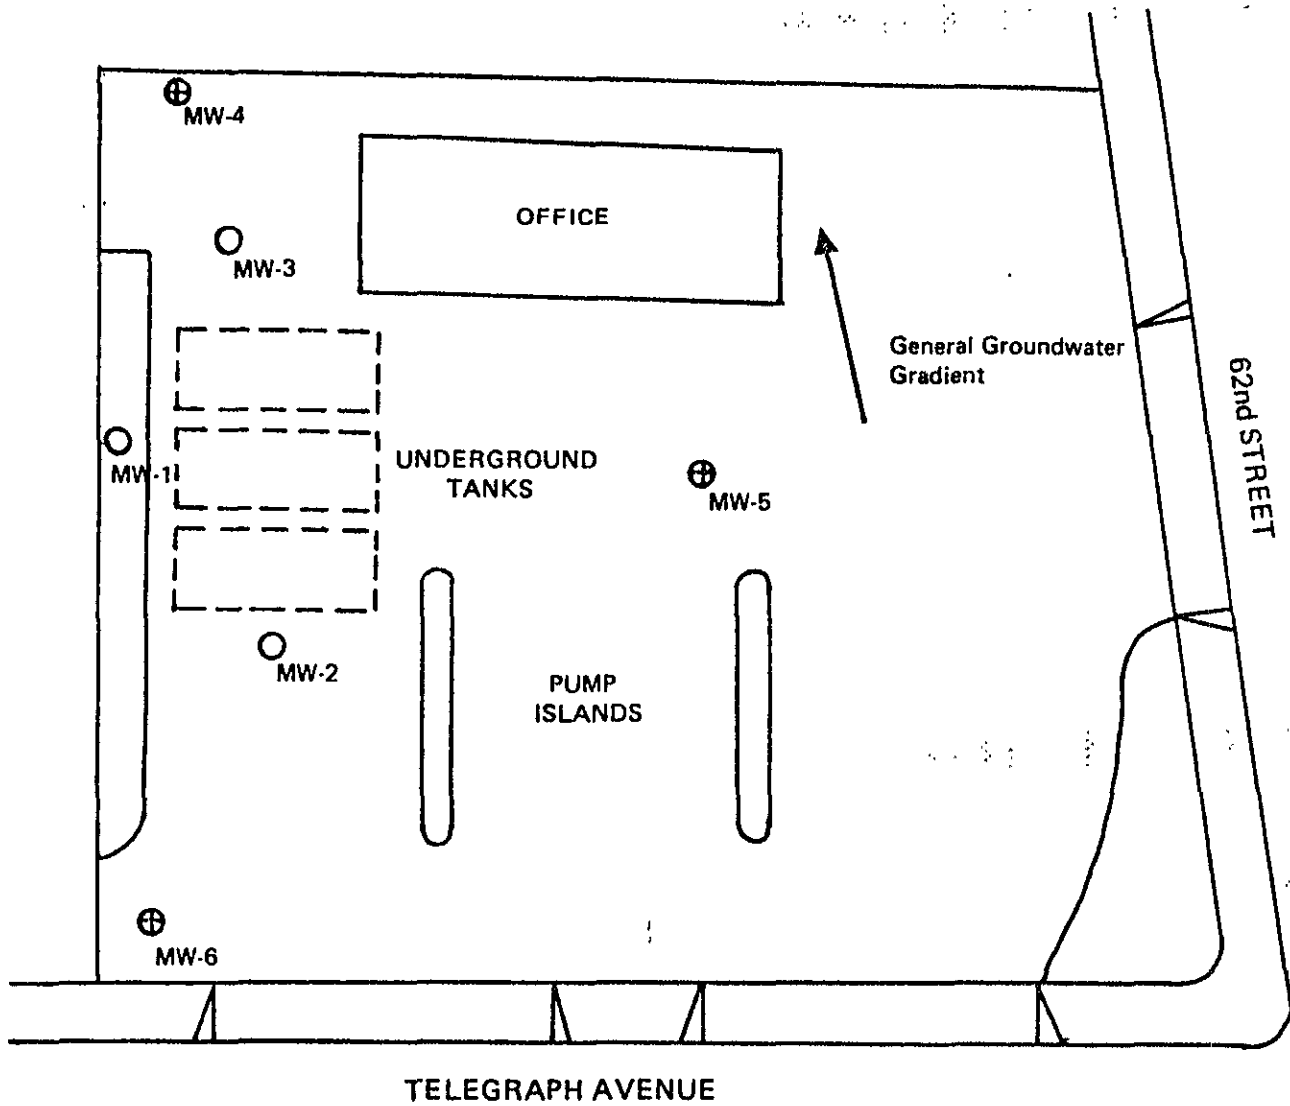
Figure 1. MONITORING WELL LOCATIONS

The installation of the three borings and monitoring wells was conducted on November 13, 1986 using a Mobile B-53 rig with 8-inch hollow stem augers. Locations of the boring/monitoring wells are shown in Figure 1. All wells were located to better delineate the groundwater contamination and free product discovered in the previous investigation. Observations made during the installation of MW-4 and the contamination levels in wells MW-1, MW-2, and MW-3 suggest that the primary area of contamination was centered around the tank pit and that migration is occurring generally to the west. Both MW-5 and MW-6 were found to be clean with no hydrocarbon odors or vapors detected in the samples or cuttings. The majority of these cuttings were placed in an onsite dumpster for general disposal. Because of the hydrocarbon odors noted in MW-4, a composite sample of the cuttings was taken for analysis. These cuttings and the remaining cuttings from the other borings were then placed in four drums, sealed, labeled and left onsite pending sample analysis.

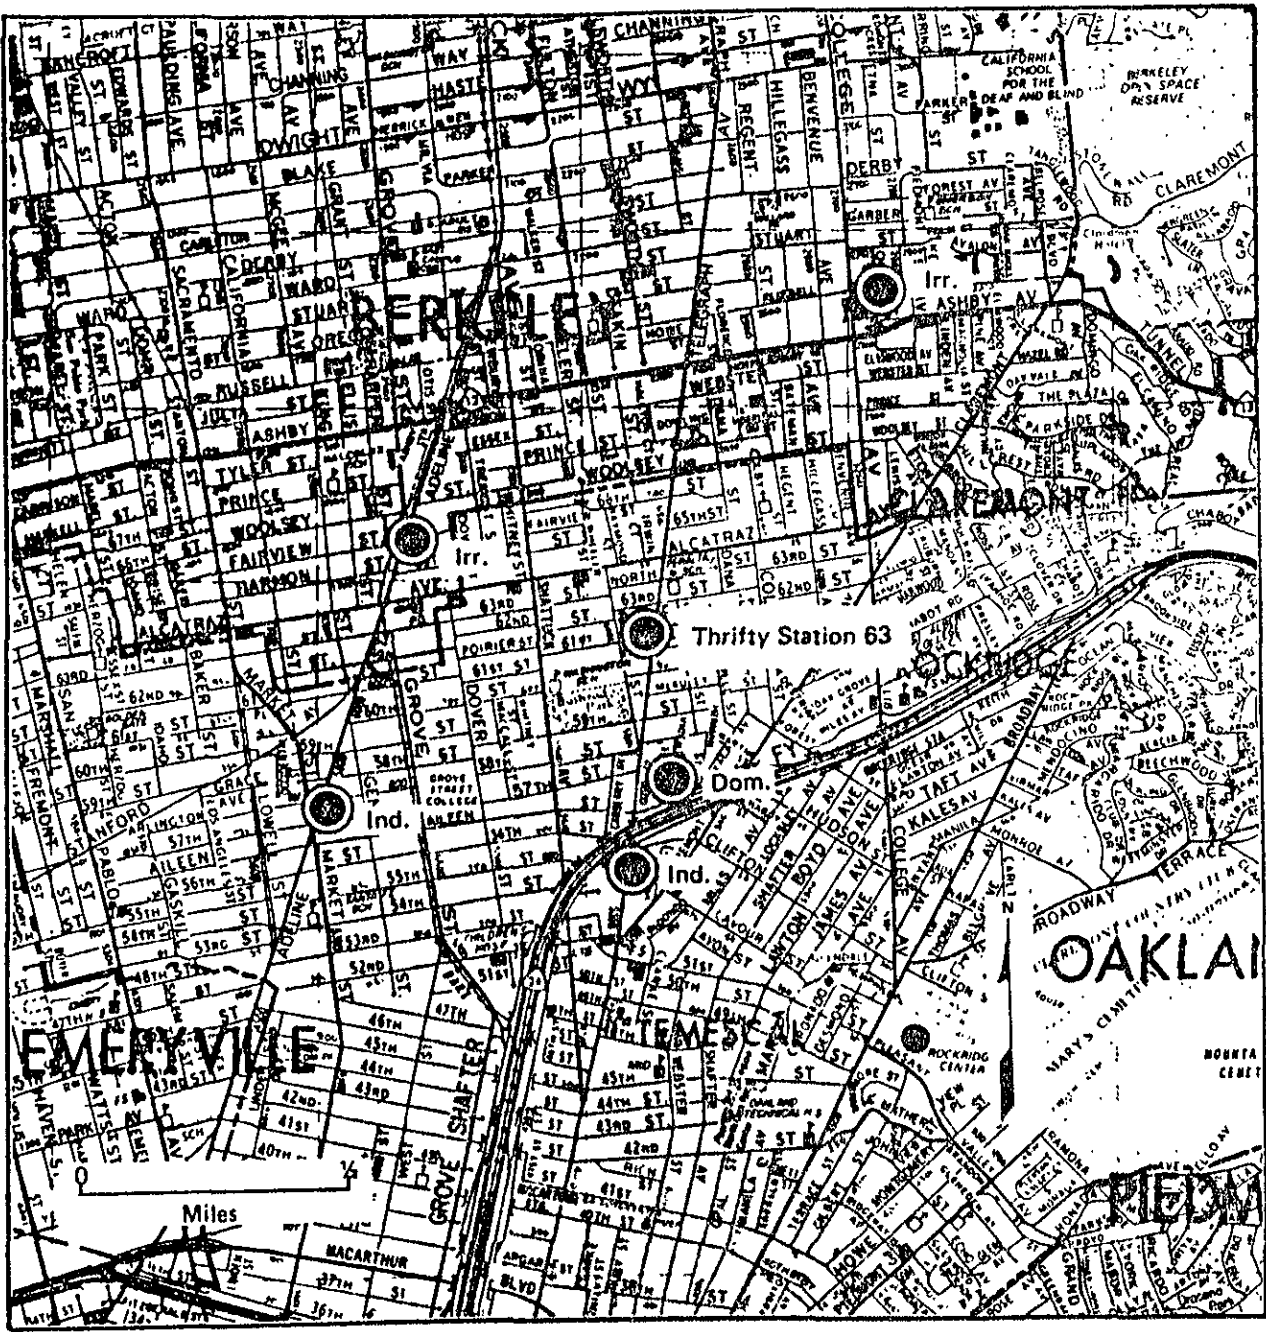
Figure 2. LOCAL WATER WELL LOCATIONS

The records on active wells in the area appear to be complete but outdated, and very little data is available on well construction. The records indicate that approximately five wells exist within a 1-mile radius of the site. This information, however, is rarely updated unless the well owner contacts the ACFC&WCD which, in turn, means the wells may or may not currently be in operation. The previous assessment also identified five wells within a one-mile radius and found that only three were currently in use. Unfortunately, the report neglected to state which wells were operating. Two of the wells in the area are, or were, used for industrial purposes, two for irrigation and one for domestic use. No municipal wells were identified anywhere near the site. The closest well is the domestic well located approximately 1/4 mile to the south. The closest one in the downgradient direction is an irrigation well 1/2 mile to the west northwest. The locations of the wells are shown in Figure 2.

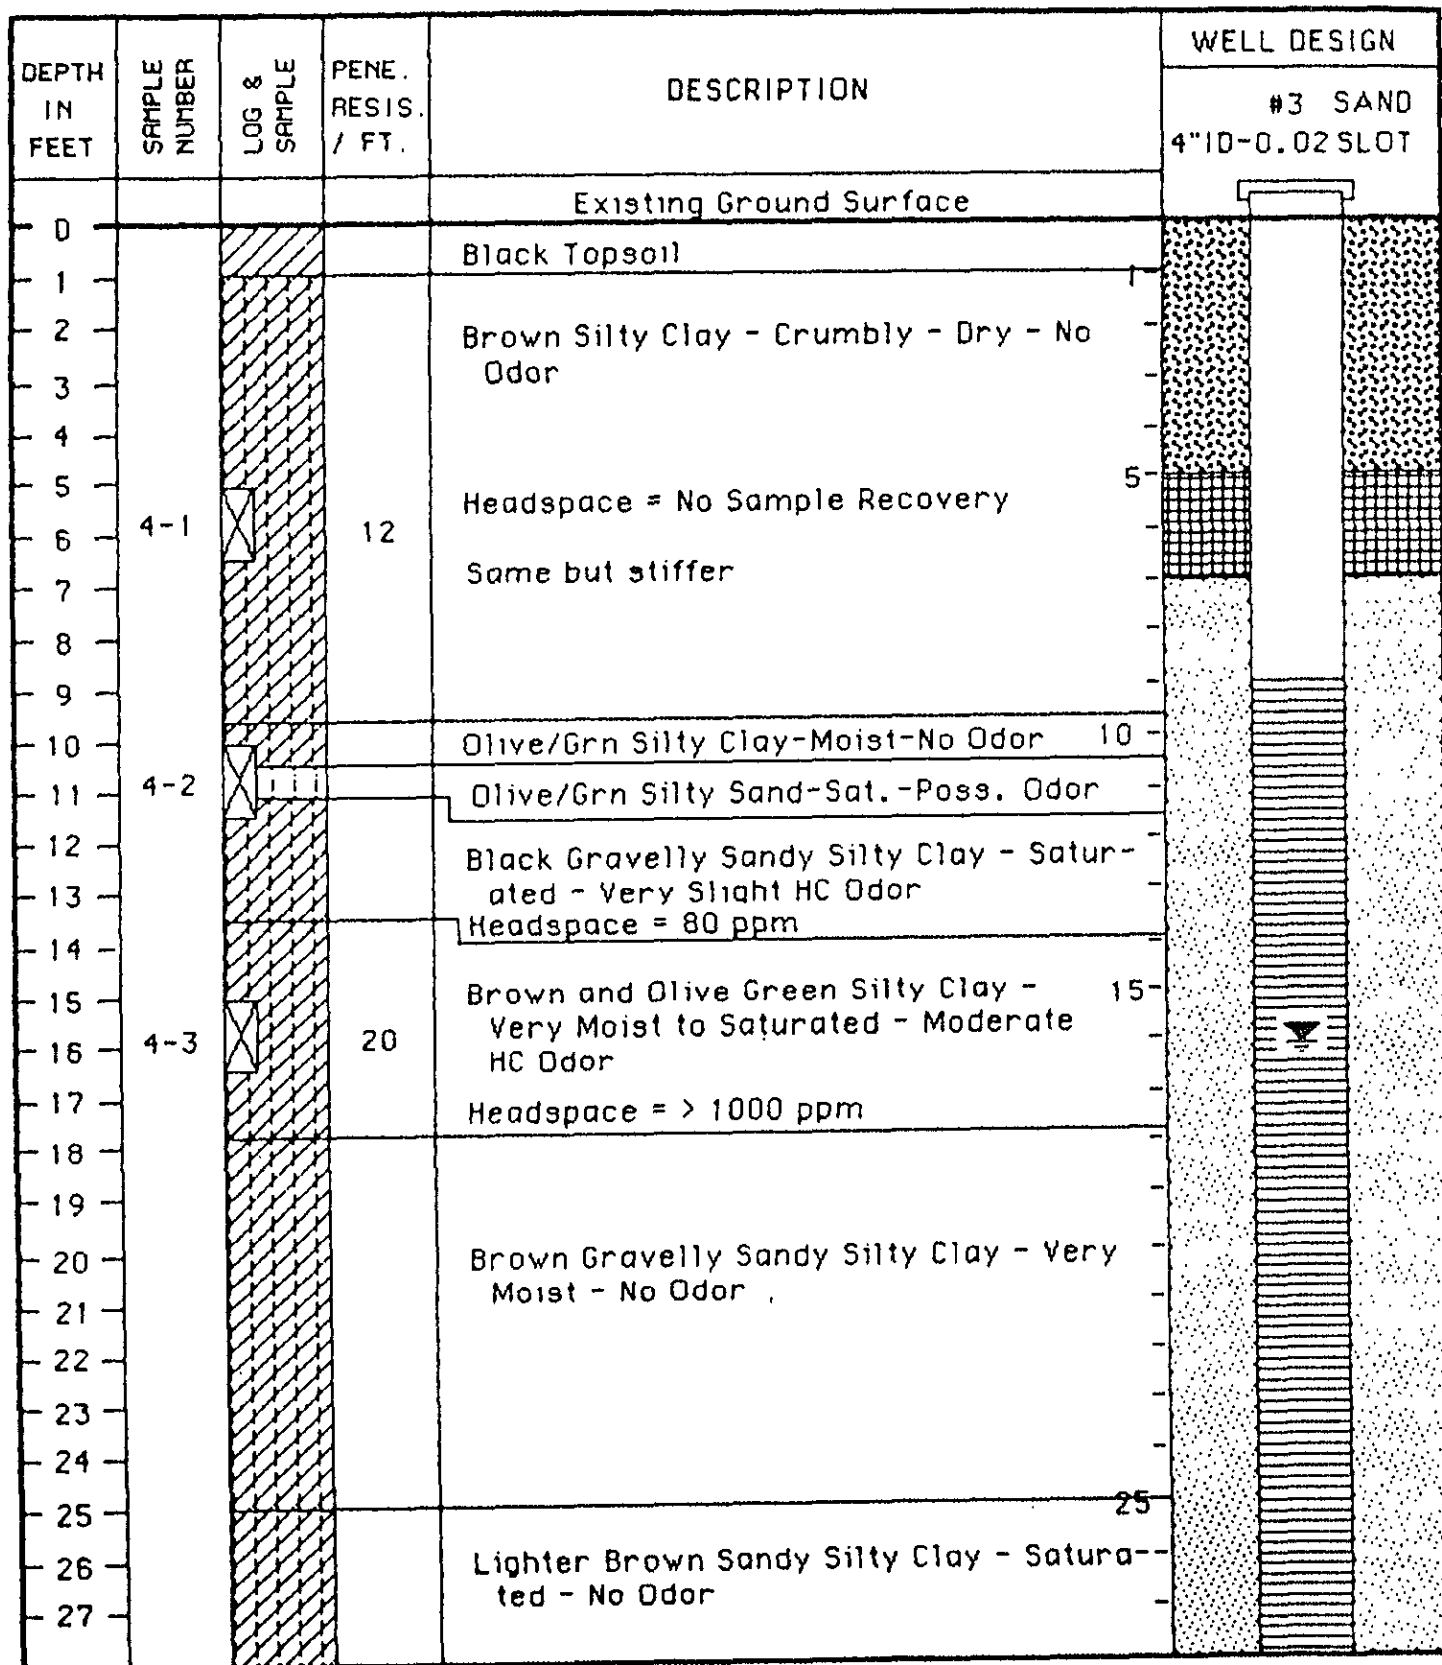
Figure 3A - Test Boring Log No. 1
- Monitoring Well No. MW-4

DEPTH IN FEET	SAMPLE NUMBER	LOG & SAMPLE	PENE RESIS / FT.	DESCRIPTION	WELL DESIGN			
					#3 SAND 4"10-0.02 SLOT			
				28 Feet Below Existing Ground Surface				
28				Light Brown Sandy Silty Clay - Saturated - No Odor				
29					30			
30				Bottom of Boring at 30 ft.				
31								
32								
33								
34								
35					35			
36								
37								
38								
39								
40					40			
41								
42								
43								
44								
45					45			
46								
47								
48								
49								
50					50			
51								
52								
53								
54								
55					55
