Subject: Subsurface Assessment Report
Thrifty Oil Company
6125 Telegraph Avenue
Oakland, California

SUBSURFACE ASSESSMENT
SERVICE STATION 63
OAKLAND, CALIFORNIA

December 15, 1986

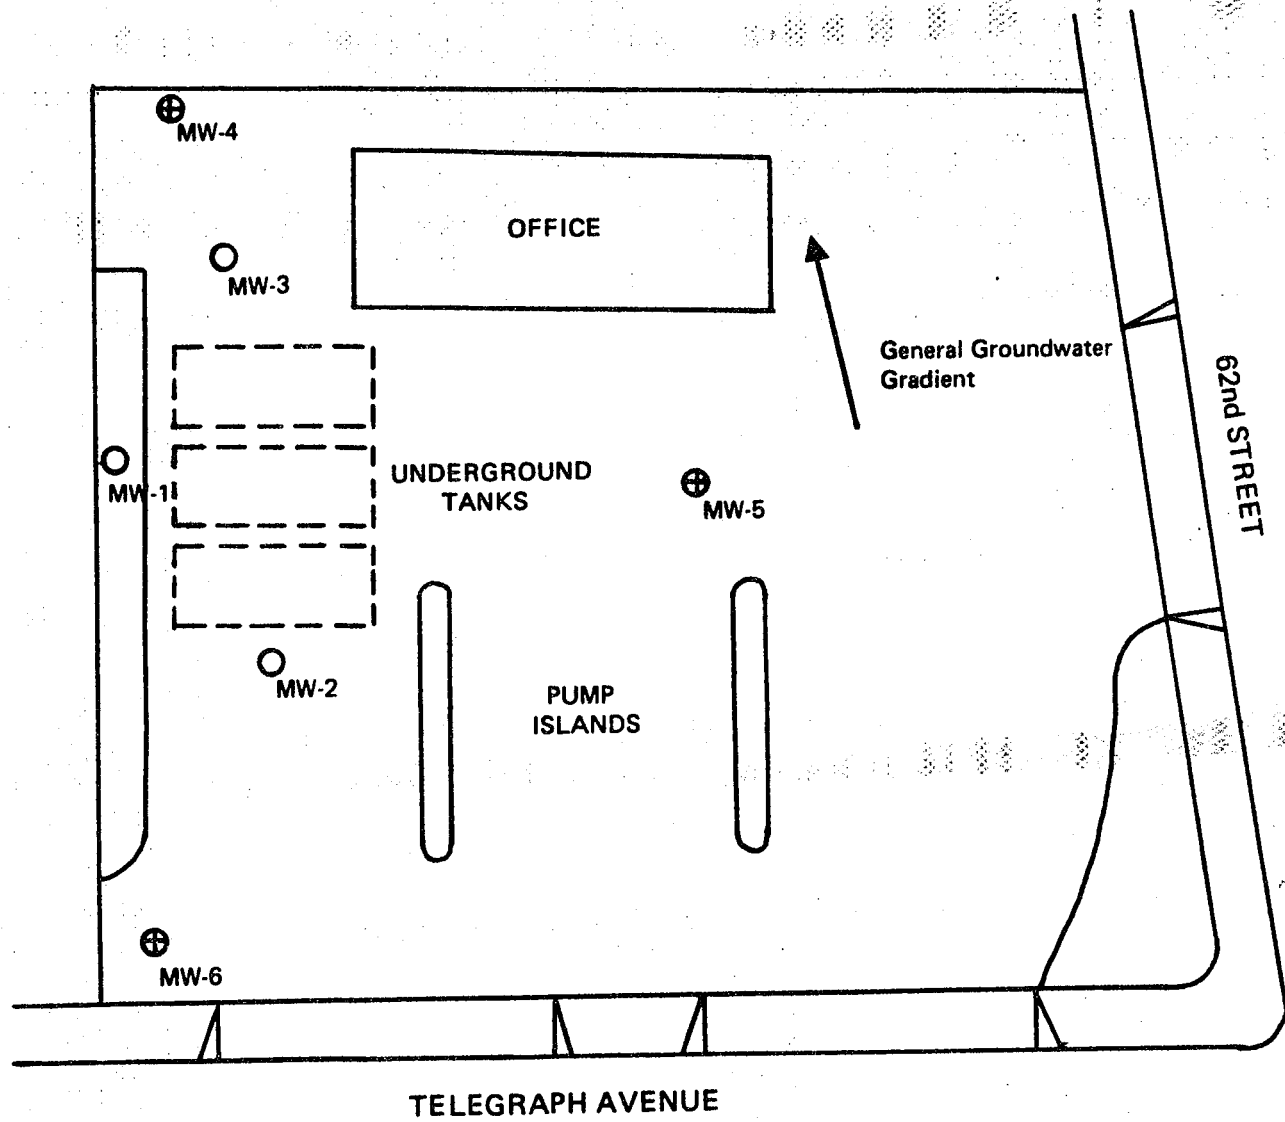
Figure 1. MONITORING WELL LOCATIONS

The initial site assessment was conducted by Groundwater Technology from June through August of 1986 and consisted of advancing three borings and installing three 2-inch monitoring wells. Boring and well locations are shown in Figure 1. Soil samples were taken at 5-foot intervals in all borings beginning at a depth of 6 to 8 ft. The samples were field analyzed for volatile organic vapors using a photoionization detector. The samples taken at a depth of 14.0 to 14.5 in Borings, MW-2 and MW-3 and 17.0 to 17.5 feet in Borings MW-1 were submitted to a lab for analysis. The sample from MW-2 was found to contain 735 ppm total hydrocarbons while samples from MW-1 and MW-3 contained 471.5 and 52 ppm respectively. Groundwater samples were also taken from each well and analyzed for hydrocarbons. Total hydrocarbons in MW-1, MW-2 and MW-3 were 20.6, 1.5 and 49.4 ppm, respectively. Respective benzene, ethyl benzene, toluene and xylene (BTEX) levels in the three wells totaled 13.8, 0.4 and 23.9 ppm.

The installation of the three borings and monitoring wells was conducted on November 13, 1986 using a Mobile B-53 rig with 8-inch hollow stem augers. Locations of the boring/monitoring wells are shown in Figure 1. All wells were located to better delineate the groundwater contamination and free product discovered in the previous investigation. Observations made during the installation of MW-4 and the contamination levels in wells MW-1, MW-2, and MW-3 suggest that the primary area of contamination was centered around the tank pit and that migration is occurring generally to the west. Both MW-5 and MW-6 were found to be clean with no hydrocarbon odors or vapors detected in the samples or cuttings. The majority of these cuttings were placed in an onsite dumpster for general disposal. Because of the hydrocarbon odors noted in MW-4, a composite sample of the cuttings was taken for analysis. These cuttings and the remaining cuttings from the other borings were then placed in four drums, sealed, labeled and left onsite pending sample analysis.

Fluid level measurements were taken in all wells on November 24 and again on December 12. The relative well casing elevations were also surveyed to enable calculation of the local groundwater gradient. The calculations indicate that the gradient was to the west northwest which is inline with the regional gradient. Free product measuring 0.11 and 0.10 feet was discovered during the November 24 measurements in wells MW-2 and MW-3 respectively. These readings had increased to 0.30 and 0.37 feet by the December 12 measurements. All measurements are listed in Table 1.

The presence of free product in MW-2, MW-3 and initially in MW-1 endorses a previous assumption that some free product may still be present in the tank backfill. Apparently, the original product thicknesses were greater but a manual bailing recovery program implemented by Thrifty Oil has reduced these thicknesses considerably. The current product increases in MW-2 and MW-3 could be the result of water table fluctuations redistributing the product plume or possibly a recent leak or tank overflow. The presence of product in MW-2 is likely due to its close proximity to the backfill while the product in MW-3 is probably a result of it being located downgradient of the backfill. The low permeability nature of the clayey substrate surrounding the tank pit area would tend to contain, within the backfill, any free product that may have accumulated from occasional overfills or historical leaks. The product would, however, eventually migrate into the surrounding clays. The absence of free product in MW-4 and MW-1 would indicate that the plume has not migrated offsite.

Assuming the tank backfill does contain a substantial quantity of free product, remediation would consist of installing a well in the western edge of the backfill near MW-3 and recovering any product encountered either by single or dual phase pumping. Because of the amount of product in MW-3 and the distance from the backfill, it could take some time to recover the free product. A second well could also be installed at the other end of the backfill which would be used to inject a surfactant solution to flush out

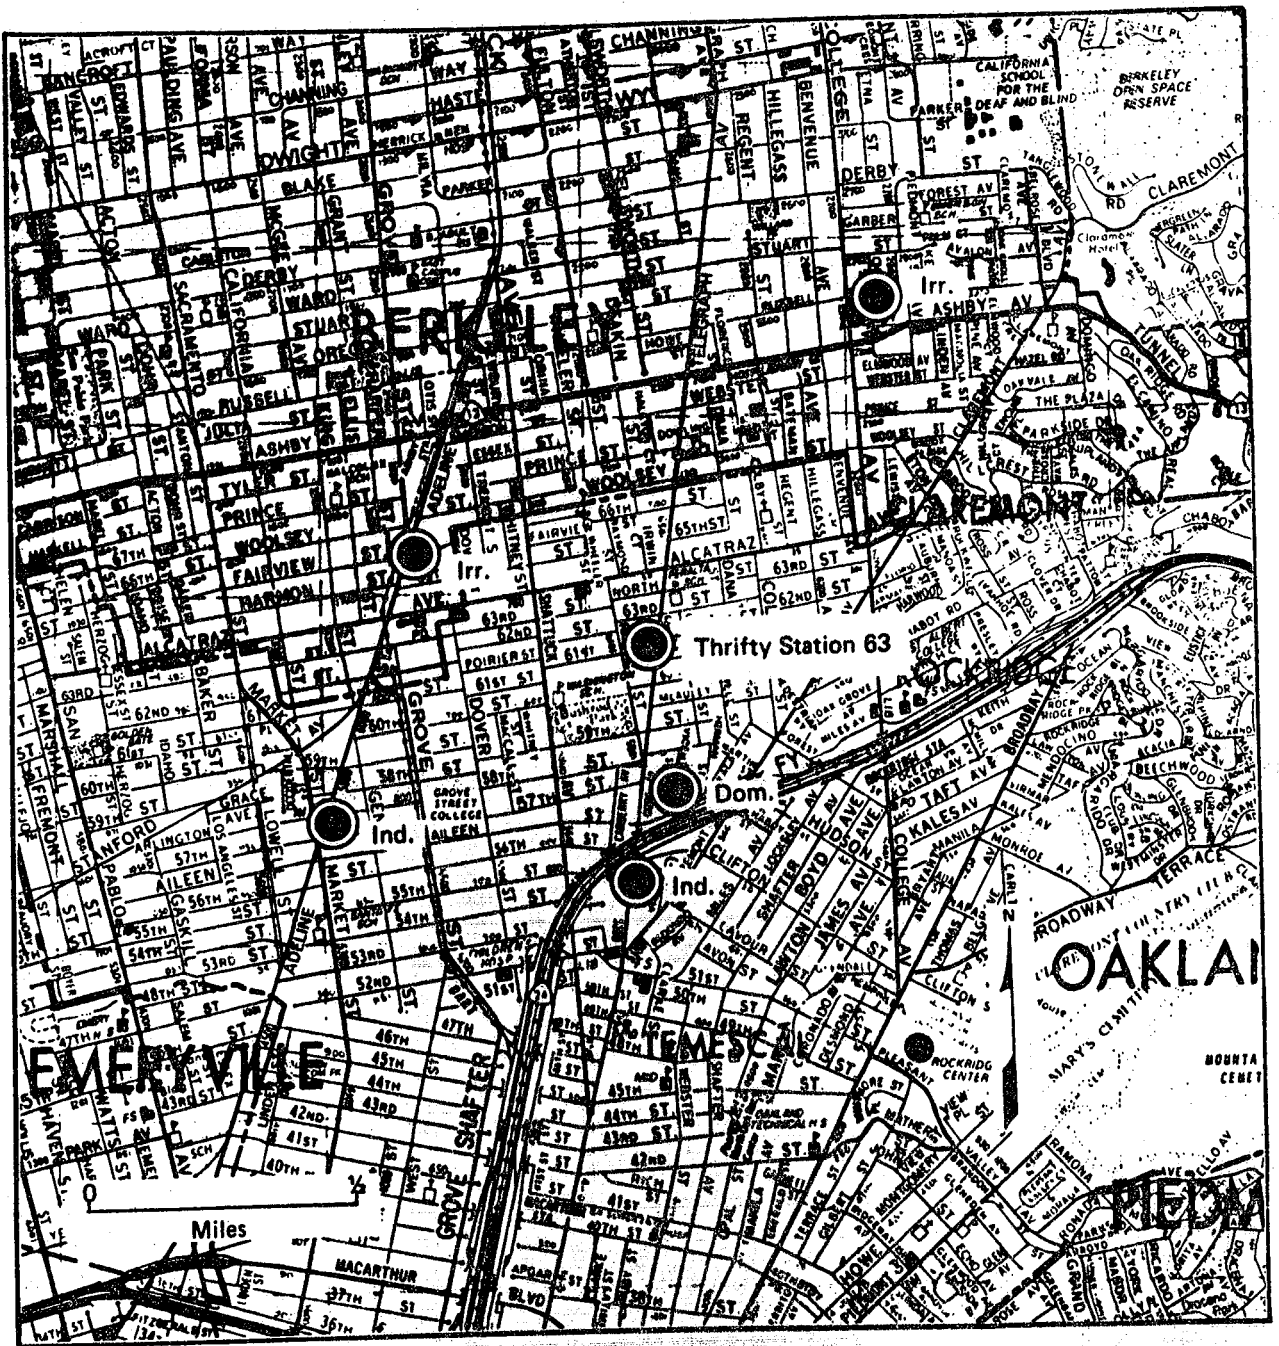
Figure 2. LOCAL WATER WELL LOCATIONS

The records on active wells in the area appear to be complete but outdated, and very little data is available on well construction. The records indicate that approximately five wells exist within a 1-mile radius of the site. This information, however, is rarely updated unless the well owner contacts the ACFC&WCD which, in turn, means the wells may or may not currently be in operation. The previous assessment also identified five wells within a one-mile radius and found that only three were currently in use. Unfortunately, the report neglected to state which wells were operating. Two of the wells in the area are, or were, used for industrial purposes, two for irrigation and one for domestic use. No municipal wells were identified anywhere near the site. The closest well is the domestic well located approximately 1/4 mile to the south. The closest one in the downgradient direction is an irrigation well 1/2 mile to the west northwest. The locations of the wells are shown in Figure 2.

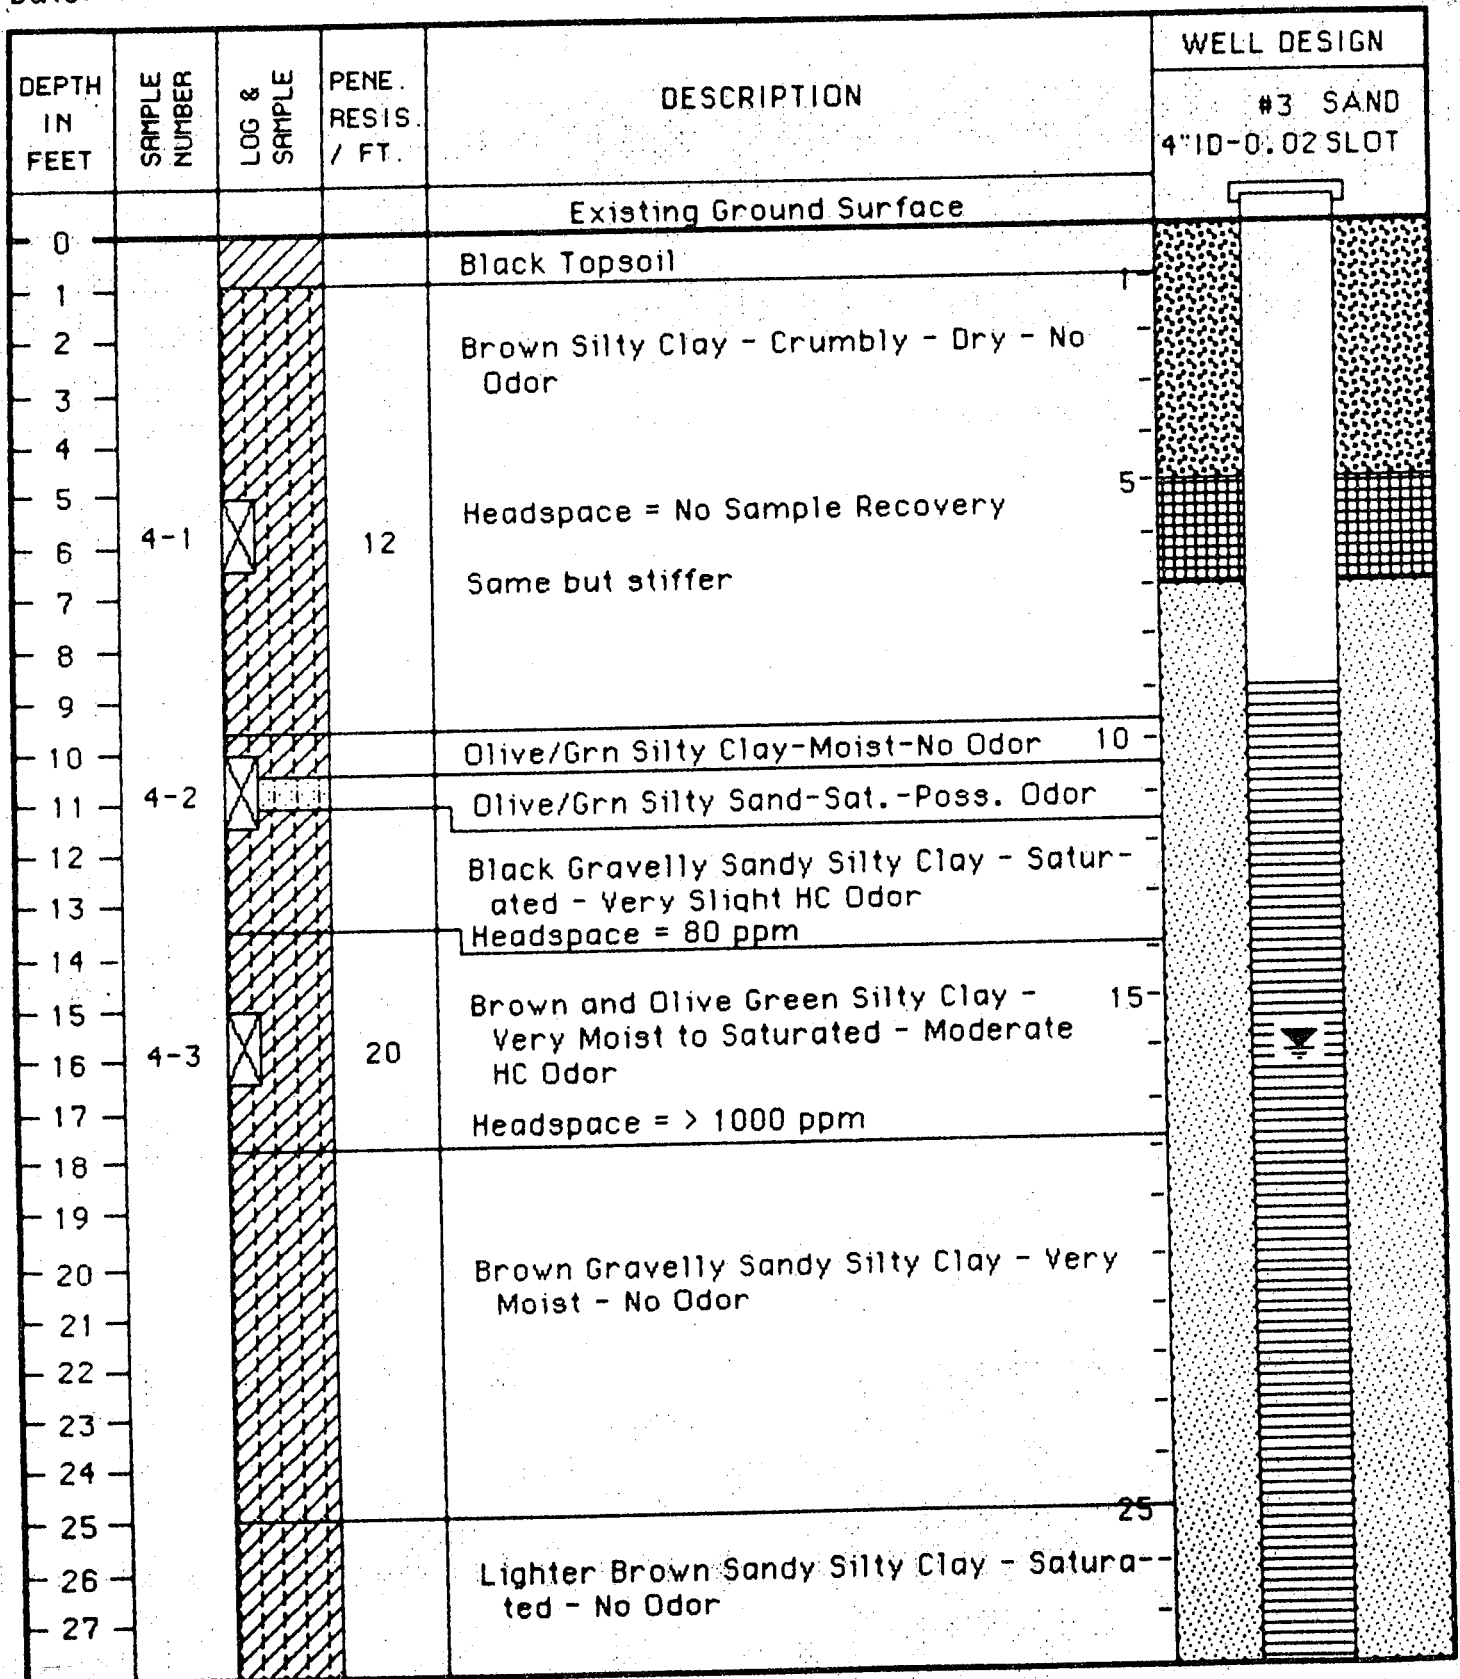
Figure 3A - Test Boring Log No. 1
- Monitoring Well No. MW-4

The soil contamination at the site does not seem to be extensive even though some elevated levels were encountered in both the current and previous assessment. The current assessment only encountered detectable soil contamination in one sample from MW-4 while contamination was found in all three of the previous borings to varying degrees. Although the contaminant level in the MW-4 sample (1,000 mg/kg total hydrocarbons) was greater than the levels found in samples from MW-1, MW-2 and MW-3 (472, 735 and 52 mg/kg respectively), free product was detected in all three of the latter wells while only a trace was found in MW-4. A possible explanation could be the locations of the samples taken in the previous investigation being above or below the water table. The sample from MW-2 was the closest of the three to the water table (0.5 ft above) which could account for it having the highest hydrocarbon content. Conversely, the sample from MW-3 contained the lowest concentration of hydrocarbons but was also the farthest from the water table. It appears the majority of soil contamination outside the suspected source (tank backfill) exists in a relatively narrow, horizon and is probably limited to the vicinity of the backfill although it does seem to be migrating downgradient to some degree.

fine-grained materials rapidly immobilizes the free product prior to migrating any great distance. The relatively high hydrocarbon contamination in the soil in MW-4 and the absence of free product in the well would appear to support this.
