QUARTERLY STATUS AND GROUNDWATER-QUALITY MONITORING
REPORT

MARCH 1, 1999 to MAY 31, 1999

208 Jackson Street, Oakland, California

Project No. 9401.114

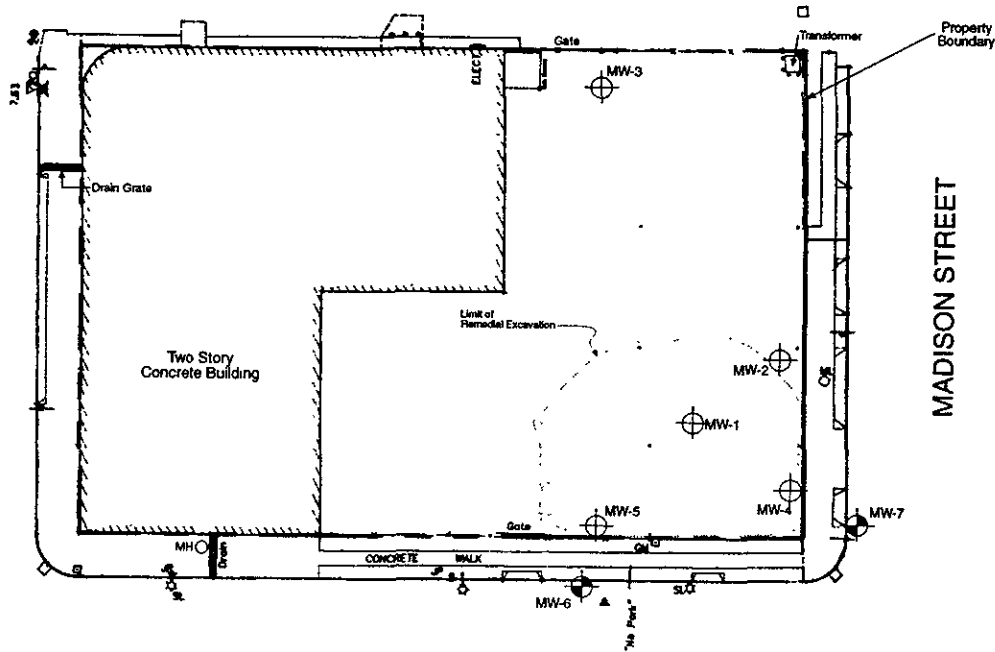
FIG. 2	The San Joaquin Company, Inc.	Project Number: 9401.114
		Drawn by: GNM Date: 01/28/99

All previously existing groundwater-quality monitoring wells present on the site were closed when the hydrocarbon-affected soil was remediated. As called for by the remediation work plan, two new off-site wells - Nos MW-6 and MW-7 - were installed on December 30, 1998 at the locations shown on Figure 2. A first round of groundwater-quality monitoring using these wells was completed on January 9, 1999

Results of the analysis of the sample recovered from MW-6 on April 25, 1999 were unexpected. That sample contained 140 µg/L of TPH(d), 4,500 µg/L of TPH(g), with 26 µg/L of Benzene, 160 µg/L of Toluene, 9.8 µg/L of Ethel benzene and 140 µg/L of Total Xylene Polymers. The previous sample of groundwater recovered from that well (January 9, 1999) contained no detectable concentrations of fuel hydrocarbons with the exception of a trace of total xylene polymers at 1.70 µg/L.

The concentrations of analytes in the sample recovered from MW-7 on April 25, 1999 were generally consistent with those detected in the sample recovered on January 9, 1999. The groundwater sample recovered from that well was affected by TPH(d) at 1,800 µg/L, TPH(g) at 4,500 µg/L, Benzene at 960 µg/L, Toluene at 47 µg/L, and Total Xylene Polymers at 730 µg/L. No Ethyl benzene was detected. With the exception of Benzene, which increased moderately, all of these concentrations are lower than the equivalent concentrations detected in the January sampling round. They are at least an order of magnitude lower than the concentrations found in groundwater in nearby MW-4, prior to its removal during the remediation of contaminated soil by excavation in late 1988.

The third round of sampling from groundwater-quality monitoring wells MW-6 and MW-7 is scheduled for July 24, 1999. Because of the unexpectedly high concentrations of components of fuel hydrocarbons detected in the sample recovered from MW-6 on April 25, 1999, each step of the sampling procedure will be carefully monitored to ensure that results are produced without cross-contamination or other element of inaccuracy. In addition, duplicate samples will be recovered from MW-6. One of the duplicate samples will be submitted to Chromalab for analysis, the other sample will be analyzed by a second Cal-EPA certified laboratory to provide a quality assurance check of the analytical procedures employed.
