Our Reference: 9401.114

SUBJECT: Closure Report: 208 Jackson Street, Oakland, California

CLOSURE REPORT

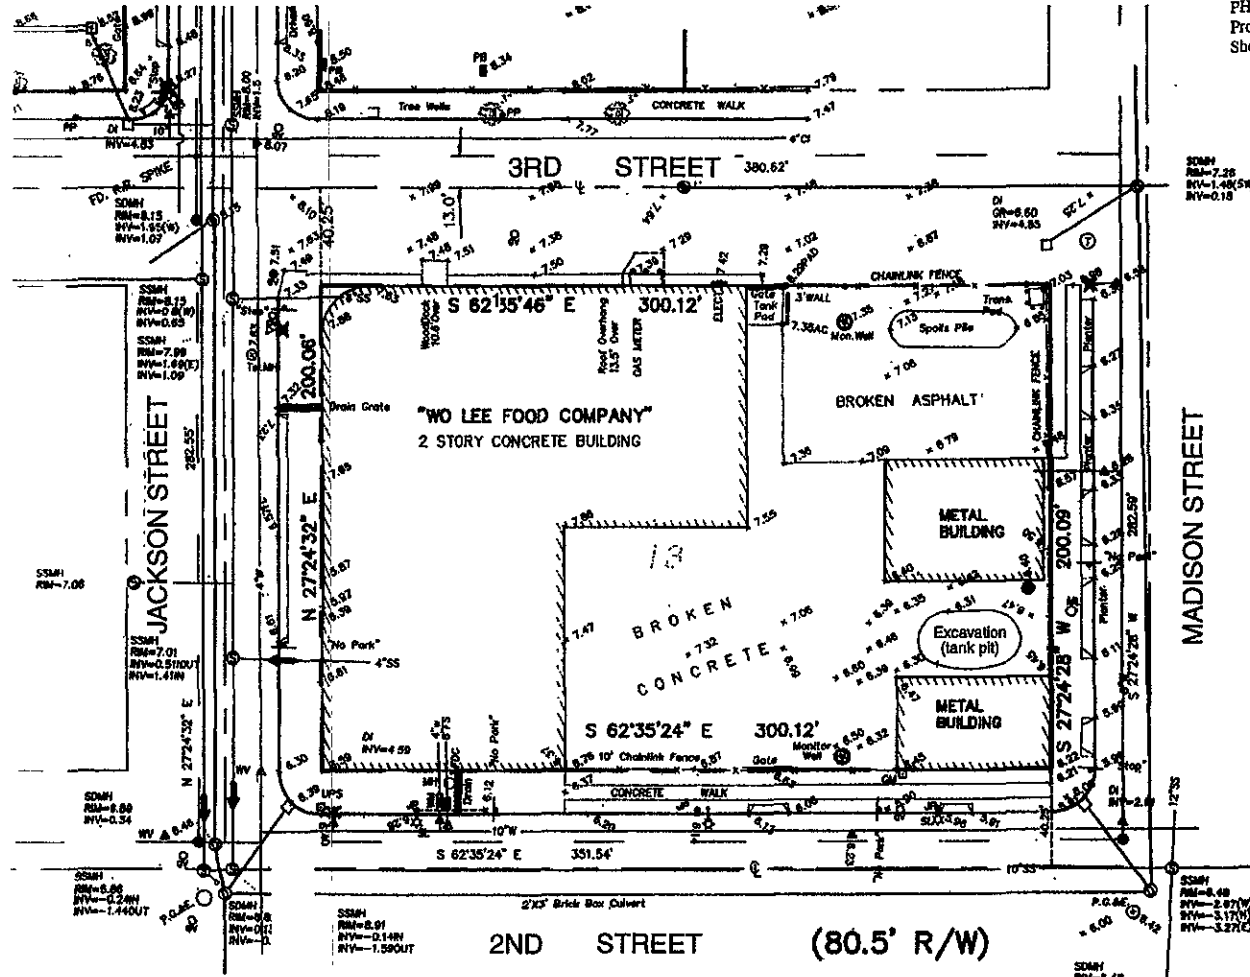
SITE PLAN		208 Jackson Street, Oakland, California	
FIG. 3	The San Joaquin Company Inc.	Project Number: 9401.114	
		Drawn by: GNM	Date: 11/15/99

Note: During the progress of the remediation work, it was found necessary to demolish the second metal building on the site, which was located at the approximate mid-point of the Madison Street frontage of the subject property (see Figure 3). This demolition was also undertaken following City of Oakland and SFBAAQMD permit and notification procedures.

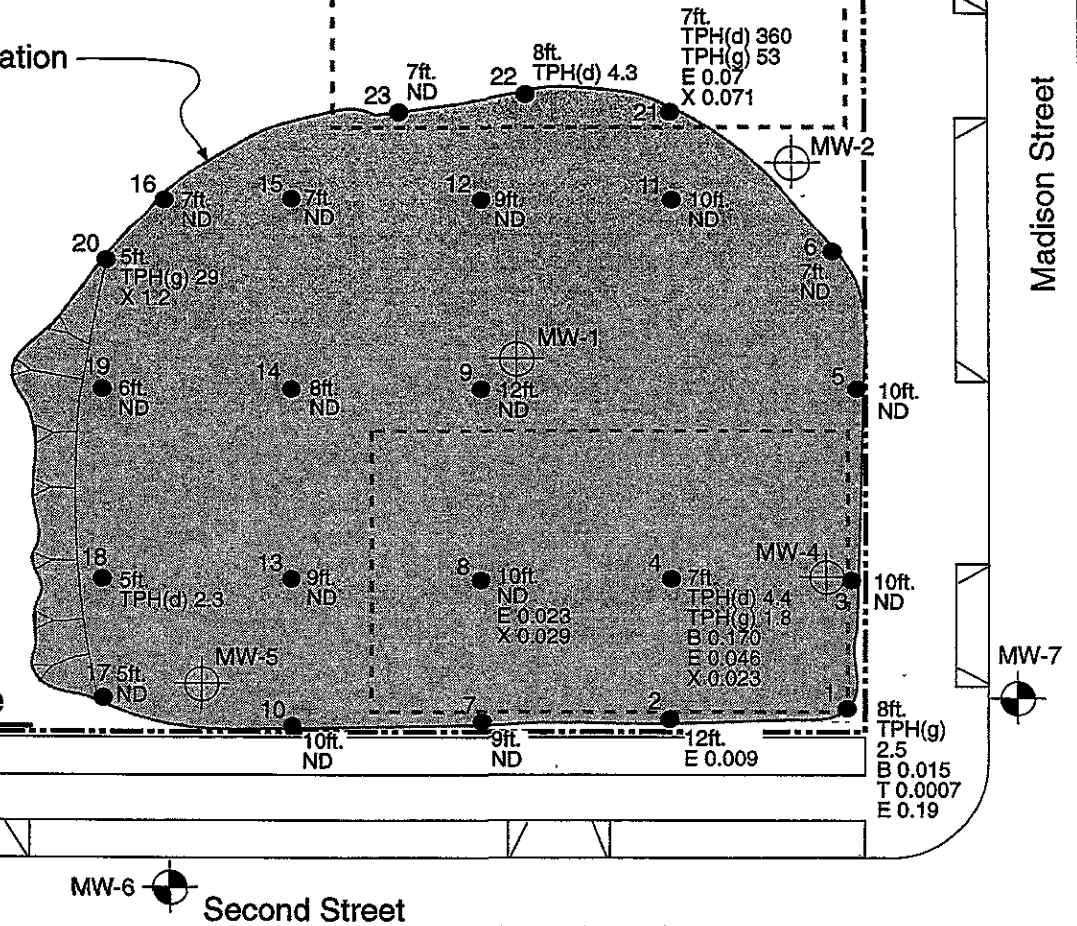
Twenty-three soil samples were recovered from the bottom of the remedial excavation. The sampling locations are shown on Figure 6. The depths from which they were recovered are also noted on that Figure.

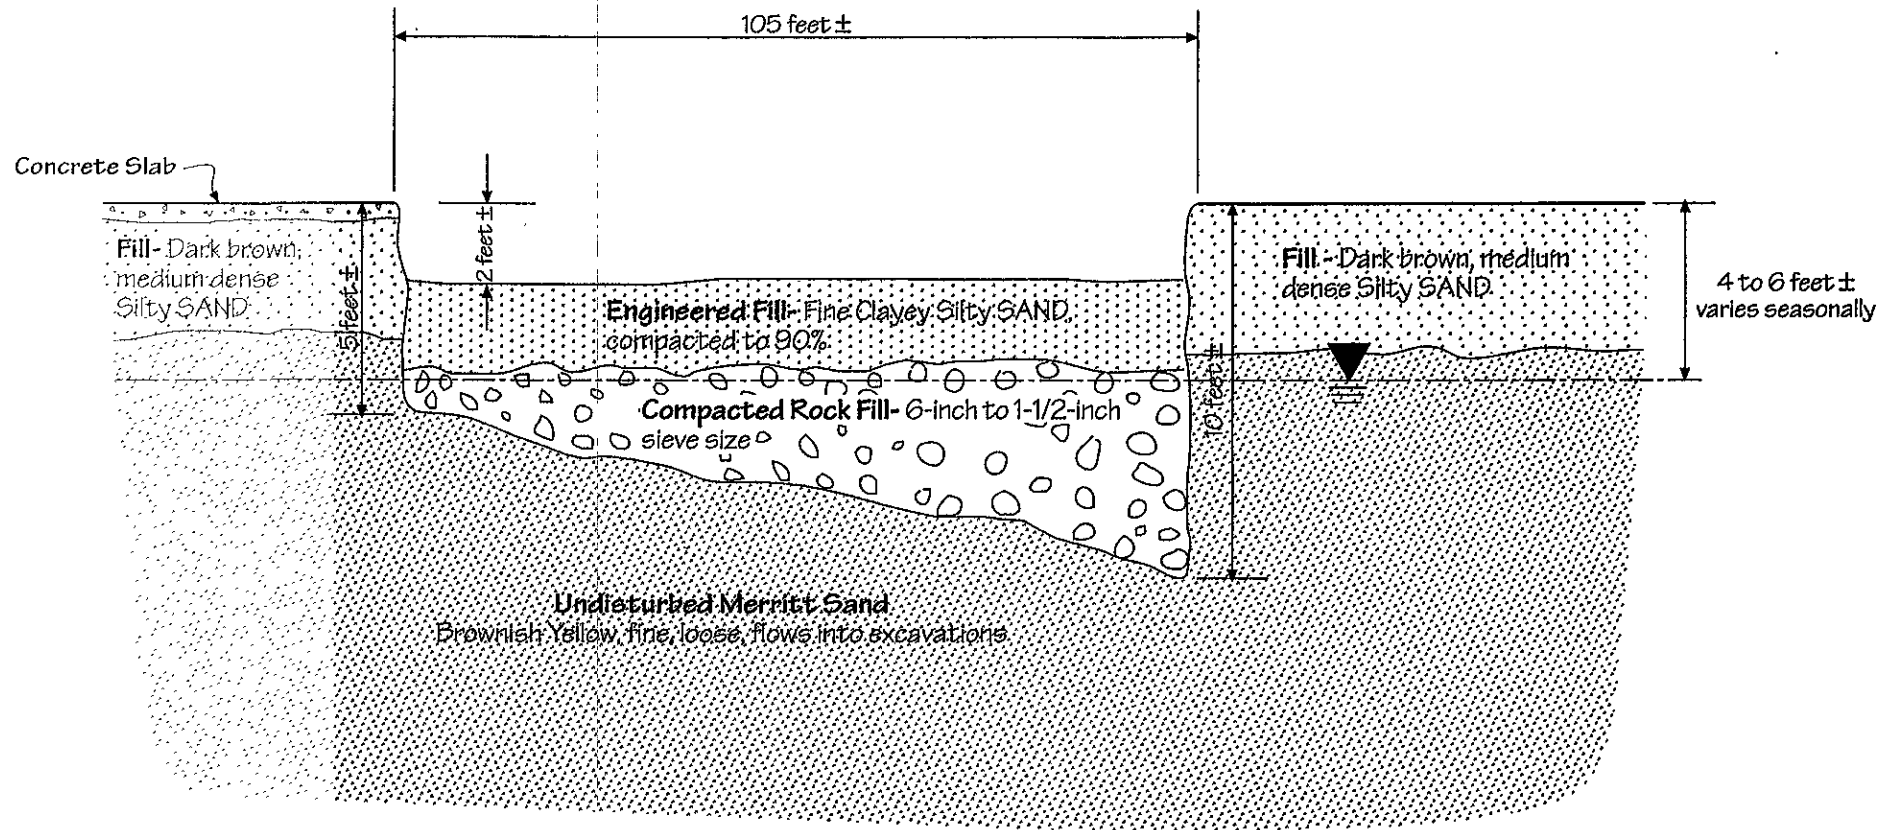
RESTORED REMEDIAL EXCAVATION

North-South Section Through Backfilled Excavation

Material from the temporary stockpile of treated soil was used to backfill the remedial excavation. As noted previously, to permit safe excavation, clean rock backfill had been placed in the excavation from the bottom of the excavation to the depth of the water table at the time soil affected by fuel hydrocarbons was removed from that zone of the subsurface. To prepare the rock already placed in the excavation for placement of this additional backfill, the front-end loader and excavator were used to carefully level its surface. It was then thoroughly compacted using a 66-in., pad-footed, vibratory compactor.
