## **GEOPHYSICAL SUBSURFACE INVESTIGATION**

for  
**INGERSOL RAND EQUIPMENT SALES**  
at  
**1944 Marina Boulevard**  
**San Leandro, California**

Geophysical subsurface investigation for underground storage tanks (USTs).

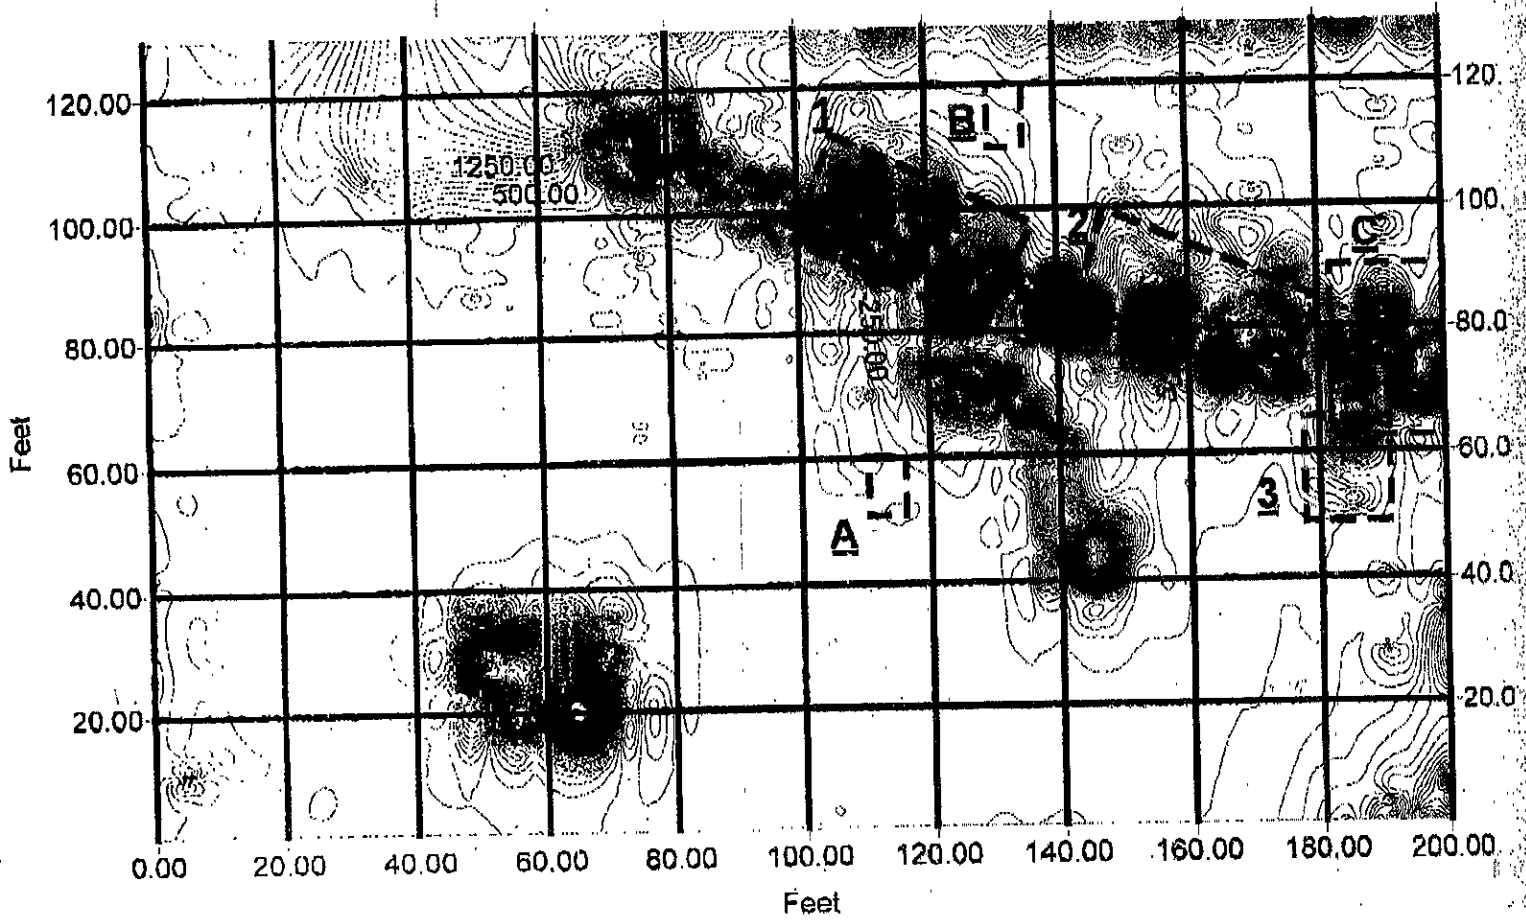
### Vertical Gradient Magnetic Data -- Contour Map

The results of the magnetic locator and the M-SCOPE survey detected two anomalies with approximate dimensions of 10 feet by 4 feet. These anomalies labelled A and B, may not contain enough steel to be observed in the magnetometer map however they warrant further exploration (see site sketch). A pipe trending north south ending approximately 10 feet from the northwest corner of the property was also detected (see site sketch). High readings in a square shaped area labelled C were detected at the northwest corner of the main service building just in front of the air compressor wash area. The cause of some of the high readings could be attributed to some steel piping, railroad tracks, or a reinforced concrete pad. The large amounts of buried steel in the area may mask the anomaly of a UST. A small line trending N-S labelled 3 on the west edge of anomaly C is seen on the magnetometer contour map and is detected by the Schonstedt.

The results from the magnetometer (858G) show anomalies either caused by objects known to be buried (i.e. railroad tracks) or objects visible at the surface (i.e. above ground tanks). Two rectangular shaped anomalies adjacent to the railroad tracks are labelled 1 and 2 are marked on the magnetometer contour map. The cause of these anomalies may be debris or mechanical devices related to the tracks or a buried UST in the vicinity. A third area south the large metallic anomaly labelled

C is also marked. This anomaly may be due to piping, however it too should be verified with excavation.

- Anomalies Detected with M-SCOPE and Schonstedt
- A These anomalies do not show up on the magnetometer maps.
  - B They may be too small to be detected.
  - C
  - 3
- Anomalies Interpreted from Magnetometer
- 1 These anomalies are adjacent to the tracks and
  - 2 warrant further investigation
  - 3

The anomalous areas should be verified with excavation. The cause of the anomalies in area C need to be verified, it could be from a reinforced concrete pad.
