ALAMEDA COUNTY
HEALTH CARE SERVICES

Attachment 2

September 28, 2007

Subject: Fuel Leak Case No. RO0000018 and Geotracker Global ID T0600100262, Carnation Dairy, 1310 14th Street, Oakland, CA 94607

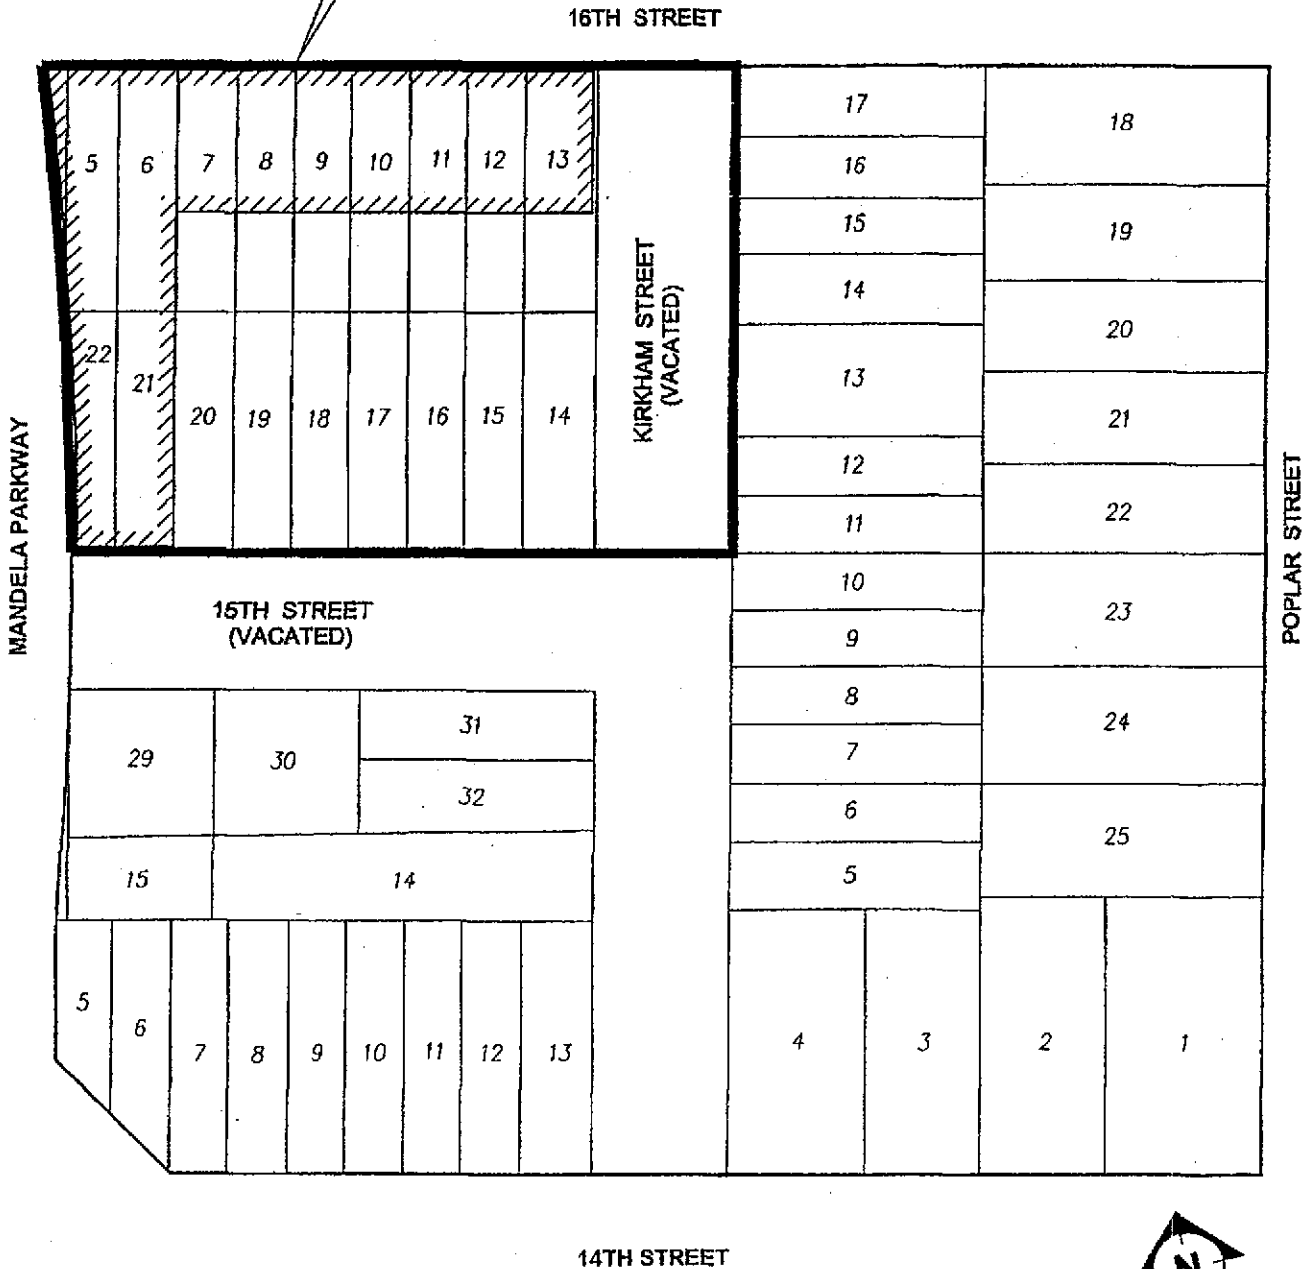
1

AREA FOR WHICH ENVIRONMENTAL RESTRICTIONS APPLY

FORMER NESTLE FACILITY (CARNATION DAIRY FACILITY) SHOWING NORTHWEST SECTION FOR WHICH ENVIRONMENTAL RESTRICTIONS APPLY, NESTLE OAKLAND FACILITY, 1310 14th STREET, OAKLAND, CALIFORNIA
