**Phase I Environmental Site Assessment  
and Soil and Ground Water Quality Evaluation**

1310 Fourteenth Street  
Oakland, California

March 17, 2004  
Project No. 1950-3

**RE: PHASE I ENVIRONMENTAL SITE  
ASSESSMENT AND SOIL, SOIL  
VAPOR, AND GROUND WATER  
QUALITY EVALUATION  
1310 FOURTEENTH STREET  
OAKLAND, CALIFORNIA**

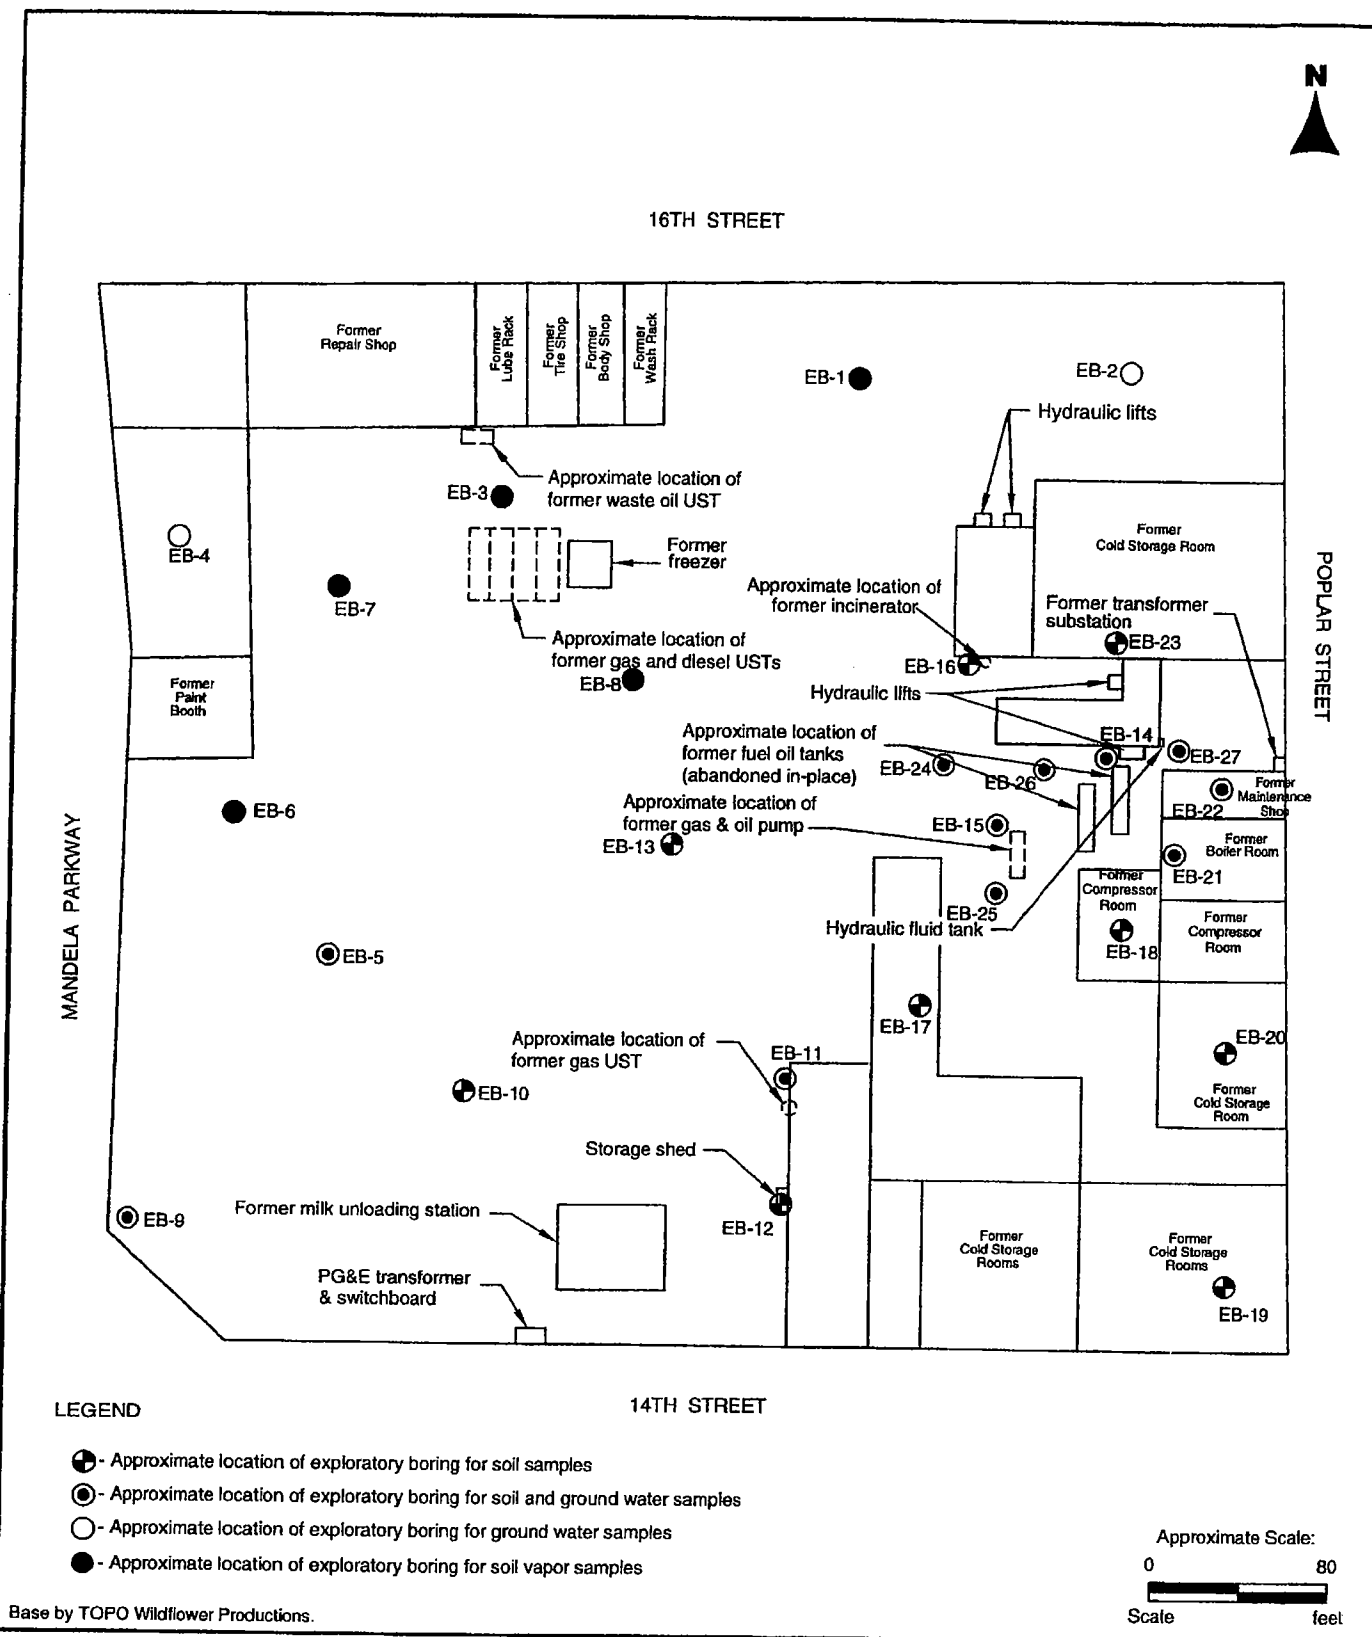
**SITE PLAN**

Additionally, three radar anomalies were located in the area of the tanks that were reportedly abandoned in-place (Figure 2). According to the geophysical survey report, two of the radar anomalies may potentially be associated with two USTs. The third radar anomaly was suspected to be caused by a buried storm or sewer line. Also, metal rings observed imbedded in the concrete appeared to be indicative of a third possible UST location. Detailed results of the survey are presented in Appendix G.
