ANANIA GEOLOGIC ENGINEERING

SUBJECT: Revised Preliminary Assessment - PCB's at
Oakland

TITLE: PRELIMINARY ASSESSMENT OF THE SOURCE OF PCB CONTAMINATION			
PROJECT NAME: CASHMATION/OWLAND		PROJECT NO: 004-88-003	
SITE LOCATION: 1370 14th ST. AT POPLAR OAKLAND, CA.			
DATE: 11-1-89	DRAWING NO.: 003-001	SCALE:	1" = 30'

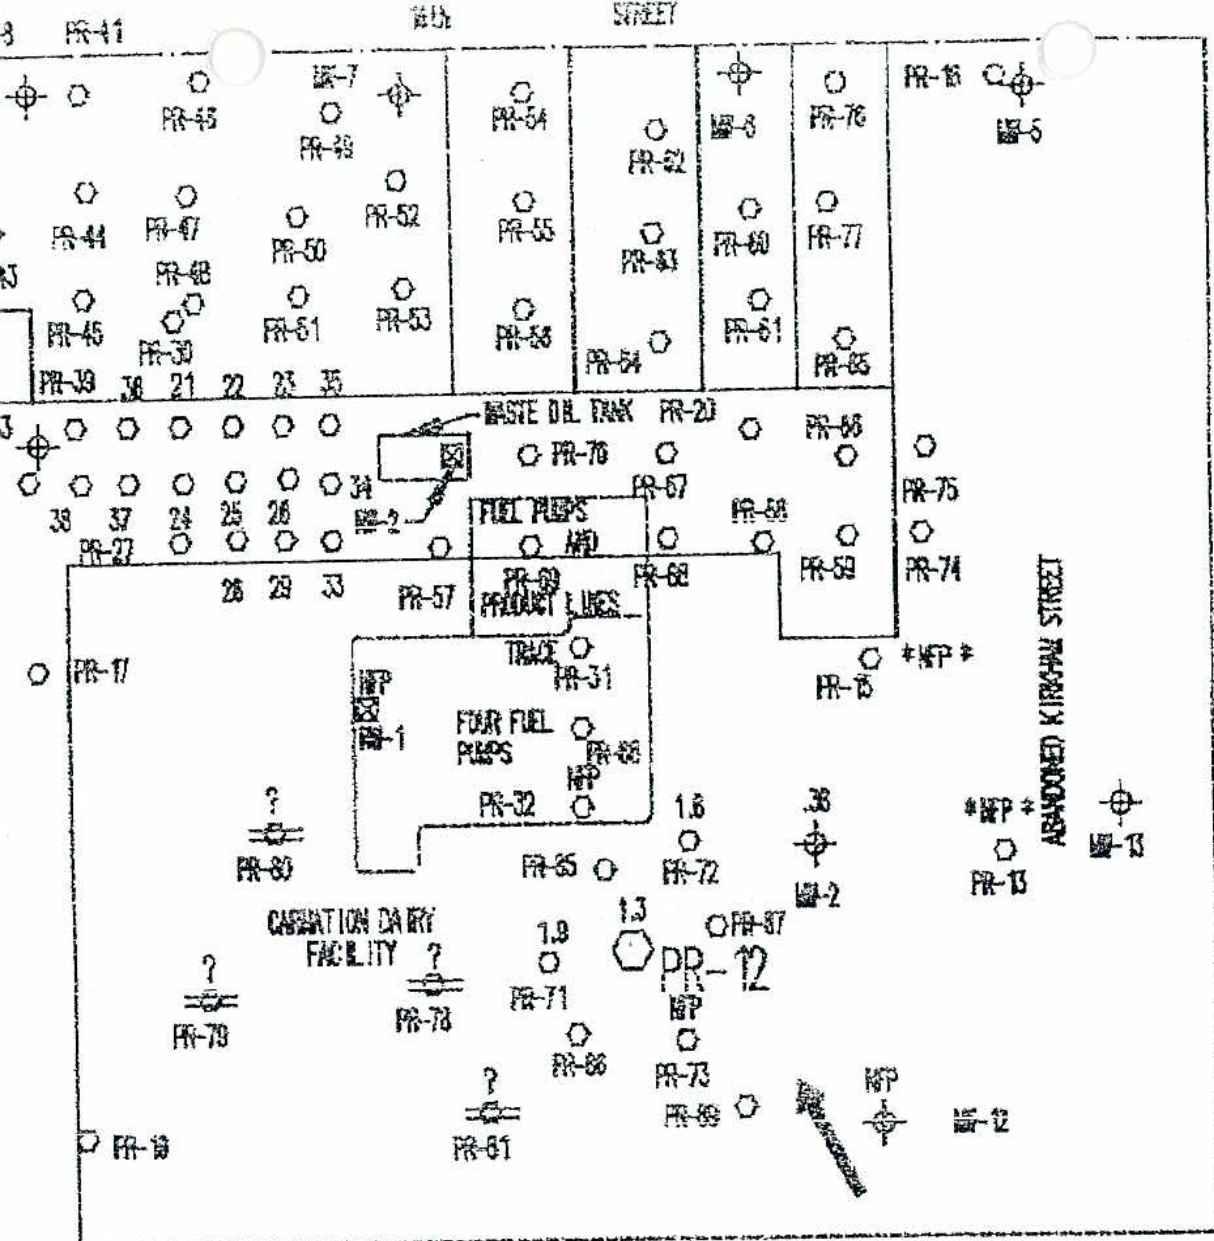
Carnation's Oakland Dairy Facility is located at 1310 14th Street in the City of Oakland, Alameda County, California. Figure No. 1 shows the northwestern quadrant of the Facility including locations of the product recovery probes, monitoring wells, and recovery wells. The areas excavated to remove the former underground gasoline and diesel fuel tanks and the associated fuel pumps and product lines, and the underground waste oil storage tank are outlined on Figure No.1.

those near PR-12, indicate the groundwater flow direction in the area is to the northwest, as shown on Figure 1. PR-12 was installed south and up gradient of the former fuel and waste oil tanks. Three of the four product recovery probes are up gradient from the fuel tank excavation area. It is clear that the PCB source is not associated with the former fuel tanks.

On July 5 and 13, 1989 free product thicknesses were measured in the monitoring wells, recovery wells and product recovery probes located around PR-12. The product thicknesses measured in RW-1, MW Nos. 2 and 12, and PR Nos. 12, 13, 15, 32, 71, 72, and 73; RW-1 and MW Nos. 2 and 12 were listed in Table 1 and shown on Figure 1. These product thickness measurements indicated additional product recovery probes were required west of PR-12 to further define the extent of free product in that direction and if necessary remediate any free product encountered.
