Results of Geophysical Investigation
Former Carnation Terminal Site, Berth 30 (STID-5801)
2700 7th Street
Oakland, California

GEOPHYSICAL INVESTIGATION AT BERTH 30
PORT OF OAKLAND
OAKLAND, CALIFORNIA

September 20, 1996

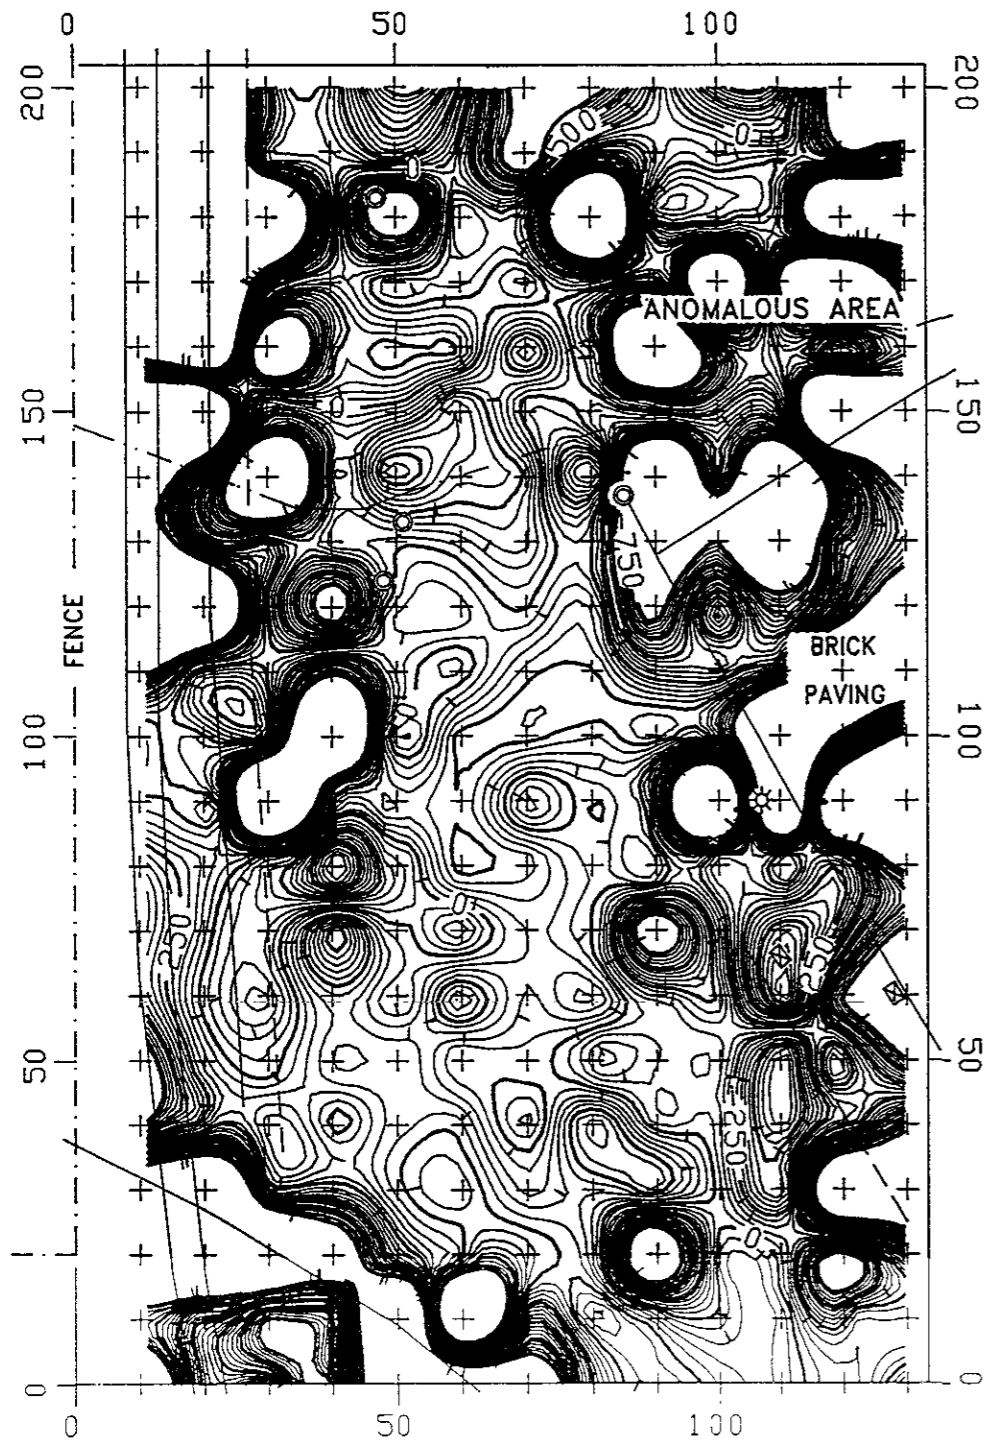
Magnetic Contour Map
 Berth 30
 Port of Oakland
 Oakland, California

Drawing 2 illustrates the magnetic contour map. There are numerous magnetic anomalies throughout the area. We suspect most of the anomalies in the area of the approximate center of the excavation were caused by surface metal. The surface metal included K-rails, crane rails, utilities, and curbs. There was an area in the southeast portion of the area investigated that had magnetic anomalies caused by buried metal. This anomalous area is labeled in Drawing 2 and was approximately 80 feet from the approximate center of the excavation. We could not determine from the anomalies or the radar data what the buried metal was.

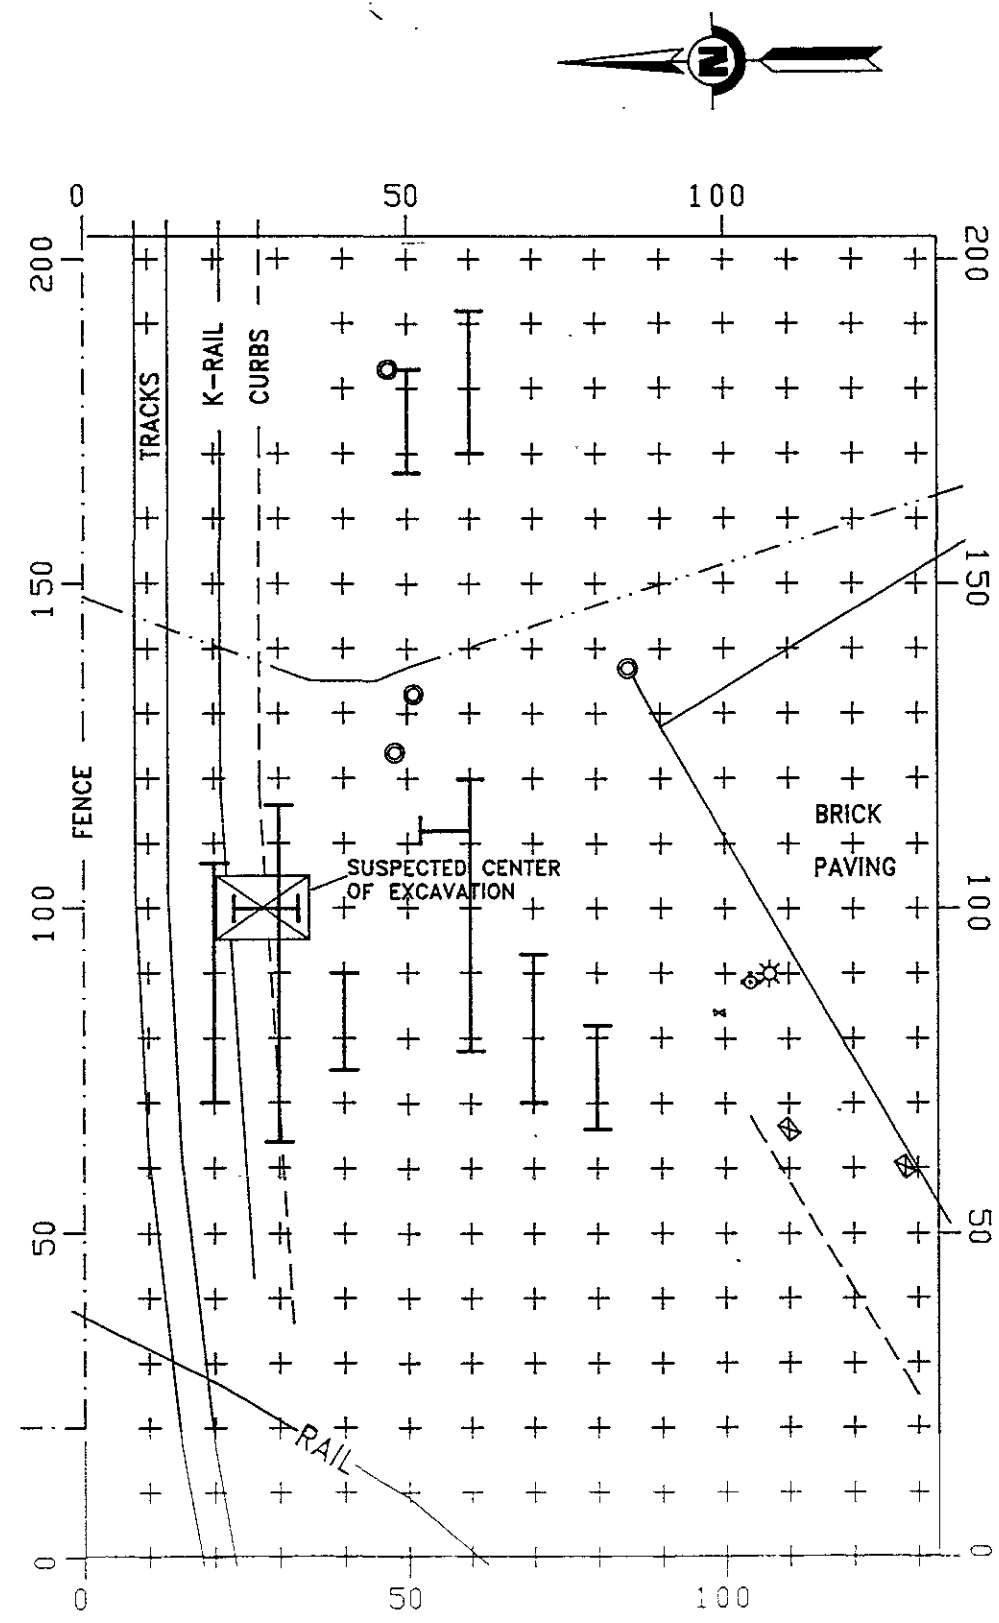
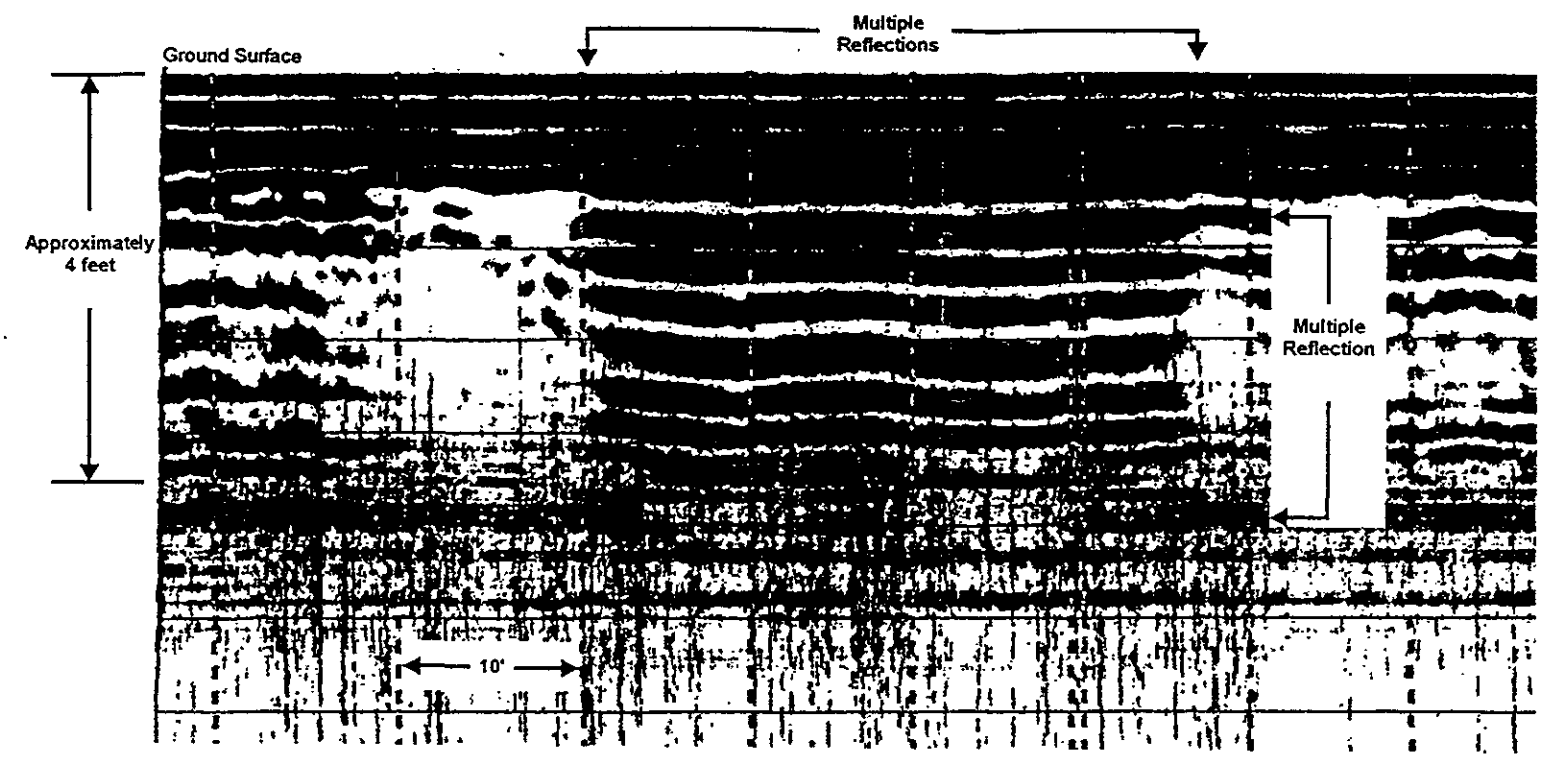
Radar Anomalies Berth 30 Port of Oakland Oakland, California	SCALE: 1" = 30'
	DATE: 9-16-1996
J R ASSOCIATES CIVIL AND ENVIRONMENTAL GEOPHYSICS 1886 EMORY STREET, SAN JOSE, CA 95126 (408) 293-7390	DRAWN: J.J.R.
	REVISED.
	JOB: 121138-96
	DRAWING 3

We could not find any indication of the sides of the excavation in the radar data. If the dirt at the site was removed and recompactd to a depth of six feet, then the radar would not have penetrated to the native soils that might still contain indications of the old excavation. We did see multiple reflections in the radar profiles near the approximate center of the excavation (Drawing 3). Multiple reflections are caused by a change in electrical properties at the base of the asphalt. The change could be due to a thin layer of material that is different from the recompactd soils or it could be due to a void developing under the asphalt. If the fill material in the excavation was settling, it could

cause the multiple reflections seen in the radar profiles. Drawing 3 shows the location of the multiple reflections. The multiple reflections are a possible indication of the old excavation but are less conclusive than a reflection from the side of the excavation.
