From: Xinggang Tong [xtong.otg@gmail.com]
Sent: Wednesday, February 03, 2016 4:33 PM
To: Detterman, Mark, Env. Health
Cc: Nancy Humphrey
Subject: field sampling on January 29 at RO#61, City of Emeryville Fire Station #2
Attachments: 20160129_143742.jpg

Here is a summary of field sampling at the City of Emeryville Fire Station #2 (RO#61) site:

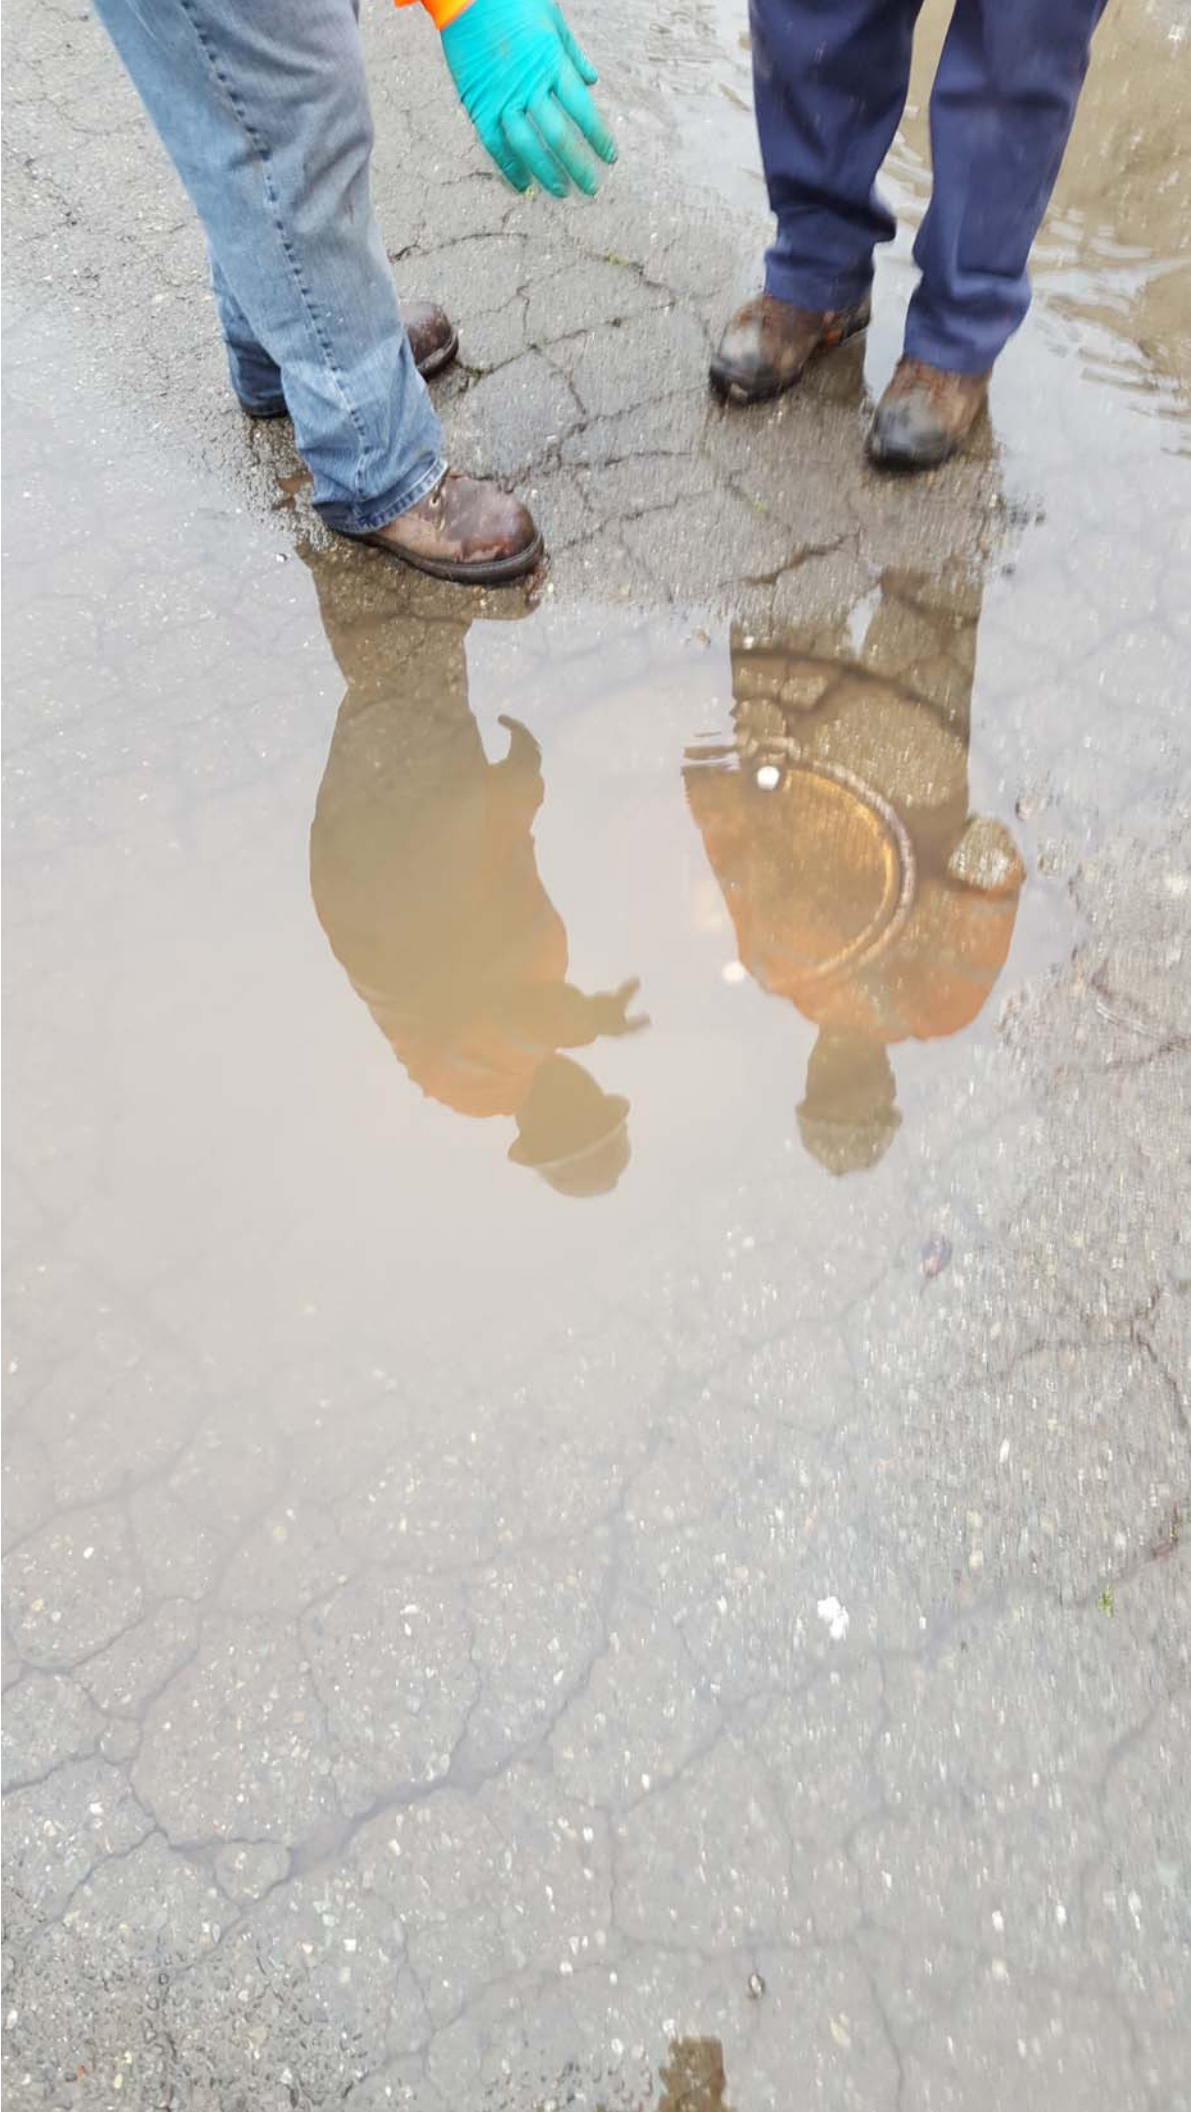
It had moderate rain in the afternoon. The area where the exiting monitoring well MW-1 is located is under water. Please see the attached photo. It is located in heavy traffic area where fire engines drive through and the surface appears to have sunken around 3 to 4 inches, resulting in rain water pooling in the well location area. We removed surface water in the well area and opened the well cap, water inside the well is at about 2.9 ft bgs. I believe the water inside the well casing is from the surface water infiltration, not true groundwater. The area around the well has sunken about 3 to 4 inches, and I think the well seal is not water-tight anymore. Kleinfelder redeveloped the well back on April 5, 2010. It stated in its report that after surging the well and after removing 82 gallons of water (30 casing volumes), the turbidity of the water was still over 400 NTU (out of scale, the instrument can only measure up to 400 NTU). I think this is an indication that the well seal was broken even back in 2010.
