**Clayton**  
ENVIRONMENTAL  
CONSULTANTS

November 23, 1994

Clayton Project No. 47616.01

**Subject:** Apparent Groundwater Mound Issue/Leak Investigation for  
Powell Street Plaza

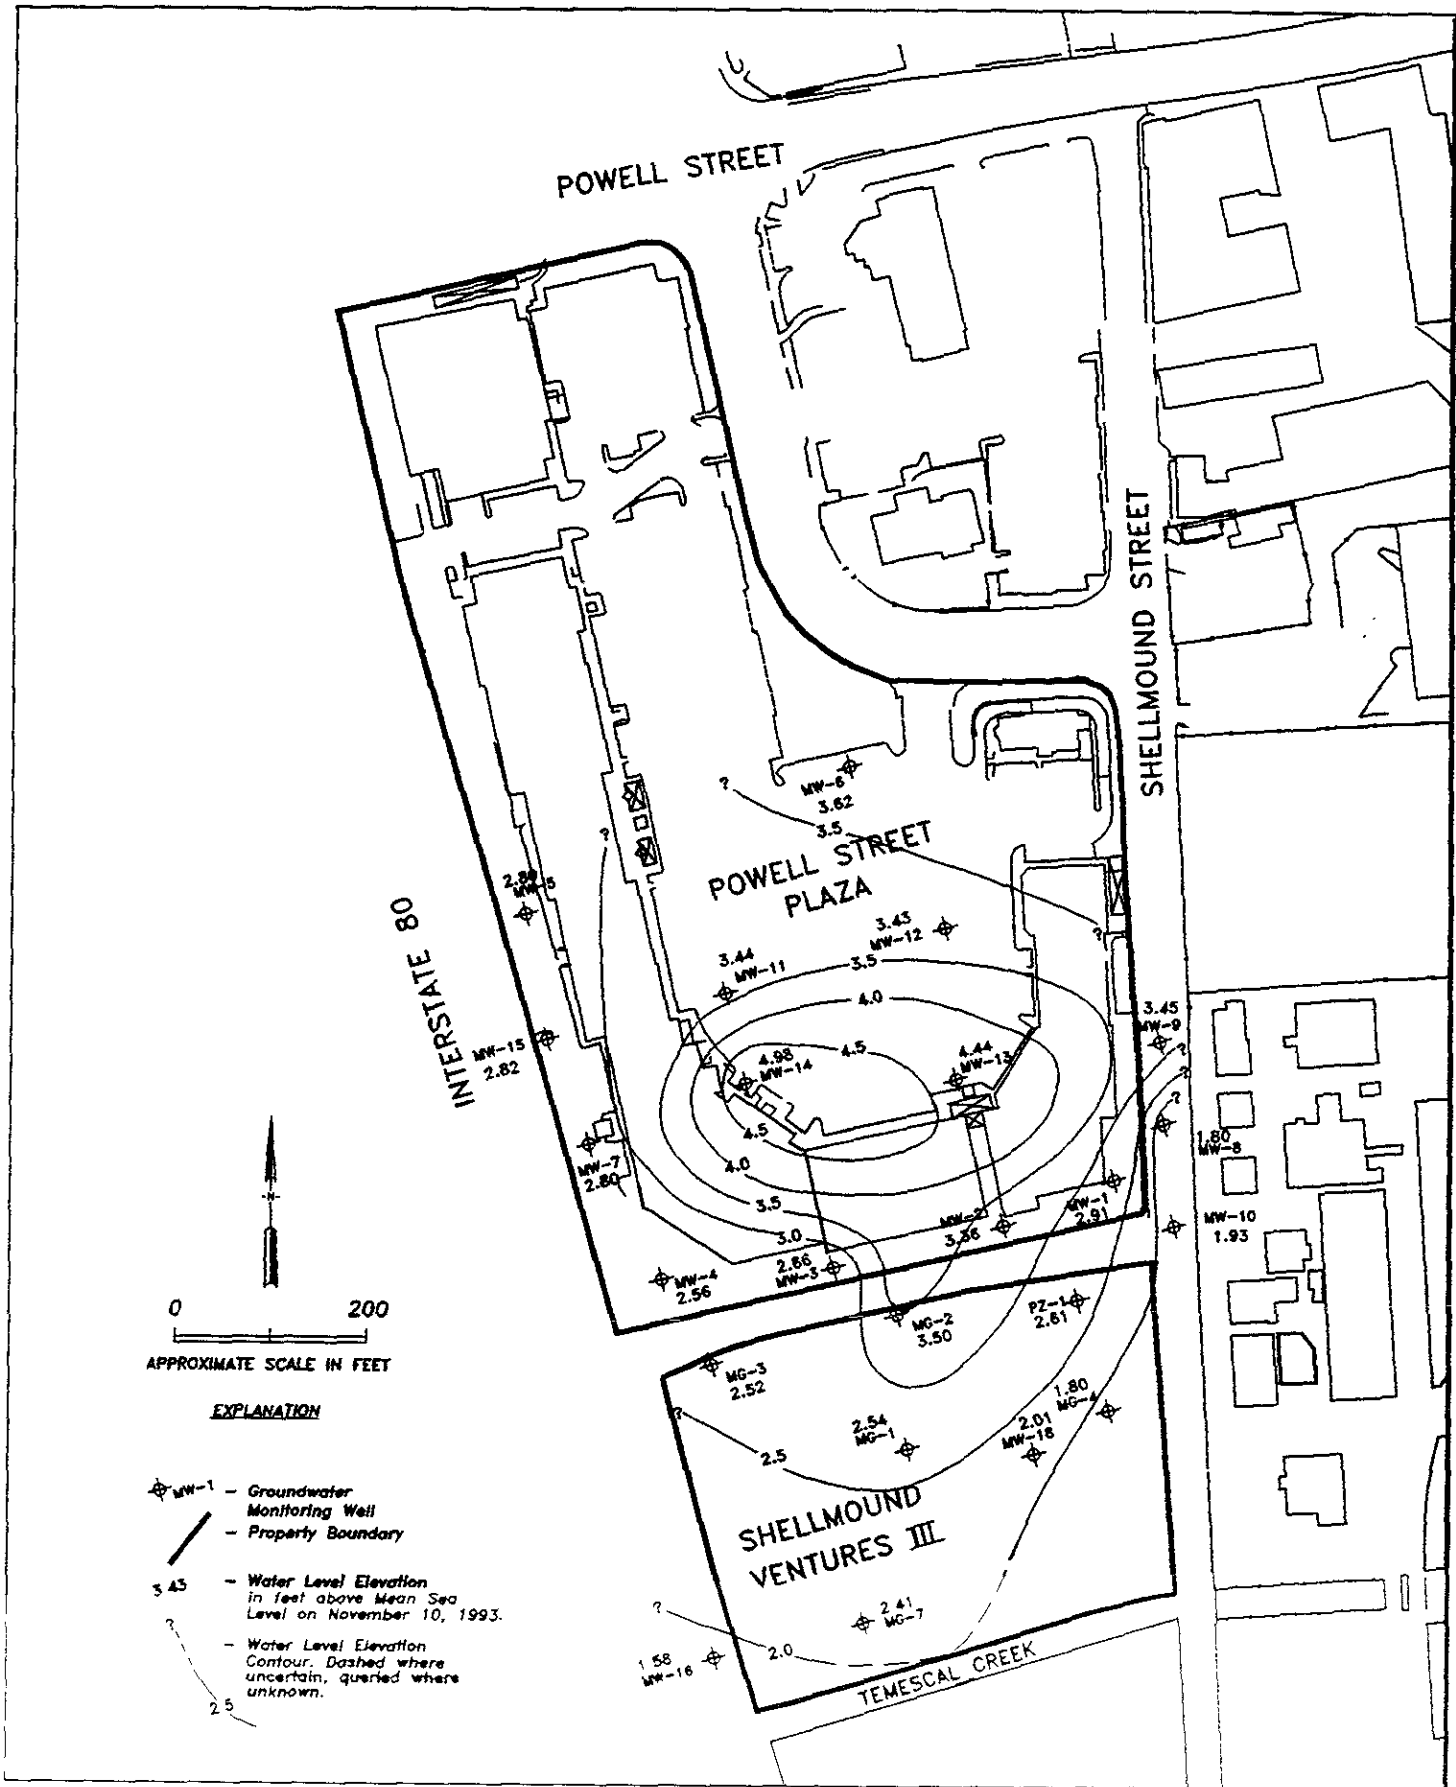
**2**

Site Map with Water-level Elevation Contours-  
 November 10, 1993  
 Powell Street Plaza and Shellmound  
 Ventures III  
 Emeryville, California

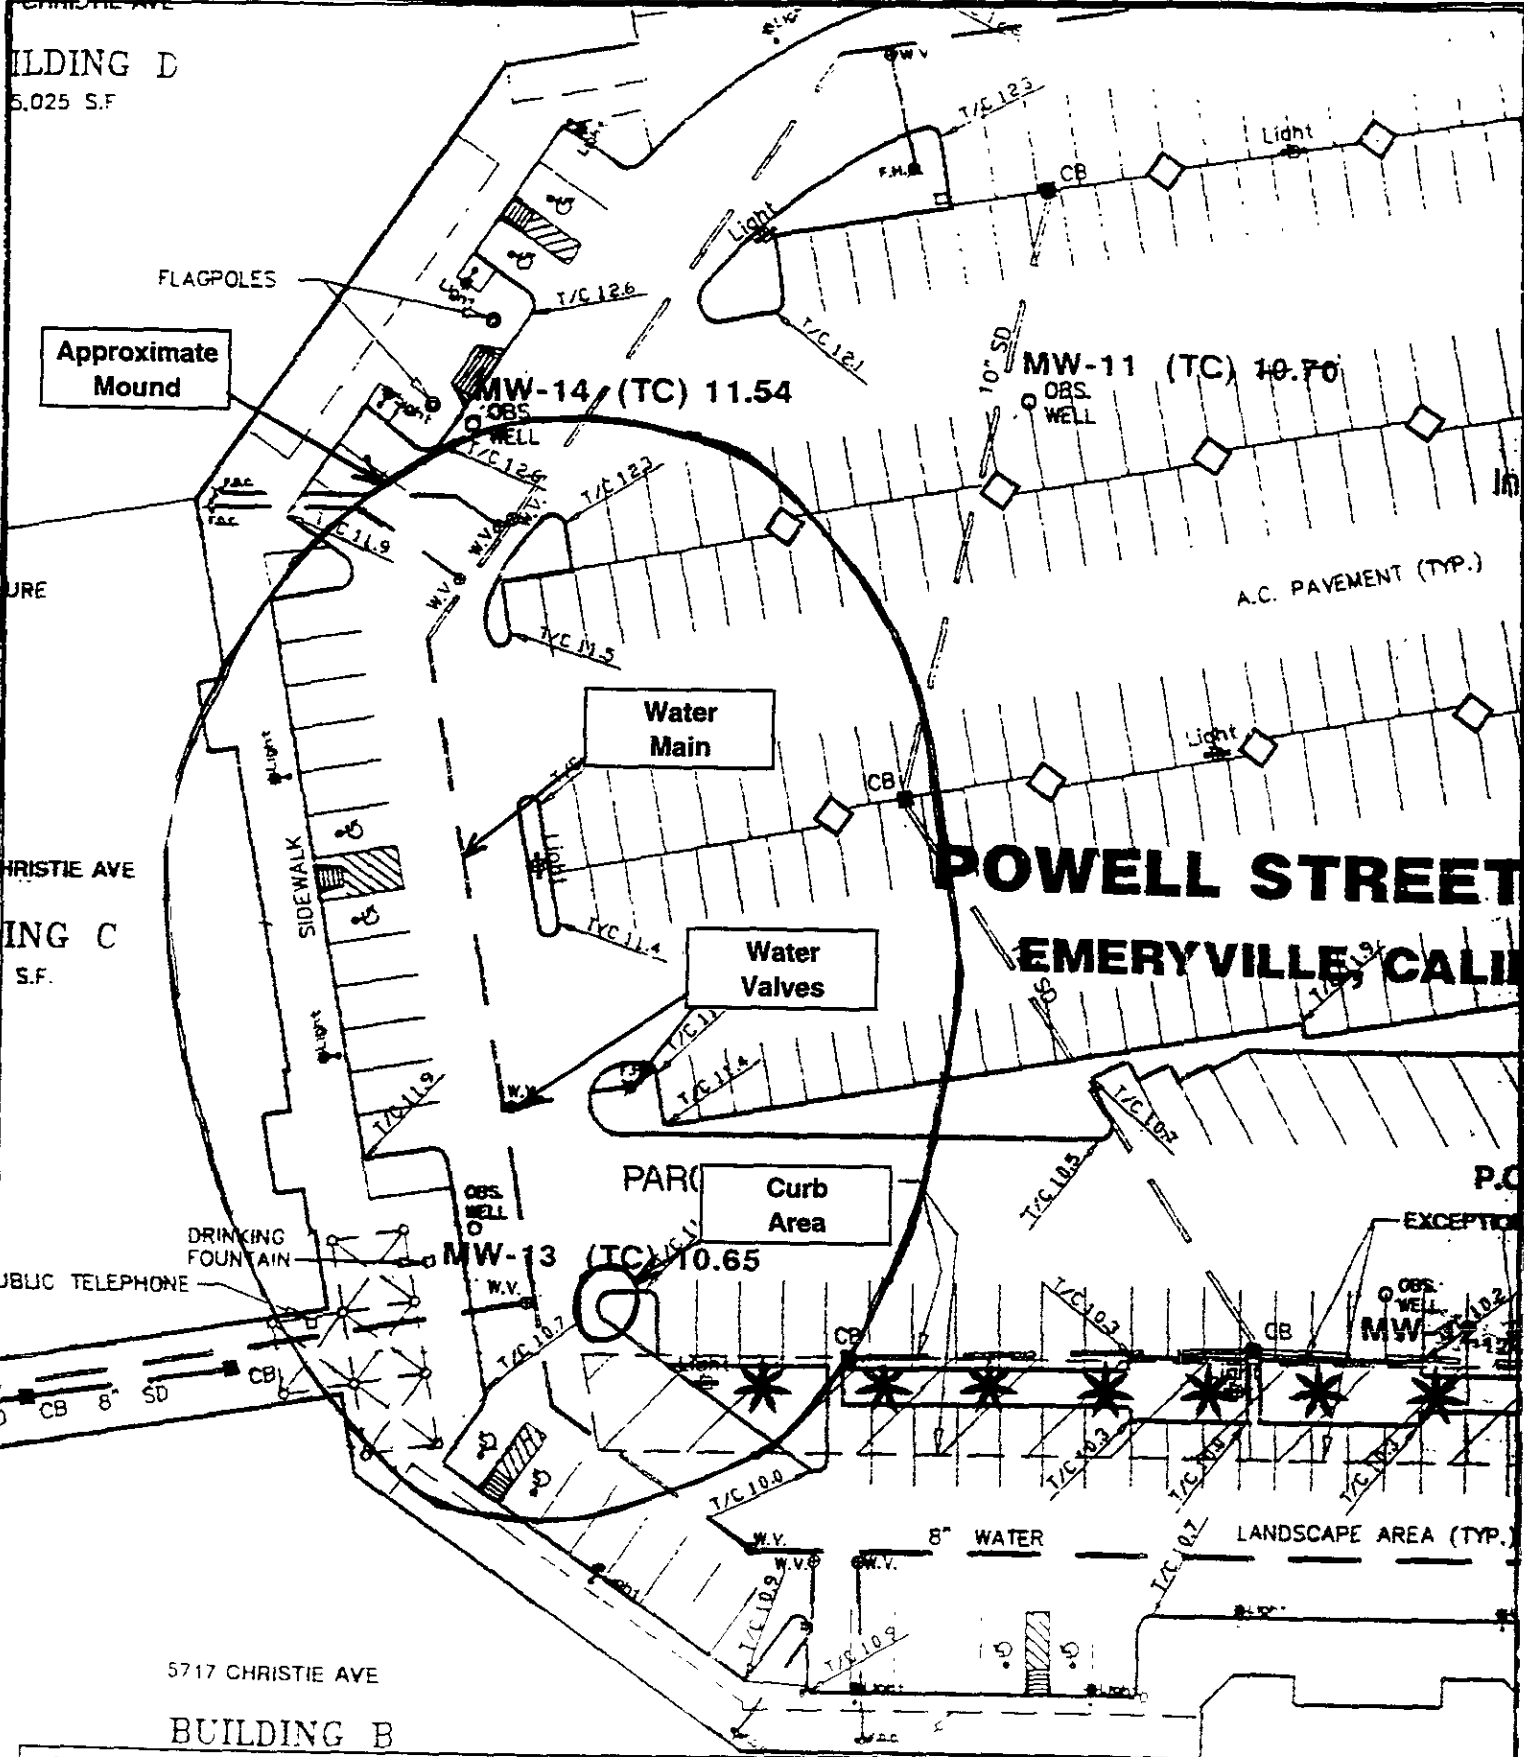
PLATE  
**3**

As noted on the Cullen Engineering Associates drawing labeled Plate 3 of your June 3, 1994 letter, an 8-inch water main and associated valving runs beneath the area of the apparent groundwater mound. This line is part of the fire suppression supply loop which runs along the front and rear sides of the buildings and supplies the various fire hydrants at the site. Two meters register usage of the fire suppression system. According to East Bay Municipal Utility District (EBMUD) billing records, over the four month period February 2, 1994 to June 6, 1994, only one unit of water was used at each, consistent with the amount consumed in testing. Therefore, the fire suppression system is not a source of infiltration water.

Another possible source of infiltration water is the water supply main, laterals and water valves "w.v." which supply the facilities at Powell Street Plaza. As shown on Plate 3, a water main runs directly through the middle of the observed groundwater mound with several

Locations of Possible Water  
Infiltration Sources  
Powell Street Plaza  
Emeryville, California

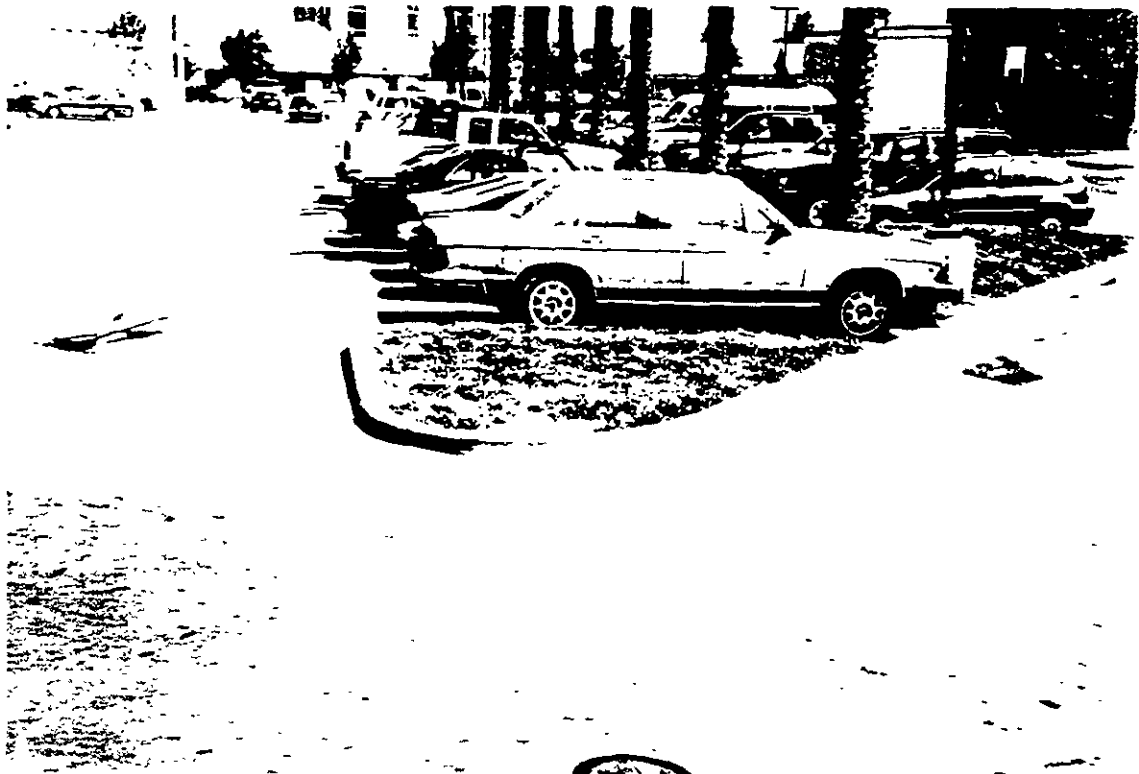
Our site inspection also showed that there is no damaged sprinkler head in the landscaped parking area which you speculated might be damaged by delivery trucks, adjacent to MW-13. The puddle of water shown in your photograph (Plate 4 of your June 3 letter) is due to irrigation water draining from the lawn area to that low point in the curbed area. The amount of water applied at any point in the watered areas is sufficient to wet the soil to just below the root line. Therefore, although there is a small puddle of water intermittently present in this area, our investigation does not indicate that it is a source of infiltration.

Photograph 1. View from south end of Powell Street Plaza parking lot looking north toward Christie Avenue and Powell Street. Curb with standing water is shown in foreground.
