**PRELIMINARY
ENVIRONMENTAL SITE ASSESSMENT**

**LATHROP PROPERTY
EMERYVILLE, CALIFORNIA**

June 1989

Woodward-Clyde Consultants

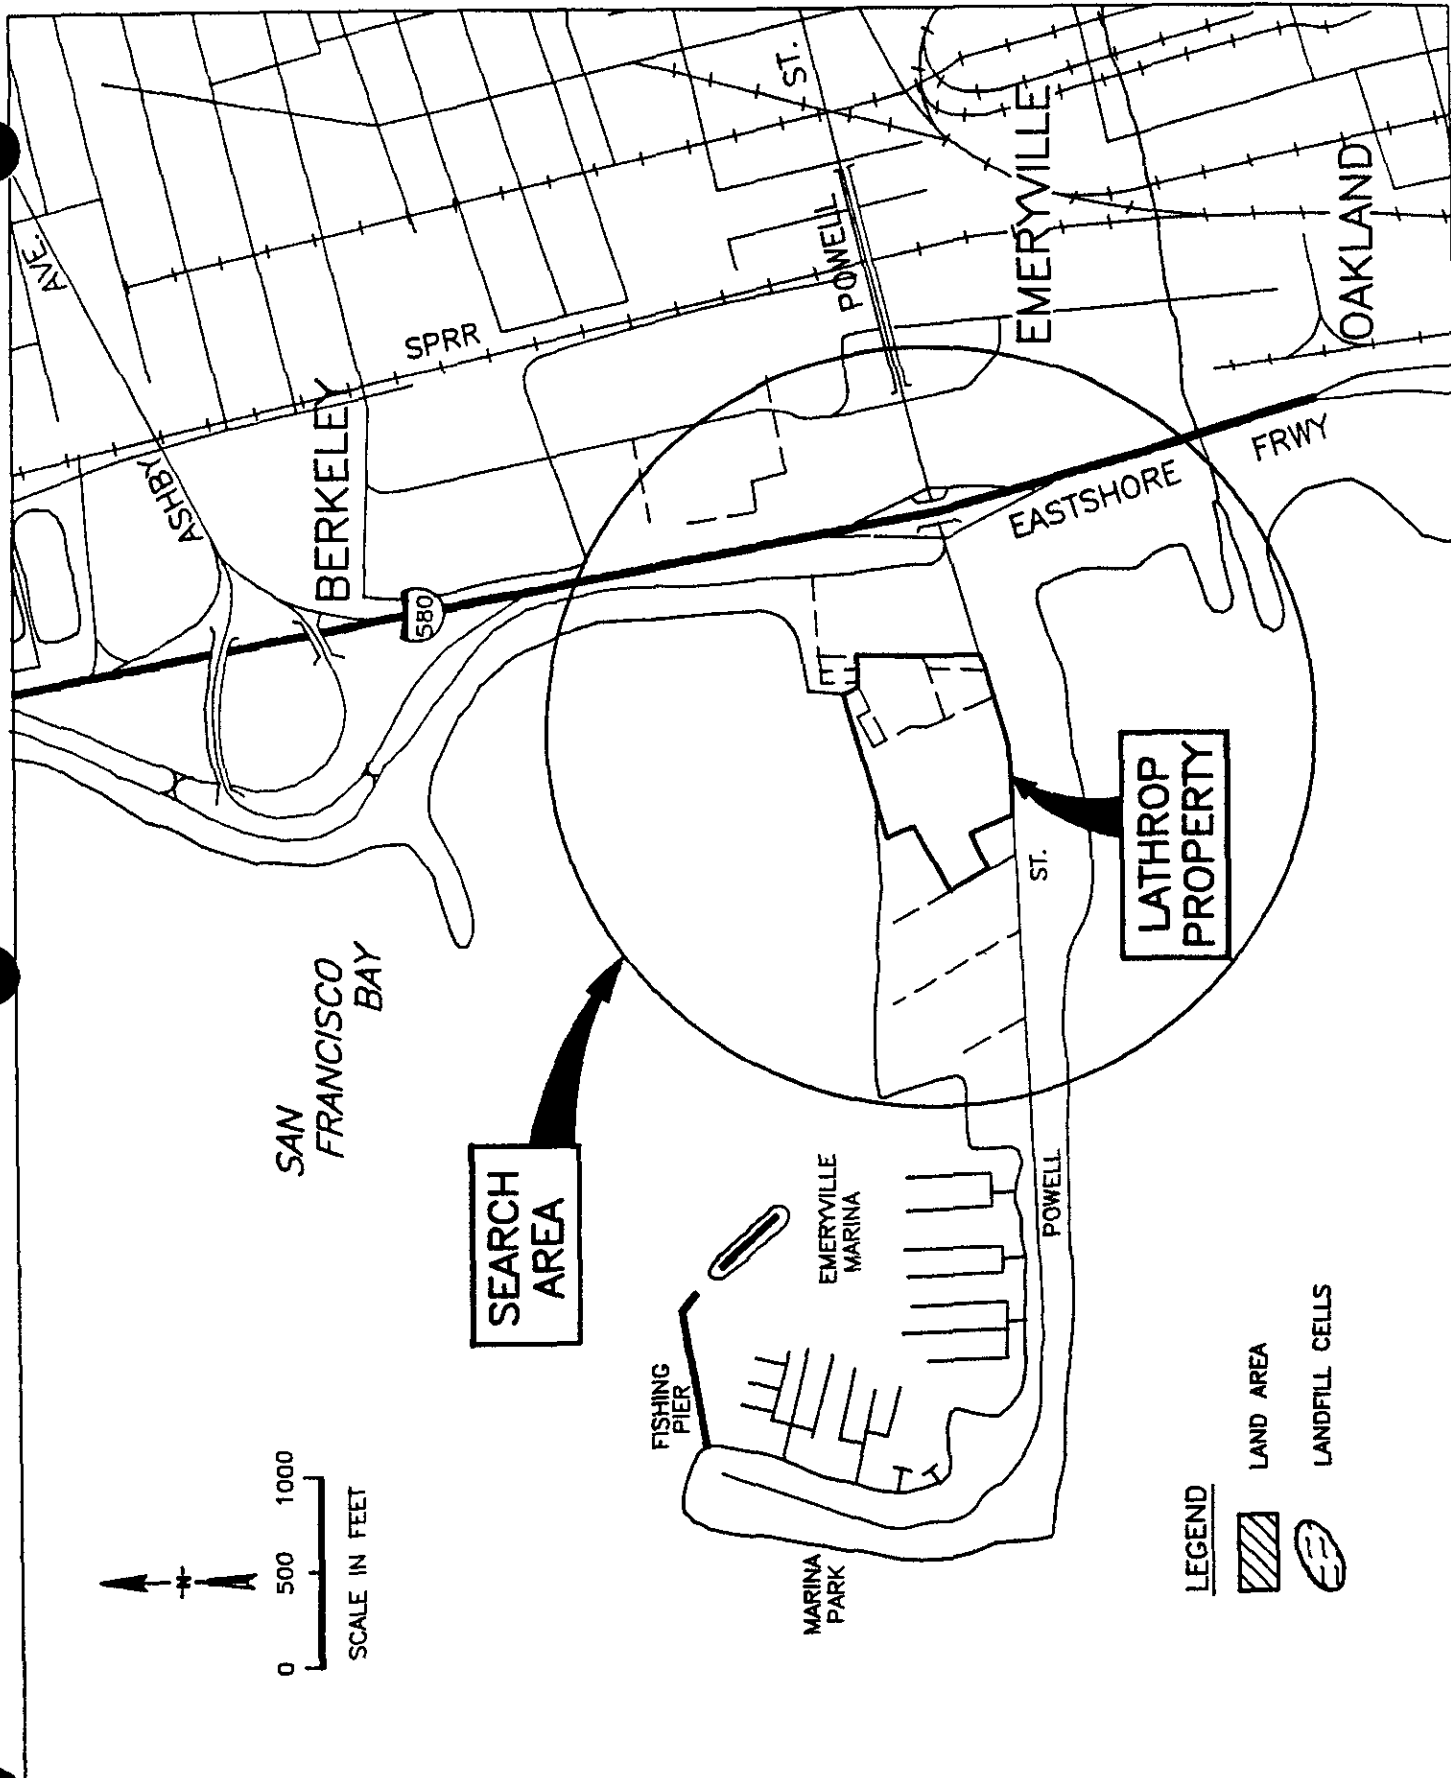
The subject property is located in Emeryville, California. It is an 18-acre site, more or less, lying at the east end of the man-made Emeryville peninsula jutting westward into San Francisco Bay from the Emeryville shoreline. The nearest major road intersection is that of Powell Street and U.S. Highway 880. The Lathrop property boundary is described in the Agreement and shown on Figure 1, Project Site Map.

The Search Area shown on Figure 1 is centered on the Lathrop property. The Search Area, a circle with a 2000-foot radius, was used to screen other sites in the vicinity during our file searches.

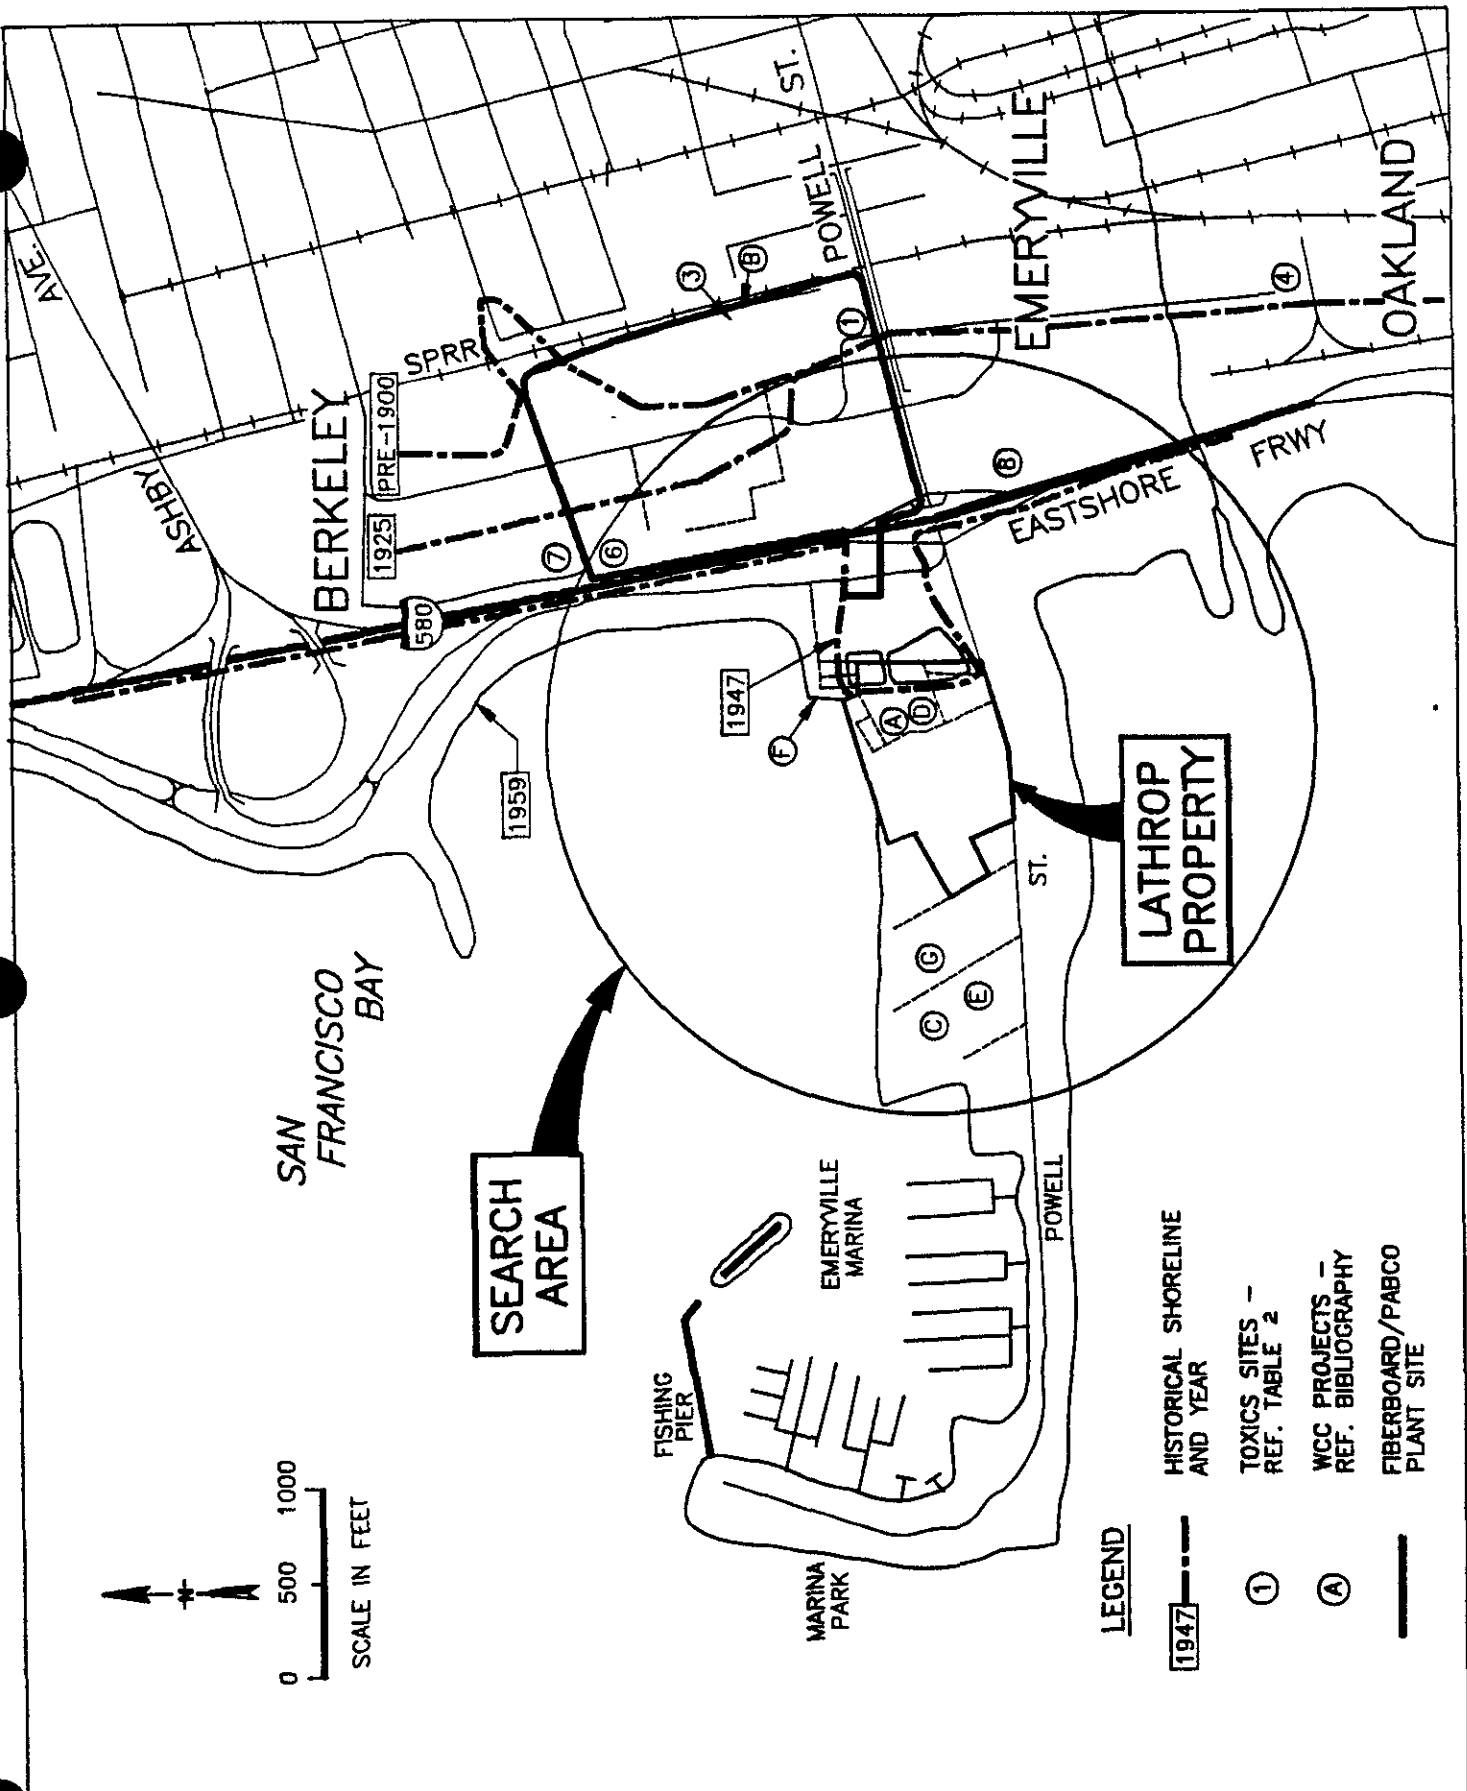
Project No. BB10235A	LATHROP PROPERTY ENVIRONMENTAL ASSESSMENT	REFERENCE MAP	Figure 8
Woodward-Clyde Consultants

The Lathrop property is located in an area of Emeryville which was formerly submerged beneath San Francisco Bay. The historical (1856) bay shoreline was located near the Southern Pacific (SPRR) railroad tracks in Figure 8.

There are two reported fuel leaks in the Search Area and four others nearby, but outside the Search Area (Figure 8). The two sites within the Search Area (Table 2, #6 and #8) are located north and south, respectively, of the Emeryville peninsula. Garrett Freight Line (Table 2, #6) at 64th and Lacoste is known to be the site of several drum and tank leaks. The nature and extent of the contamination resulting from these leaks is currently under investigation.
