September 27, 1993

RE: Investigation / Remediation Related to the Former
Underground Storage Tanks at Dunne Quality Paints,
1007 41st Street, Oakland, California.

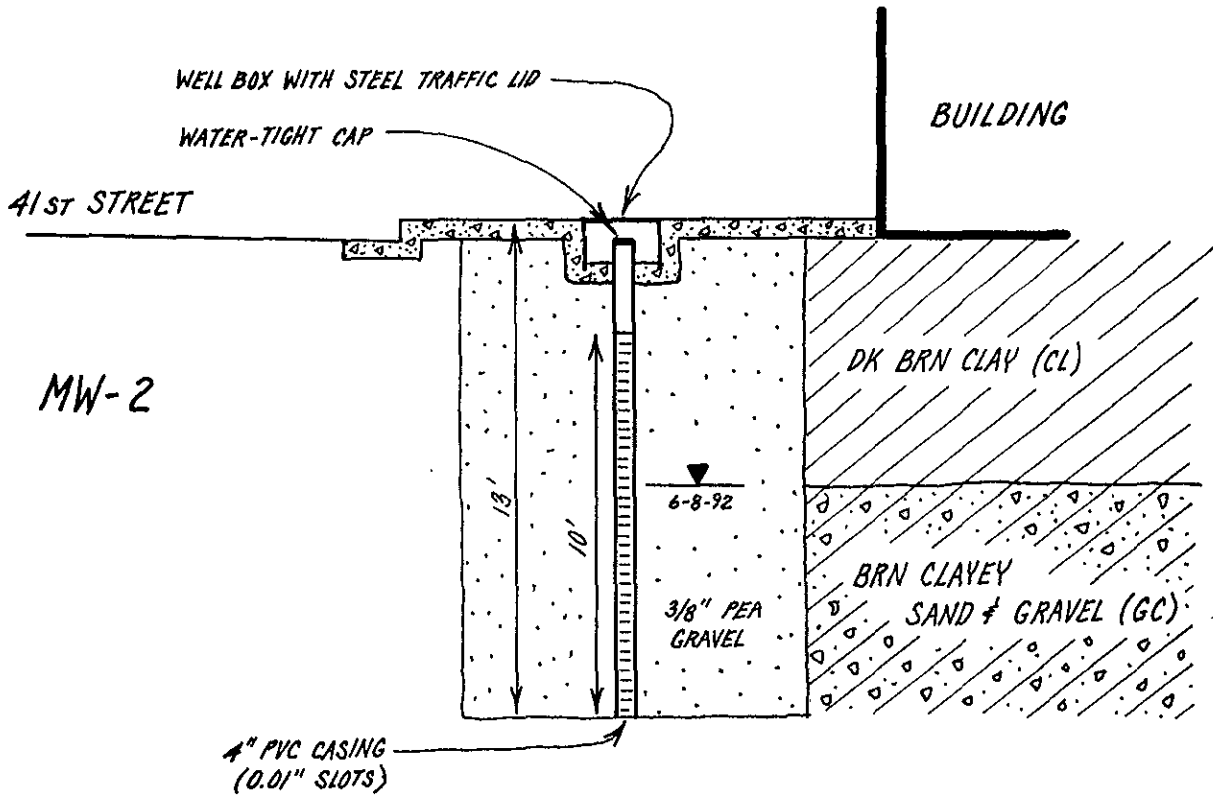
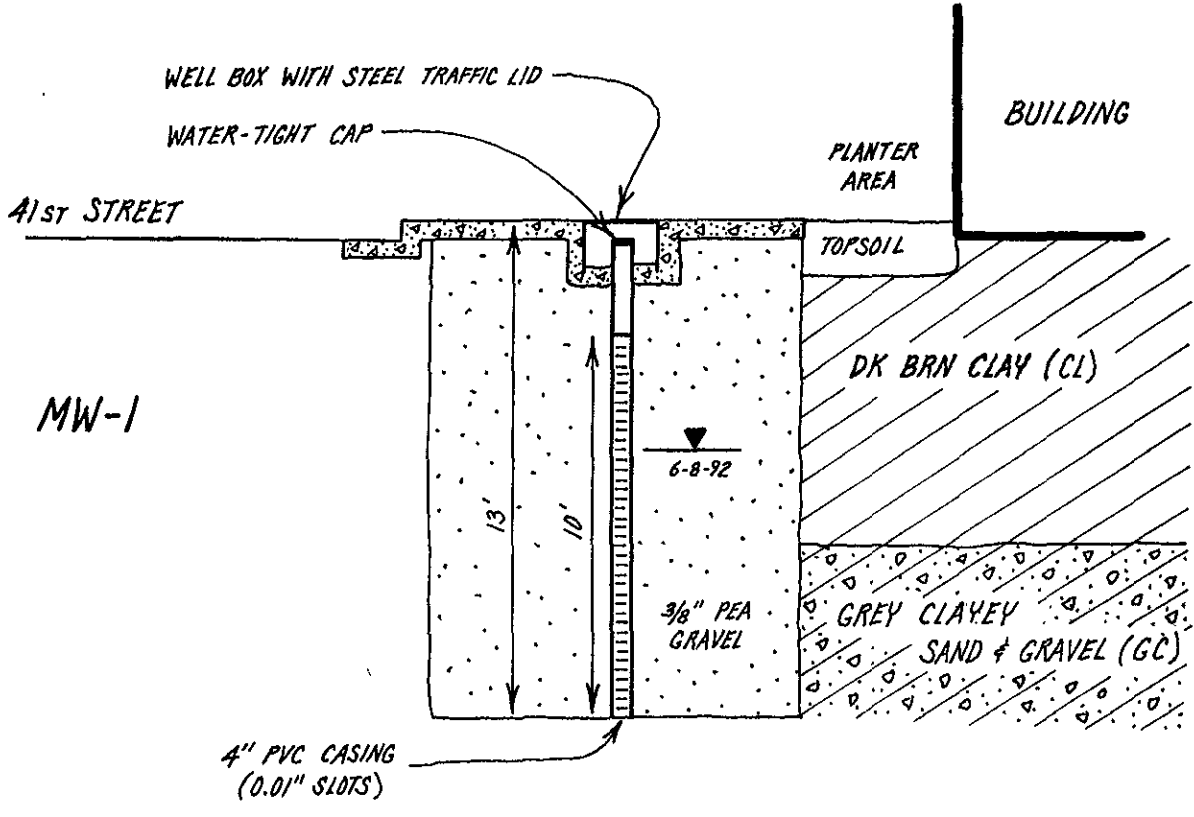
FIGURE 1.
Well Construction.

- 4) **Monitoring Well Construction.** The two on-site shallow groundwater monitoring wells were constructed by SEMCO. Upon completion of the soil excavation, two 4-inch well casings were suspended inside the excavation, with the bottoms resting on the bottom of the excavation. Each well casing consisted of 10 feet of 4-inch PVC slotted screen pipe (0.01" slots), and were each completed up to the ground surface with 4-inch PVC blank casing. The total depth of each well is 13 feet below ground surface. The excavation was subsequently backfilled around each well casing with 3/8" pea gravel.

The well construction is illustrated on Figure 1. As shown by this figure, each of the monitoring wells MW-1 and MW-2 is screened to intercept free floating product and to accommodate water table fluctuations. It would appear that the samples collected from these two monitoring wells are representative of the shallow groundwater quality in the immediate vicinity of the

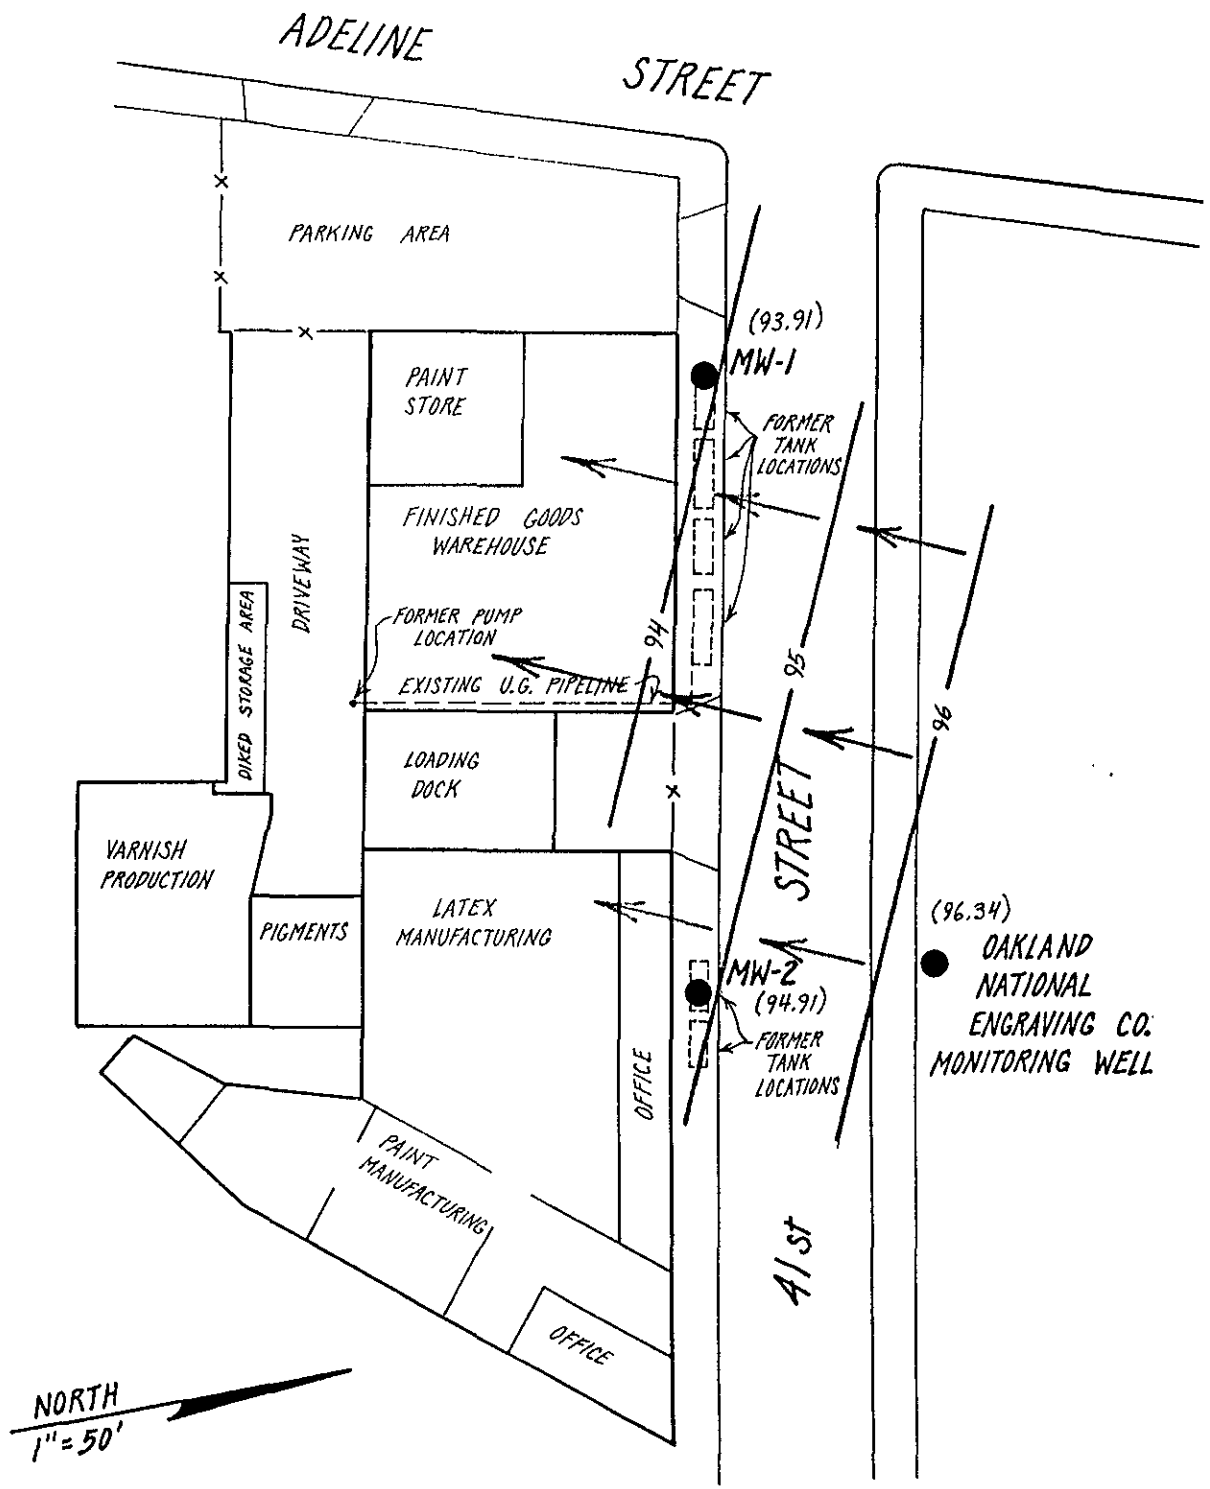
FIGURE 2.
 Shallow Groundwater Table
 Contour Map. (June 18, 1992)

Figure 2 presents a contour map for the shallow groundwater table beneath the site (June 18, 1992). As shown in this figure, the data from these monitoring wells indicate that the shallow groundwater flow beneath the site is calculated as being in a southwesterly direction.

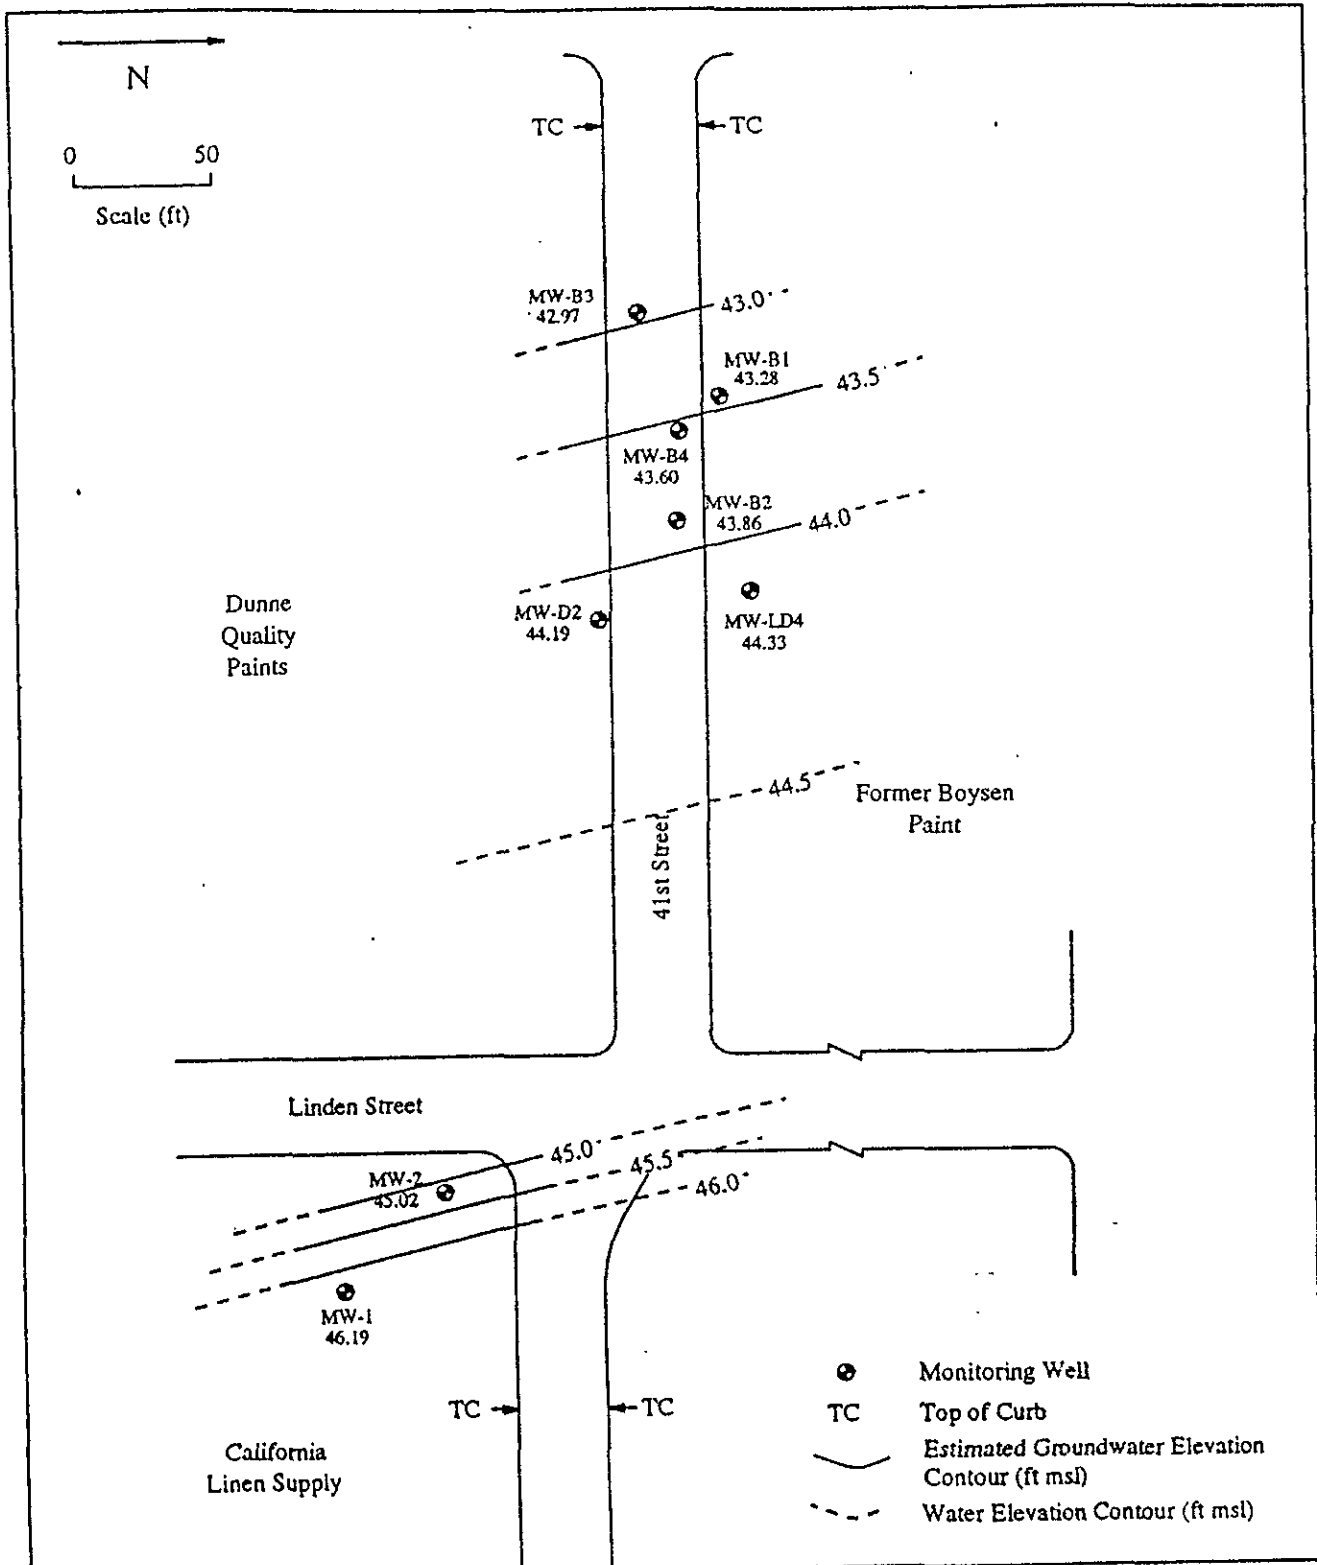
Figure 8
 Groundwater Elevation Contours - July 8, 1993
 Former Boyesen Paint Company
 Emeryville, California

groundwater elevations have been made available by the work conducted by Environmental Strategies Corporation at the Former Boysen Paint Company. The contour map for the shallow groundwater table on July 8, 1993, in the vicinity of the former Dunne Paint site is shown on Figure 3. As shown in this figure, the data indicate that the shallow groundwater flow is calculated as being in a west-southwesterly direction.

Based upon the data presented above, it would appear that a verified down-gradient direction has been established for the former Dunne Paint site.
