September 15, 1995
Project 20805-135.004

Re: Product line repair, precision line testing, and soil sampling at ARCO service station
6148, 5131 Shattuck Avenue, Oakland, California

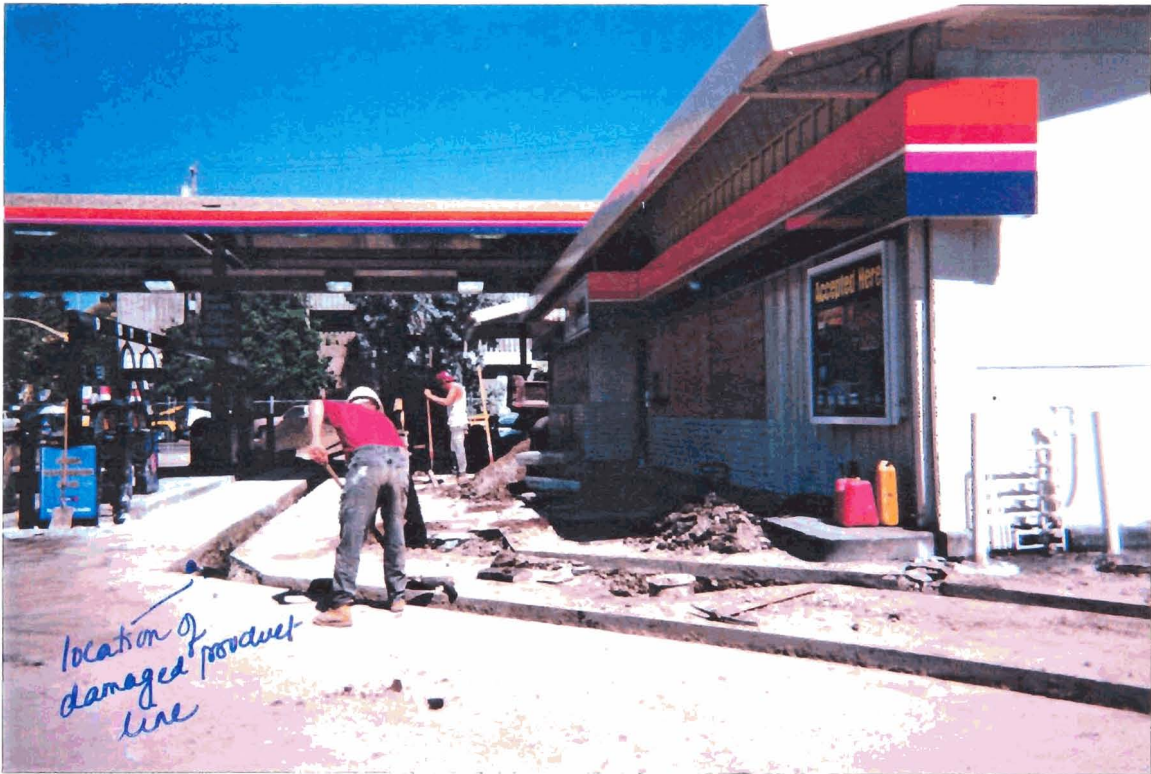
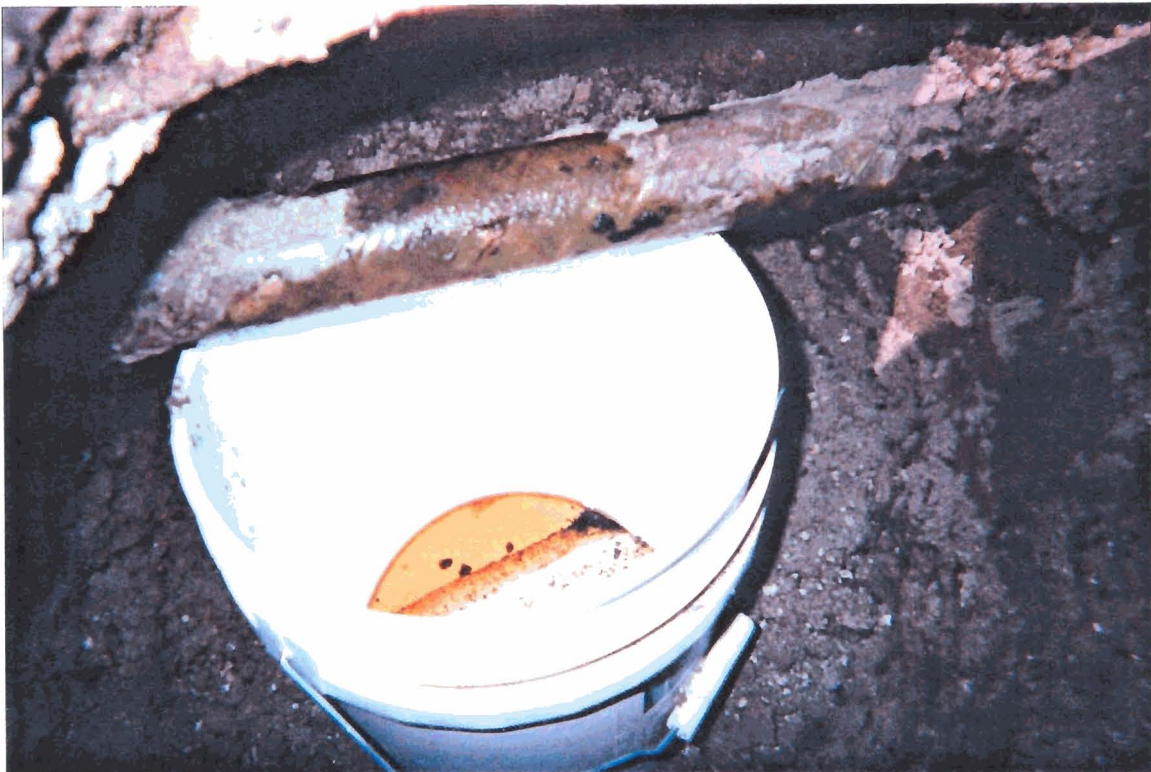
APPENDIX A
COPIES OF PHOTOGRAPHS OF DAMAGED PRODUCT LINE

On August 14, 1995, ARCO commenced construction activities at the subject site for installation of an interim soil and groundwater remediation system. EMCON, on behalf of ARCO, was observing the construction activities. On August 15, 1995, during excavation of a trench approximately 4 feet south of the southern pump island, Balch Petroleum, Inc. (Balch), the subcontractor for ARCO on the project, damaged a gasoline product line 26 inches below ground surface (BGS) (Drawing C1). Balch crew members were hand-digging in the proposed excavation zone as a precautionary measure to avoid damaging existing underground utilities in the excavation zone. Despite the cautious procedure of hand-digging, the gasoline product line was scraped by a shovel being used by one of Balch's crew members, resulting in a slow drip of gasoline product from the product line.

The incident occurred at 11:00 a.m. Balch's crew immediately placed a 5-gallon bucket under the product line to prevent the gasoline from dripping into the subsurface soil in the excavated zone; the crew then informed Sailaja Yelamanchili of EMCON regarding the incident. Photographs of the damaged product line are presented in Appendix A. Subsequently, Linda Andrews, environmental coordinator for ARCO, was informed of the incident, who then informed Susan Hugo of the ACHCSA. Brian P. Oliva, Hazardous Materials Specialist, ACHCSA, arrived at the site the same day (August 15, 1995) at 2:00 p.m. to inspect the damage. Between 11:00 a.m. and 2:00 p.m. on August 15, 1995,

less than 4 ounces of gasoline leaked from the product line. Mr. Oliva inspected the damaged product line, and completed a hazardous materials inspection form, a copy of which was given to Ms. Yelamanchili.

On August 16, 1995, EMCON observed that a total of less than 6 ounces of gasoline had leaked from the product line into the 5-gallon bucket.

- Balch repaired the damaged product line on August 16, 1995. (A copy of the procedure adopted to repair the fiberglass product line is presented as Appendix B.)
