Subject: Corrective Action Implementation Work Plan
Pacific Gas and Electric Company, Oakland General Construction Yard
4930 Coliseum Way, Oakland, California

Corrective Action Implementation Workplan

Oakland General Construction Yard
4930 Coliseum Way
Oakland, California

January 2016

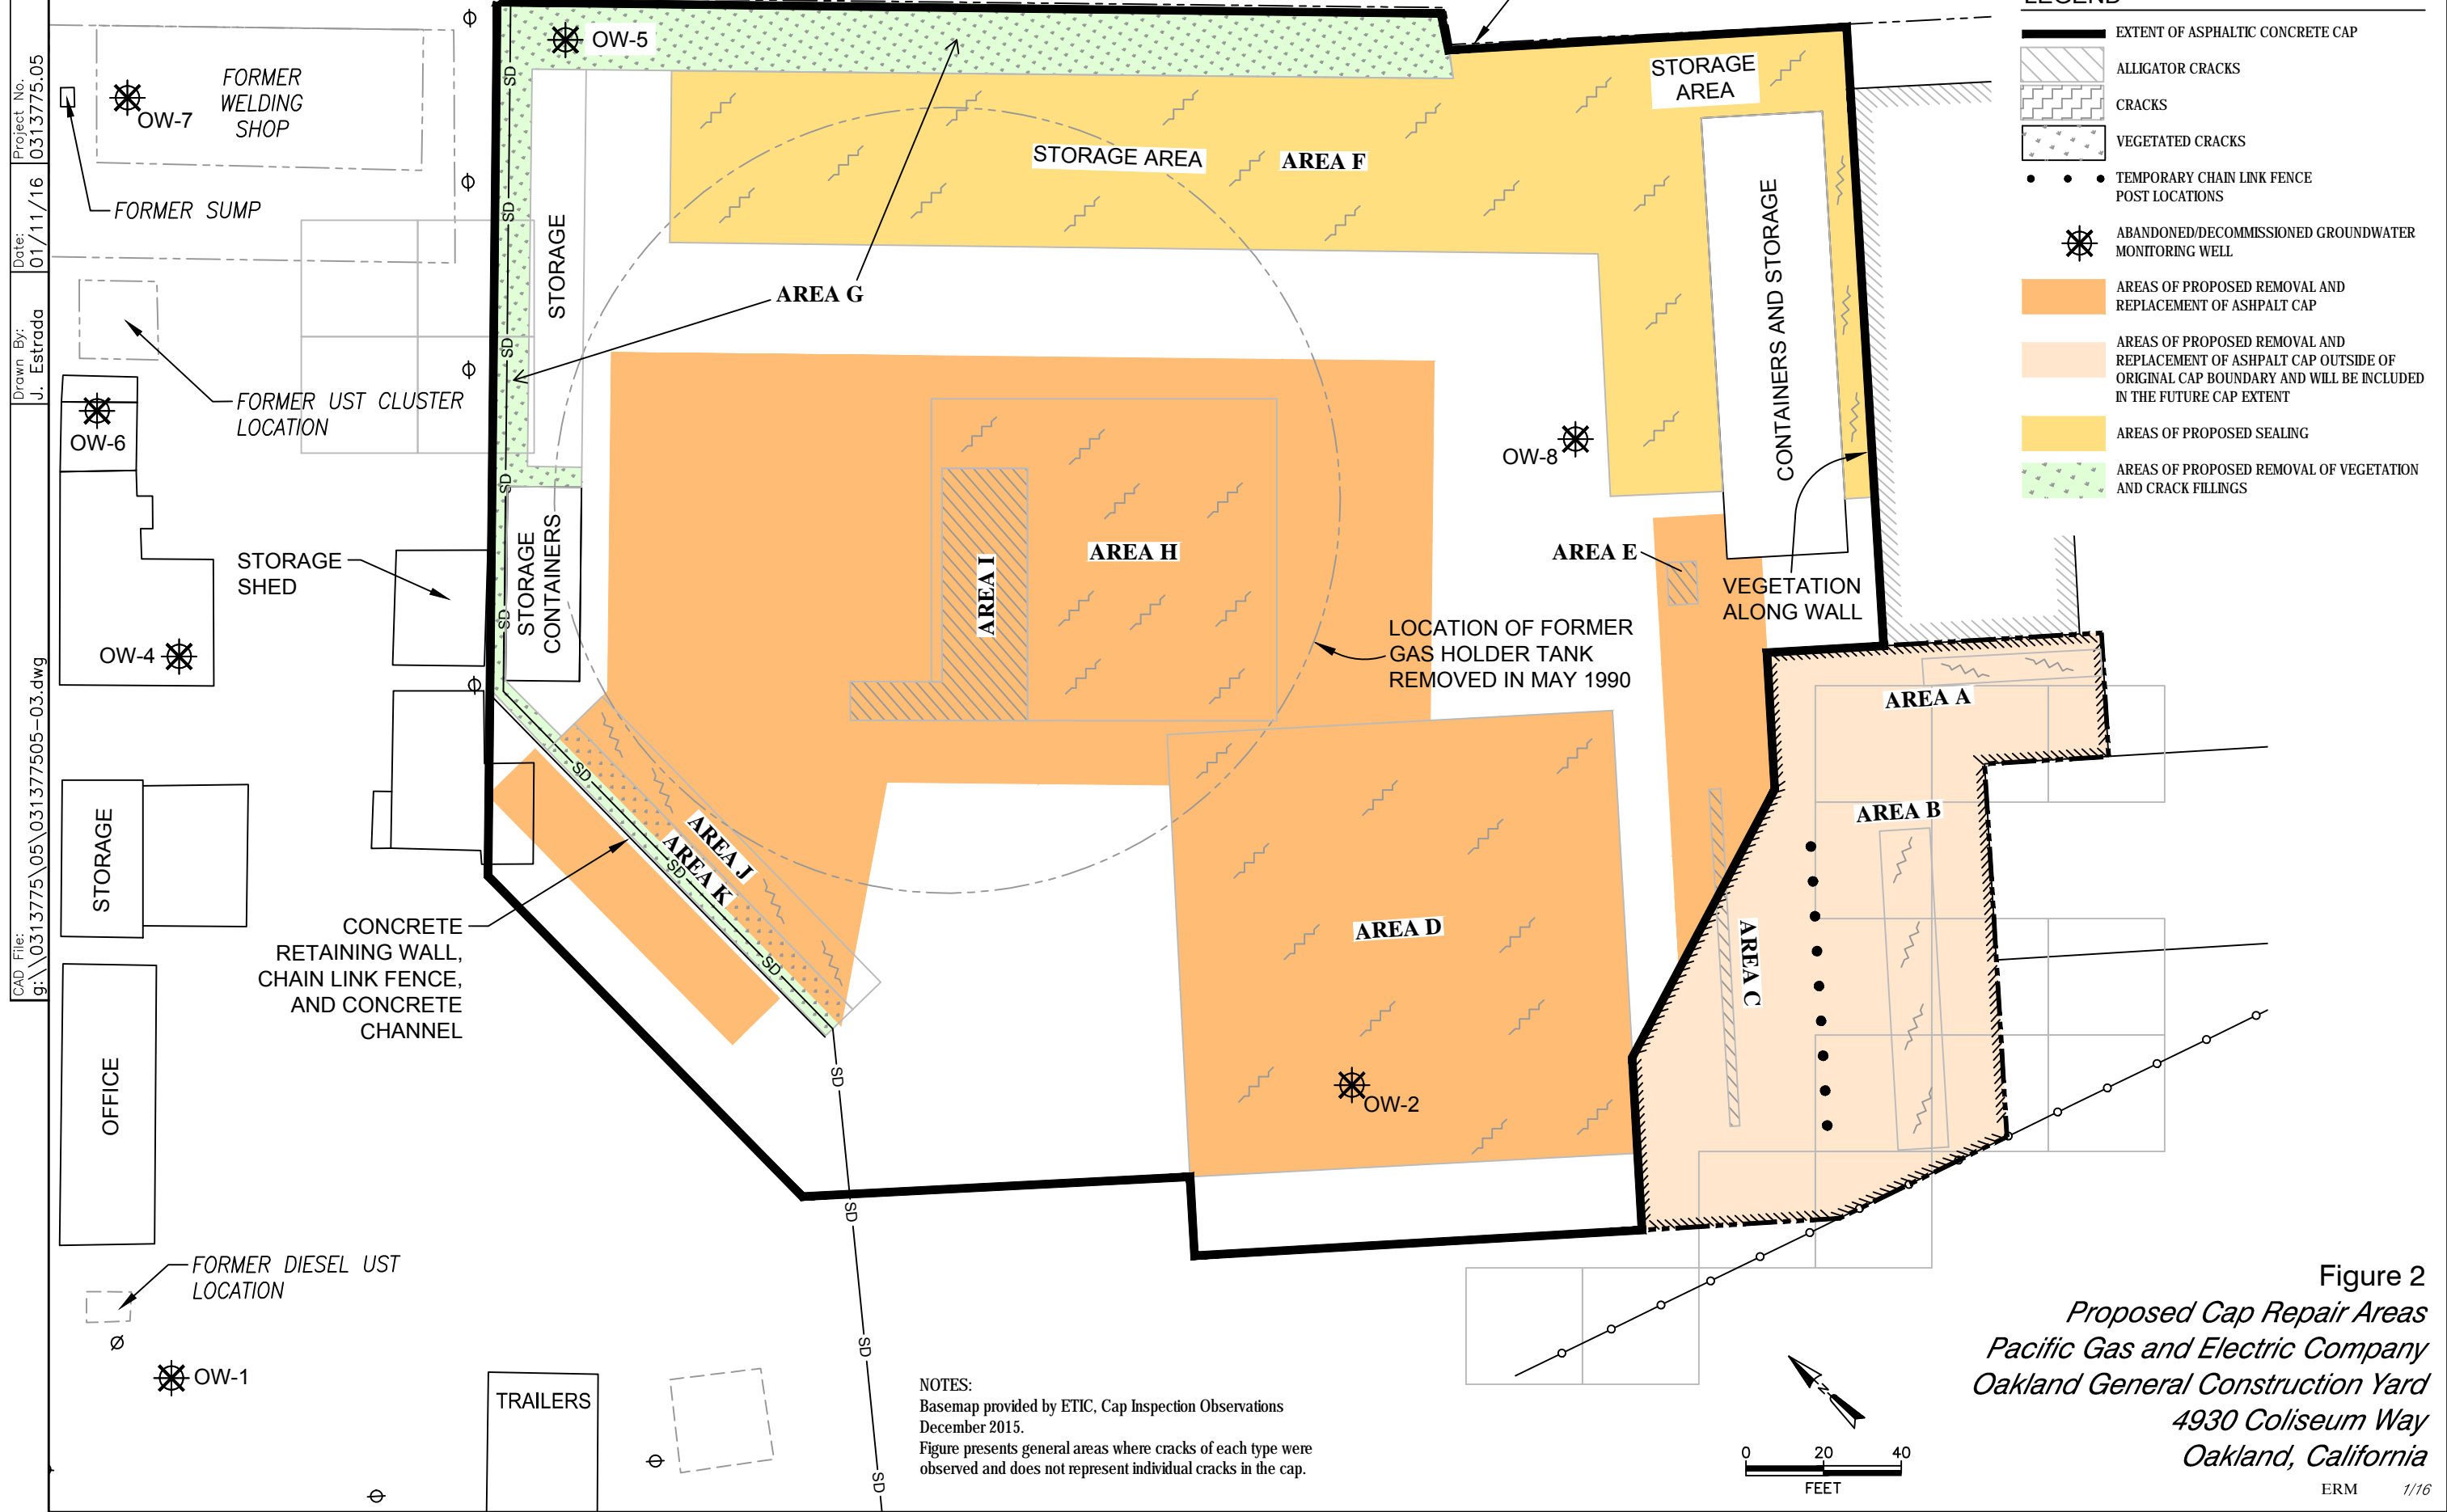
Figure 2
 Proposed Cap Repair Areas
 Pacific Gas and Electric Company
 Oakland General Construction Yard
 4930 Coliseum Way
 Oakland, California
 ERM 1/16

- Areas G and K: Vegetation removal and crack sealing;
- Areas C, E, I: Maintenance, repair, or replacement of approximately of asphalt with alligator cracking.
- Areas D, F, H, J: Asphalt containing cracks should be monitored for spreading, and sealed with asphaltic slurry as needed;
- Areas outside of the cap (areas A and B): Monitor for spreading and seal as needed; and
- Area to the southeast and outside of the Cap: Nine fencepost holes are recommended to be backfilled and sealed, as needed.

The areas of removal/replacement and repair are listed below and the approximate areas are shown on Figure 2. The varying thicknesses of asphalt are proposed to accommodate how the area is currently used (i.e., heavy traffic, parking of heavy equipment, etc.):

- Remove and replace 3-inch thick asphalt area – This includes the outside/south-southeast of cap; and Area A, B and C (southern portion) as indicated in the 2015 Inspection Report;
- Remove and replace 4-inch thick asphalt area – This includes the central and southern portions of the cap; and Areas C (northern portion), D, E, H and I as indicated in the 2015 Inspection Report; and
- Remove and replace 6-inch thick asphalt area – This includes the plate storage on the western area of the cap; and Area J as indicated in the 2015 Inspection Report.

In areas with vegetated cracks (Area G), the vegetation will be removed to the extent practicable, and the cracks blown clean. The approximate area of the crack filling/sealing inside the cap is estimated to be 200 linear feet (Figure 2). The actual footage will be determined in the field. The cracks will be filled with a hot asphaltic emulsion and/or asphalt caulking troweled to a smooth finish.

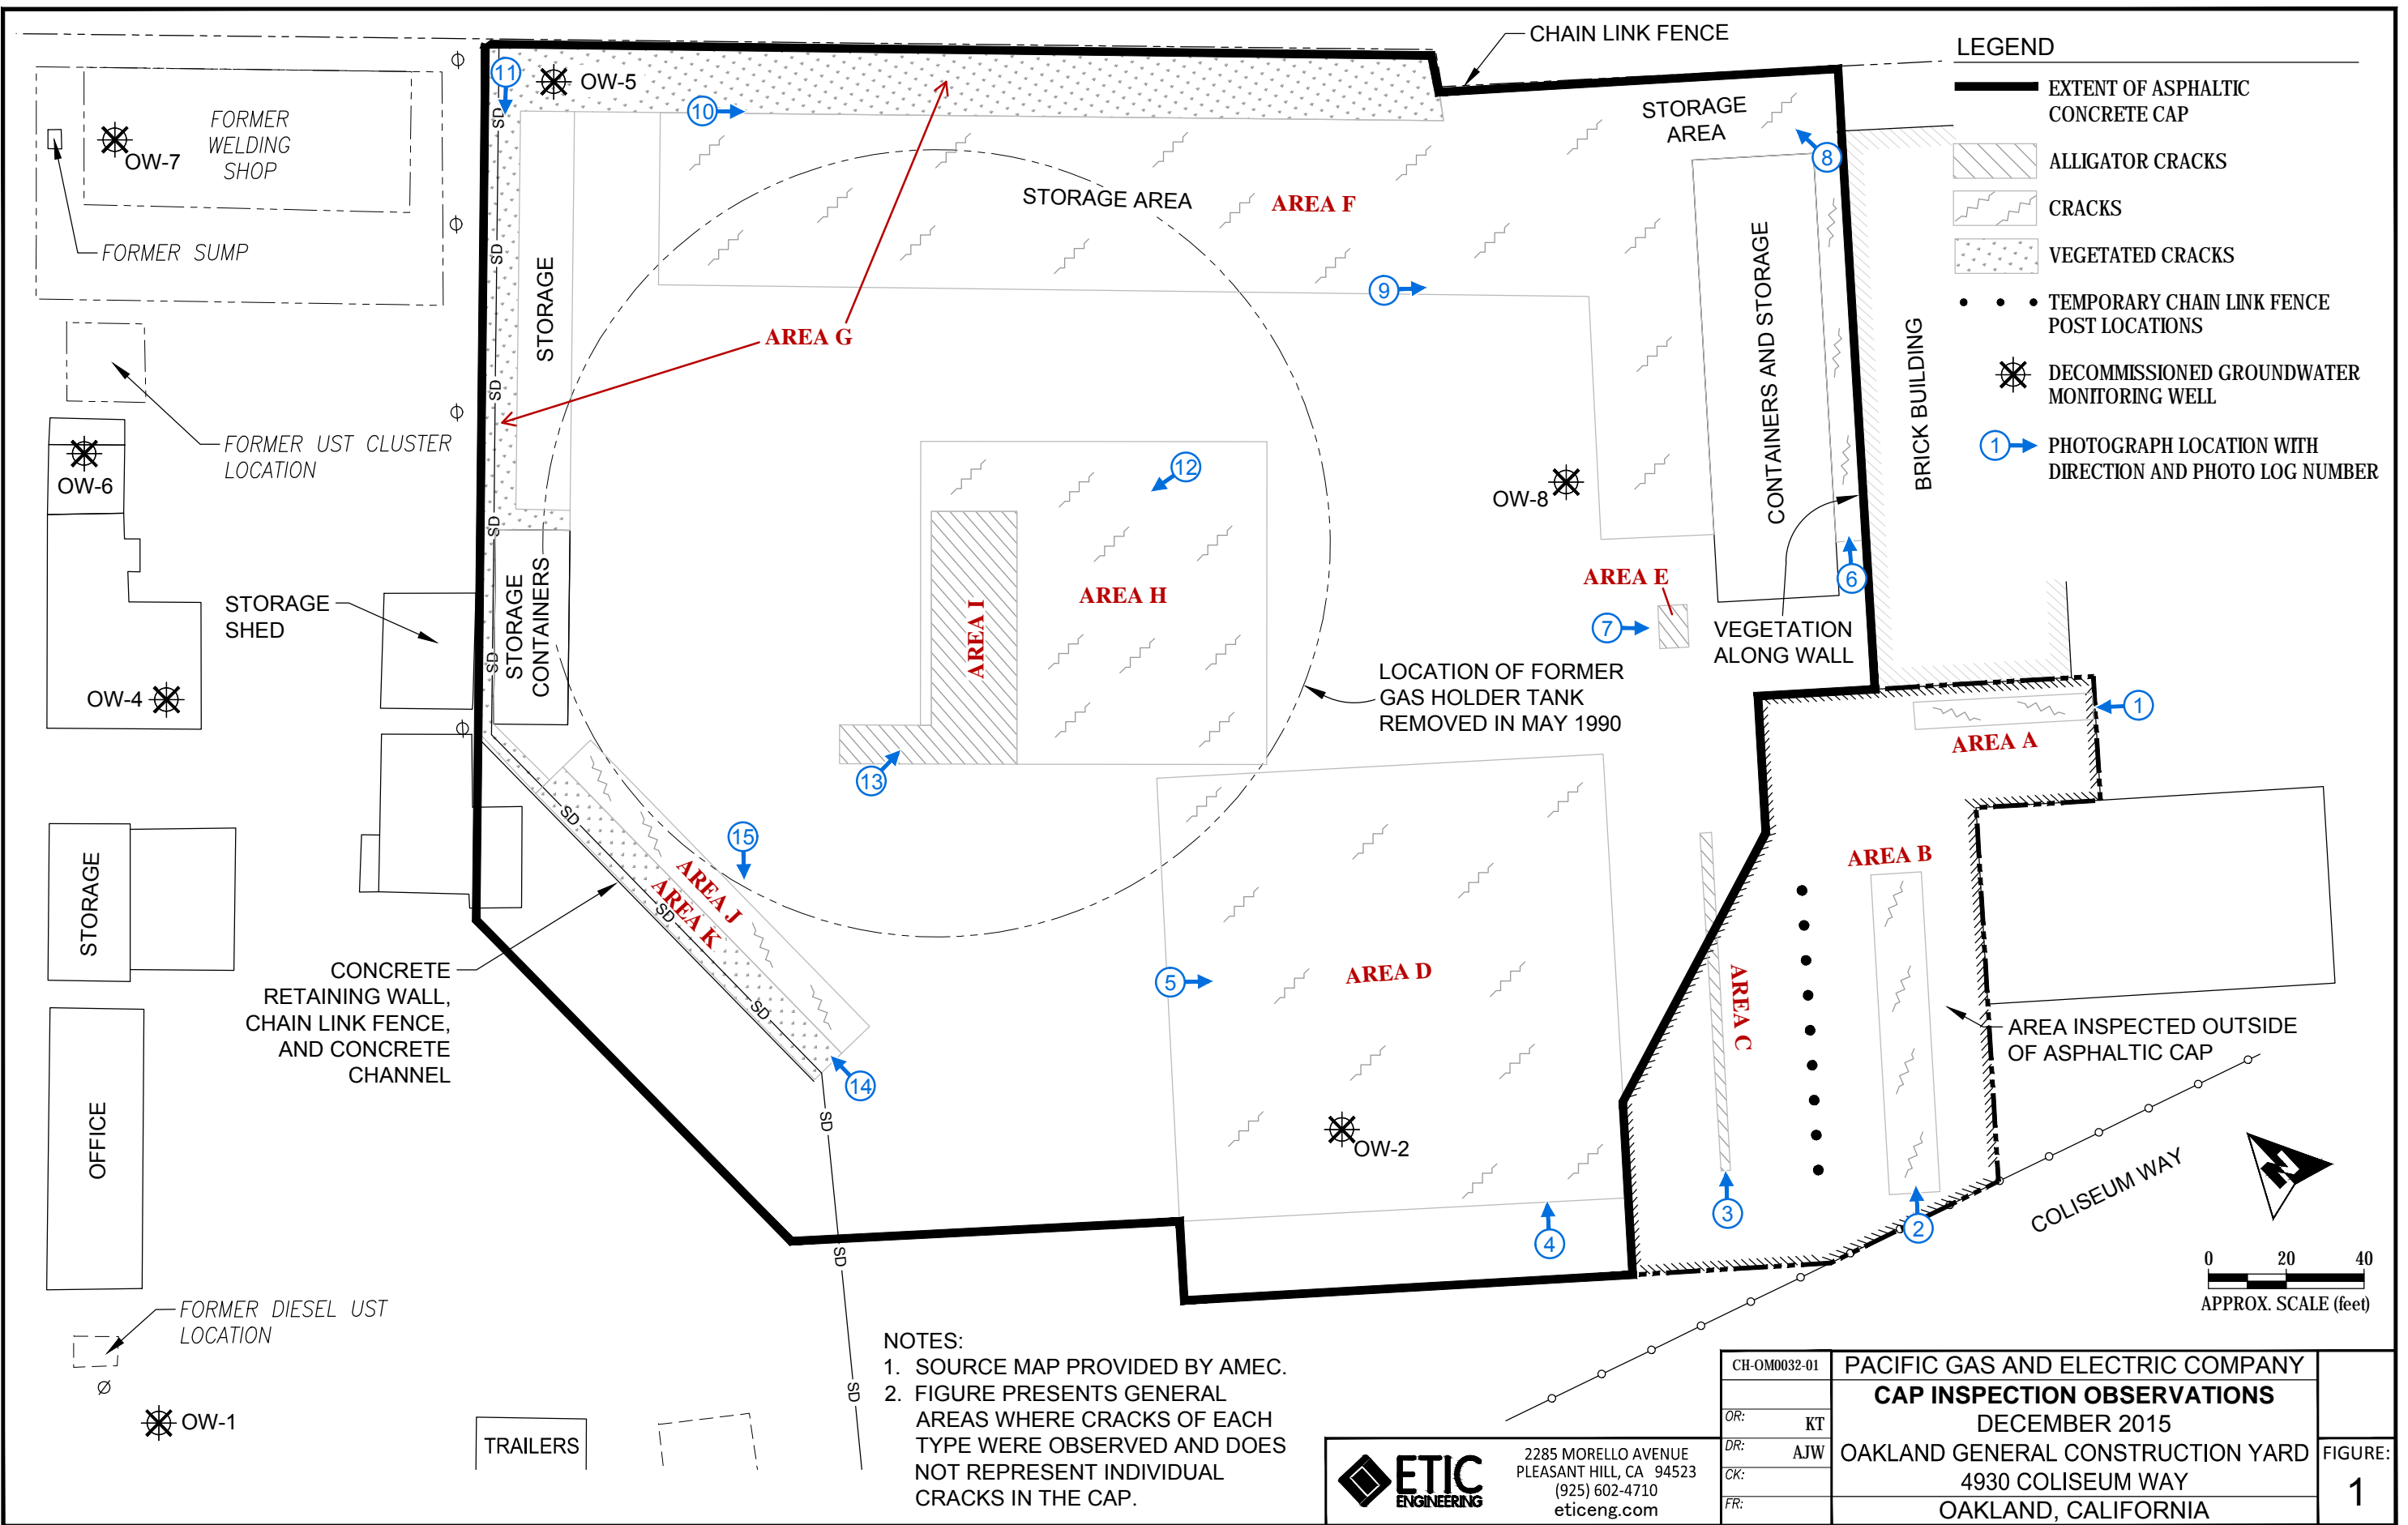
CH-OM0032-01	PACIFIC GAS AND ELECTRIC COMPANY	FIGURE: 1
OR: KT	CAP INSPECTION OBSERVATIONS	
DR: AJW	DECEMBER 2015	
CK:	OAKLAND GENERAL CONSTRUCTION YARD	
FR:	4930 COLISEUM WAY	
	OAKLAND, CALIFORNIA

Deteriorated areas of the Cap and of the adjacent southeastern section have been categorized as either: cracked (width > ¼ inch), cracked with vegetated growth, or alligator-cracked (pavement failure). Figure 1 identifies the areas of the Cap called out below.

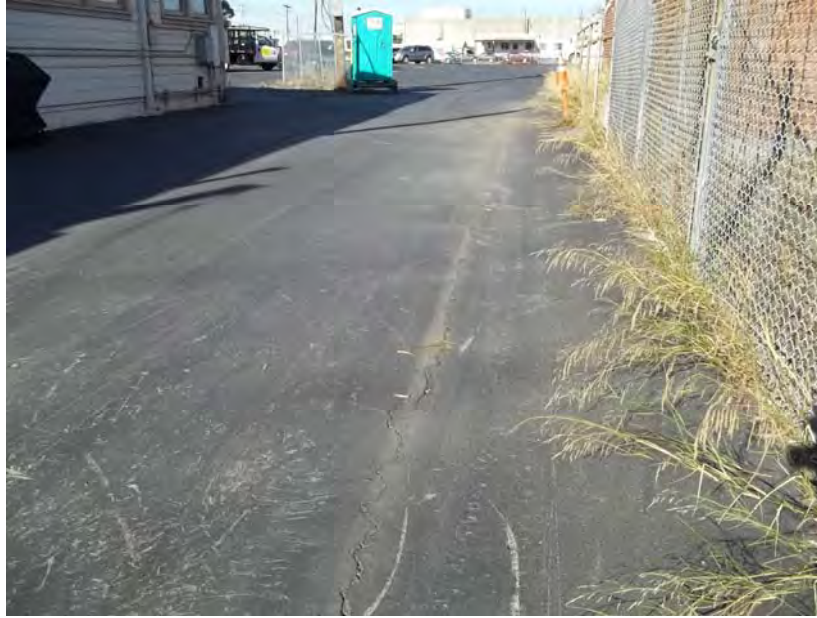
Photograph 1: Cracks in Area A

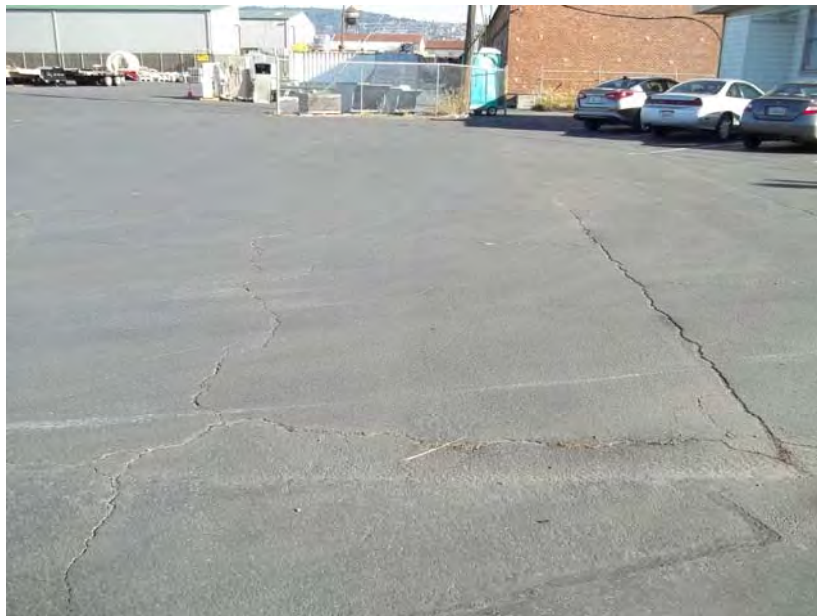
Photograph 2: Cracks in Area B

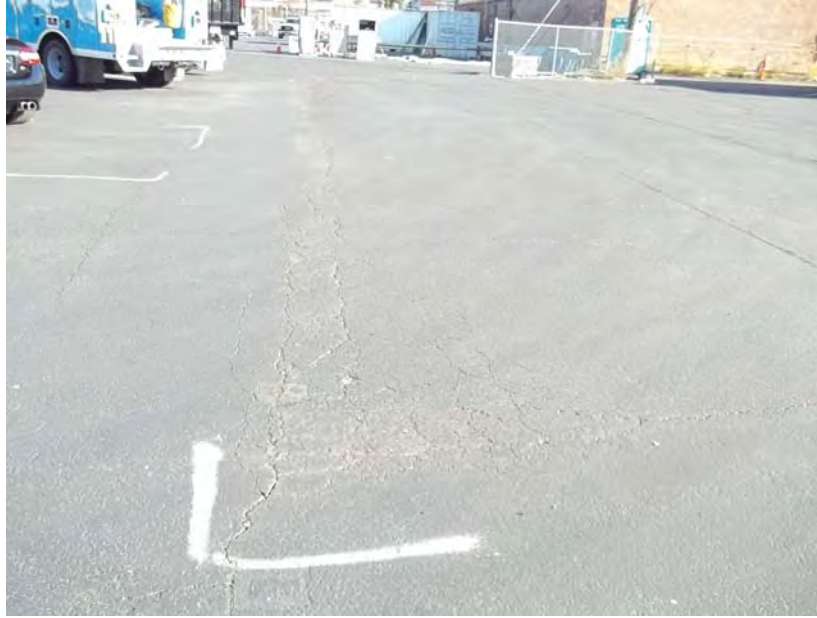
Photograph 3: Cracks in Area C

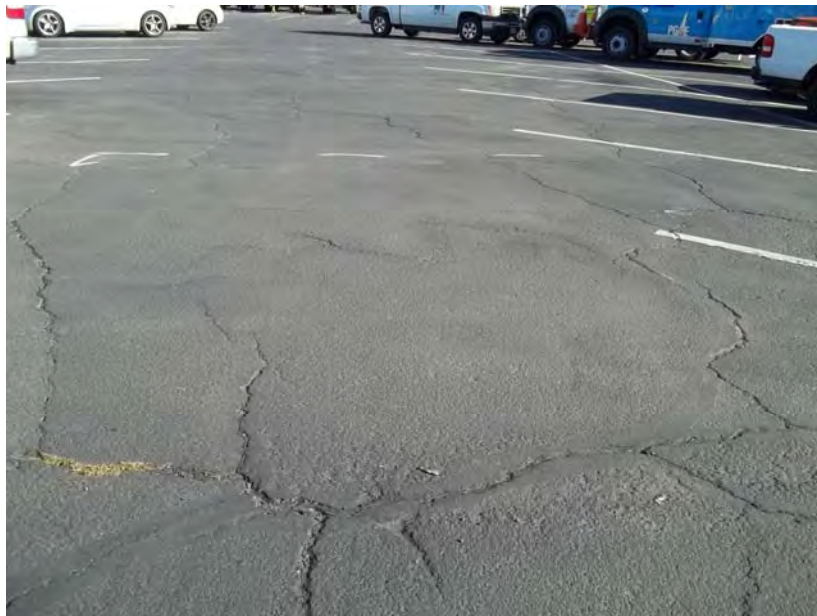
Photograph 4: Cracks in Area D

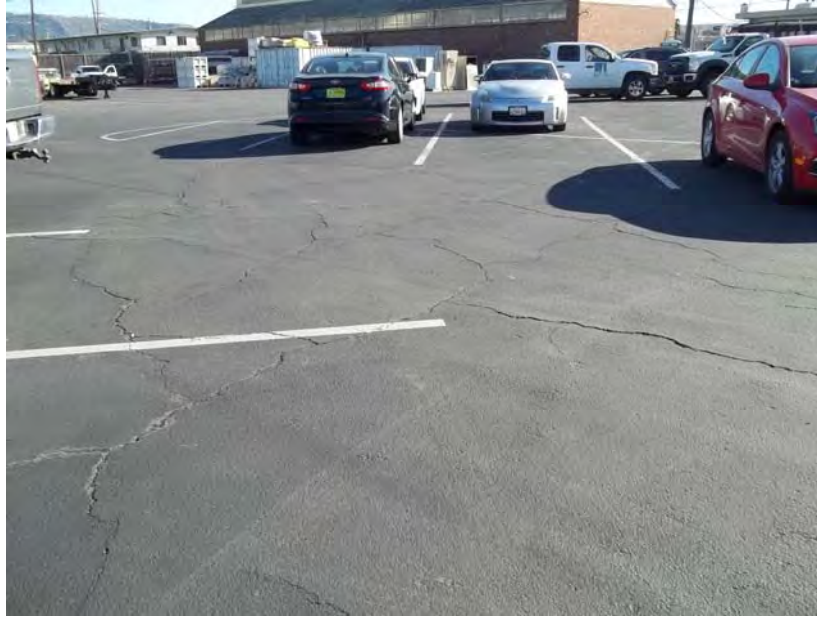
Photograph 5: Cracks in Area D

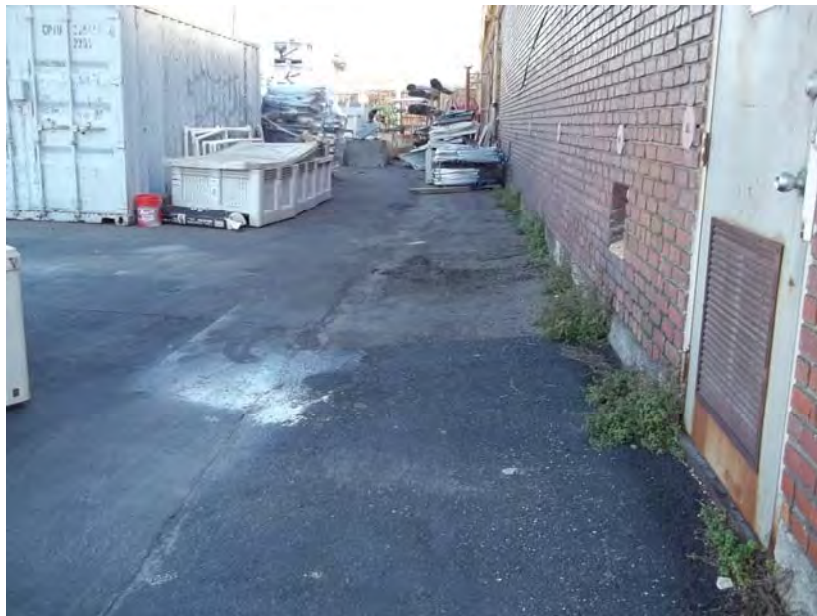
Photograph 6: Vegetation and cracks along wall of adjacent building in Area F

In areas with cracks of greater than 1/4 -inch width (Area F), the area containing these cracks will be slurry sealed. The slurry will typically

comprise of a mixture of emulsified asphalt, fine aggregate, mineral filler and water which is then applied to the cracked areas.

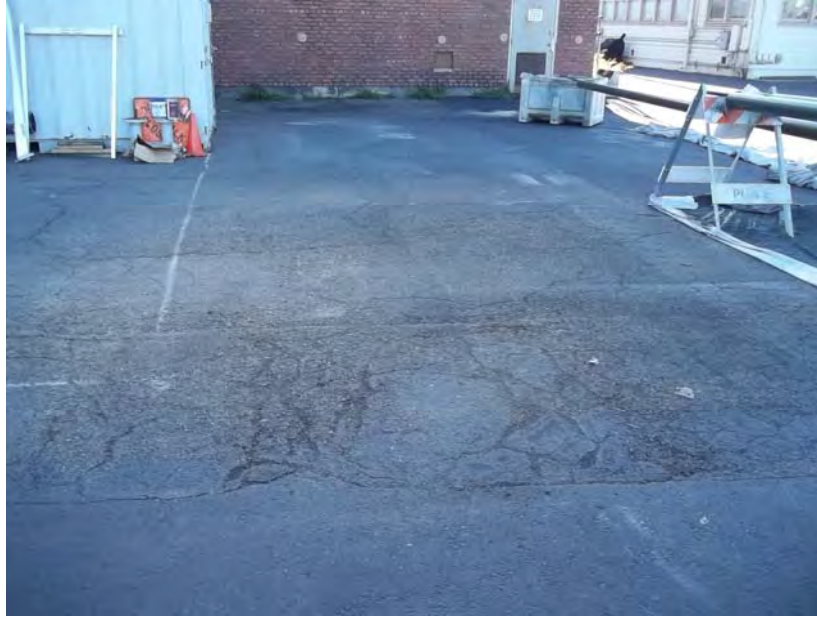
Photograph 7: Alligator cracking in Area E

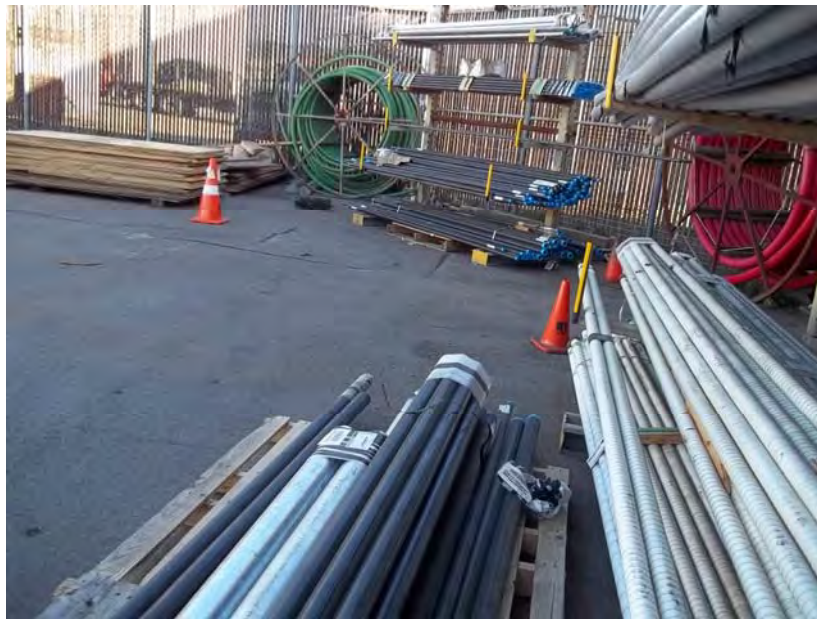
Photograph 8: Cracks in Area F

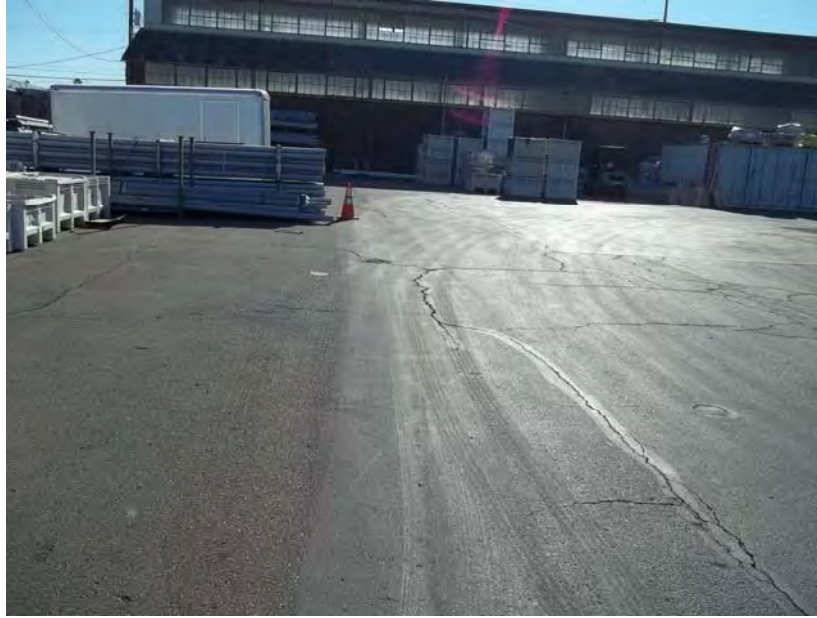
Photograph 9: Cracks in Area F

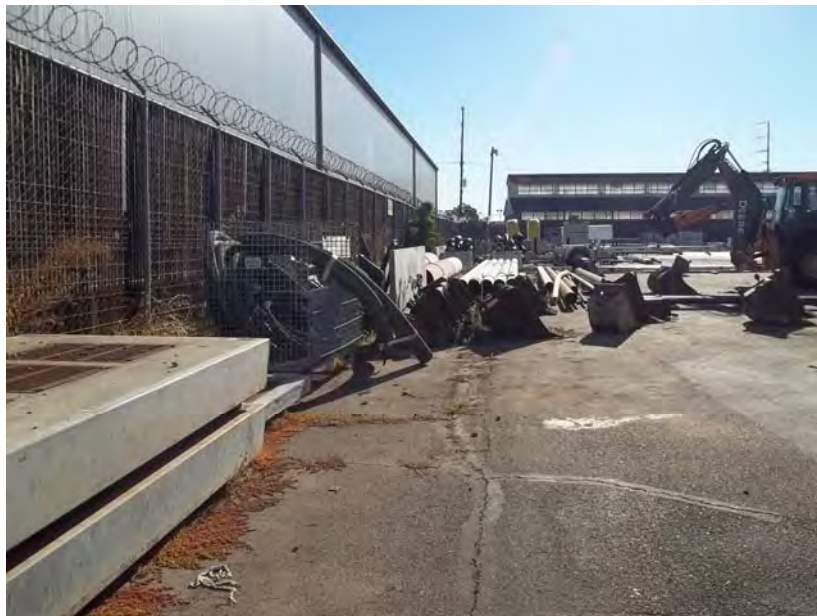
Photograph 10: Cracks in Area F, and vegetation in cracks in Area G

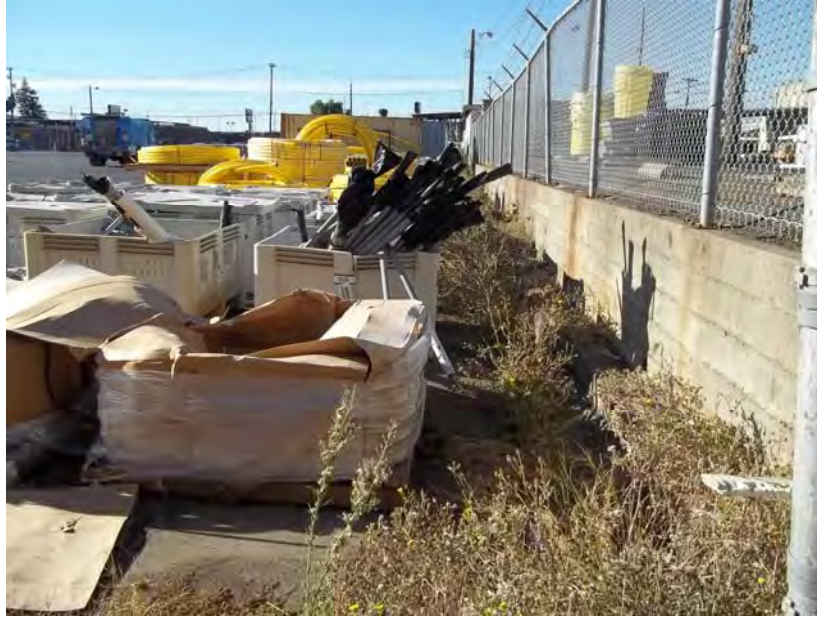
Photograph 11: Vegetation in cracks in Area G

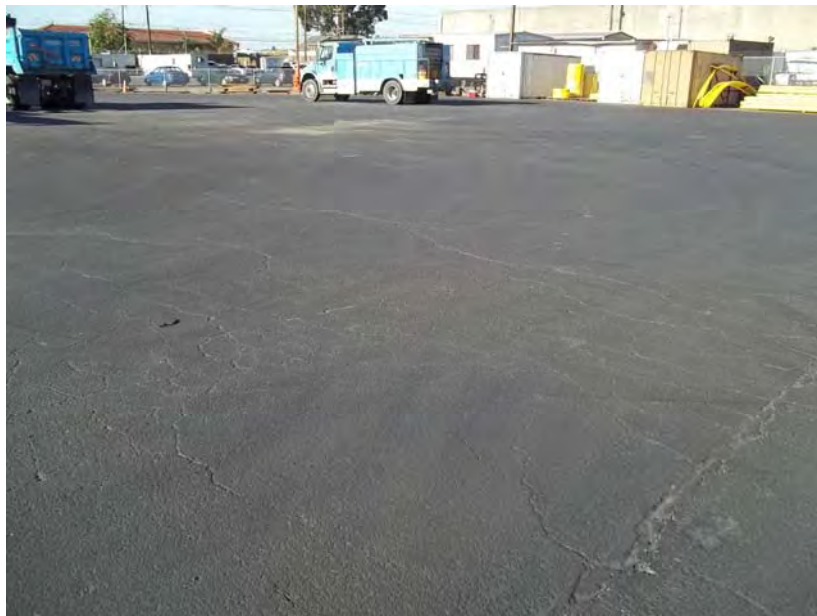
Photograph 12: Cracks in Area H

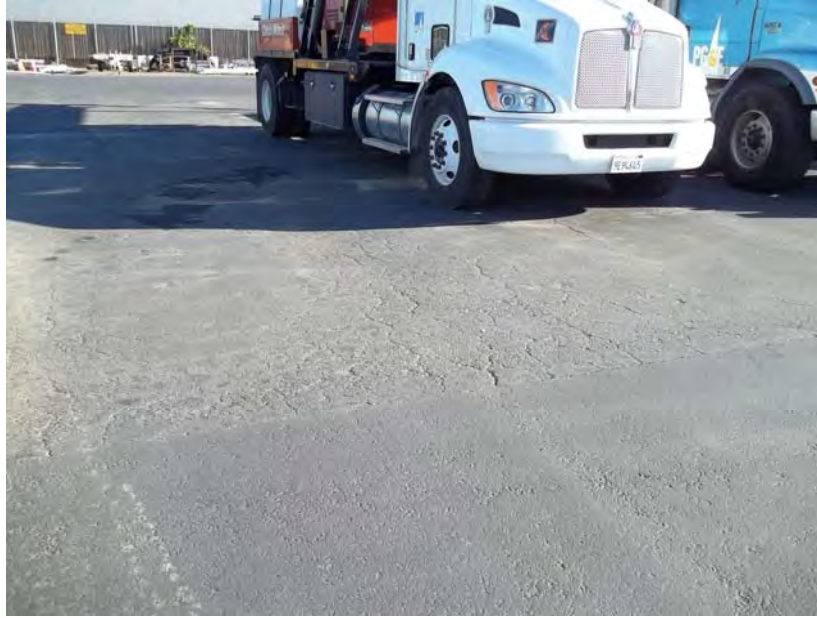
Photograph 13: Alligator cracks in Area I

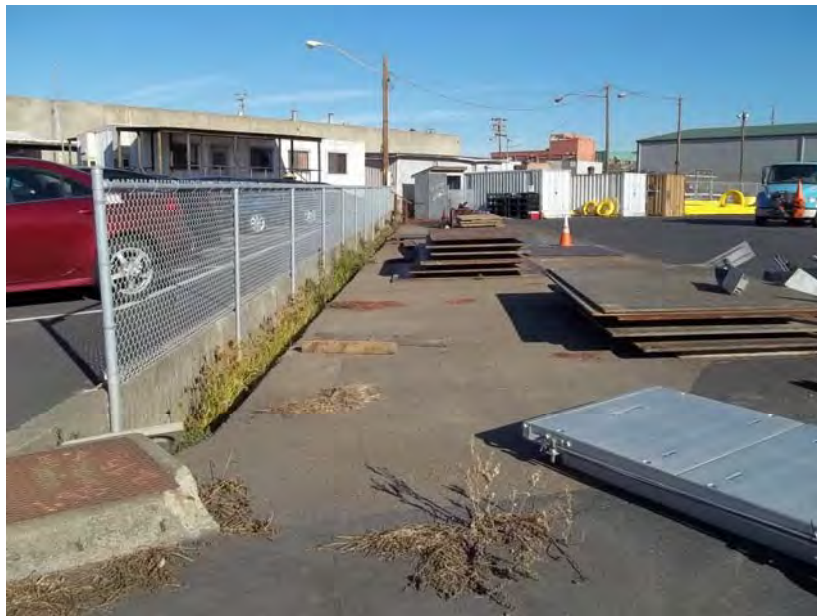
Photograph 14: Vegetation in cracks and in stormwater channel in Area K.

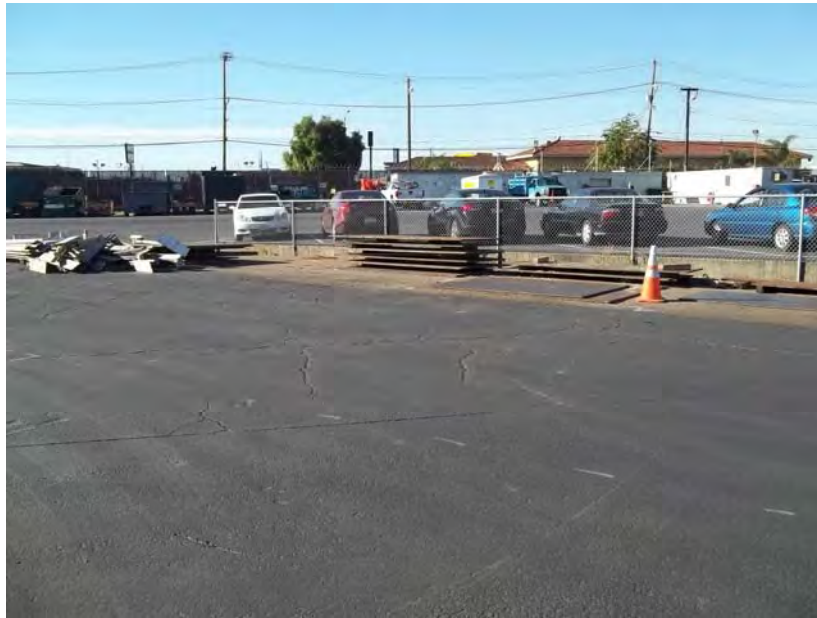
Photograph 15: Cracks in Area J

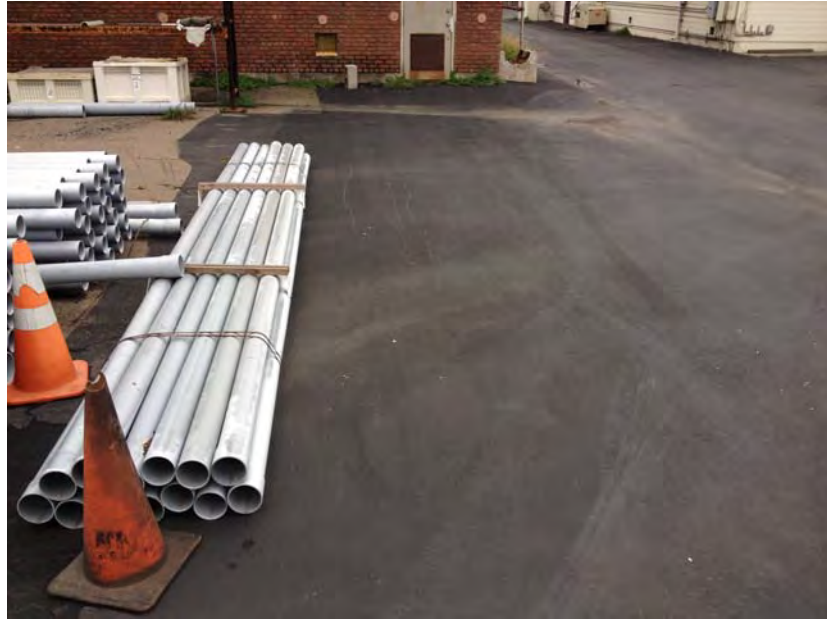
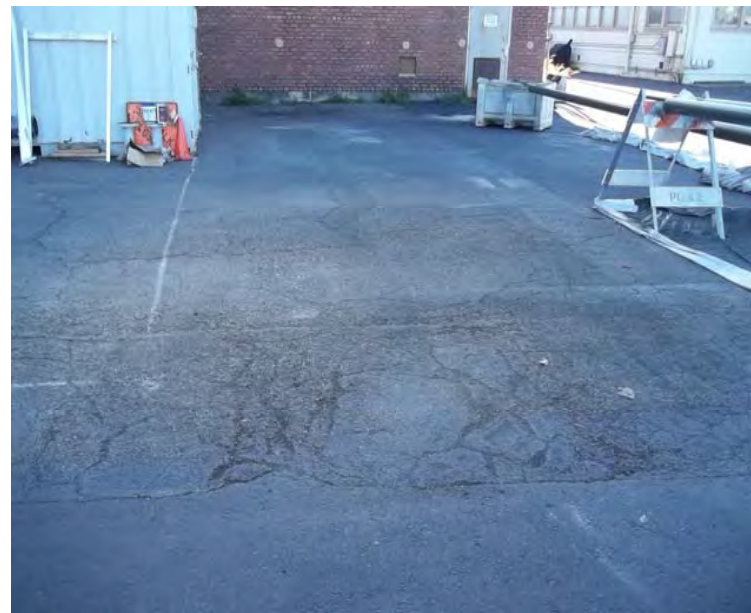
Eastern side of the cap, Area E, looking toward adjacent brick building. Alligator cracks in the foreground consistent with 2014 report. Vegetation along the base of the building has persisted since 2014.

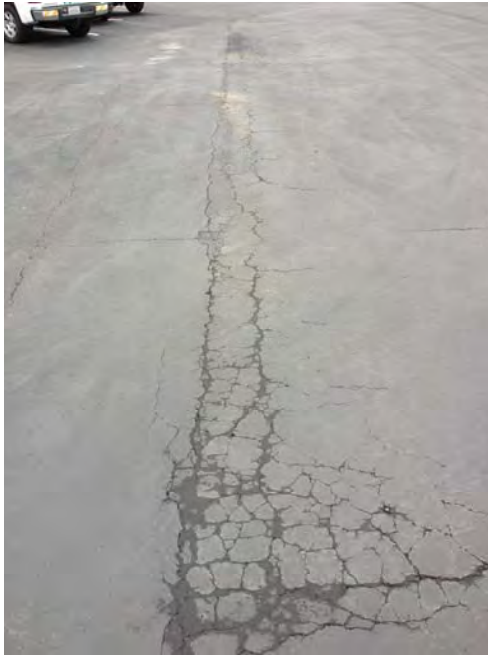
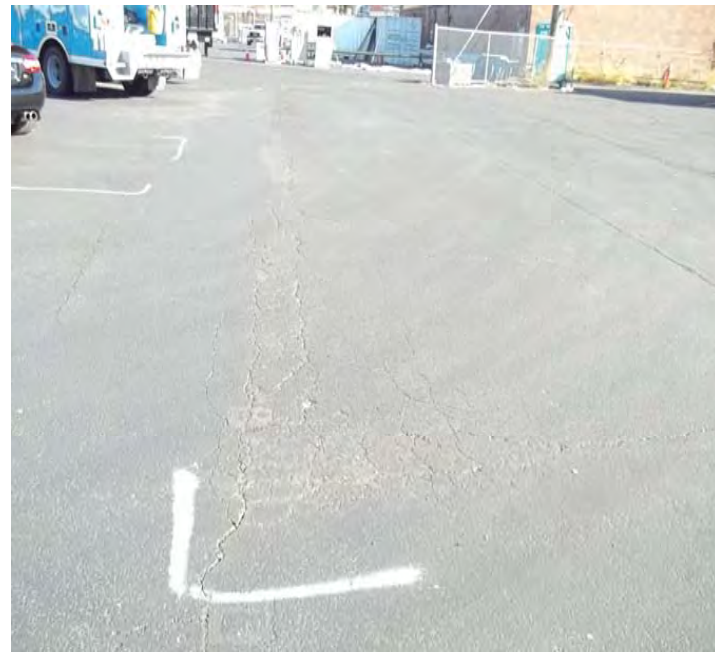
The southeastern area outside and adjacent to the cap, Area C. Alligator cracks remain in similar condition to 2014.

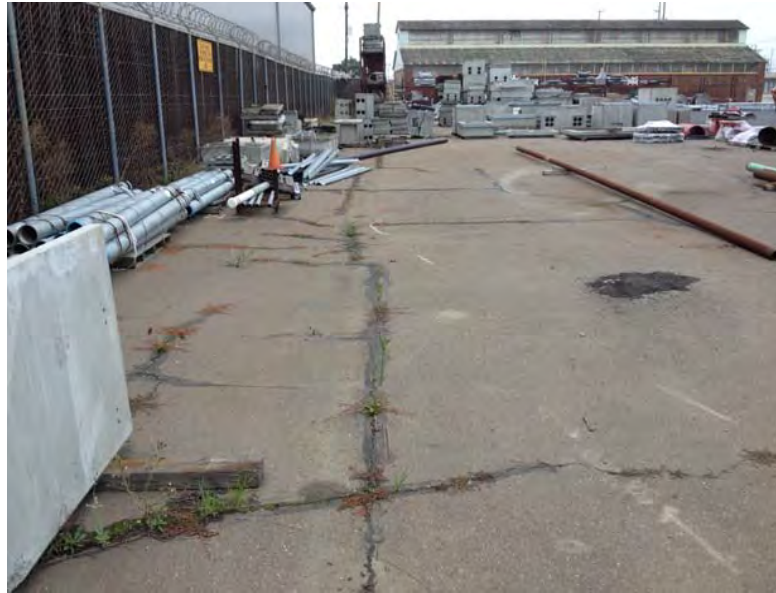
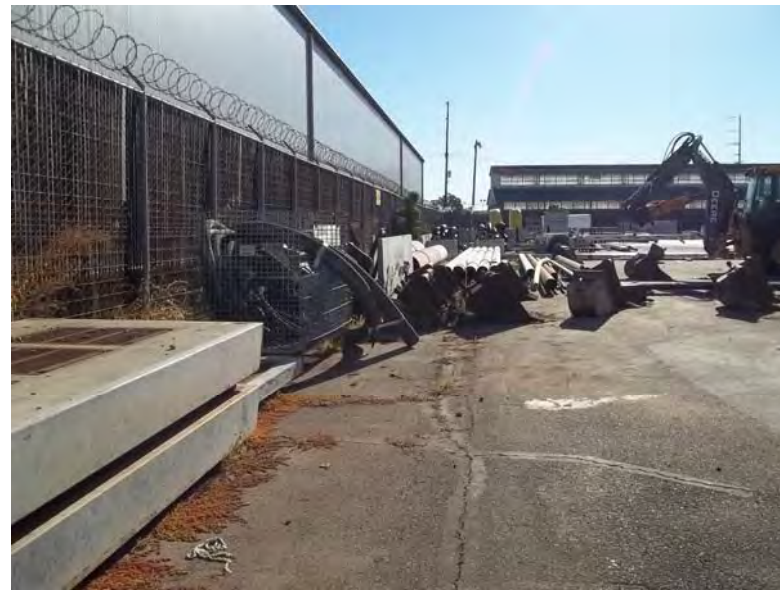
Northern corner of the cap, looking southeast along border of Areas F and G. Vegetation observed in 2014 remains along fence line but has been removed toward the center of the cap.

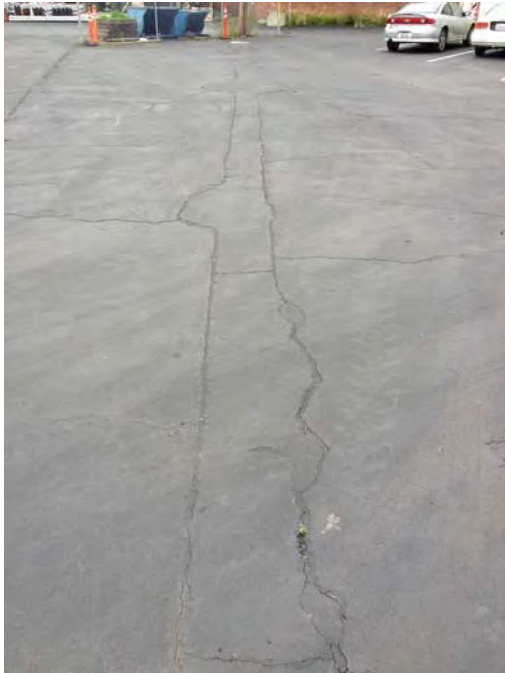
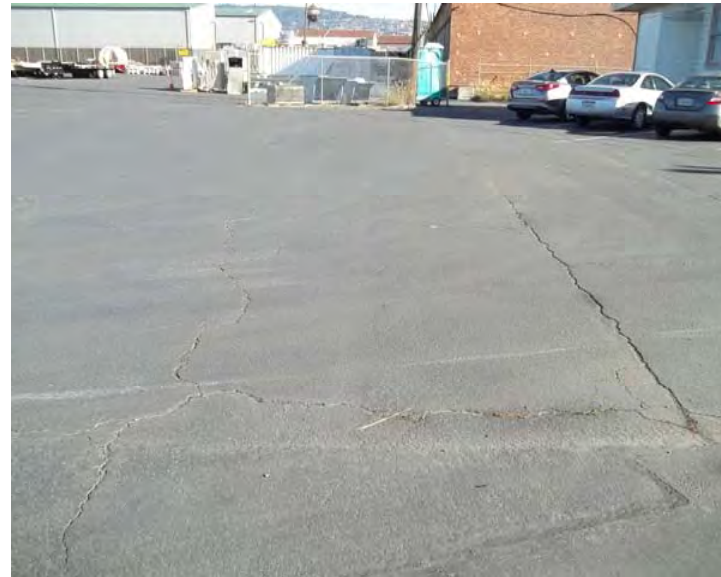
The southeastern area outside and adjacent to the cap, Area B. Cracks remain in similar condition to 2014.

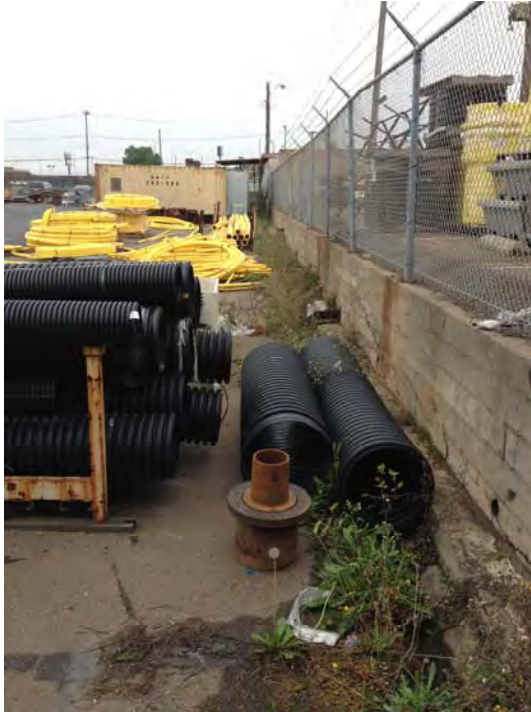
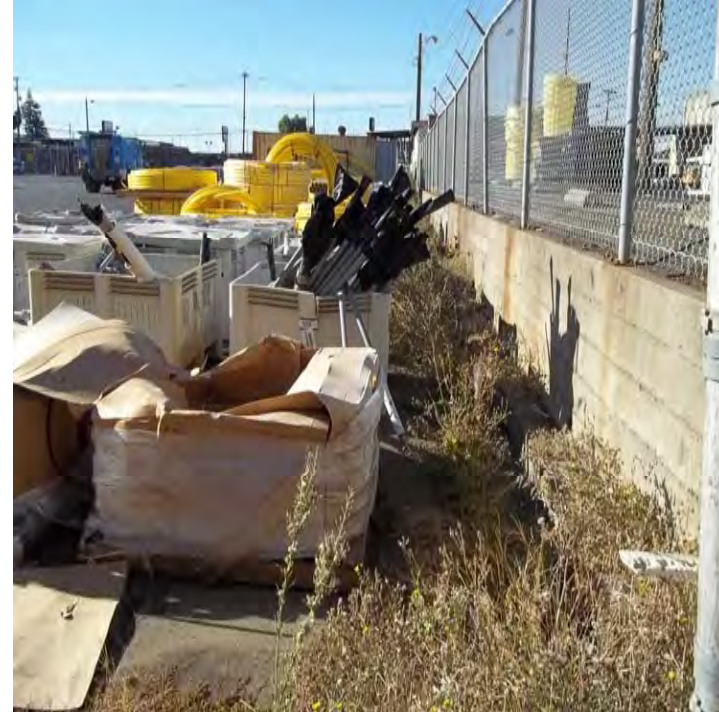
Northern corner of the cap within Area G, looking southwest. Vegetation in the stormwater channel present in 2014 has continued to grow in 2015.

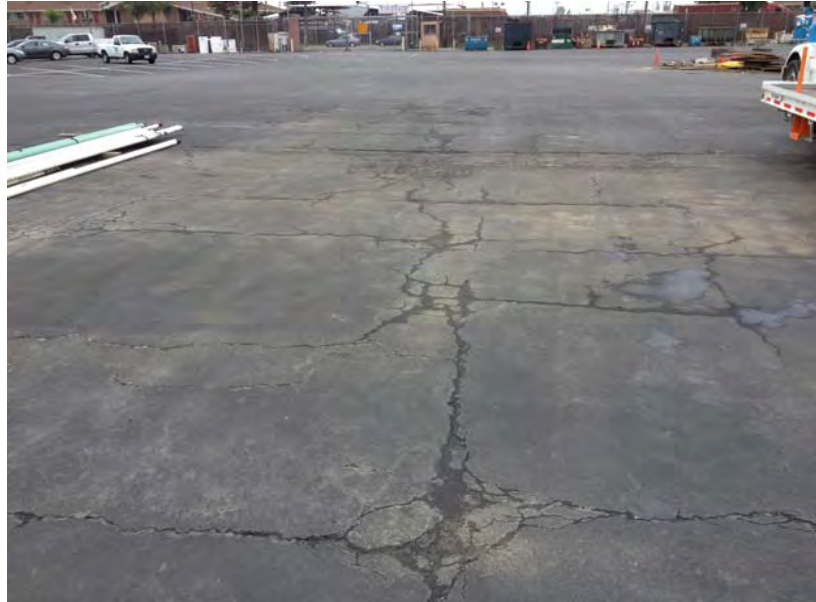
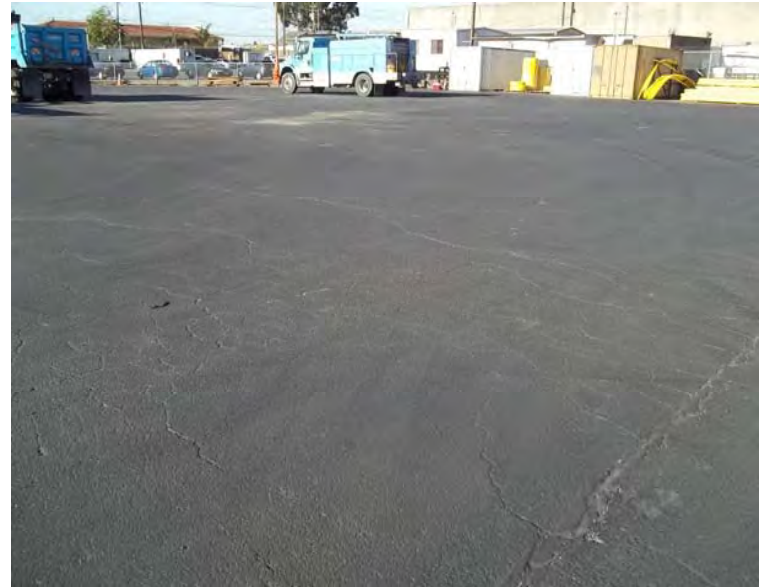
Cracks in asphalt slurry seal had become exposed during 2014 and remained similar in 2015. The 2014 photo faces southwest. The 2015 photo faces northeast toward Area I.

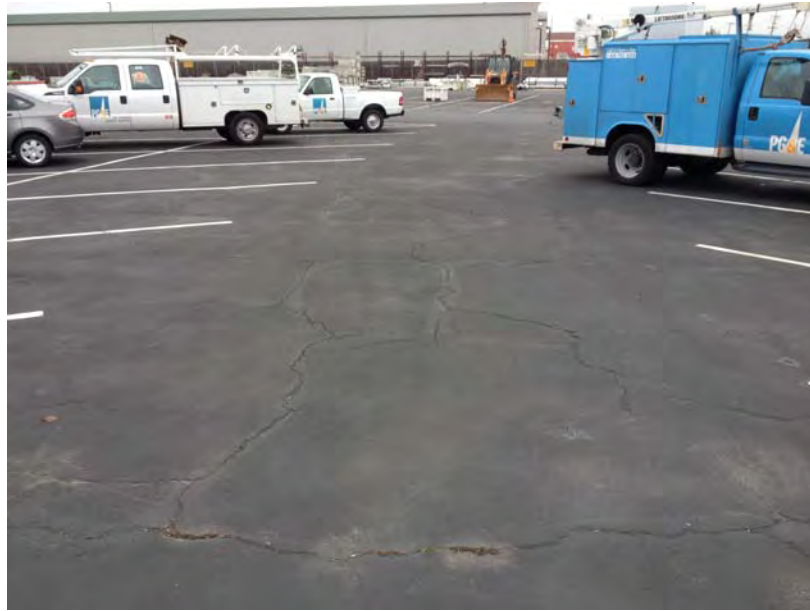
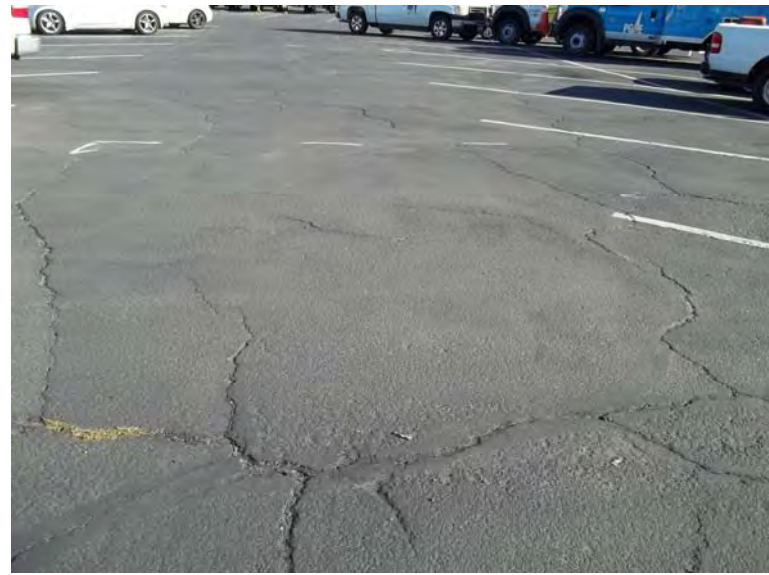
In the southern corner of the cap, in Area D. Vegetation present in 2014 had decreased in 2015. Cracks in asphalt slurry remained similar.
