Subject: Corrective Action Implementation Work Plan
Pacific Gas and Electric Company, Oakland General Construction Yard
4930 Coliseum Way, Oakland, California

Corrective Action Implementation Workplan

Oakland General Construction Yard
4930 Coliseum Way
Oakland, California

January 2016

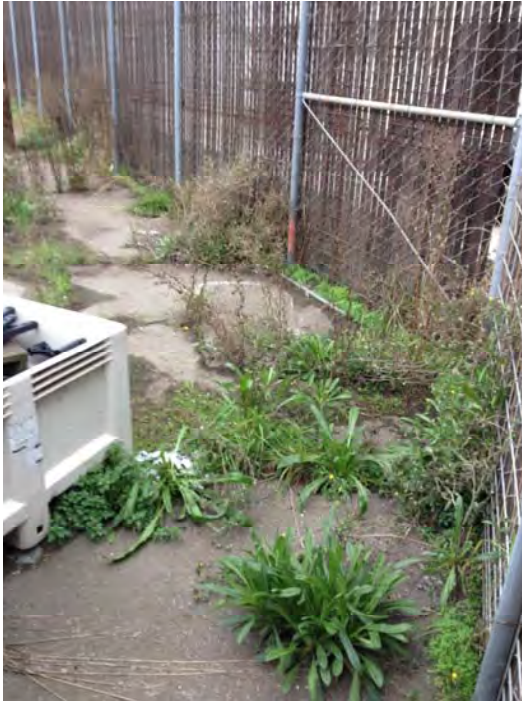
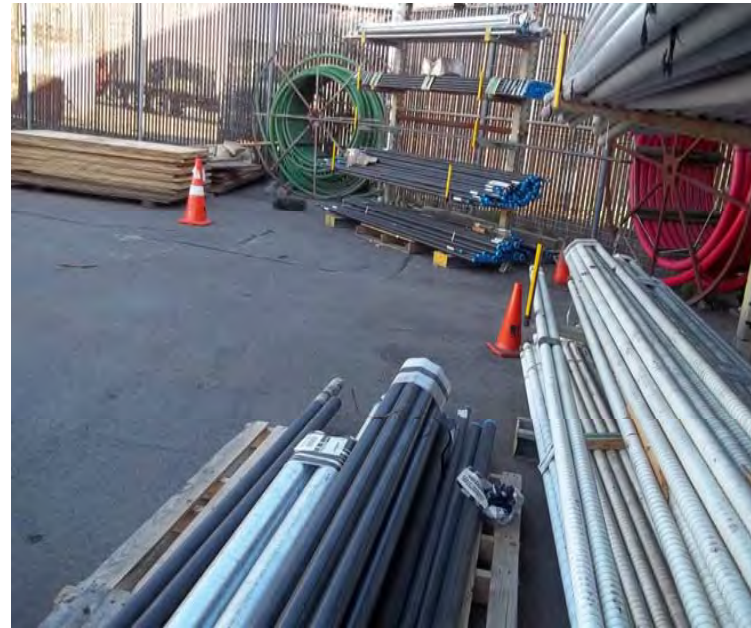
In the northeast corner of the cap, Area F. Vegetation observed in 2014 was no longer present in 2015.

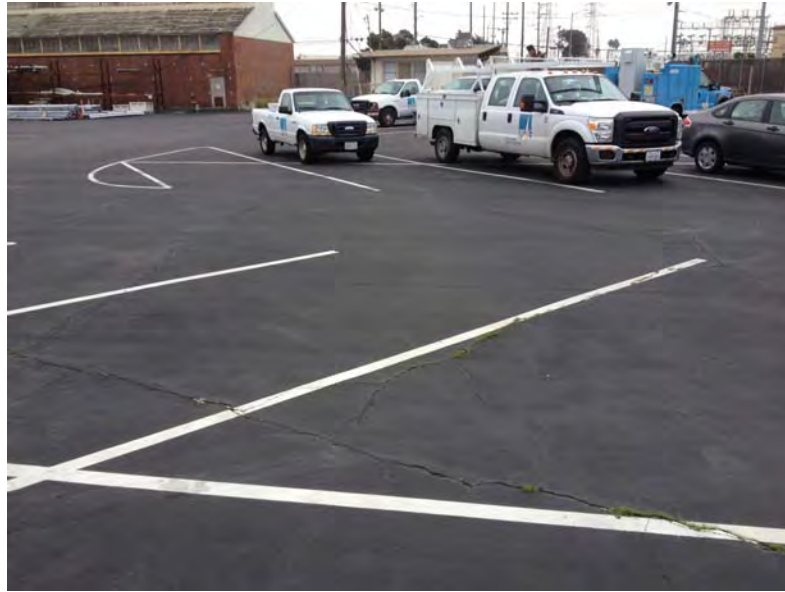
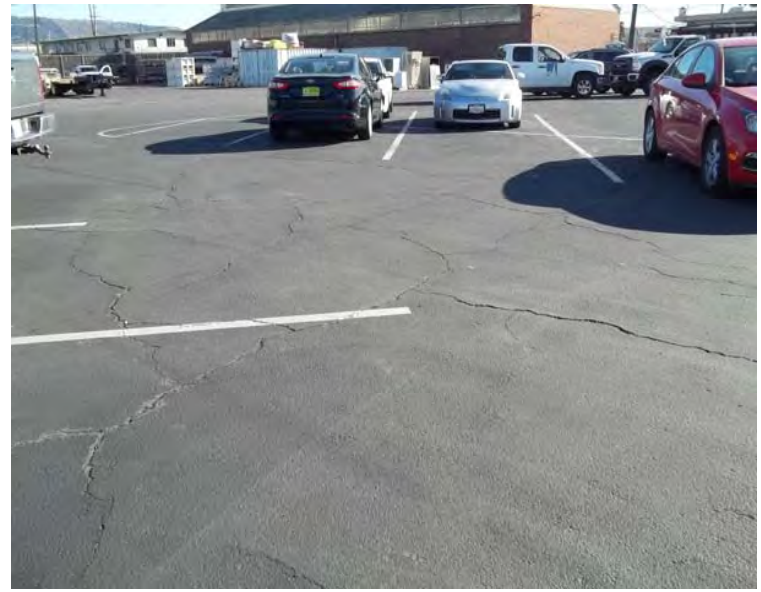
In the southern corner of the cap, in Area D. Vegetation present in 2014 had decreased in 2015. Cracks in asphalt slurry remained similar.
