Re: Third Quarter 2010 Status Report
Atlantic Richfield Company Station #2035
1001 San Pablo Avenue, Albany, California
ACEH Case #RO0000100

Re: Third Quarter 2010 Status Report, Atlantic Richfield Company Station #2035
1001 San Pablo Avenue, Albany, California; ACEH Case #RO0000100

STATION # 2035 QUARTERLY STATUS REPORT

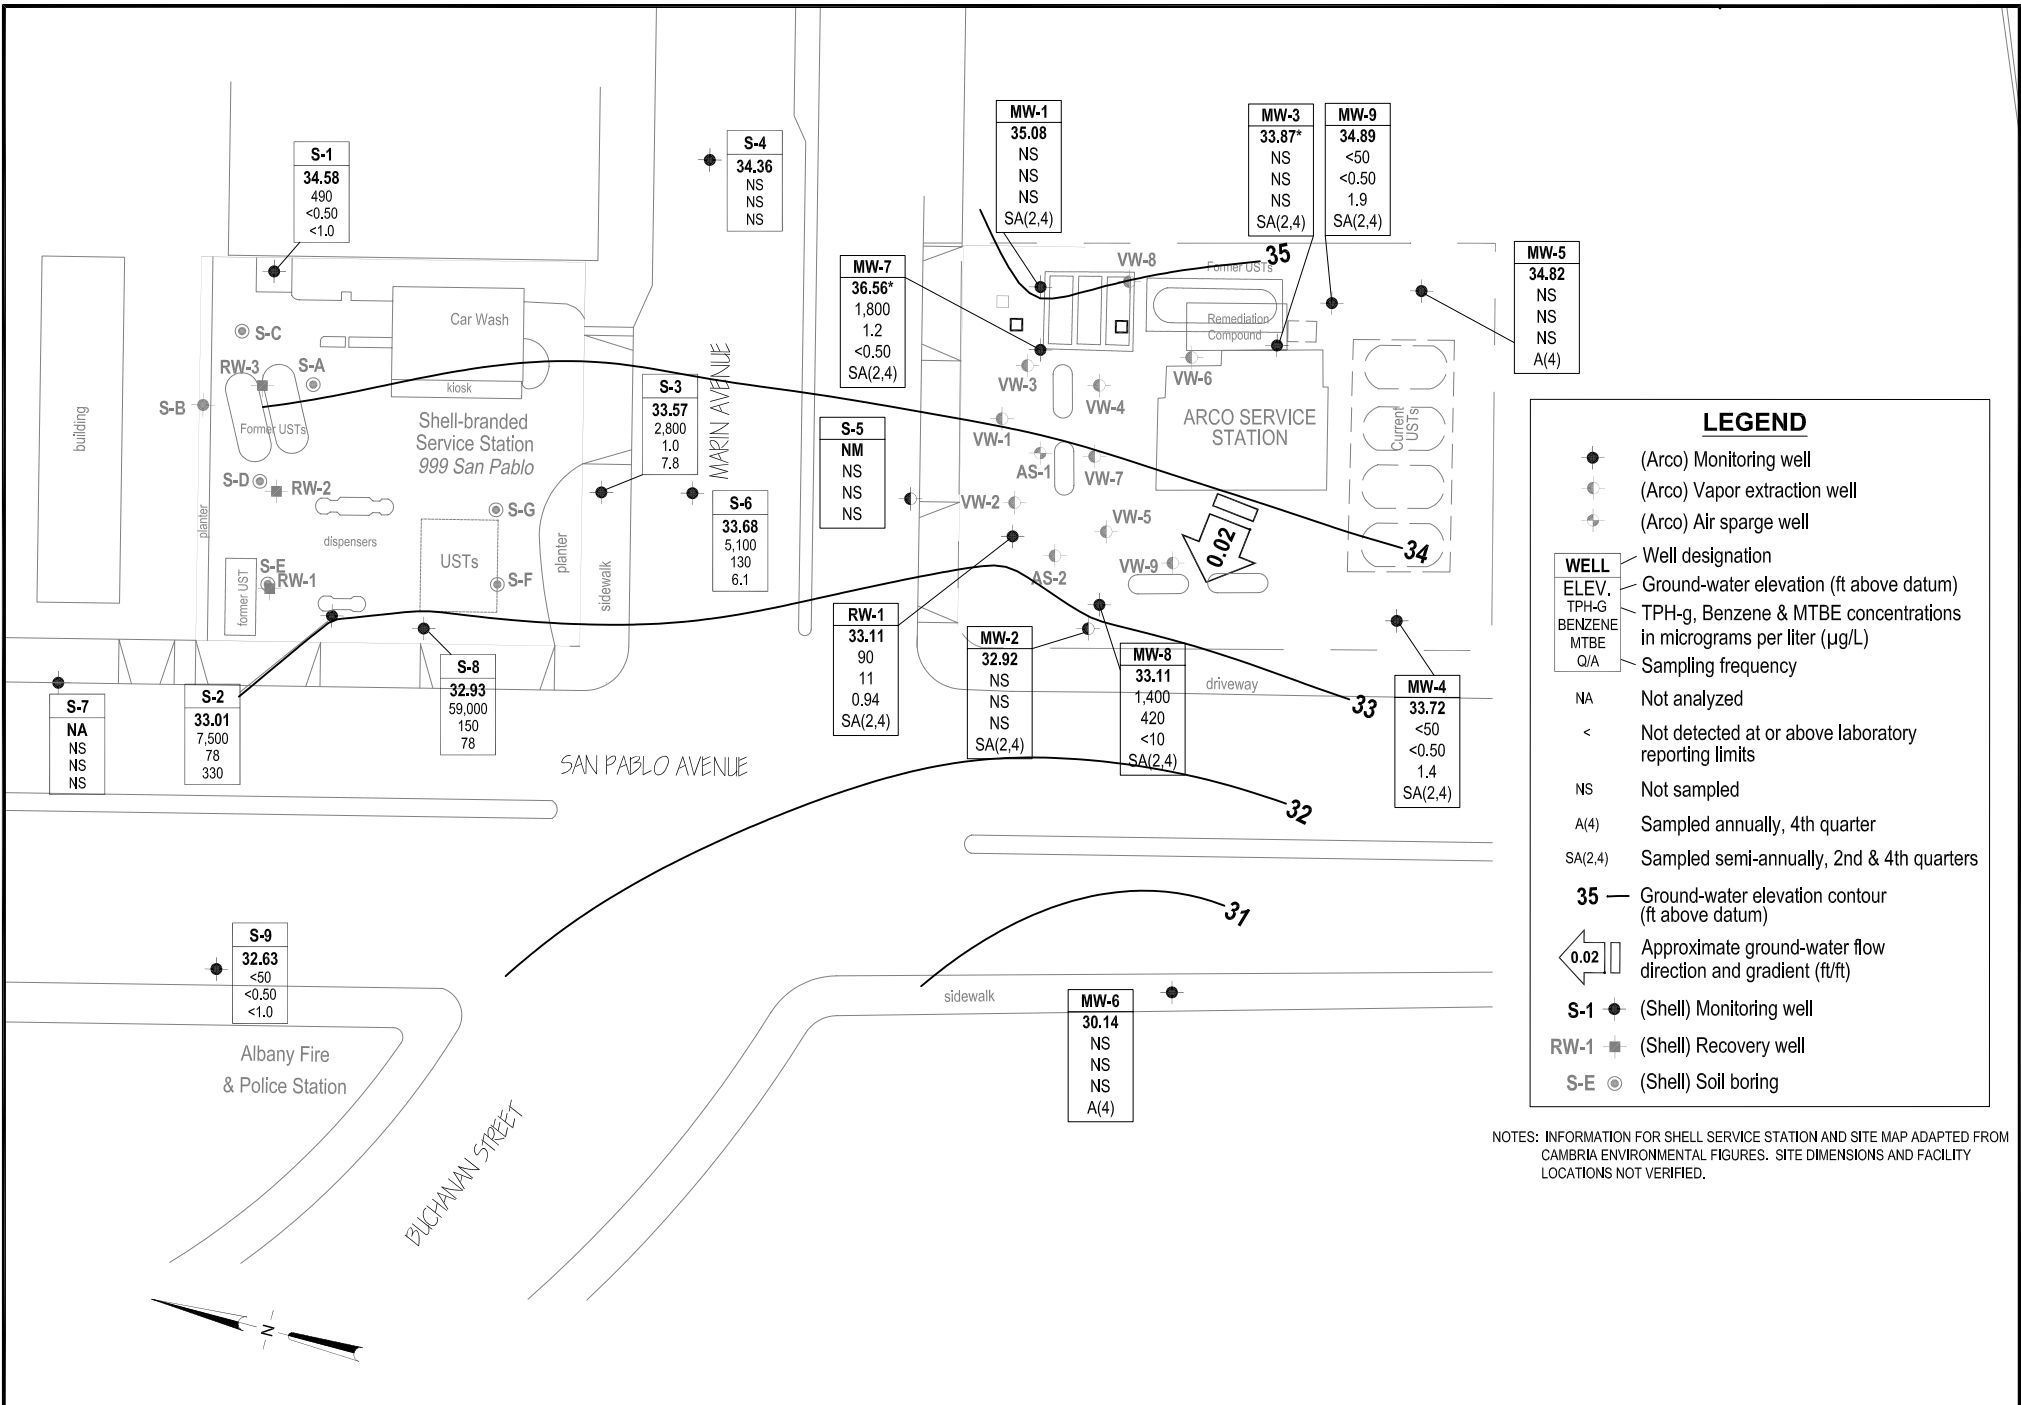
Drawing
2

Ground-Water Elevation Contour
 and Analytical Summary Map
 26 May 2010
