**SUPPLEMENTAL INVESTIGATION
501 SAN PABLO AVENUE
ALBANY, CALIFORNIA**

**LA MANCHA DEVELOPMENT COMPANY
100 WEBSTER STREET, SUITE 300
OAKLAND, CALIFORNIA**

FILE NO. 92284-ASA

Subject: Proposed Retail Development
501 San Pablo Avenue
Albany, California
SUPPLEMENTAL DATA TO PHASE I SITE ASSESSMENT

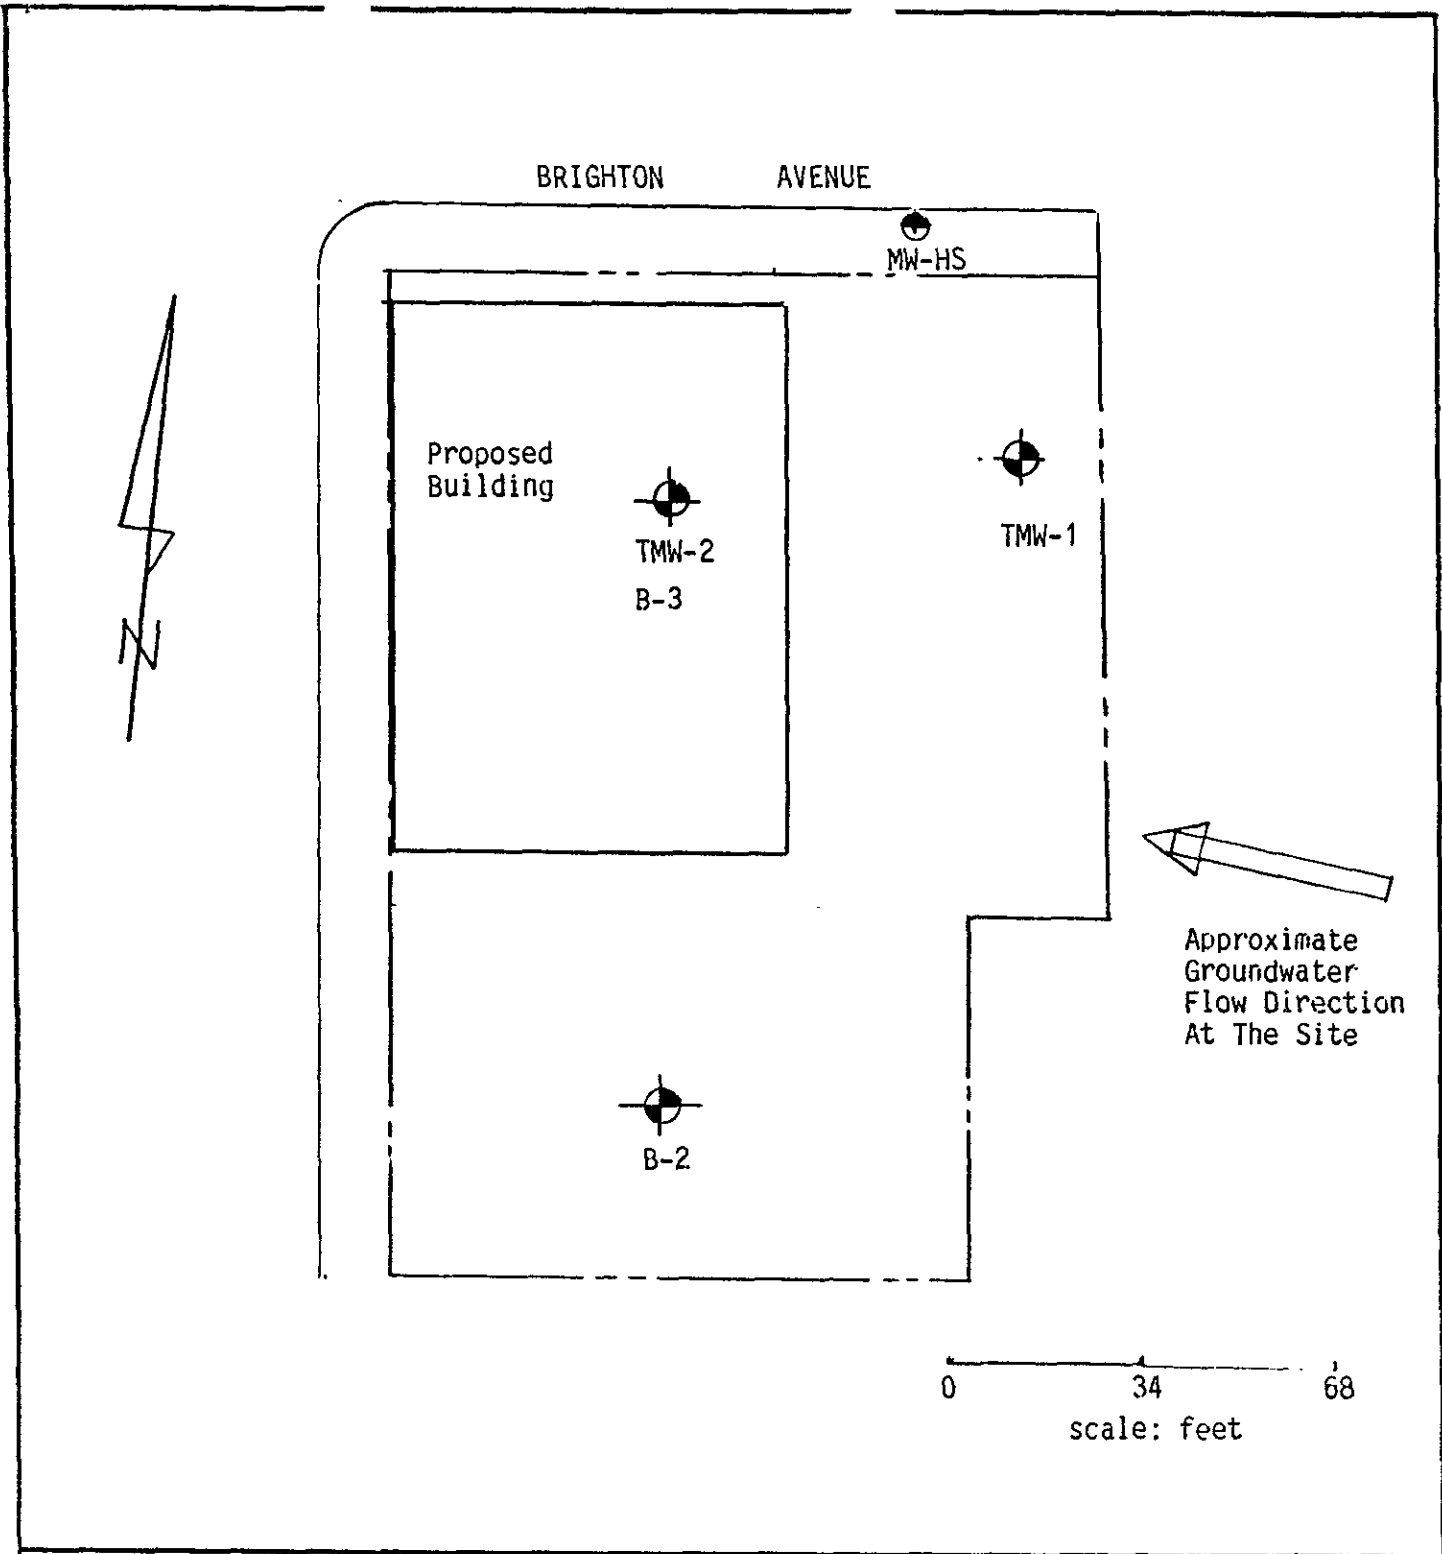
Figure: 2

Total of three exploratory borings were drilled at the site on February 24, 1992 to the depth of 15 feet below the existing ground surface at the locations indicated in Figure 2. The borings were advanced with a truck mounted drill rig utilizing a six inch diameter continuous flight auger. Soil samples were extracted as the borings progressed by driving a modified california split spoon sampler into the ground. A 140 pound hammer with a free fall of 30 inches were utilized to drive the sampler into the ground. Samples were retained within brass liners inside the split spoon sampler. A soil filled liner from each sampled interval was removed from the spoon, wrapped in foil, sealed with plastic caps, then placed on ice for transport (under chain-of-custody documentation) to a State Certified Laboratory. Prior to drilling, all drilling equipments were steam cleaned and all brass liners and sampling equipment were thoroughly washed in Alconox solution and rinsed with deionized water to minimize contamination of the borings. Drill cuttings were stockpiled at the site and covered by plastic. This material shall be properly disposed of in an appropriate disposal or at the site by the owner based on the results of the laboratory analysis.

The laboratory analyses were performed on the soil and groundwater samples that were collected at the location of the borings shown in Figure 2. It is possible that variation in the soil and groundwater may exist beyond the points explored in our investigation. Despite reasonable care during our investigation, we may fail to detect hazardous substances or underground tanks at the site.
