SUBJECT: Corrective Action Plan Development Report, Phase I
Cox Cadillac, 230 Bay Place, Oakland, California

Corrective Action Plan Development Report Phase 1

Cox Cadillac
230 Bay Place, Oakland, CA

April 1, 1996

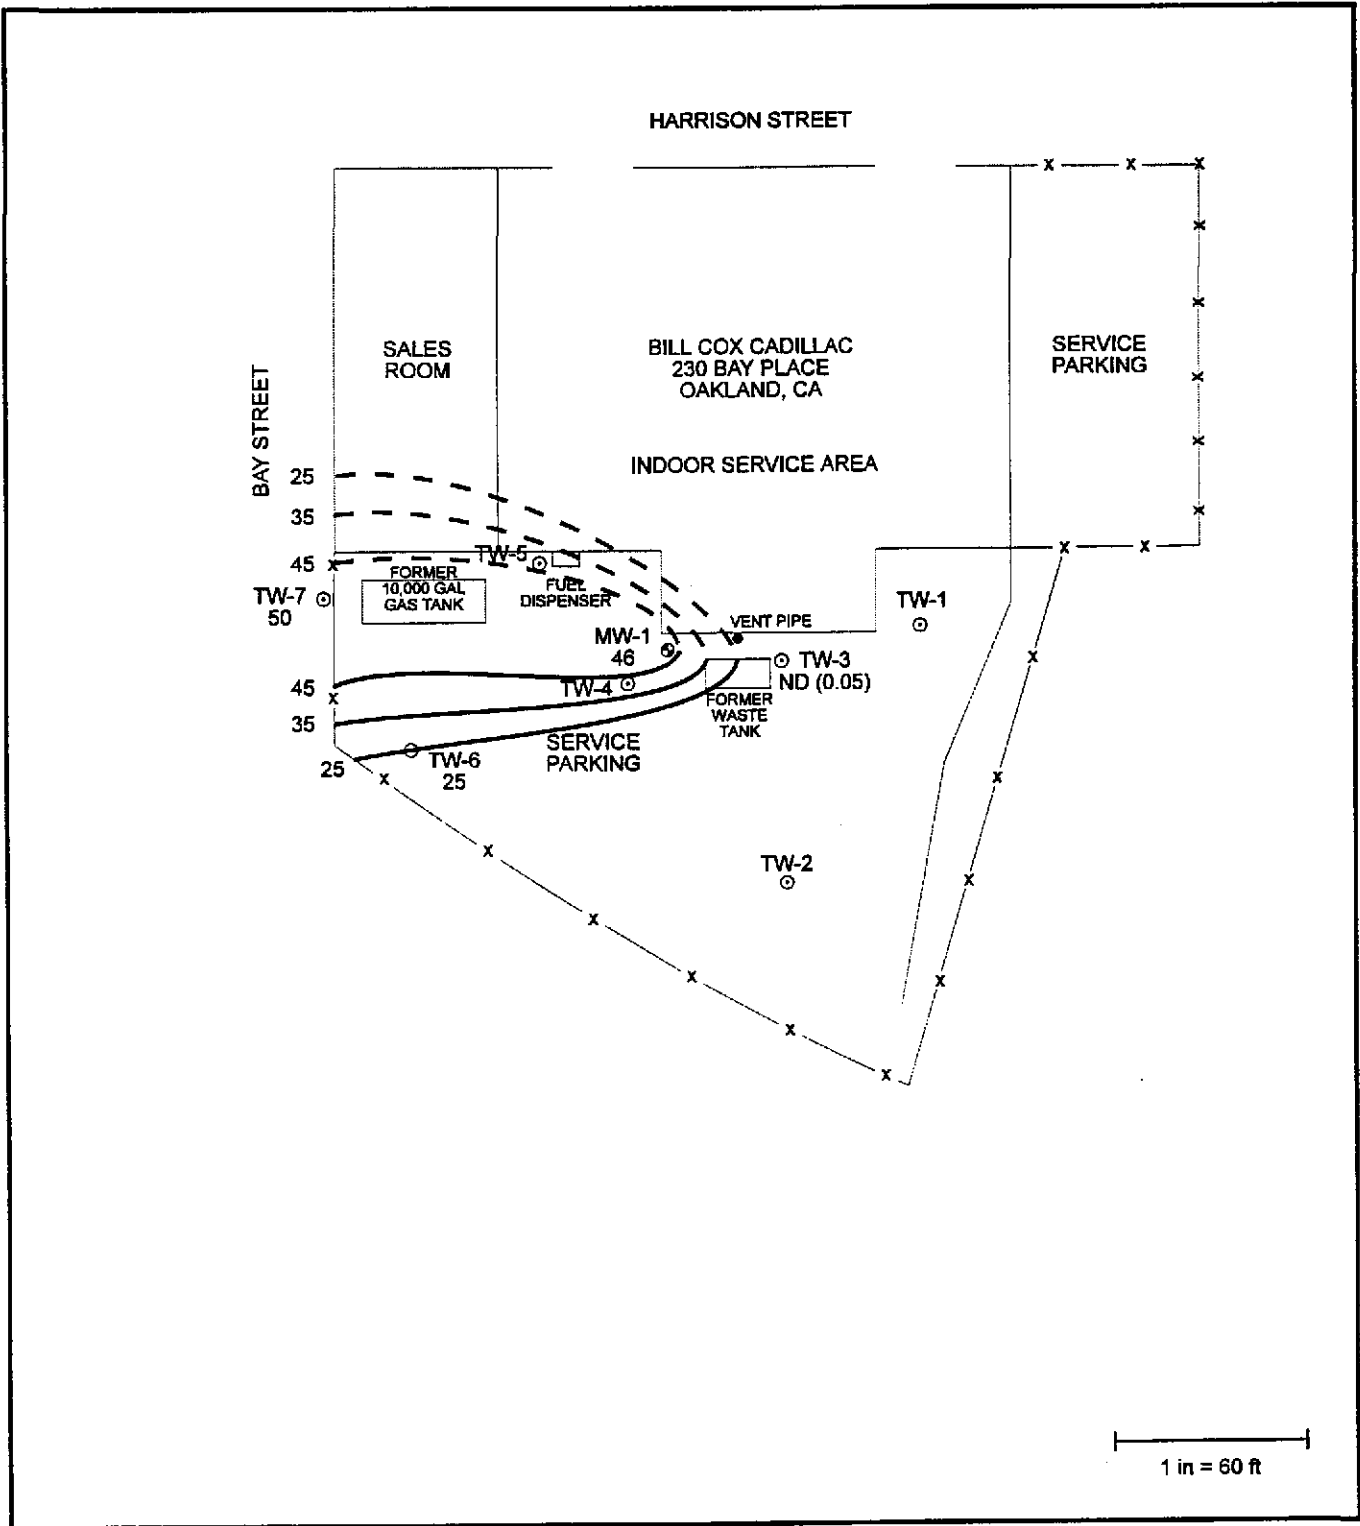
FIGURE 10: TVH Concentration in Groundwater (ppm)
February 23, 1996

Based on field observations, the depth of TVH-impacted soils is dependent on groundwater fluctuations and is located at depths of 4-6 feet, within the "smear zone". These observations are confirmed by the groundwater monitoring results that show slight fluctuations of hydrocarbon concentrations which somewhat correlate with the seasonal fluctuations of groundwater elevations. From the soil sample results, it appears that the benzene component of the soil hydrocarbons is relatively small relative to the proportion observed in groundwater. The area with relatively high benzene concentrations in soil is very limited, located in the immediate vicinity of the former piping leak. This most likely indicates that the benzene has degraded, leached, or volatilized from the hydrocarbons in the soil, or it may indicate some other, unidentified source for at least part of the groundwater pollution.

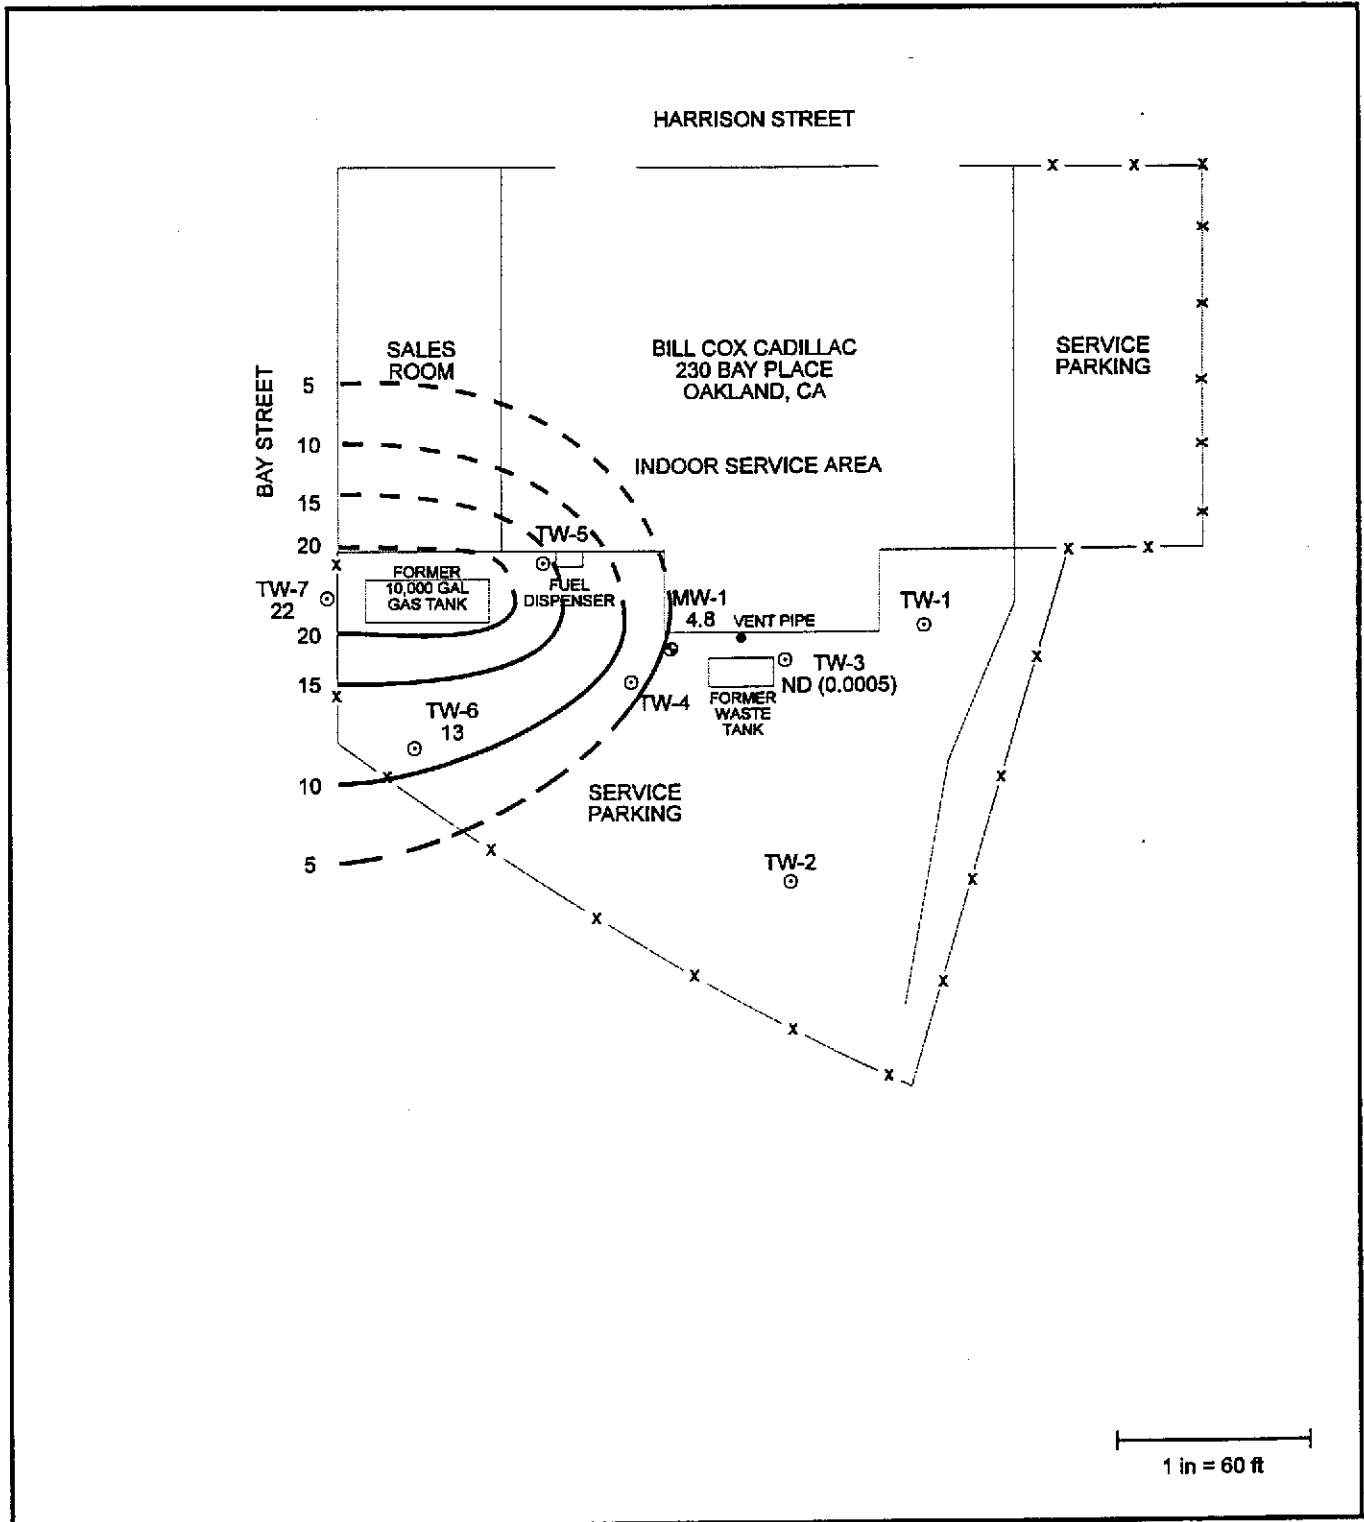
FIGURE 12: Benzene Concentration in Groundwater (ppm)

Historically, the highest benzene concentrations have been found in well TW-7, located just downgradient from the former gasoline tank. Concentrations in this well range from 13-49 parts per million (see Table 2). Over time, the concentrations have generally decreased, however, they remain within the same order of magnitude.

For the groundwater comparison, historical concentrations in well TW-7, located downgradient from the former tank location were used. Based on the field observations and the concentrations of benzene in soils, it is apparent that the source of the leak was from the pipe trench and not the underground storage tank; however, the highest concentrations were found in TW-7 and therefore, these groundwater concentrations were used in the risk screening. Comparisons of the RBSLs for benzene for the groundwater vapor intrusion to building scenario, is shown in Table 5 for groundwater.

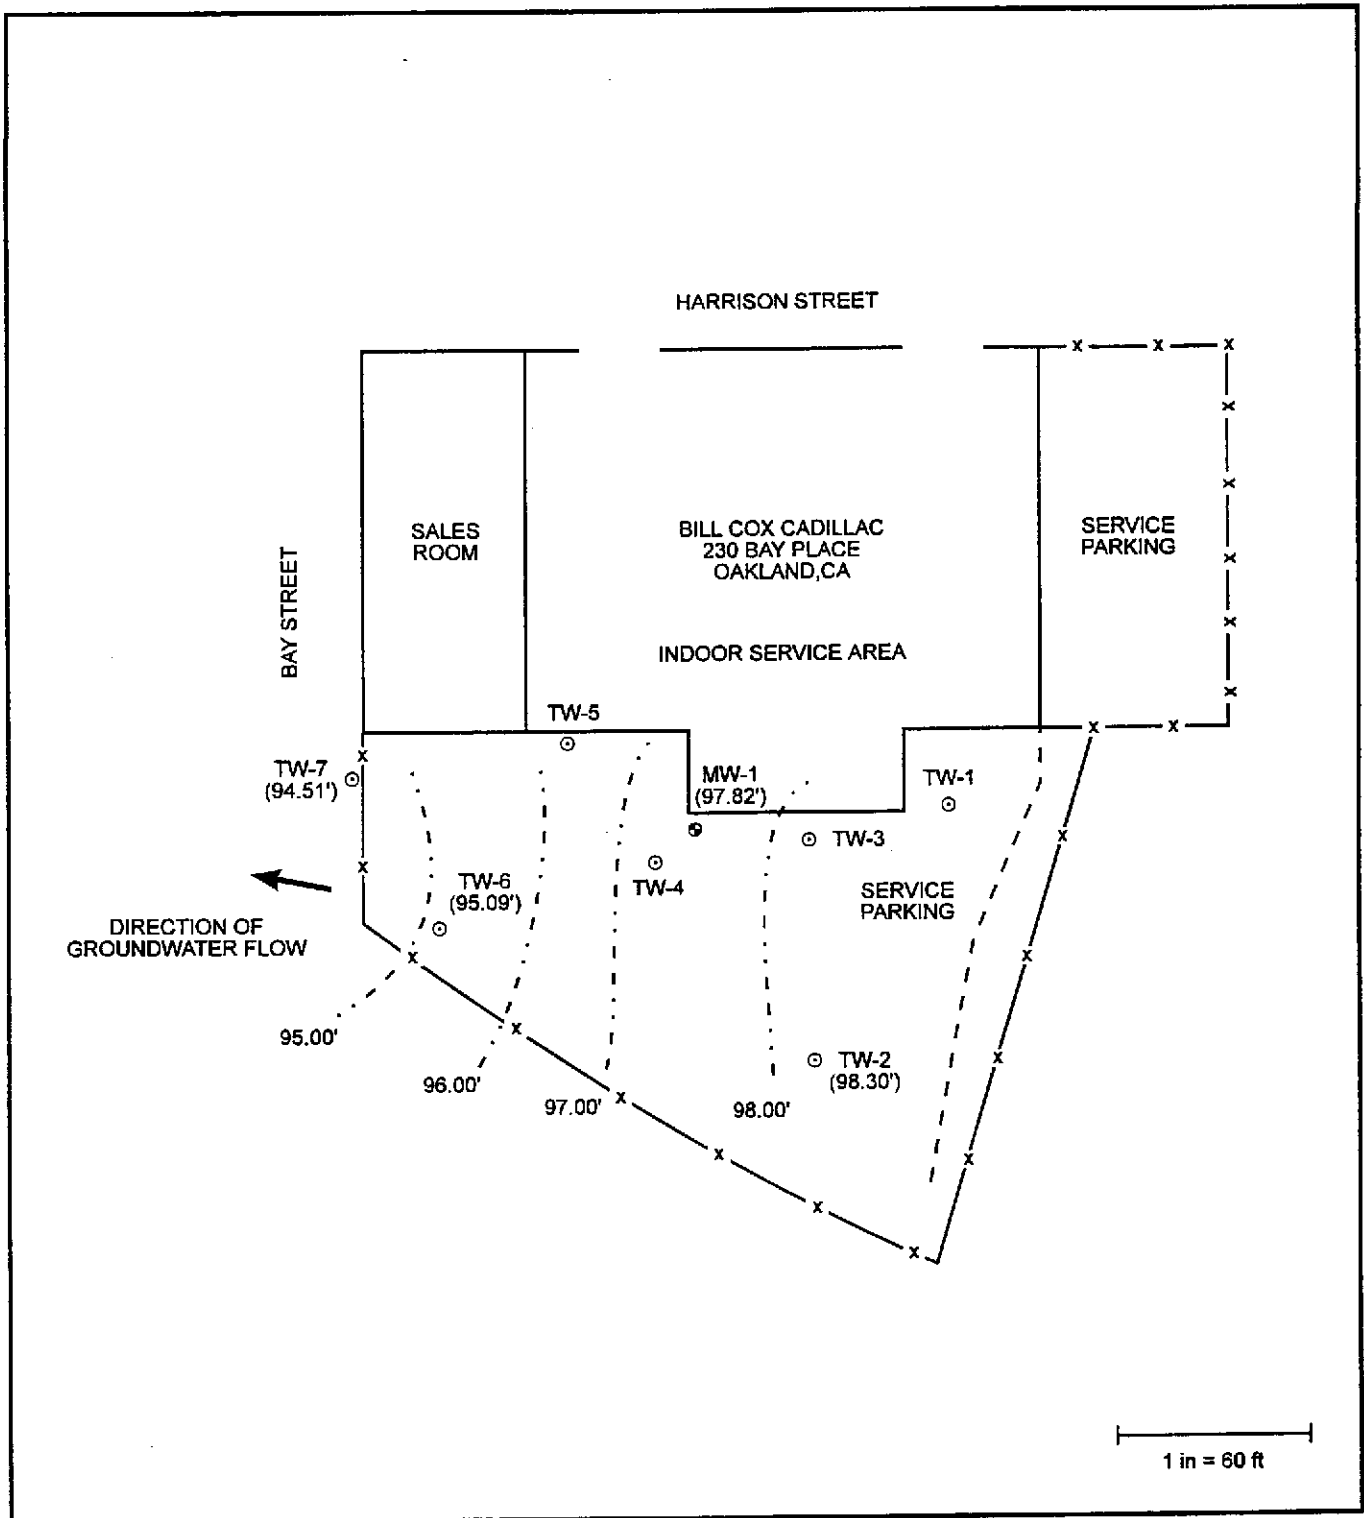
FIGURE 13: GROUNDWATER GRADIENT FEBRUARY 1996

In May 1993, PES performed a limited study of the potential for groundwater to be affected by tidal fluctuations in Lake Merritt. Groundwater levels were measured three times in one day corresponding to times of two high and one low tide at the Oakland Inner Harbor. The results of the study do not support the existence of tidally-influenced groundwater at the site.

A downgradient hydropunch groundwater sampling investigation (*Offsite Groundwater Hydropunch Sampling*, EOA, September 1995) provided information on the distribution of hydrocarbons in the downgradient direction from the site. The results of that limited sampling event suggest that the groundwater is not migrating offsite in the direction suggested by the on-site groundwater flow. Further definition of subsurface utility structures in that vicinity indicates that the backfill and/or the pipes are in a configuration and depth which suggest that they may be intercepting shallow groundwater flow.

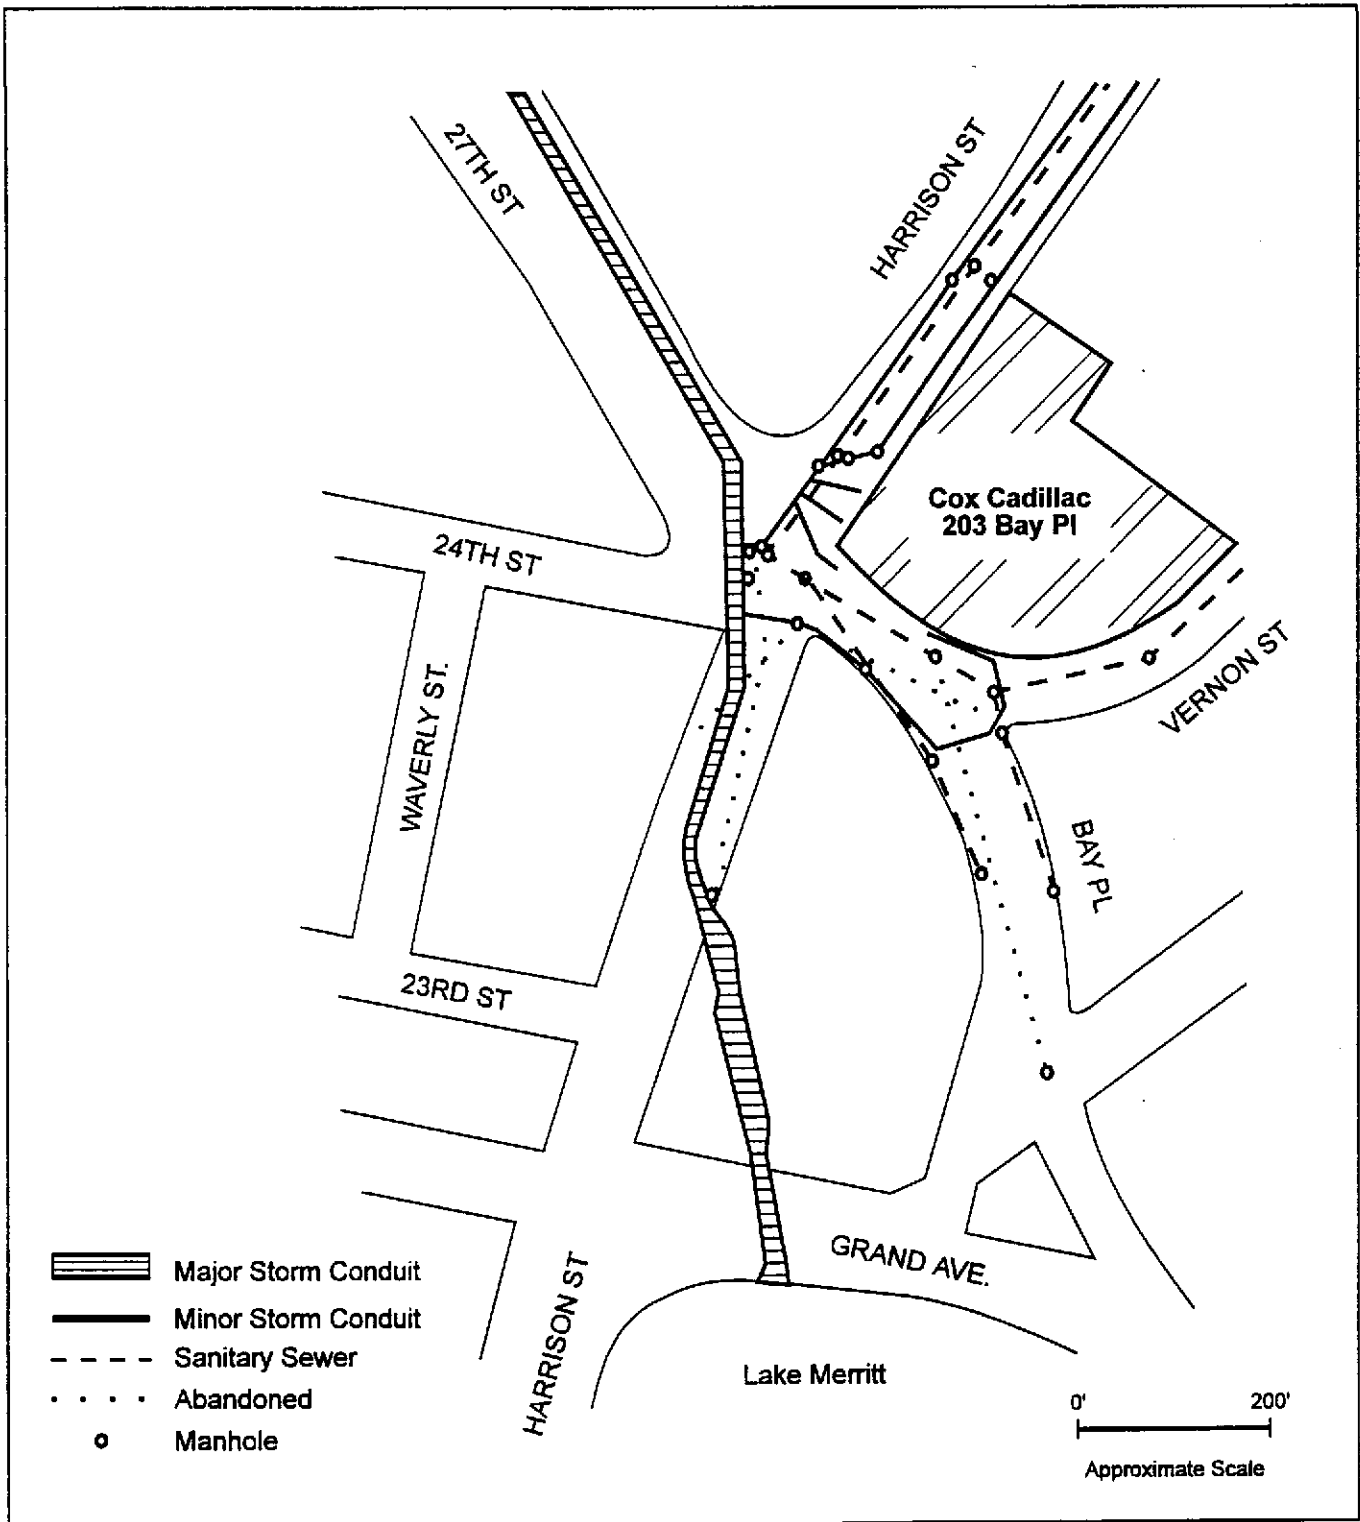
FIGURE 16: Map of Sanitary Sewer and Storm Drain Conduits Near Cox Cadillac

A more likely pathway for ecological exposure would be through infiltration to storm sewers and subsequent discharge. Potential for such discharge exists, at least during the wet season when groundwater elevations appear to rise well above the elevation of active and abandoned storm sewers in this vicinity. Odors or sheen were not observed in drop structures or utility vaults during field observations carried out for this study, but it may be reasonable to include periodic observation and/or sampling and analysis of wet and dry season flow in selected storm sewers as part of ongoing monitoring at this site, given the concentrations of benzene in groundwater on site, identified characteristic of the storm

The results regarding subsurface utilities downgradient and subsurface structures on site lead to the recommendation that no additional effort or resources be directed towards further attempts at downgradient plume definition. It does not seem feasible to track pollutant migration in this area, given the nature and complexity of utility structures.
