PHOTOS TAKEN BY RON OWCARZ  
AT UGT MODIFICATION AT VICKY  
SHELL, 2120 MONTANA ST. IN OAK.  
ON 7/6, 7/19 + 7/20/93

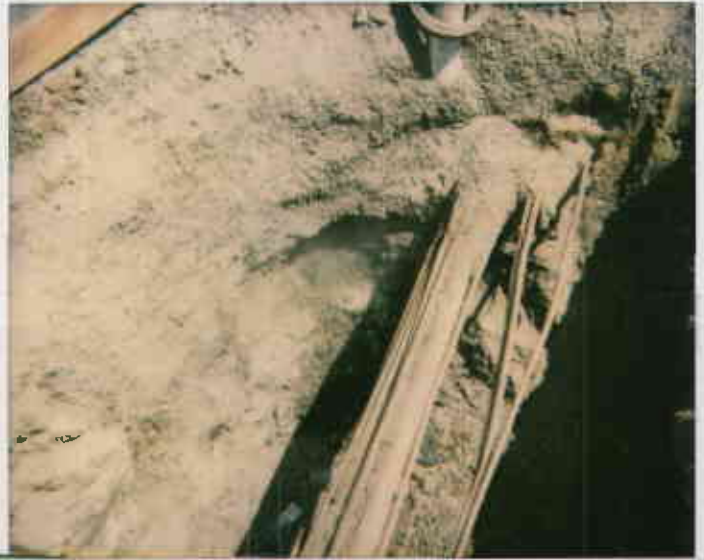
7/20/93-Photo taken by Ron Owcasz at Bansal Shell, 2120 Montana Ave. in Oak. Red caps indicate soil sample locations in side wall of pit overexcavation for UGT pipe med. @

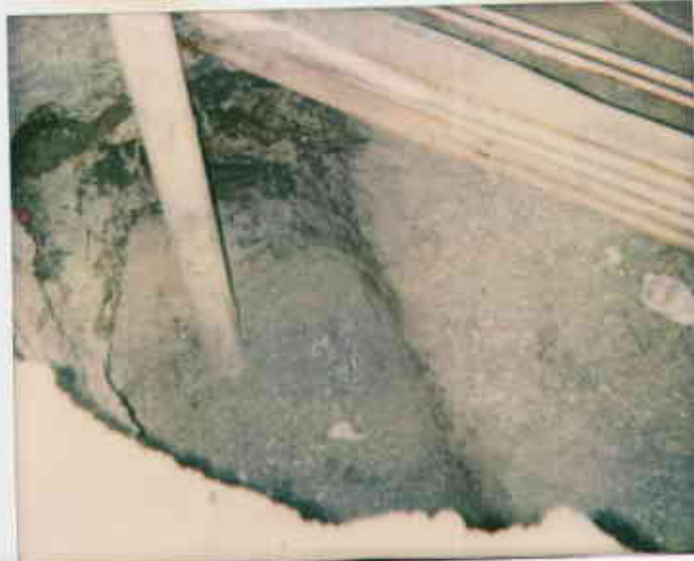
7/20/93 Photo taken by Ron Owcasz at Shell station @ 2120 Montana Ave. in Oak for piping of UGT med. where soil contamination was found at pit overexcavation. @

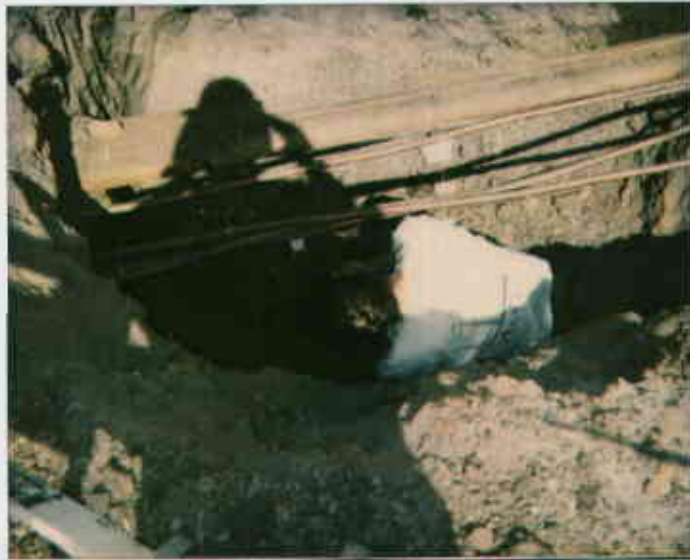
7/20/93-Photo taken by Ron Owcasz at Bansal Shell, 2120 Montana Ave. Oak. Shown is soil cont. at side wall of pit overexcavation for UGT pipe med. @

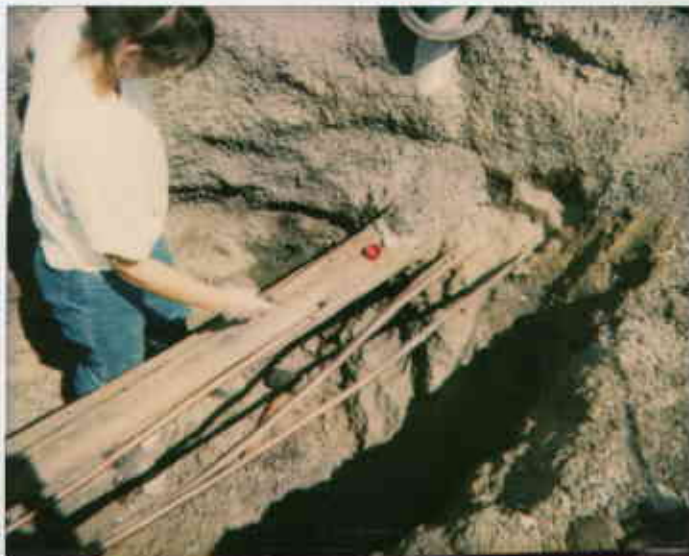
7/19/93-Photo taken by Ron Swartz at Banzal  
Shell, 2120 Montana Ave. Oak shown is Allison  
Watts taking soil samples at pit overexcavation. Ⓜ

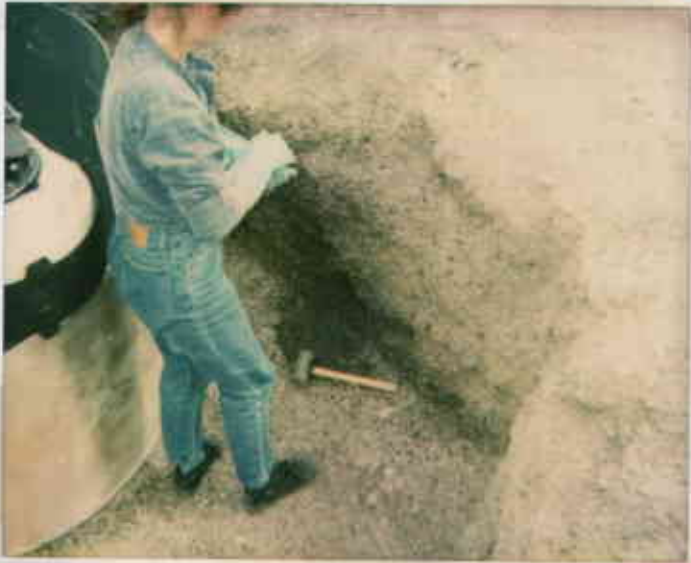
7/19/93-Photo taken by Ron Swartz at Banzal  
Shell, 2120 Montana Ave. Oak shown is Allison  
Watts taking soil samples after pit reexcavation. Ⓜ

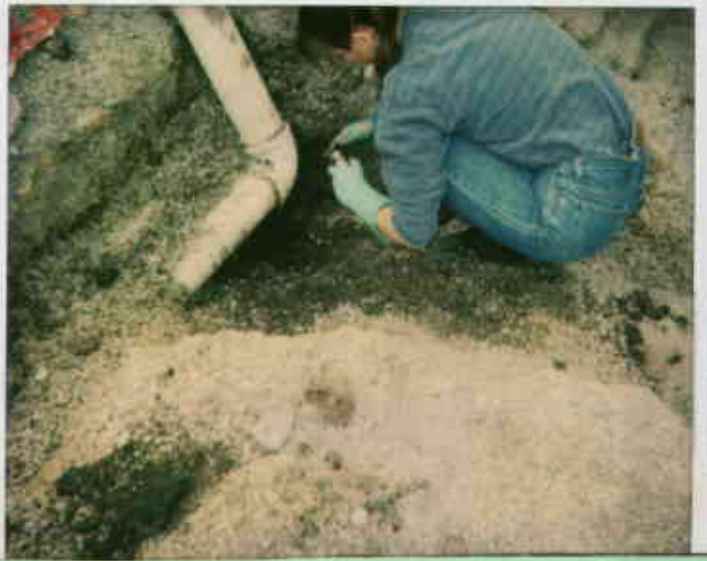
7/6/93 - Photo taken by <sup>2215117976-B</sup> Ron Owsatz at Bansal shell, 2120 Montana Ave, Oak. Shown is Allison Watts taking soil sample in side wall of pit where cont. was found at old piping node. (R)

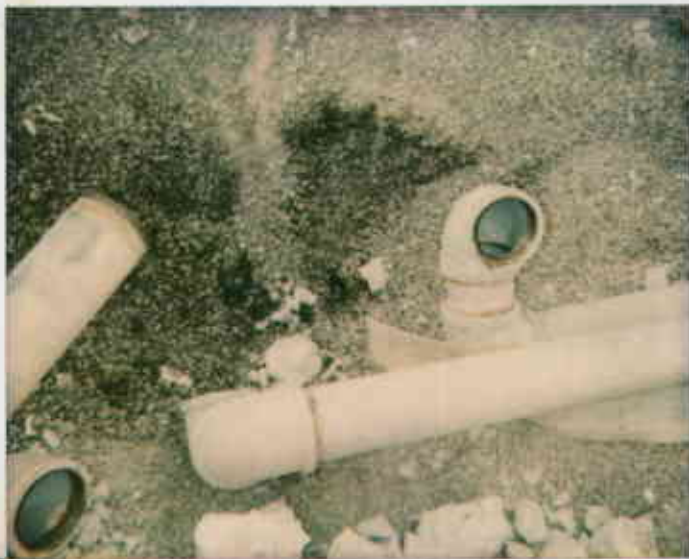
7/6/93 - Photo taken by <sup>2215117976-B</sup> Ron Owsatz at Bansal shell, 2120 Montana Ave. Oak. Shown is new sump that failed sump test twice. Also note soil cont. at side well adjacent to it. (R)

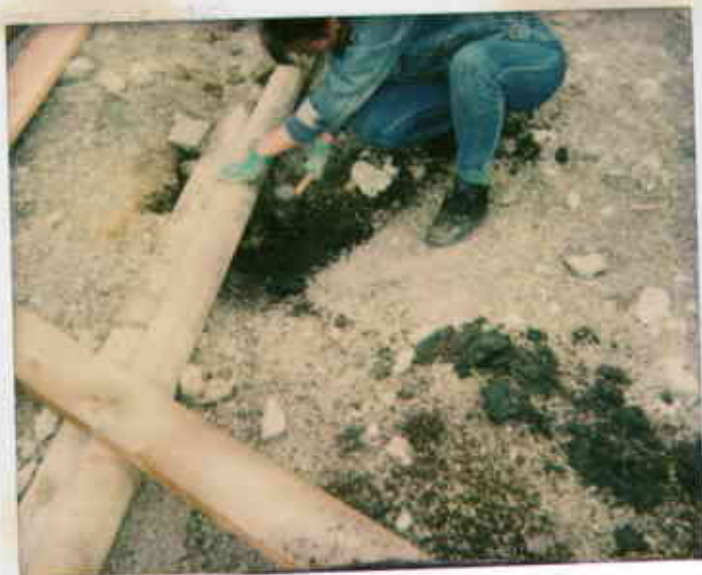
7/6/93 - Photo taken by Ron Cuccare at Banzal  
Shell, 2120 Hartana Ave, Oak. Shown is soil sample  
location at end of old pipe line for UST med. ②
