**REPORT ON SUBSURFACE INVESTIGATION AND
REMEDICATION OF CONTAMINATED SOIL**

**SITE LOCATION:
800 FRANKLIN ST., OAKLAND, CALIFORNIA**

November 3, 1989

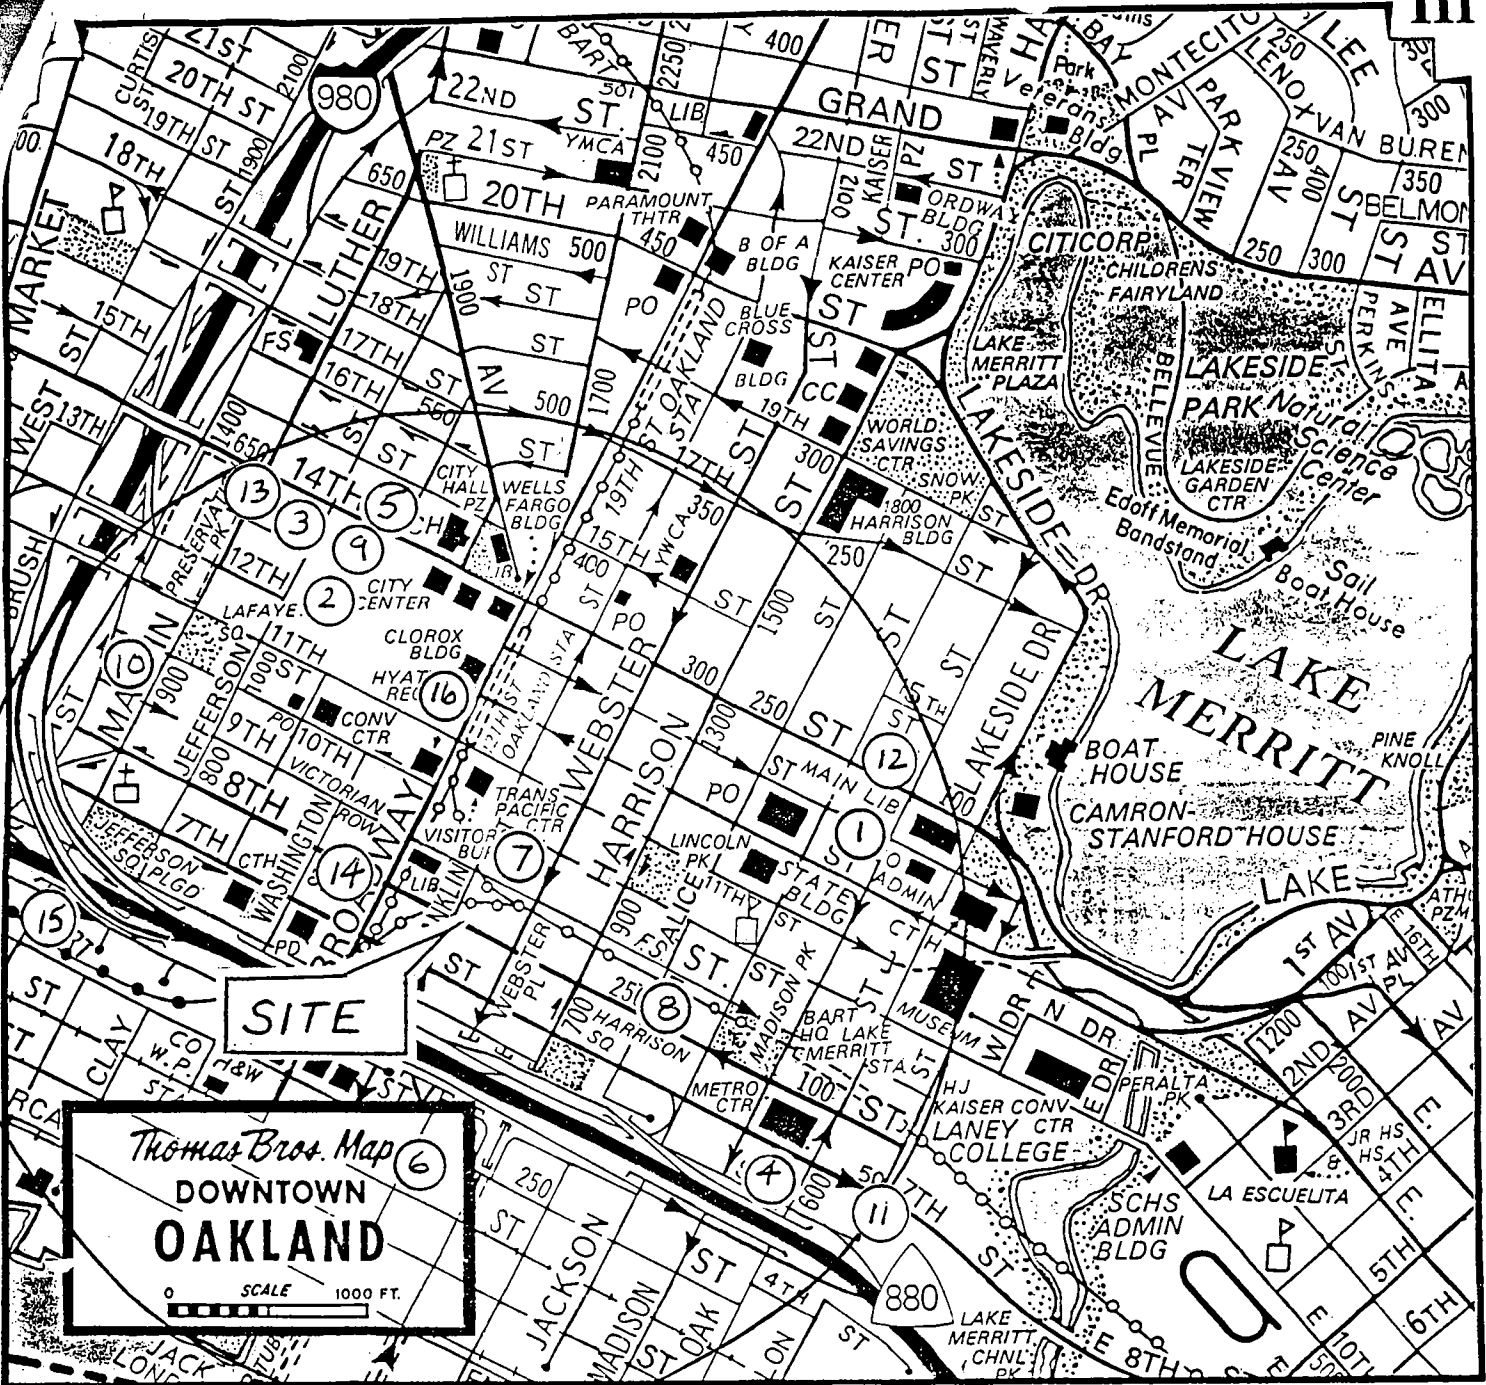
FIGURE 1
 SITE LOCATION MAP SHOWING SUBSURFACE CONTAMINATION SITES
 WITHIN 1/2-MILE RADIUS OF SITE

Miller Environmental has reviewed the records of underground fuel leak cases on file at the RWQCB. A number of ground water contamination problems were found to exist in the nearby area. Within a 1/2 mile radius of the 800 Franklin Street site there are sixteen (16) reported cases of petroleum hydrocarbon releases to the subsurface, with half of these being classified as ground water problems. The locations of these releases are shown by number on Figure 1. The sites corresponding to these numbers are listed in Table 5.

four of these sites. These include flow to the north at Shell (no. 14), to the northwest at Bramalea Pacific/Chinatown Redevelopment Agency (nos. 3, 13), and to the north-northeast at Unknown (no. 16).

None of the remaining ground water contamination cases appear to present a potential impact to the 800 Franklin St. site. Shell (no. 14) is in closest proximity but has a reported ground water flow direction to the west, away from the site. The remaining sites are either reportedly limited to soil contamination or are too far away to have an impact via ground water transport.

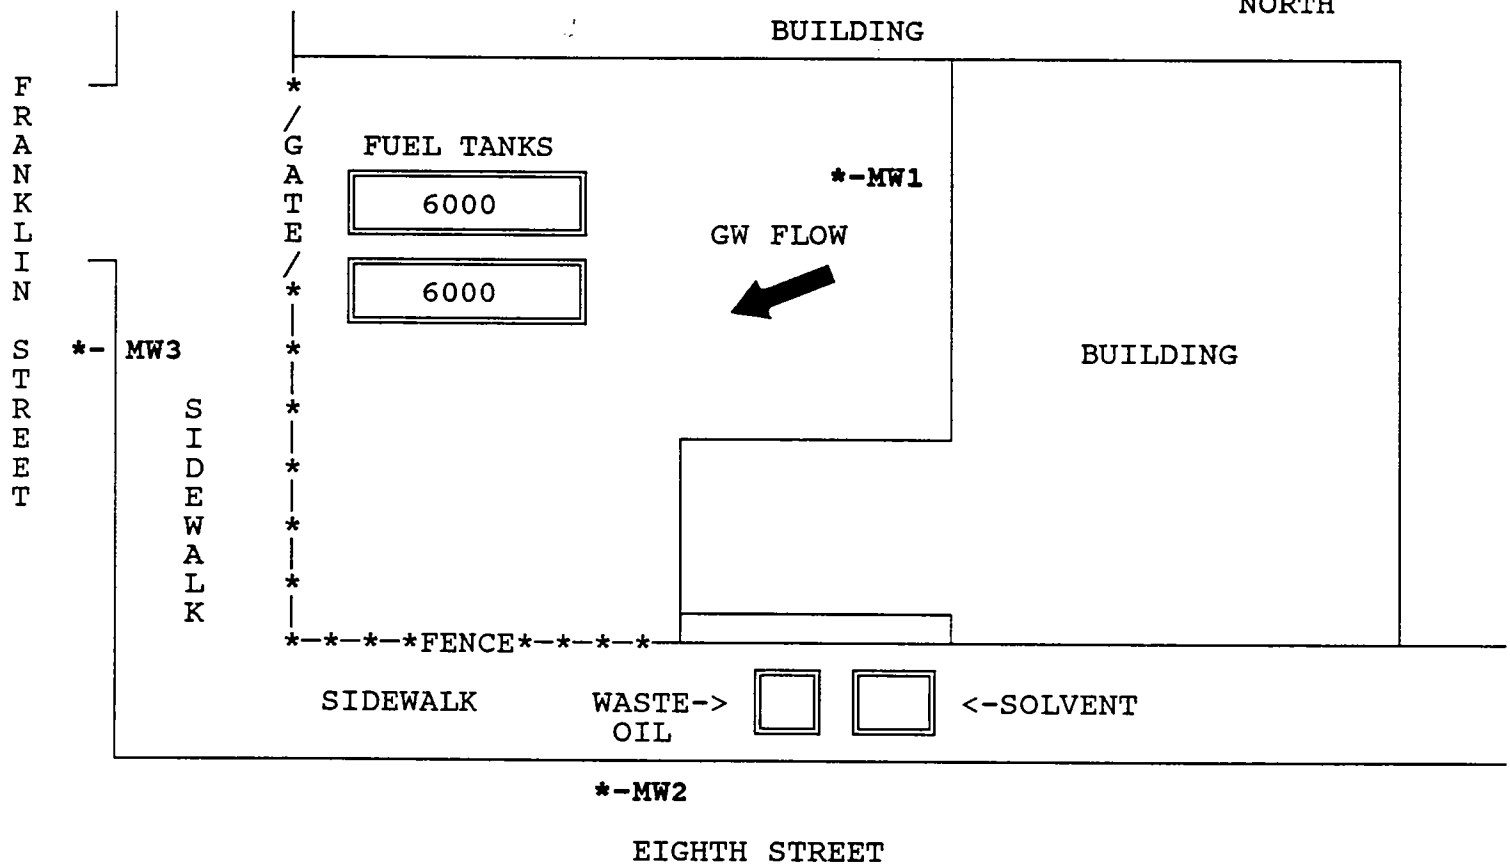
FIGURE 2
 SITE PLAN
 800 FRANKLIN STREET, OAKLAND, CA

Prior to 1989 the site operated as a service station. Five underground tanks are known to have existed at the site. At some time prior to August, 1988 one of the tanks was removed. Available records do not indicate who pulled the tank, the contents of the tank, or the exact date of removal. It is believed that this tank was located close to the current location of monitoring well MW1 (see Figure 2).

Three borings were drilled to describe the geology, locate the water table, and install the monitoring wells. Figure 2 shows the location of the wells in relation to the site. Each of the monitoring wells were drilled to the water table with hollow stem augers, logged and sampled.

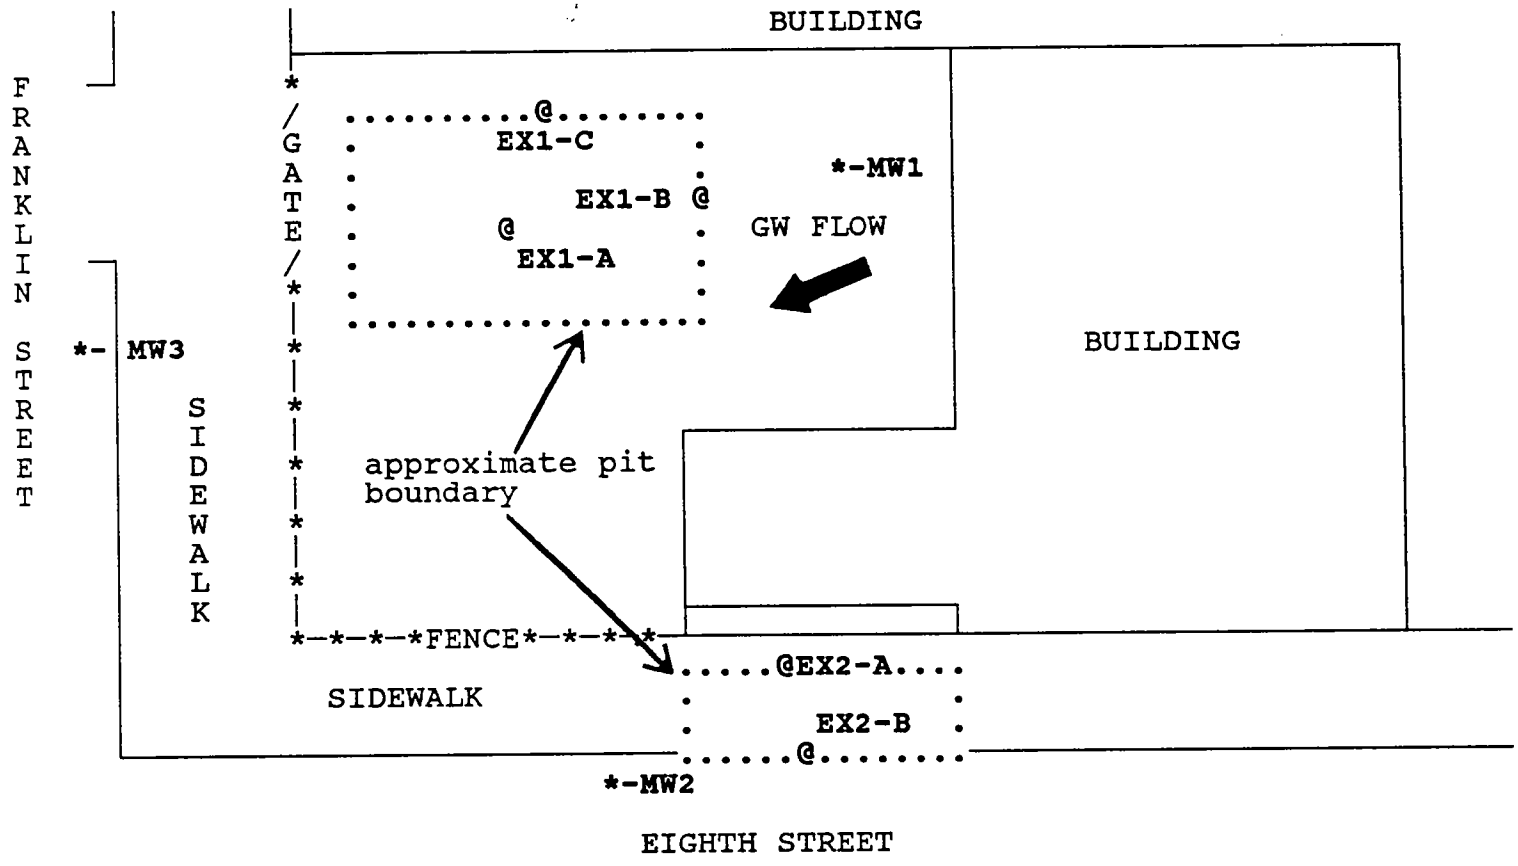
FIGURE 3
 PIT SAMPLING LOCATIONS
 800 FRANKLIN STREET, OAKLAND, CA

Discrete soil samples were collected from the sidewalls and bottom of the pits following re-excavation. The sampling locations are indicated on Figure 3. All samples were collected at an approximate depth of fifteen (15) feet. The results of laboratory analysis are summarized in Table 1.

Analytical results indicate that soil contaminated with petroleum hydrocarbons has been effectively removed from the interior of the property where the gasoline tanks were formerly located. The highest levels detected in this re-excavated pit (EX1 samples) were 2.3 ppm TPH as gasoline, none detected for TPH as diesel, 80 ppm TPH as waste oil, none detected for benzene and ethylbenzene, 0.05 ppm toluene, and 0.14 ppm xylene.

Analytical results for the samples collected from the pit in the sidewalk (EX2 samples) indicate that the re-excavation was not successful in removing all highly contaminated soil. Detected levels in EX2-A, collected from the sidewalk toward 8th Street, were 10,000 ppm TPH as gasoline, 250 ppm TPH as diesel, and 400 ppm TPH as waste oil. The extent of excavation was limited in this case to machinery capabilities and the proximity of 8th Street along the southern edge of the excavation.

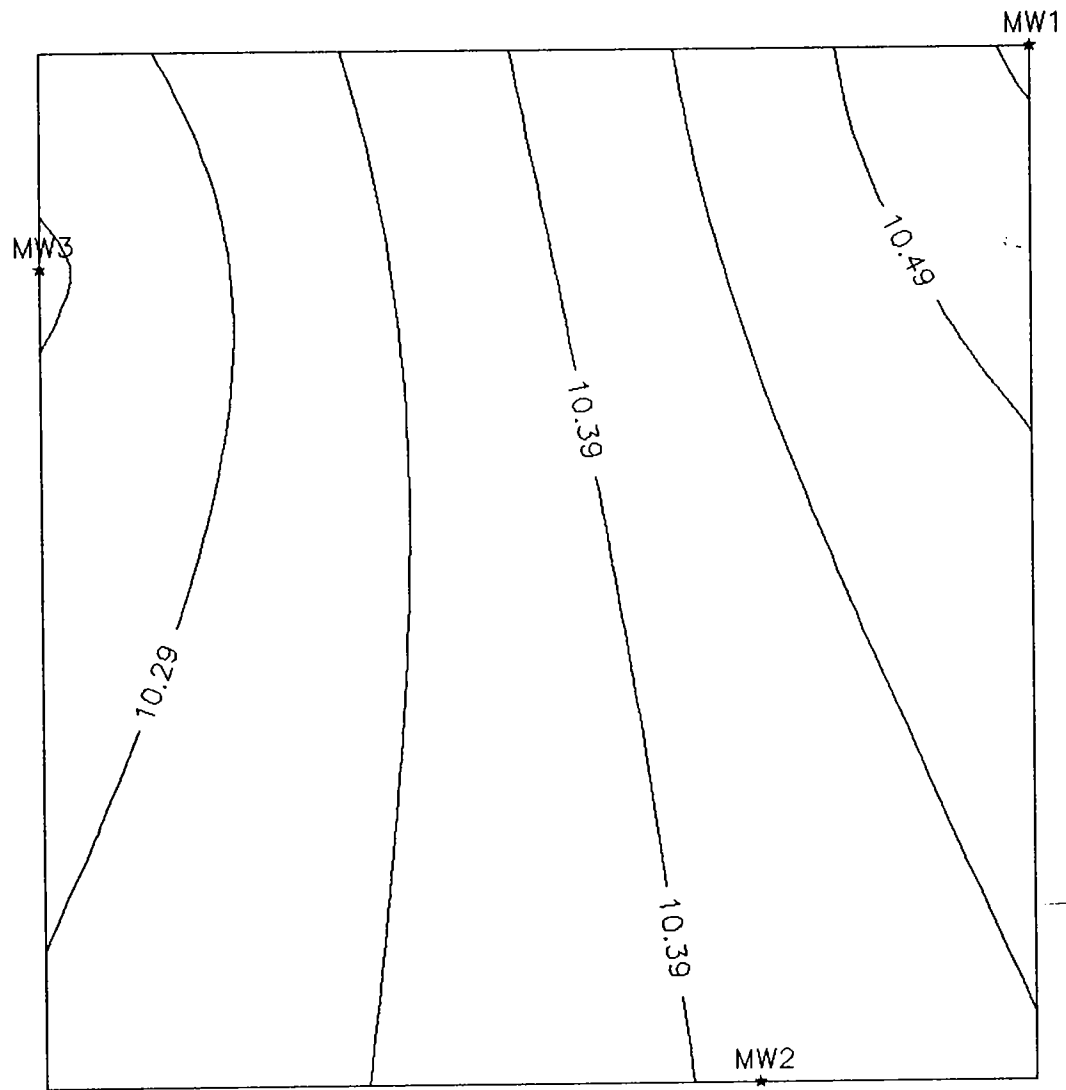
FIGURE 4—GROUNDWATER ELEVATIONS—800 FRANKLIN

The ground water gradient and flow direction have been estimated using this data with a computer model. Ground water elevation contours generated by the model are presented in Figure 4, which shows ground water is flowing in a west-northwest direction at the Shaw site. The calculated gradient based on this data is approximately 0.006 ft/ft.

Ground water flow gradient data currently indicate flow to the west-northwest. Ground water flow directions may have varied over the past few years due to nearby remedial actions and/or construction of BART tunnels.

Quarterly sampling of wells MW2 and MW3 is recommended to monitor the levels of contamination. MW1 should be included in the sampling program until the well is abandoned and removed as construction at the property begins. In addition, due to the number of ground water problems in the area, it may be prudent to confirm the ground water flow direction periodically before MW1 is abandoned.

If possible, ground water levels should be re-measured and flow calculated for changes in weather seasons and after any known change in local dewatering projects. In conjunction with continued sampling this information would help evaluate: 1) whether soil remediation measures are effective in alleviating further contamination to ground water, and 2) whether contamination from other projects might be migrating on site.
