Holland Oil

Holland Oil facility
16301 E. 14th Street

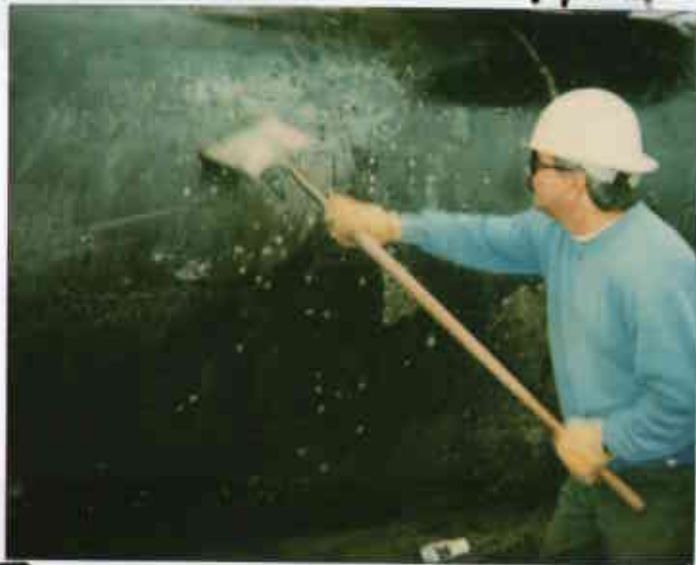
T2

tank bottom - holes, pits

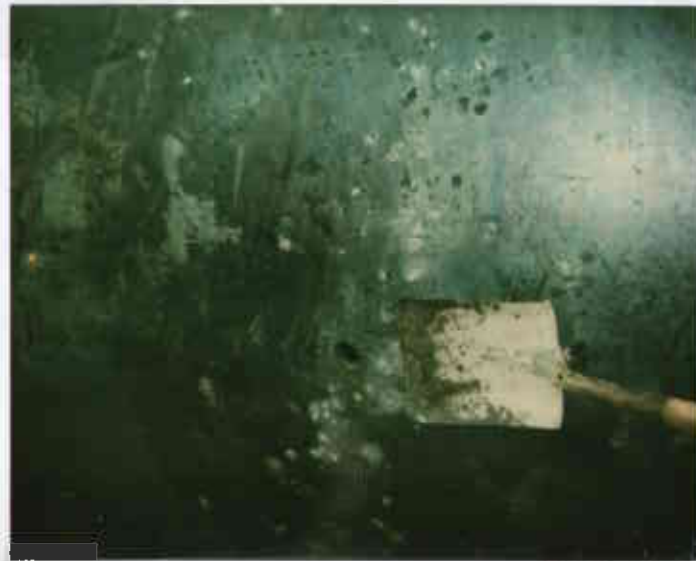
T2

tank bottom - holes

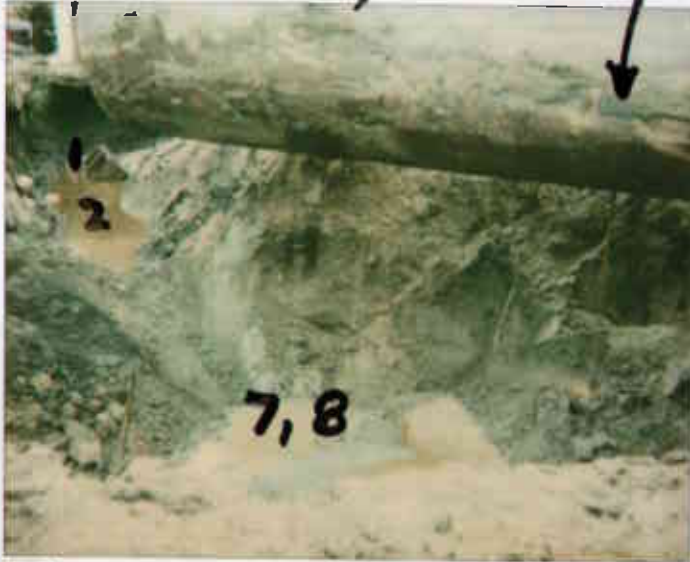
T3

water draining from tank

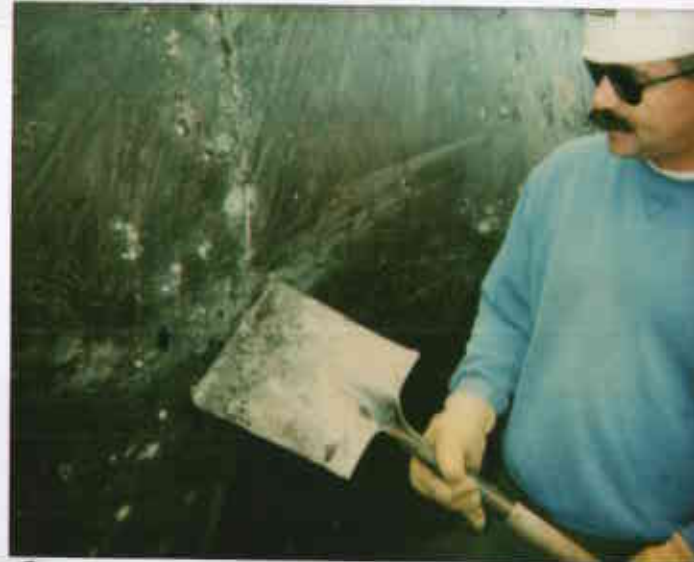
T2

tank bottom - holes

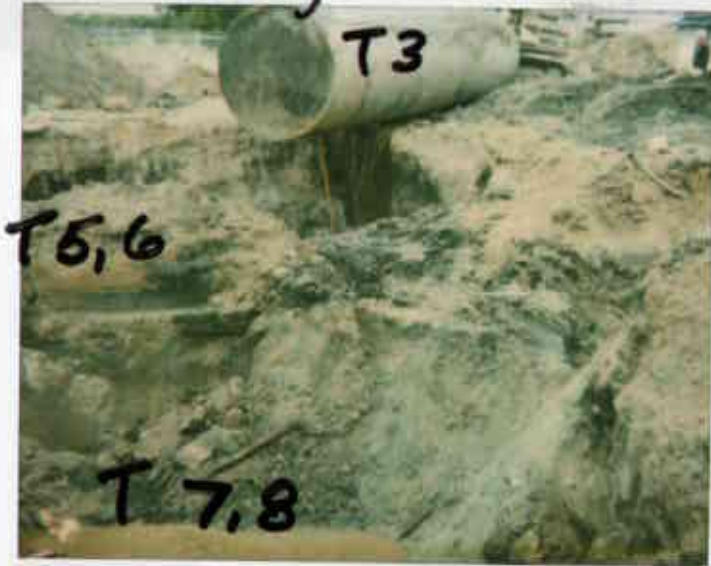
T3

water discharging from tank

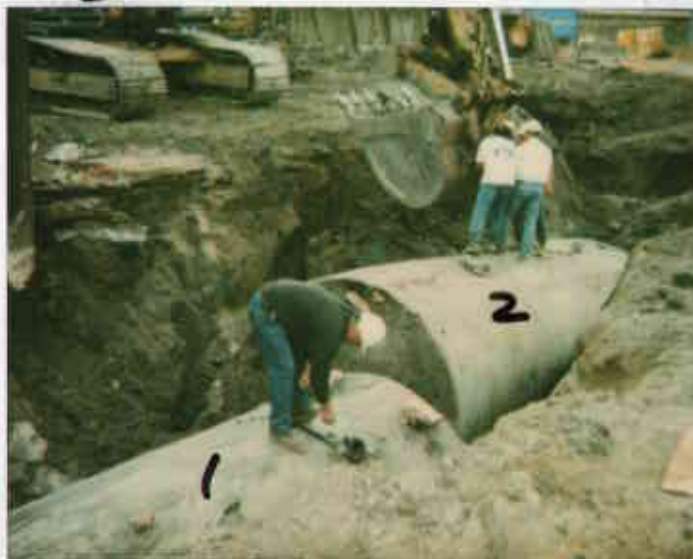
T1,2

deep pits, tank bottom

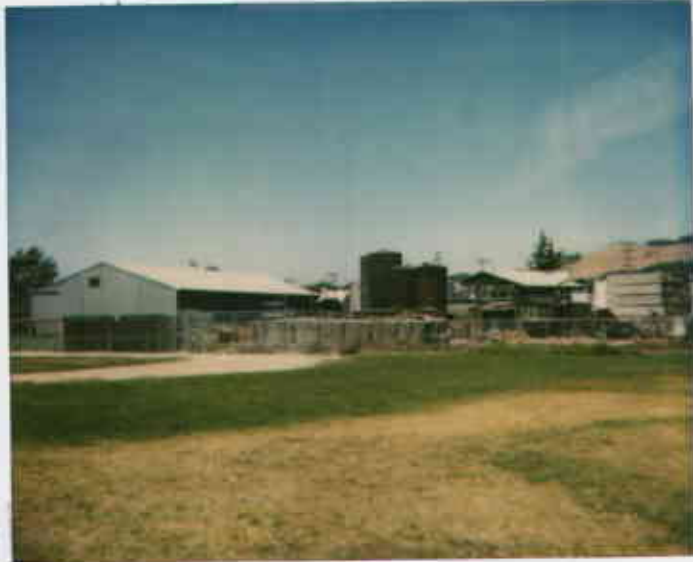
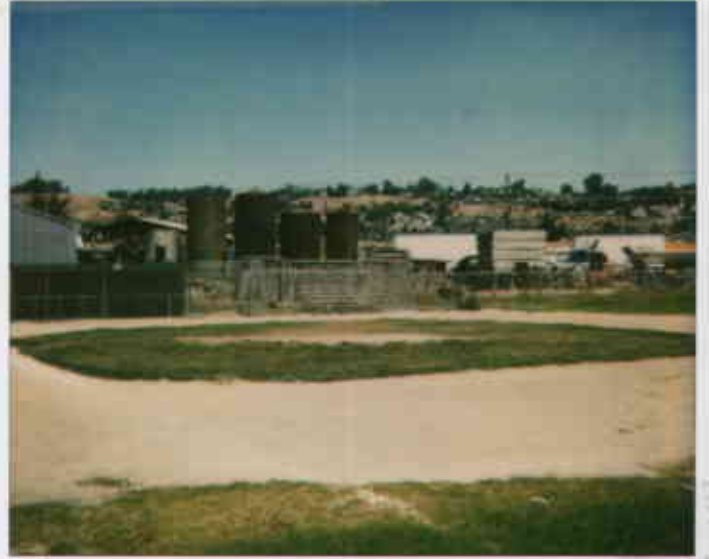
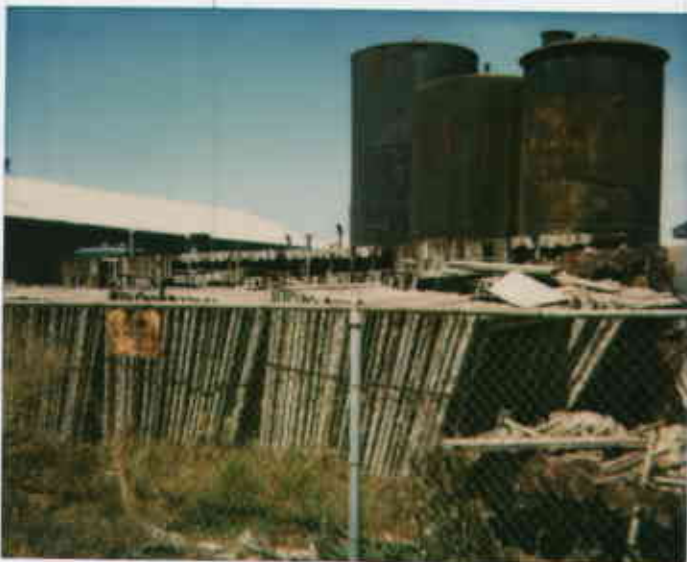
- views from Little League
field SW of site,
showing lack of progress
to begin removing "clutter"
from site

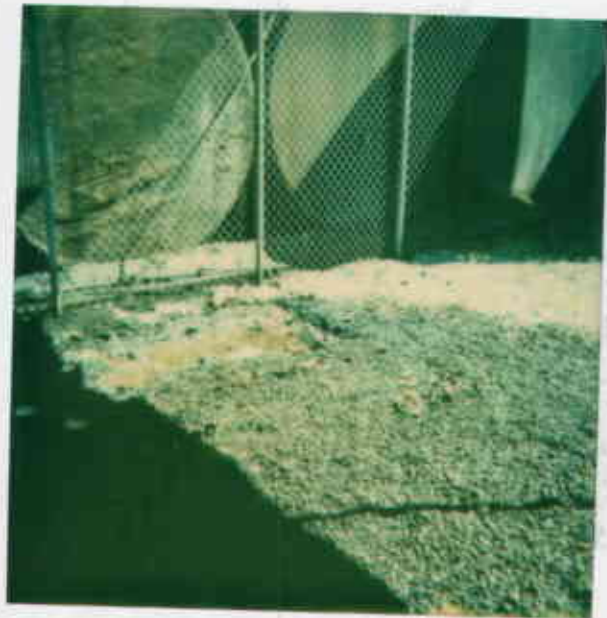
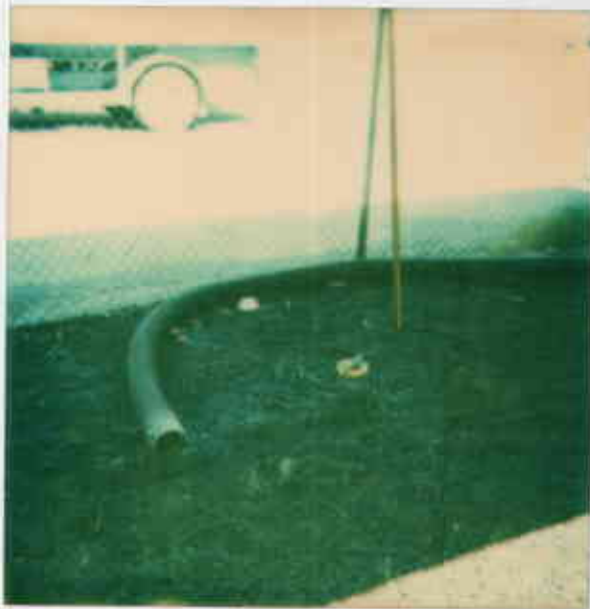
Soil discoloration in the
5,000 gal diesel tank pit area

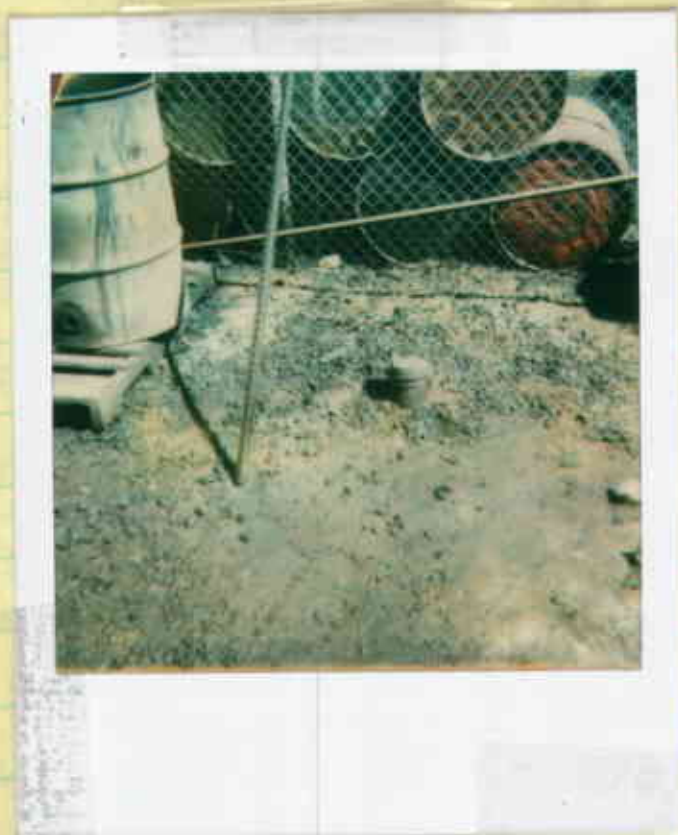
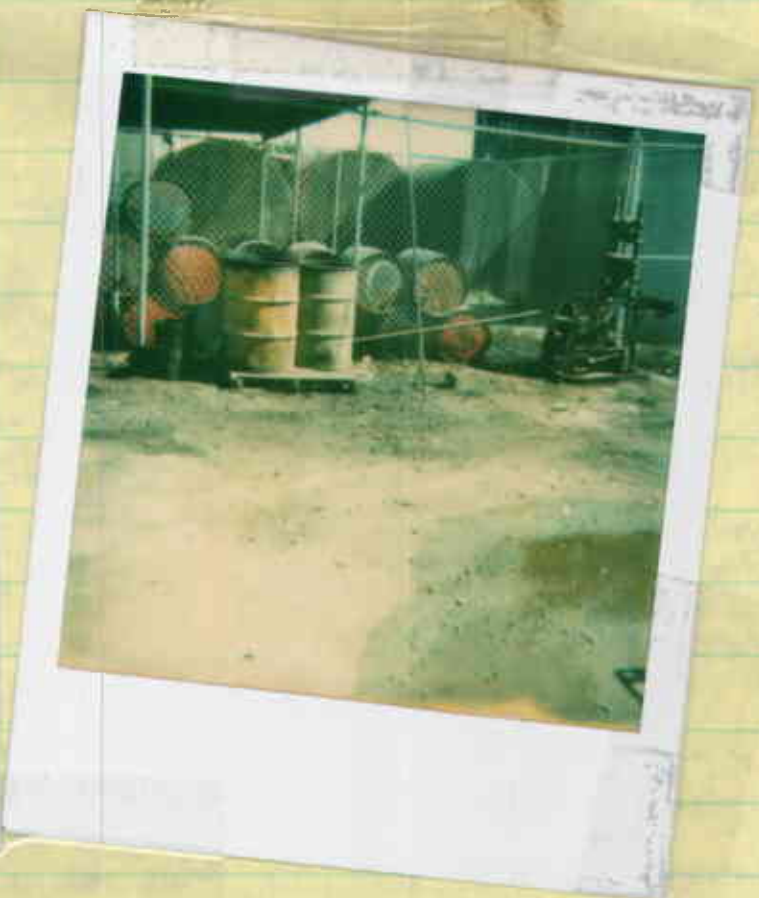
Soil discoloration near
the fill pipe of
the 6,000 gal diesel
tank
