February 28, 1994
Project No. 93110

Re: **Quarterly Monitoring Well Sampling Report**
1st Quarter, 1994 for 21123 Meekland Ave., Hayward, CA

This report covers groundwater monitoring at Beck Roofing Company, 21123 Meekland Avenue in Hayward, California (see Figure 1). Gen-Tech Environmental, Inc. (GTE) was retained to perform this initial sampling of the site monitoring wells. Three monitoring wells currently exist on-site.

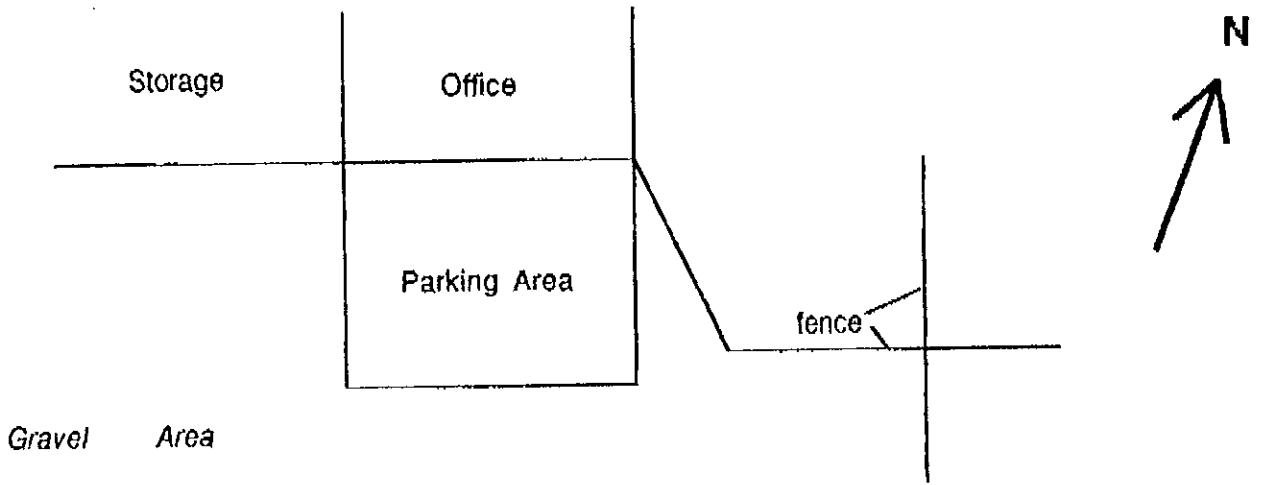
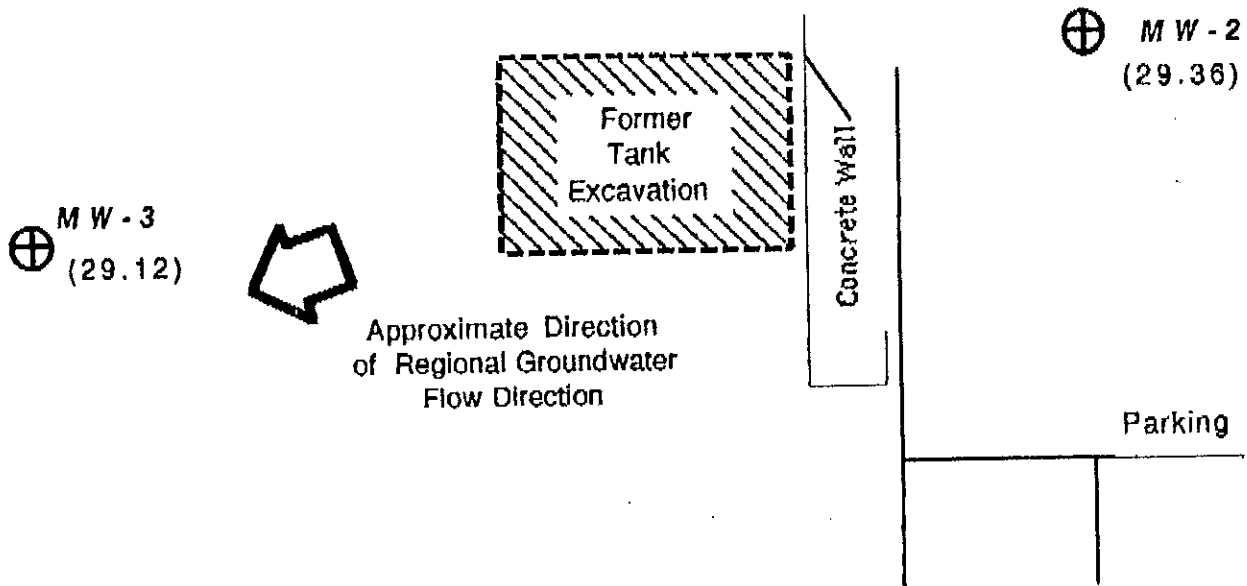
Figure 1. Monitoring Well Map

MW - 1
(covered with soil
no measurement)
