Q1/Q2 2008 BIOVENTING AUGMENTATION AND STATUS REPORT

**REDWOOD REGIONAL PARK
SERVICE YARD
OAKLAND, CALIFORNIA**

**EAST BAY REGIONAL PARK DISTRICT
OAKLAND, CALIFORNIA**

July 14, 2008

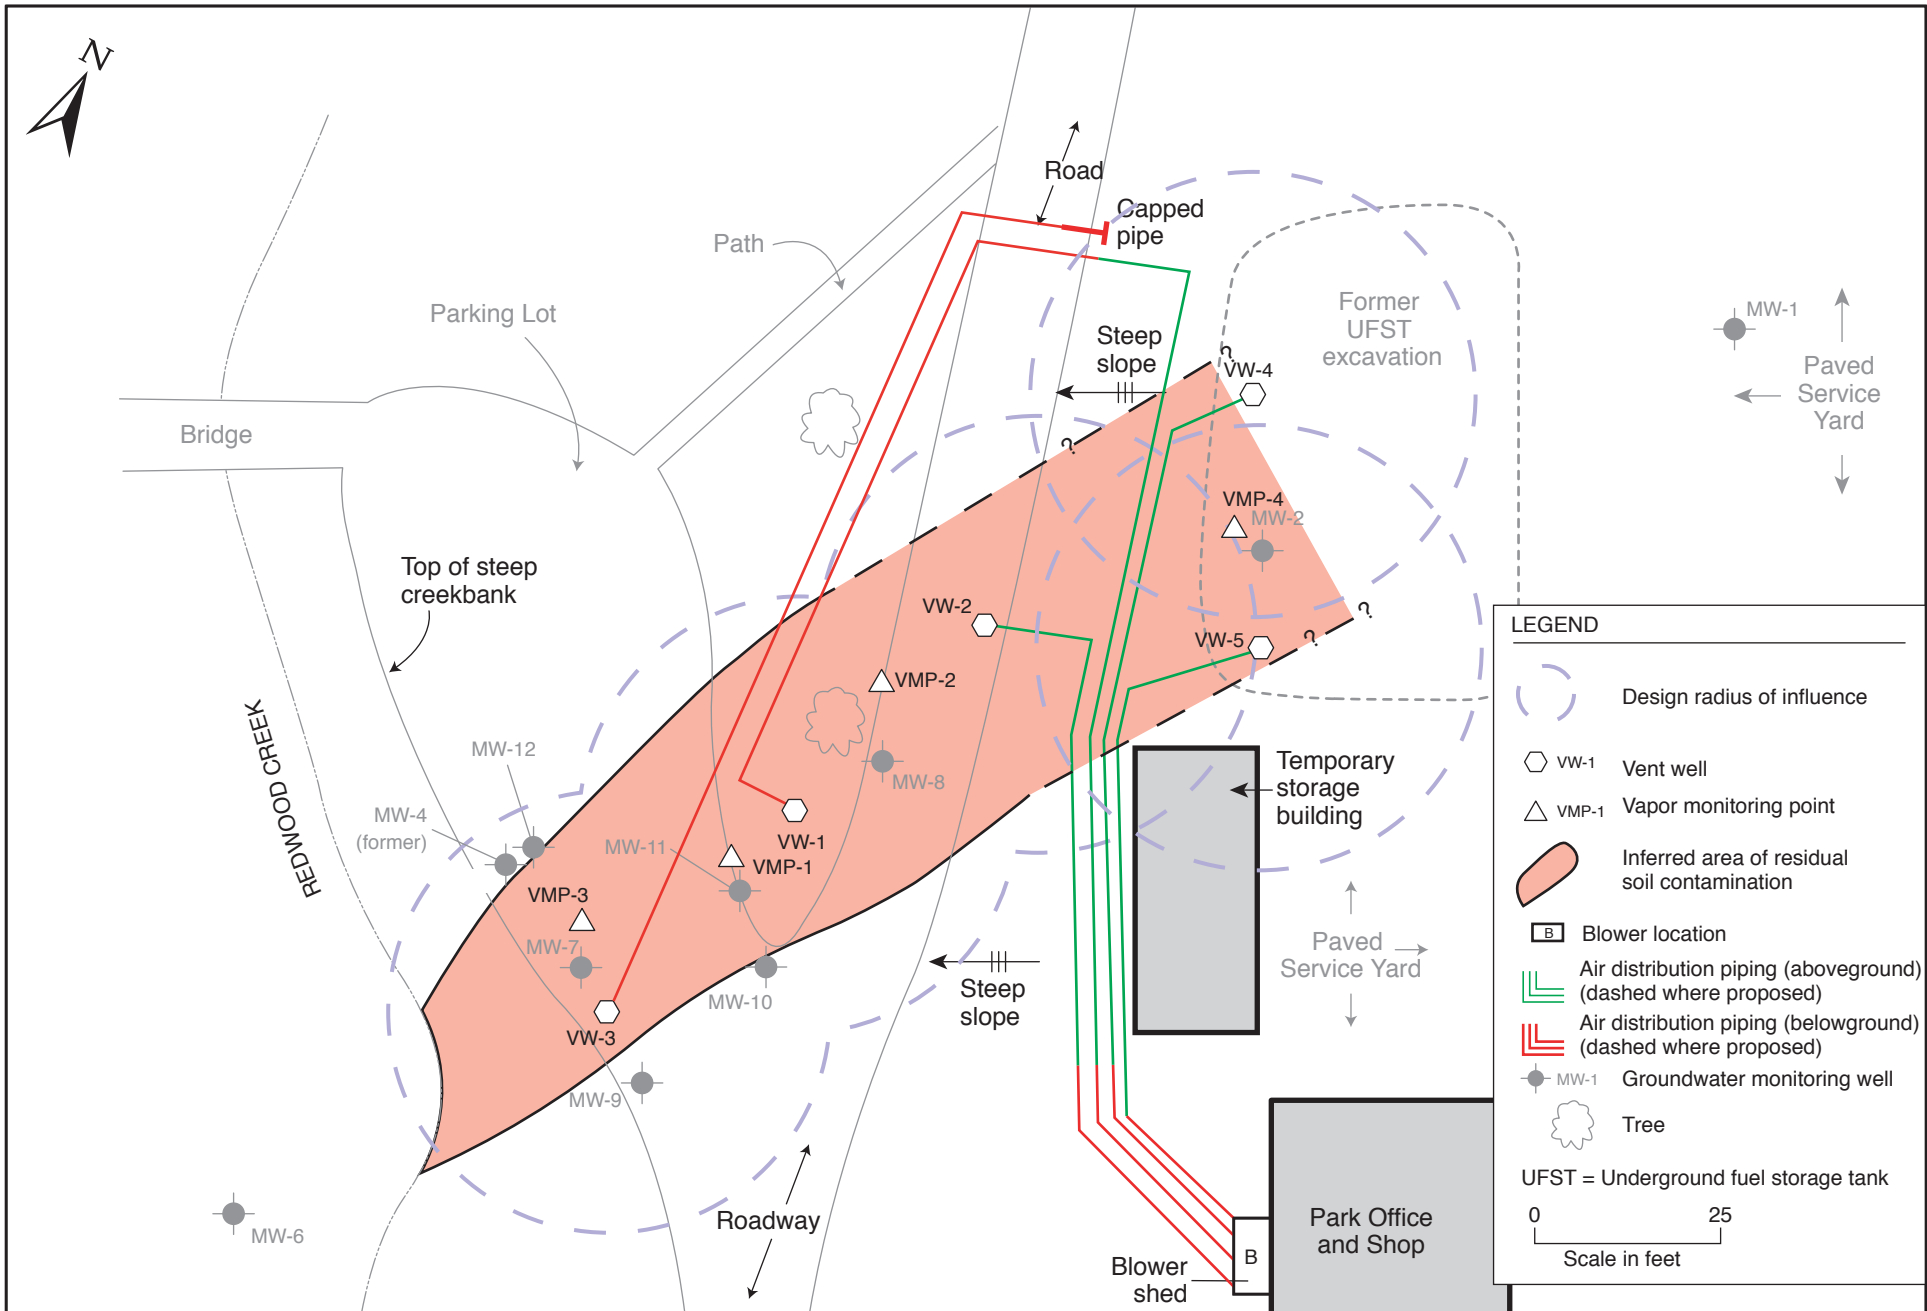
Figure 2

BIOVENTING SYSTEM
7867 Redwood Rd, Oakland, CA

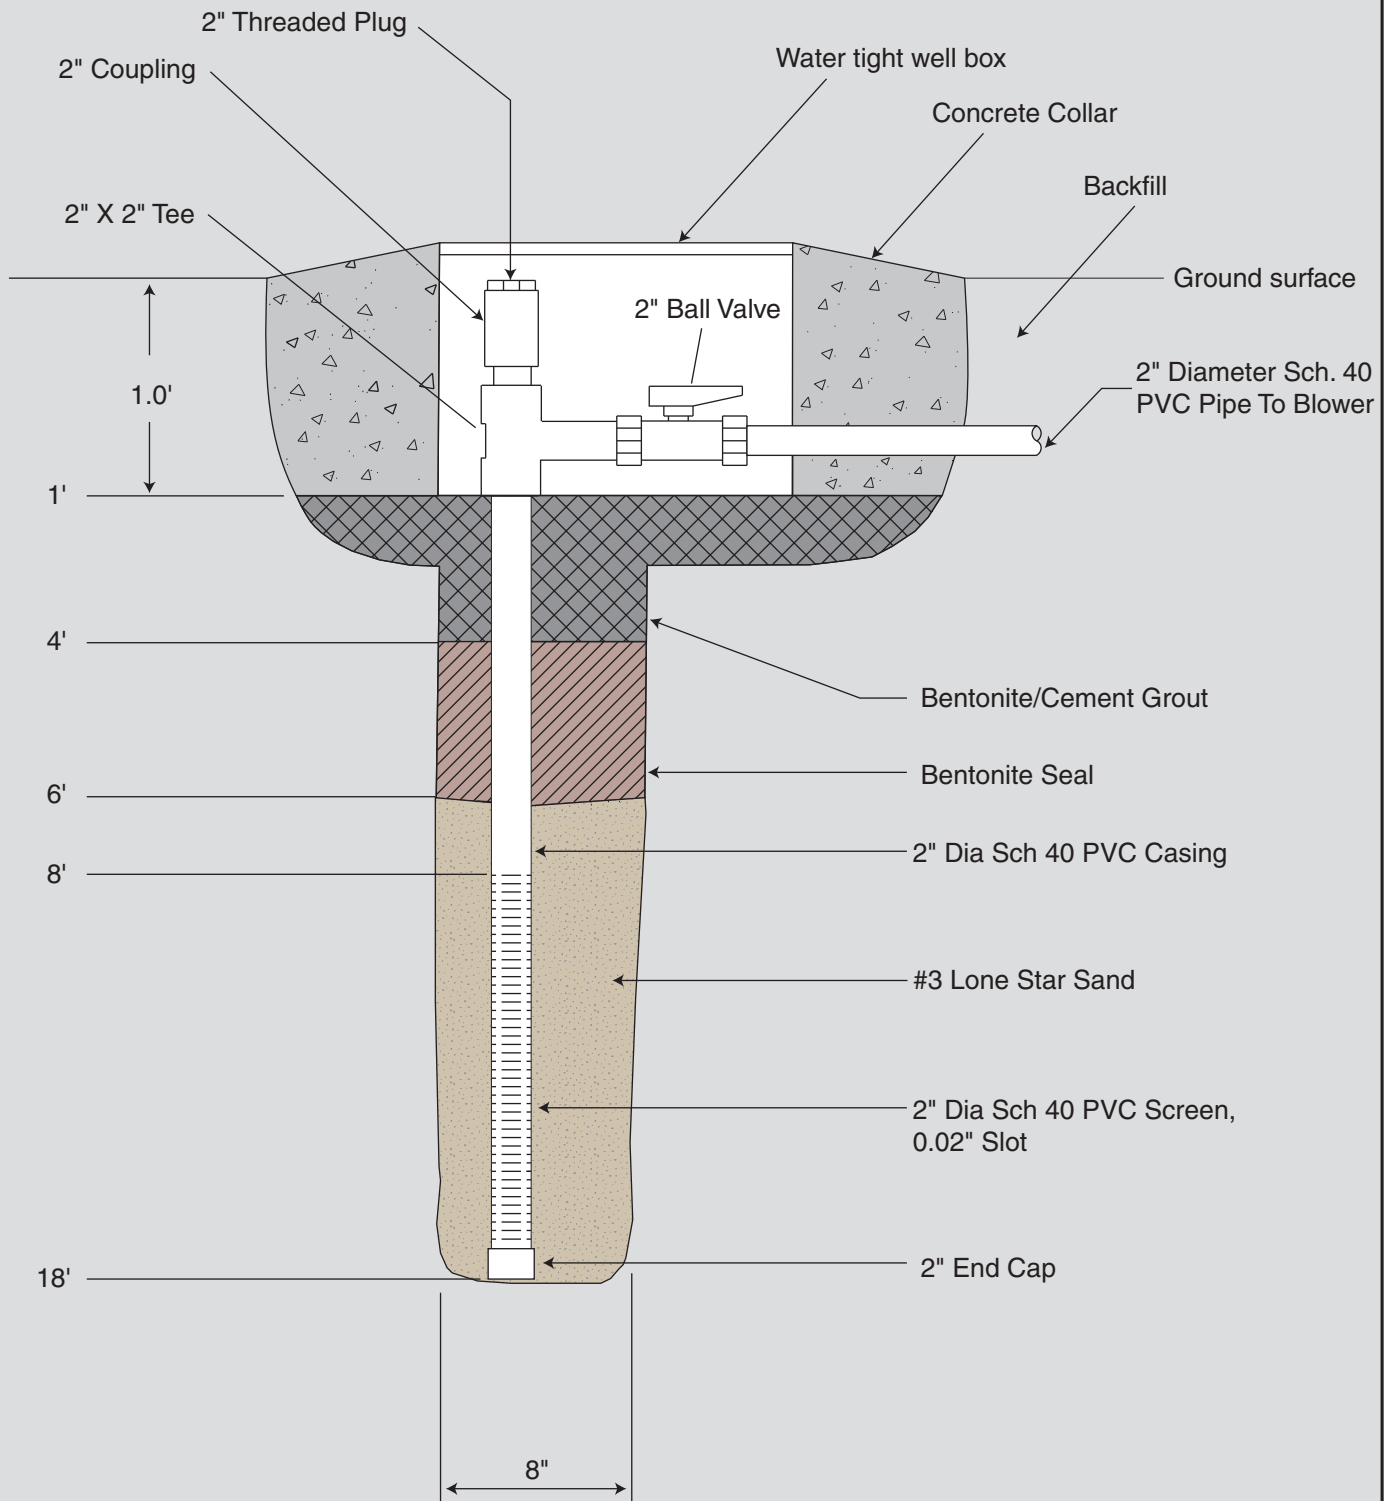
Figure 3

AS-BUILT VENT WELL CONSTRUCTION DETAILS

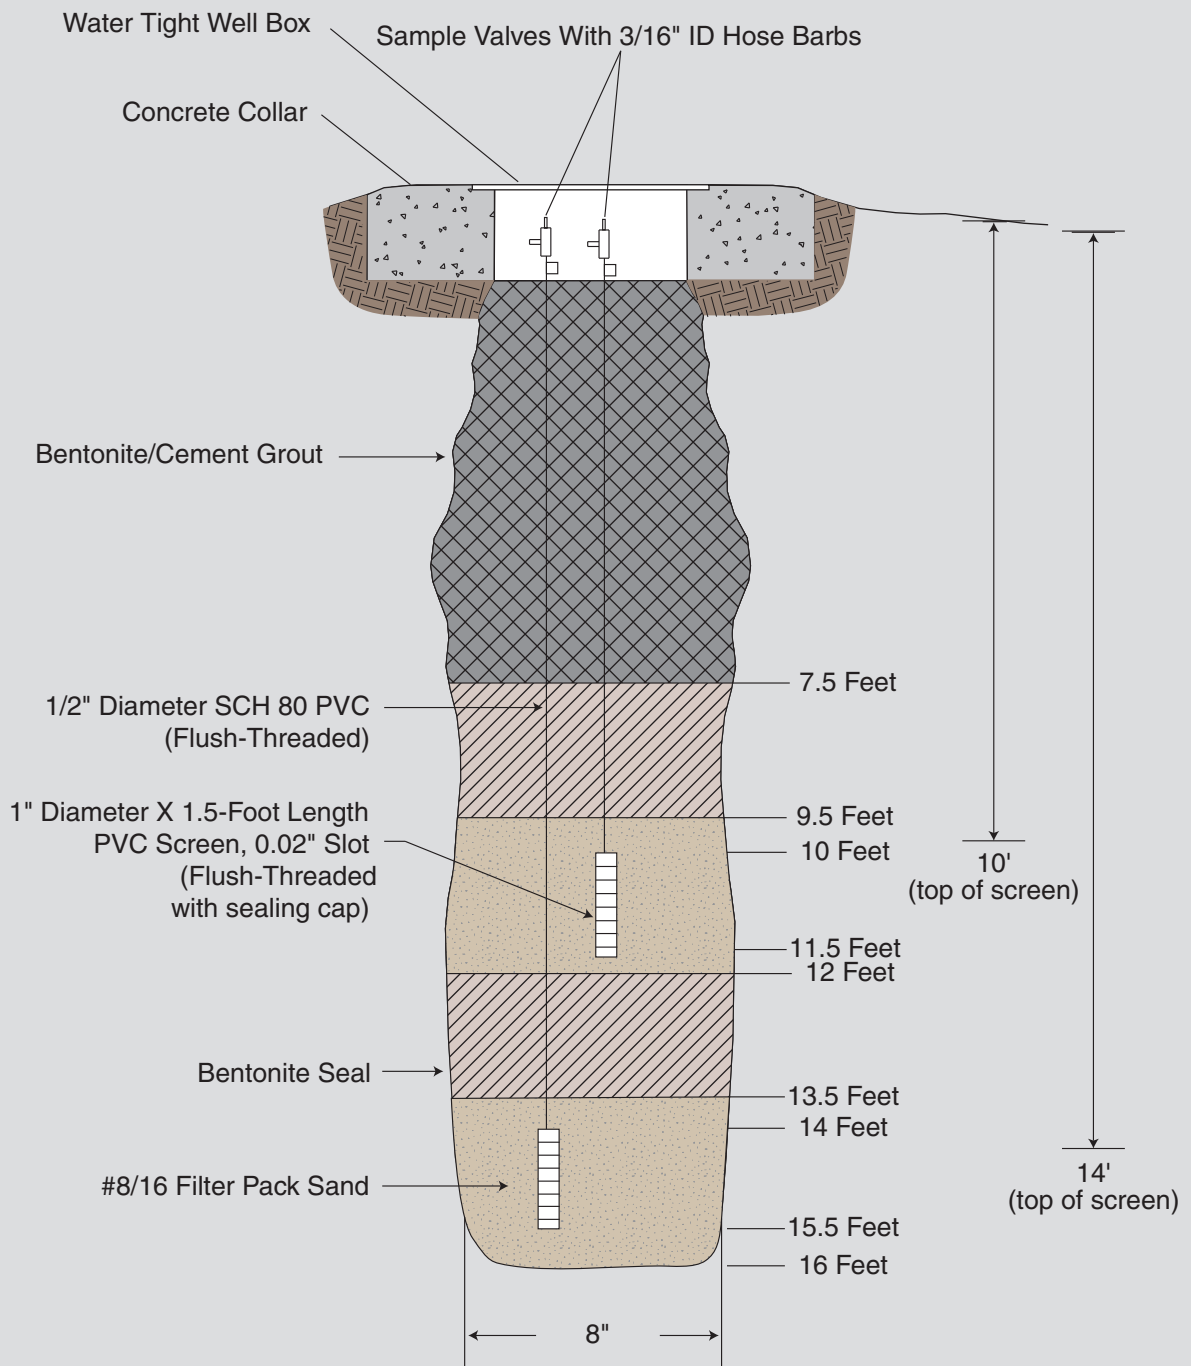
Figure 4

AS-BUILT VAPOR MONITORING POINT CONSTRUCTION DETAILS

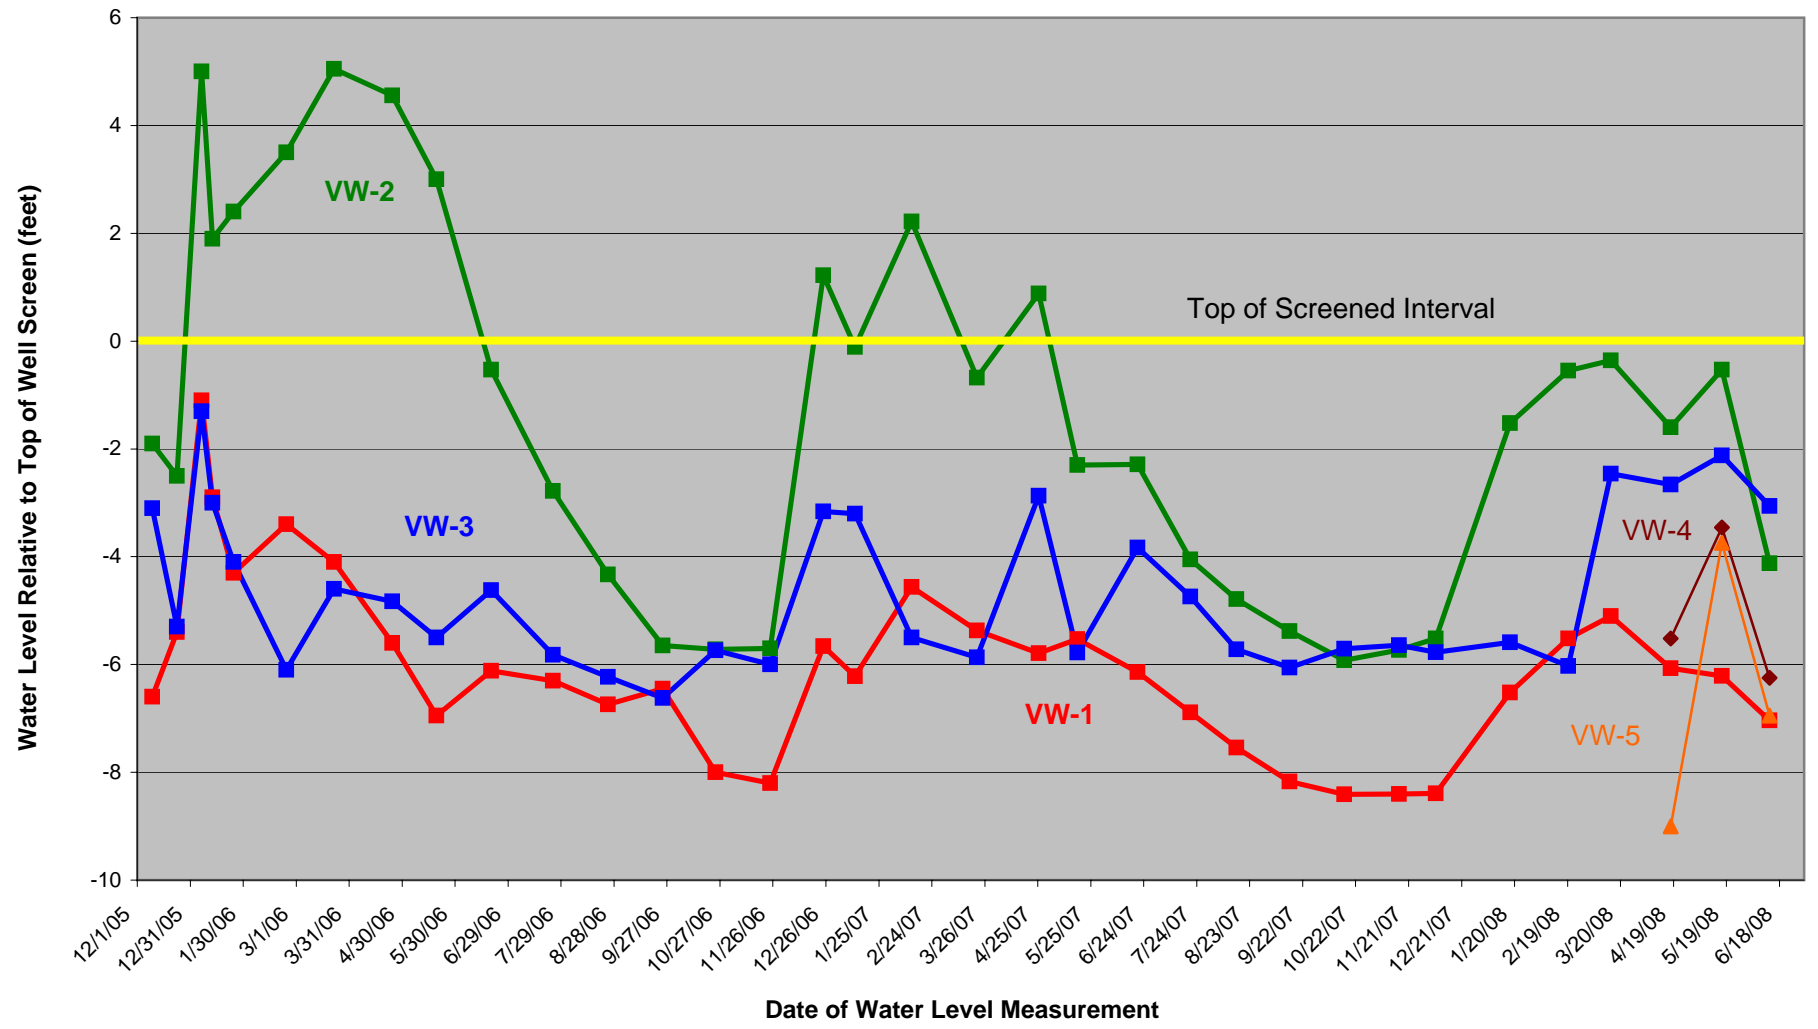
**Figure 6 - Historical Groundwater Levels Relative to Top of VW Screened Intervals
Redwood Regional Park Service Yard - Oakland, California**

Note: "0" line represents the top of well screened interval;
water levels above that line represent fully flooded screen.

- High groundwater levels from January to March of 2008 in the bioventing well VW-2 had resulted in a partially or fully saturated screen, thus impeding air flow to the sediments. The groundwater level has been well below the screen since April 2008, which corresponds to the increasing levels of air moving through the well as observed in April and May 2008.

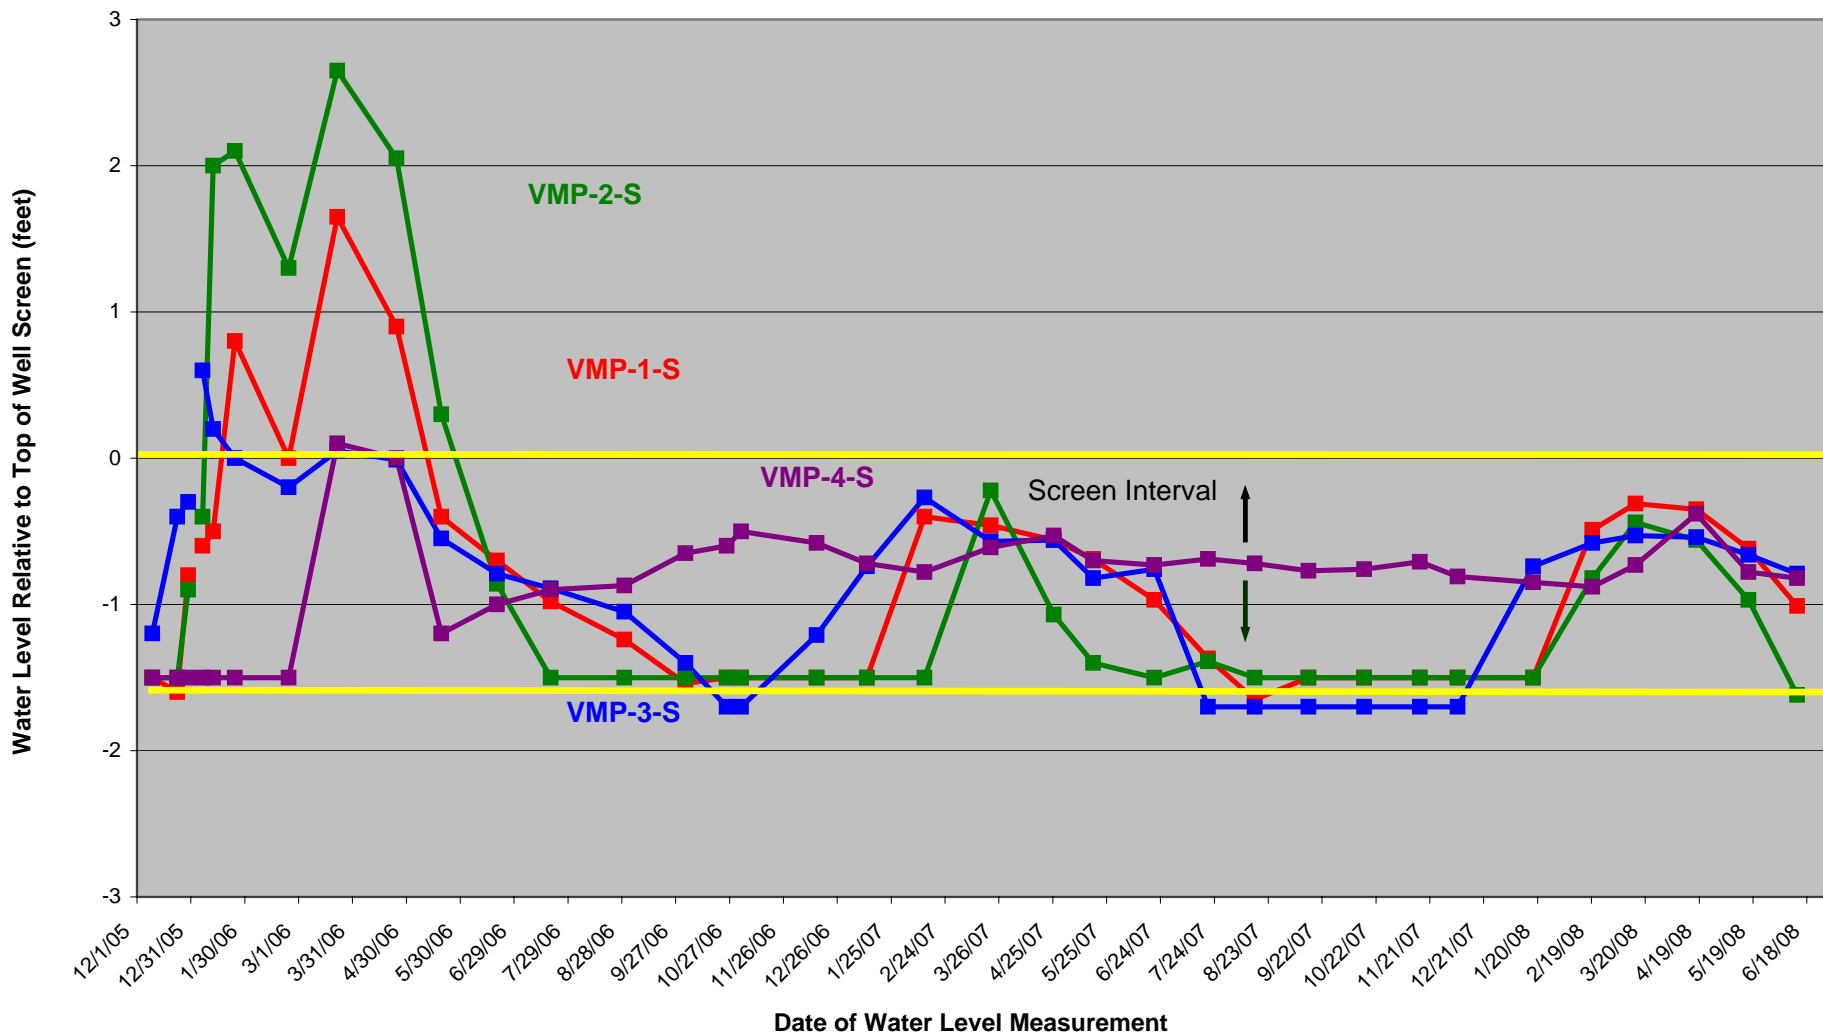
**Figure 7 - Historical Groundwater Levels Relative to Top of Shallow VMP Screened Intervals
Redwood Regional Park Service Yard - Oakland, California**

- As shown on Figure 7, water levels in the shallow VMP wells initially rose until March of 2006 and by May 2006 they lowered to below the top of the screened interval where they have remained to present.

Note: "0" line represents the top of well screened interval; water levels above that line represent fully flooded screen.

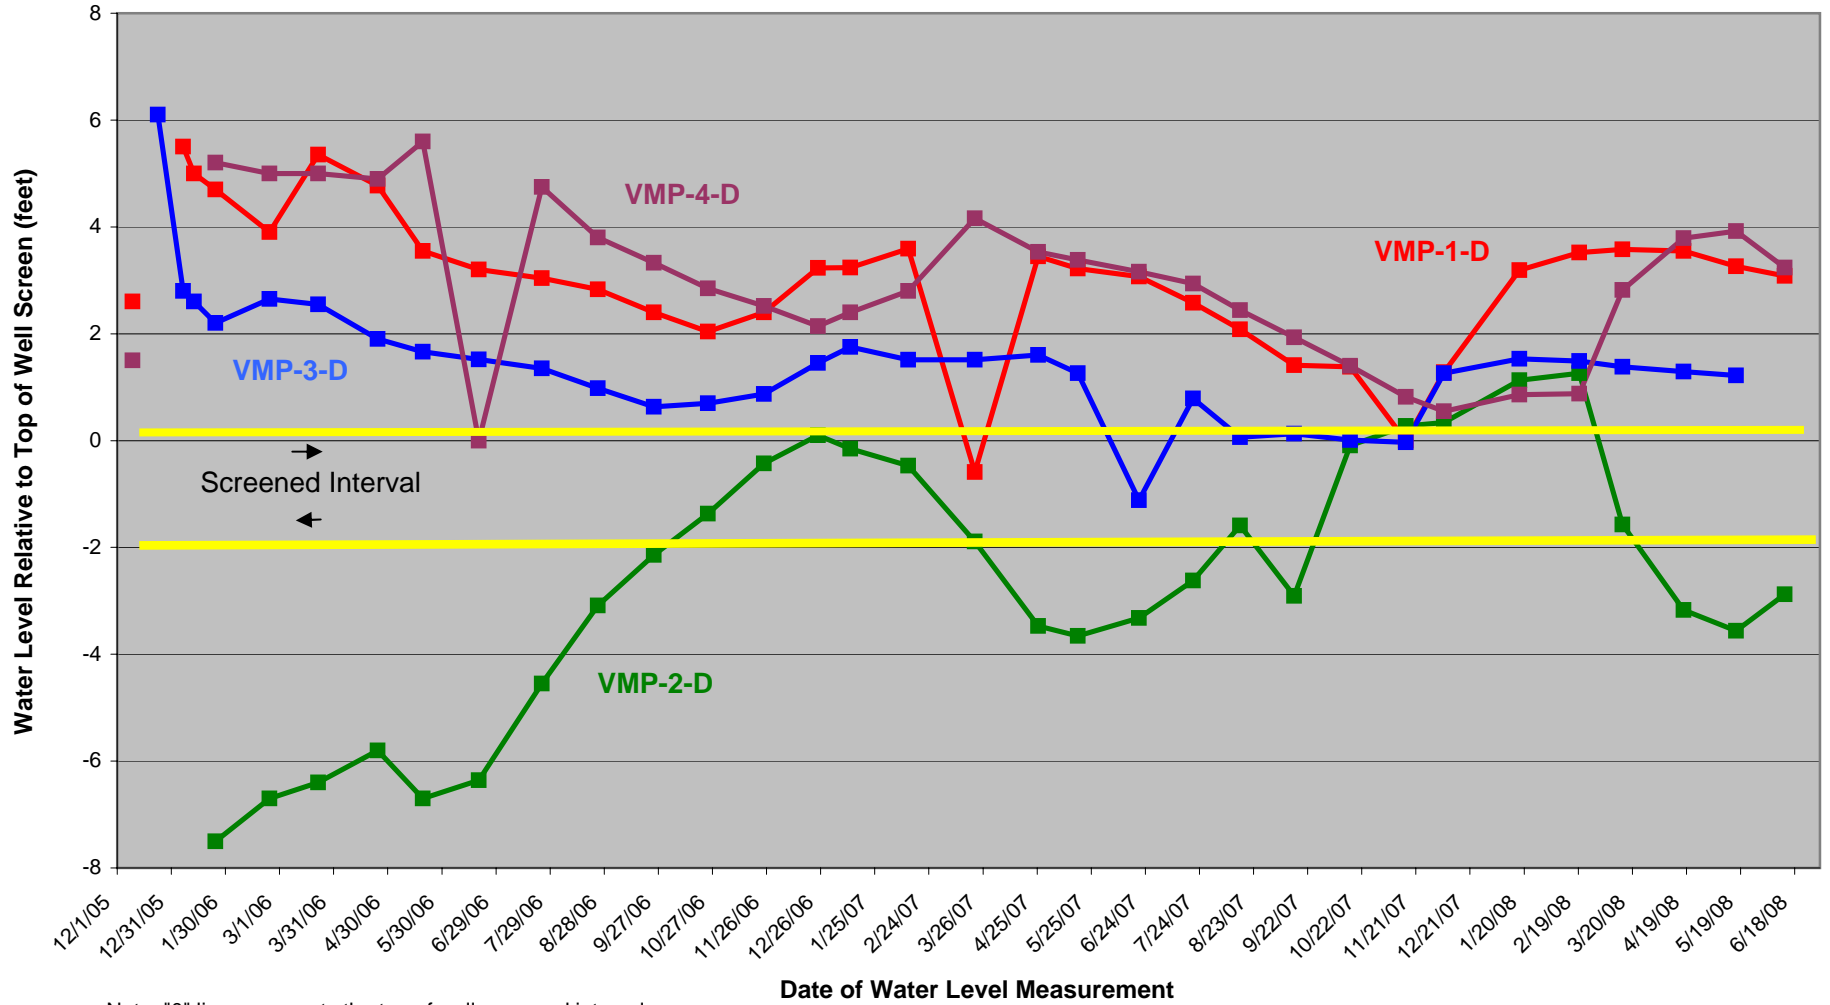
**Figure 8 - Historical Groundwater Levels Relative to Top of Deep VMP Screened Intervals
Redwood Regional Park Service Yard - Oakland, California**

Note: "0" line represents the top of well screened interval;
water levels above that line represent fully flooded screen.

- As shown on Figure 8, water levels in deep VMPs have been relatively stable since the VMPs were installed. The exception is VMP-2-D, which showed an increase from March 2006 to February 2008, and then showed a sharp decrease to below the screened interval. A slight rise was observed between May and June 2008, but the water level remains below the screened interval. Since the deep VMPs were installed, water levels in three of the four deep VMPs have been above the top of the well screen; only VMP-2-D has exposed well screen above the water table.

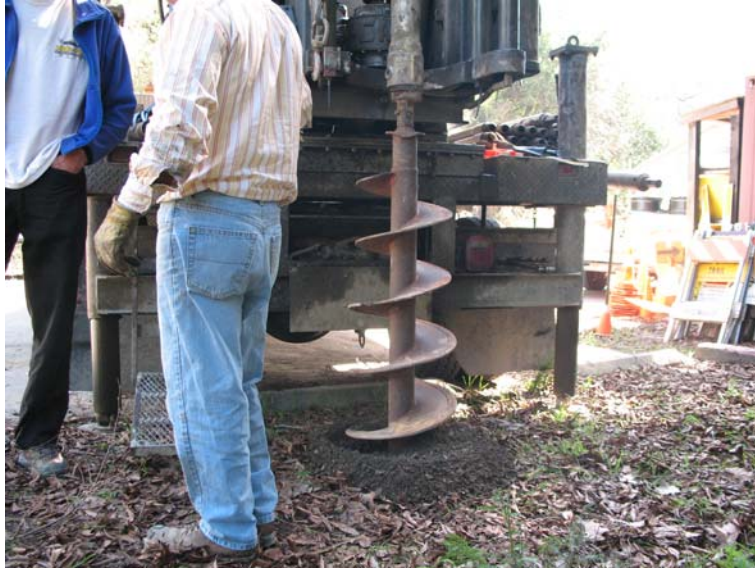
Photo No.: 01

Subject: View of drilling at location of VW-5

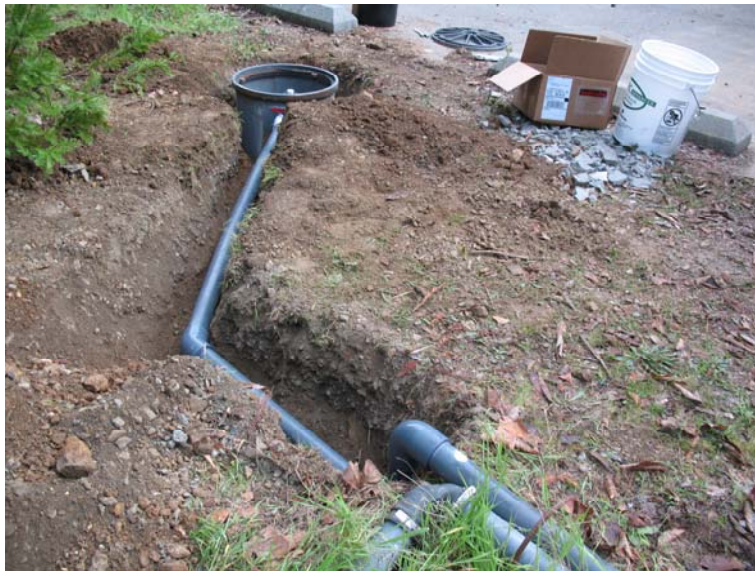
Subject: Installation of plumbing at VW-4
