Q1/Q2 2007 BIOVENTING STATUS REPORT

**REDWOOD REGIONAL PARK
SERVICE YARD
OAKLAND, CALIFORNIA**

**EAST BAY REGIONAL PARK DISTRICT
OAKLAND, CALIFORNIA**

July 9, 2007

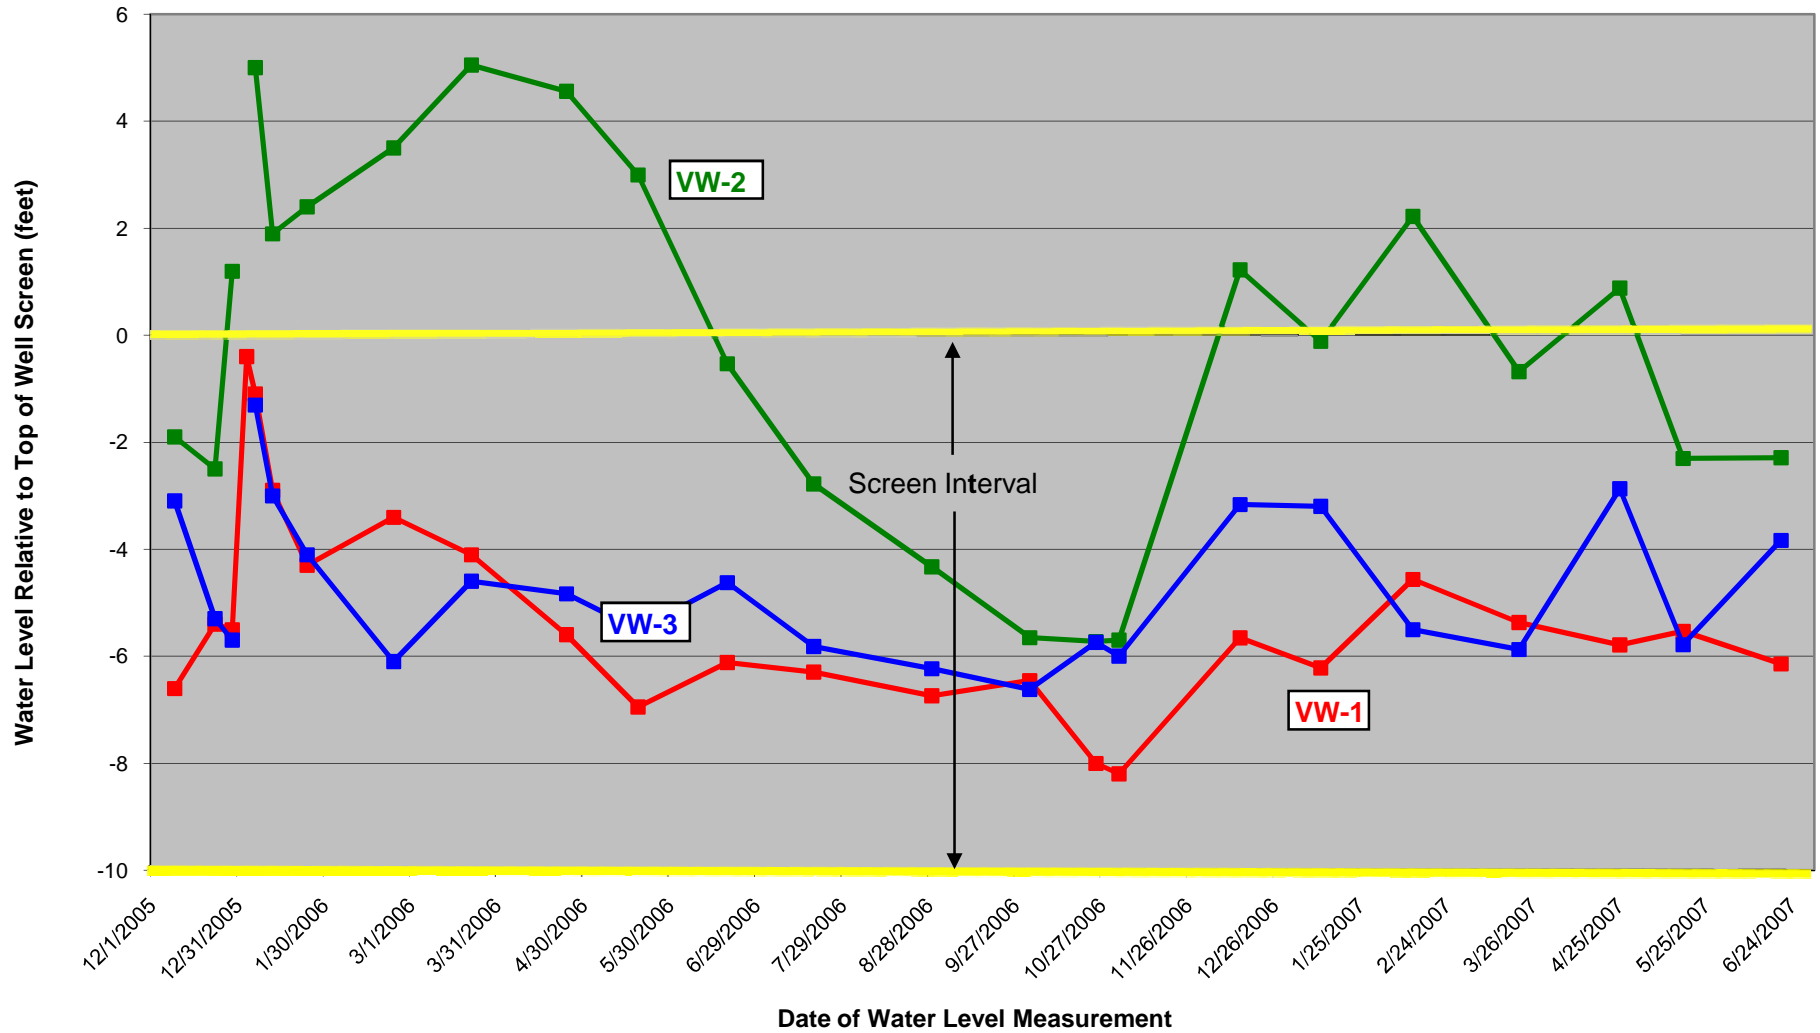
**Figure 6 - Historical Groundwater Levels Relative to Top of VW Screened Intervals
Redwood Regional Park Service Yard - Oakland, California**

- Water levels in VWs showed a general increase after the wells were installed, resulting in partially or fully flooded well screens in all VWs. VW-1 and VW-3 showed a water level decrease through September 2006; the water levels in these VWs have fluctuated since then, but have always been below top of screen. Figure 6 shows groundwater levels in VWs relative to the top of the screened interval. The screen in VW-2 was fully flooded as of May 2006, was lower than the screen interval until October 2006, and has fluctuated above and below the screen since then. As of May 2007 the water level has been below the screen interval.

Note: "0" line represents the top of well screened interval;
water levels above that line represent fully flooded screen.

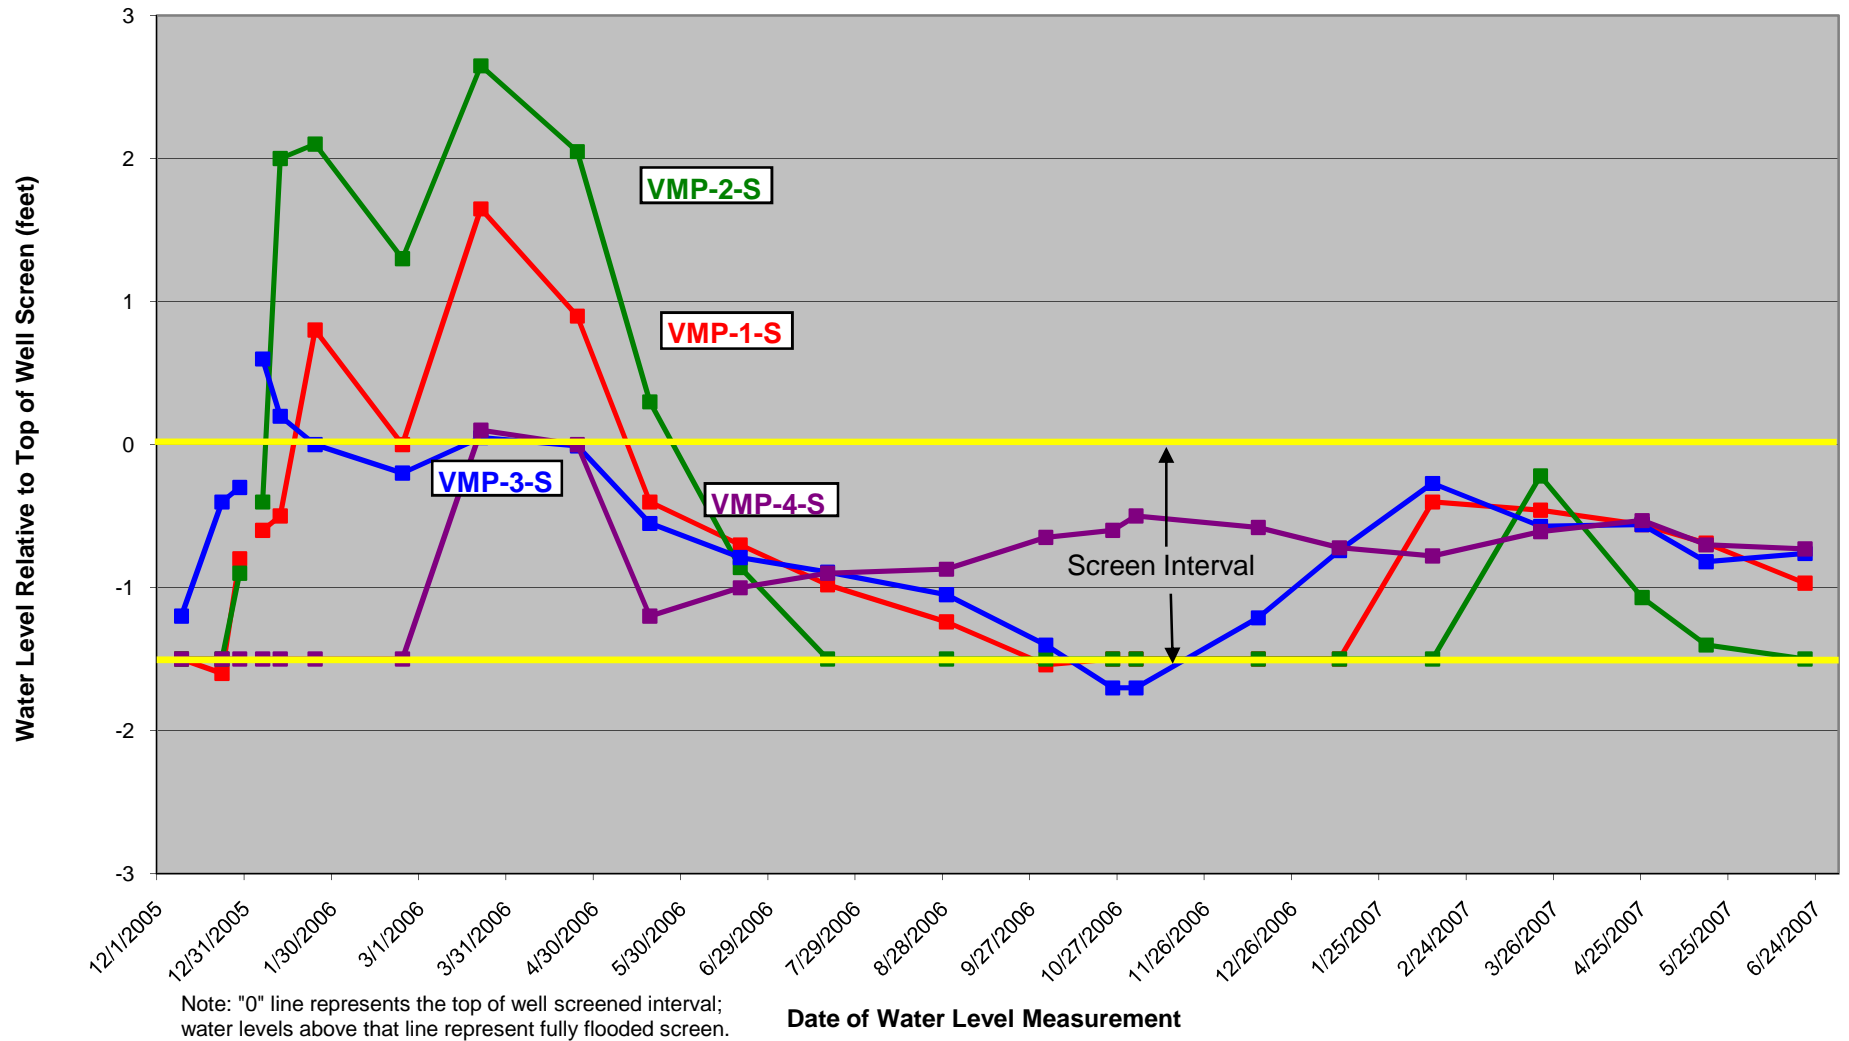
**Figure 7 - Historical Groundwater Levels Relative to Top of Shallow VMP Screened Intervals
Redwood Regional Park Service Yard - Oakland, California**

- As shown on Figure 7, water levels in the shallow VMP wells initially rose until March of 2006 and by May 2006 they lowered to below the top of the screened interval where they have remained to present.

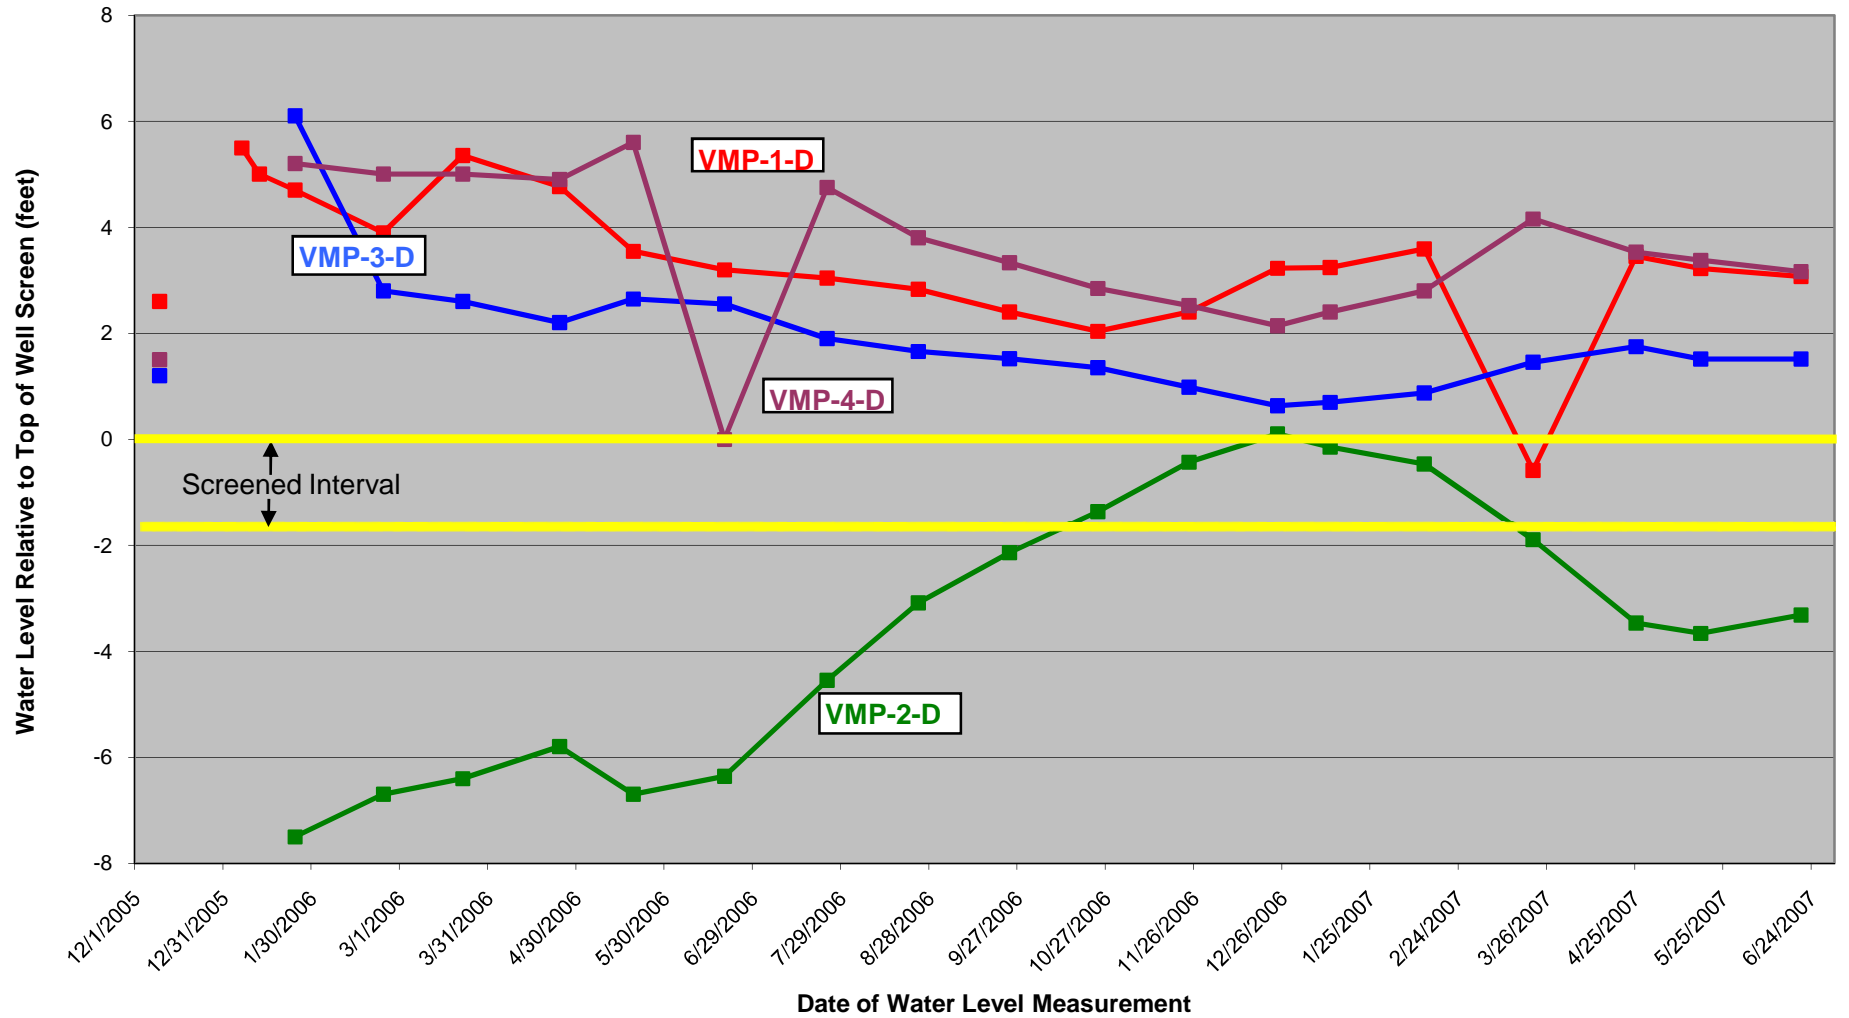
**Figure 8 - Historical Groundwater Levels Relative to Top of Deep VMP Screened Intervals
Redwood Regional Park Service Yard - Oakland, California**

- As shown on Figure 8, water levels in deep VMPs have been relatively stable since the VMPs were installed, with the exception of VMP-2-D, which has shown an increase since March 2006. Since the deep VMPs were installed, water levels in three of the four deep VMPs have been above the top of the well screen; only VMP-2-D has exposed well screen above the water table.

Note: "0" line represents the top of well screened interval;
water levels above that line represent fully flooded screen.
