Q3/Q4 2007 BIOVENTING STATUS AND ANNUAL SUMMARY REPORT

**REDWOOD REGIONAL PARK
SERVICE YARD
OAKLAND, CALIFORNIA**

**EAST BAY REGIONAL PARK DISTRICT
OAKLAND, CALIFORNIA**

Project No. 2006-17

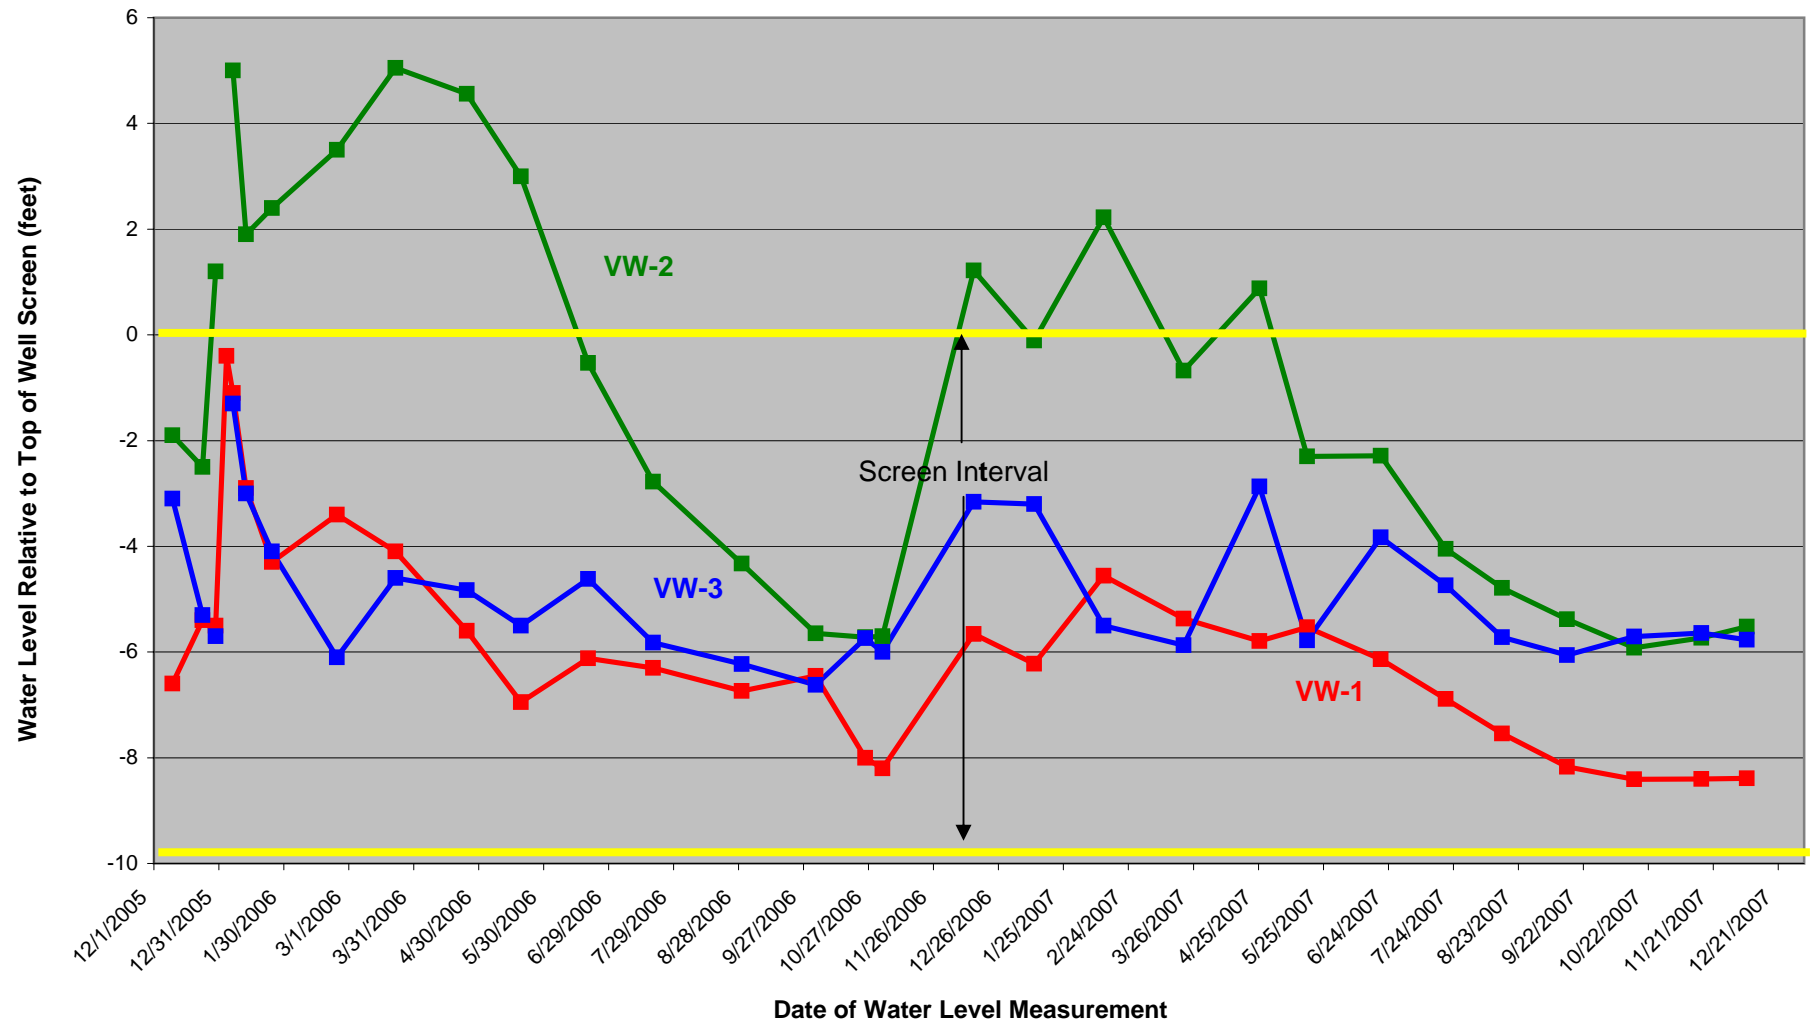
**Figure 6 - Historical Groundwater Levels Relative to Top of VW Screened Intervals
Redwood Regional Park Service Yard - Oakland, California**

- Water levels in VWs showed a general increase after the wells were installed, resulting in partially or fully flooded well screens in all VWs. Water levels began to decrease after January of 2005. The water levels in VW-1 and VW-2 have fluctuated since then, but have always been below top of screen. Figure 6 shows groundwater levels in VWs relative to the top of the screened interval. The screen in VW-3 was fully to partially flooded from January 2007 to approximately April of 2007, at which point the water level began to lower. All three wells have had fully exposed screens since April of 2007. Water levels in all of the VWs have been decreasing since May of 2007.

- Air is being injected (and has been since system startup) in the non-flooded portion of the VW-1 screen, but at flow rates less than optimum due to the partially flooded screen. Optimum air flow was reached in October of 2007, but gradually began to lower as rainfall levels increased.

- No measurable air injection occurred in VW-2 December 2006 and March 2007, due to the fully flooded screen. Sporadic air flow occurred between March and June 2007. However, a significant increase was observed in July 2007 which remained steady until optimum flow was reached in October 2007. Partial flow was observed in November and December of 2007 as water levels begin to rise.

- No measurable air injection has occurred in VW-3 since system startup, although that well's screen has been at least partially exposed (not flooded) since installation. SES confirmed (by physical probing) that the screened interval of that well is properly installed (from 8 to 18 feet), and that water is infiltrating into the well (confirming that the annular filter pack was not inadvertently cemented in during well installation). The inability to inject air may be due to residual saturation in the well filter pack and/or surrounding soils, or because the native soils in the borehole annulus may have been smeared during installation. The well was redeveloped on August 15, 2007 to clean any smear that may have occurred in the borehole annulus. Although the screen was exposed, there remains no measurable air injection in VW-3.

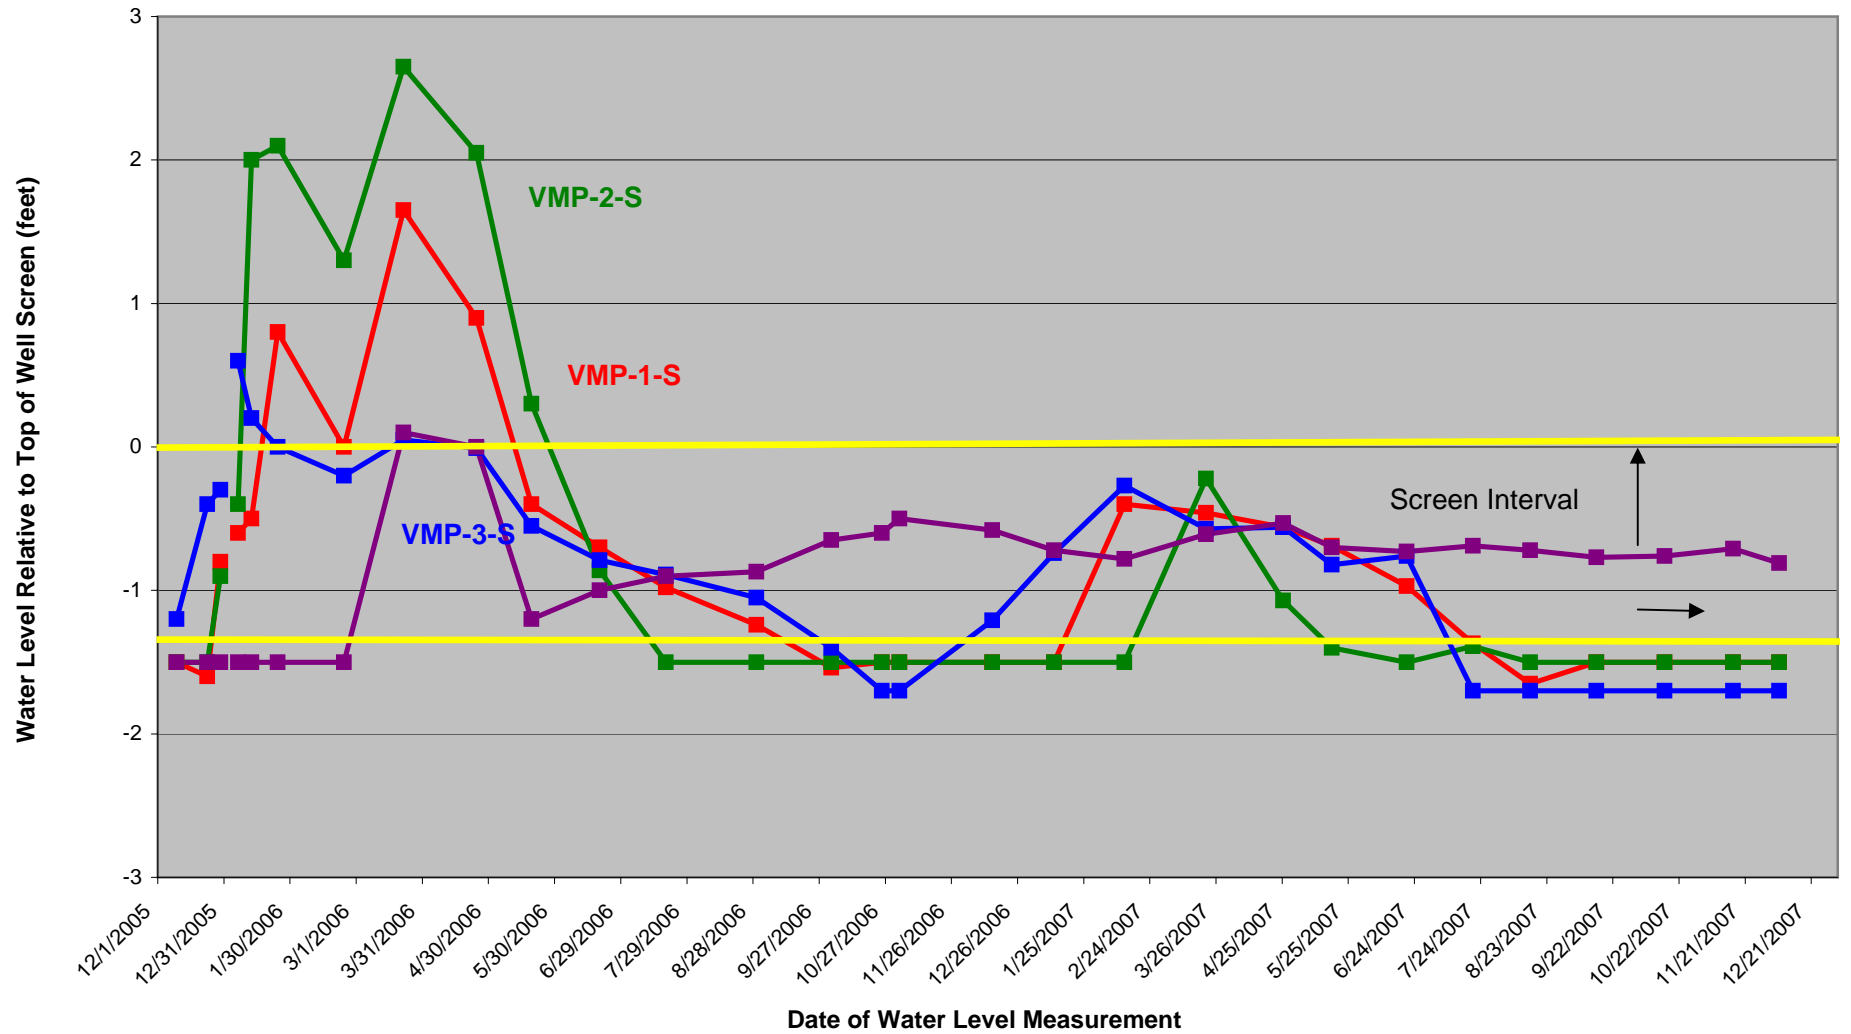
**Figure 7 - Historical Groundwater Levels Relative to Top of Shallow VMP Screened Intervals
Redwood Regional Park Service Yard - Oakland, California**

- As shown on Figure 7, groundwater levels in the shallow VMPs have fluctuated slightly since March 2006. However, all of the VMPs have been below the top of the well screen since May 2006.

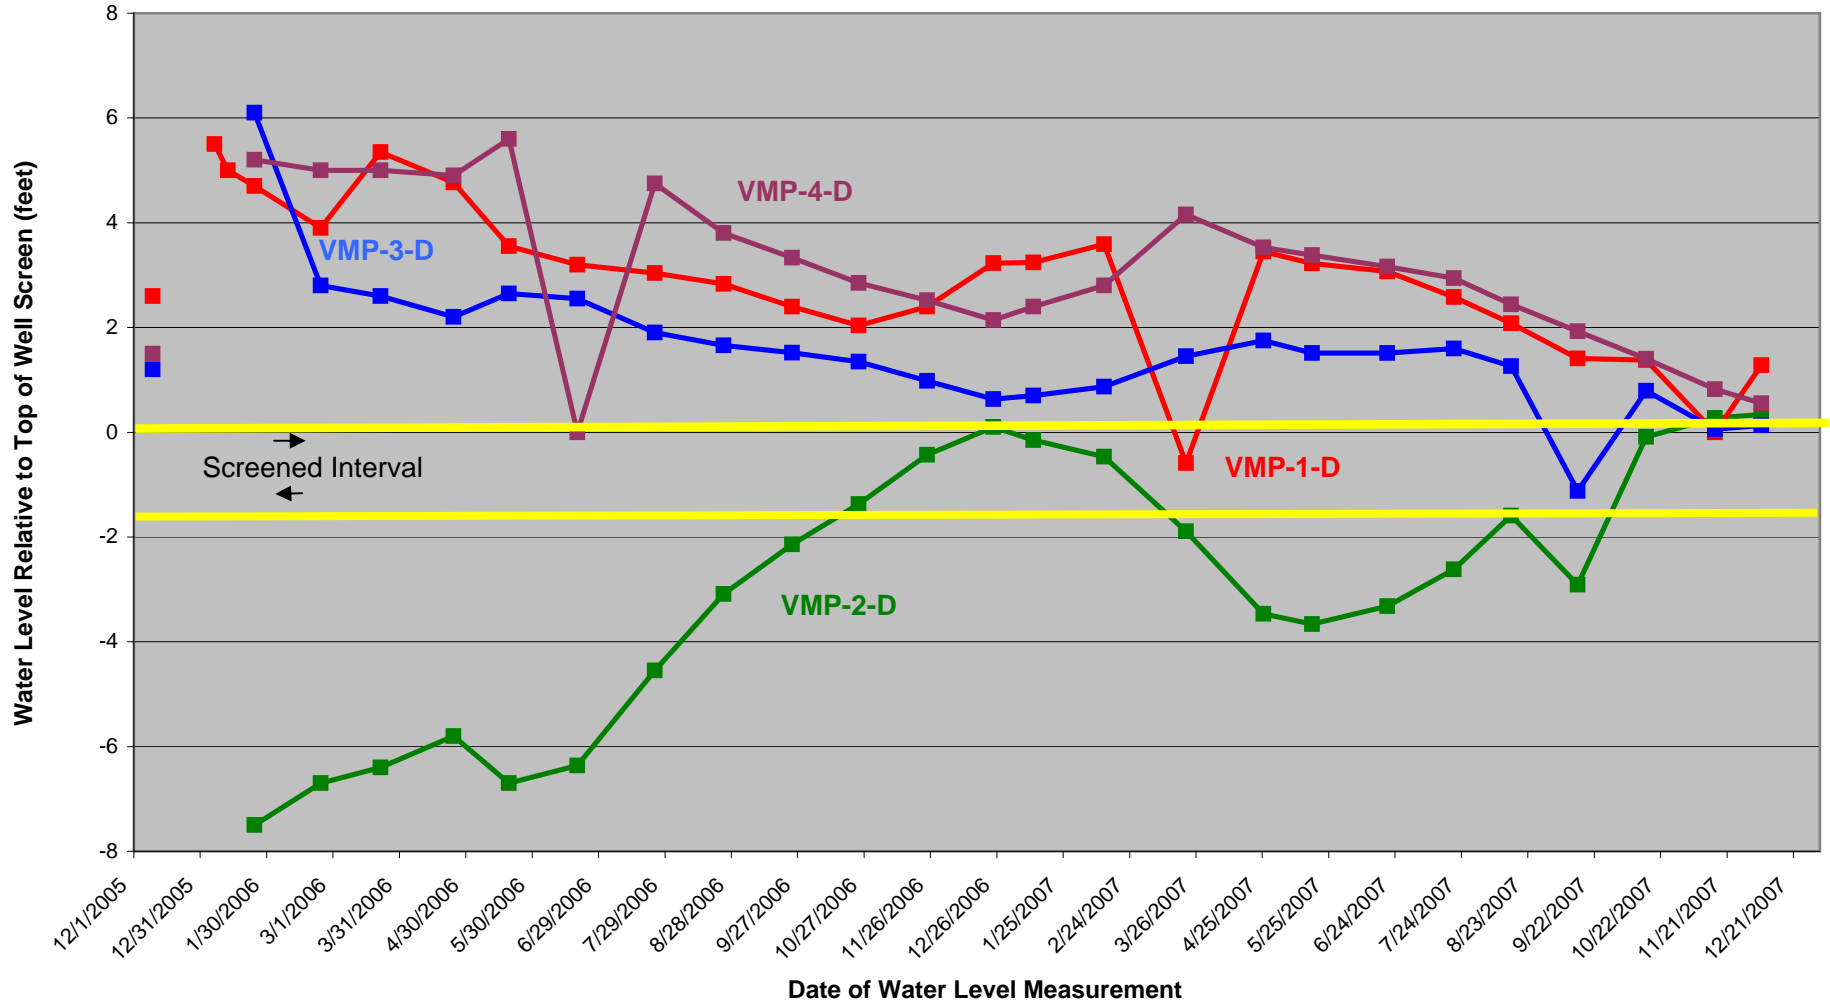
**Figure 8 - Historical Groundwater Levels Relative to Top of Deep VMP Screened Intervals
Redwood Regional Park Service Yard - Oakland, California**

- As shown on Figure 8, groundwater levels in deep VMPs have been relatively stable since the VMPs were installed, with the exception of VMP-2-D, which has shown a general increase in groundwater level since March 2006. Since the deep VMPs were installed, water levels in three of the four deep VMPs have been above the top of the well screen. Water levels in VMP-2-D have historically been below the well screen; however, they have been above the well screen since September of 2007.

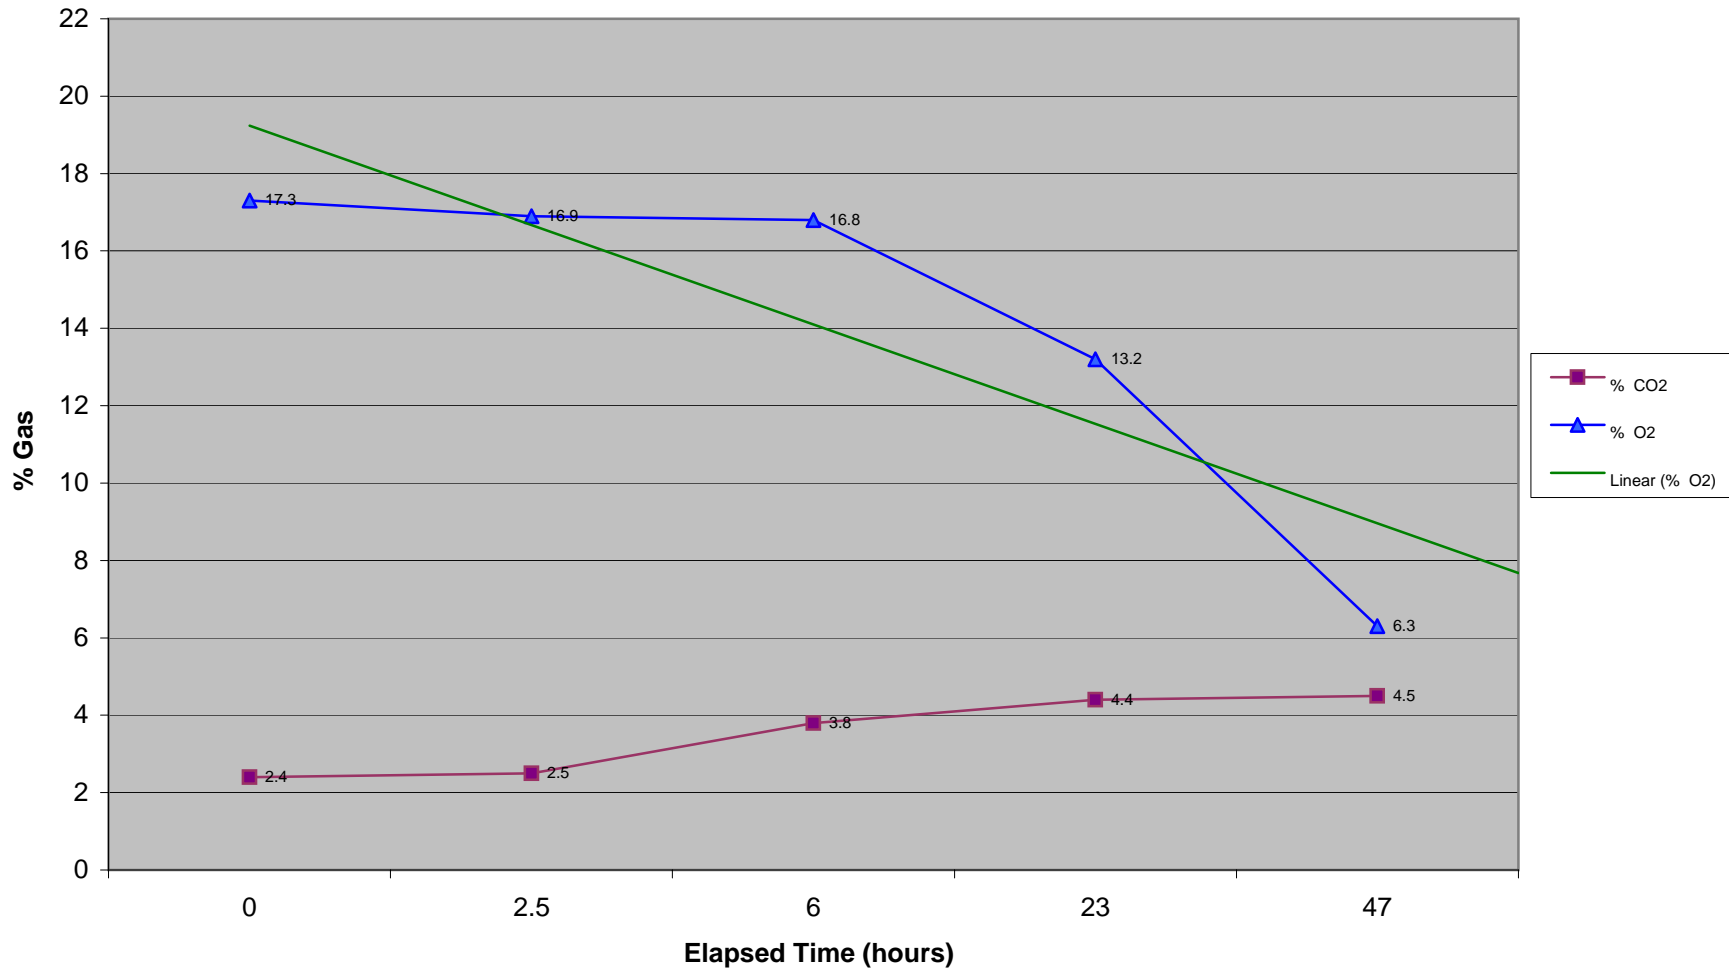
Figure 9: Respiration Test VMP-2 O₂-CO₂ Trend Plot
October 15-17, 2007
Redwood Regional Park Service Yard, Oakland, CA

VMP-2 and to a lesser extent VMP-1 showed a significant decrease in oxygen that would be indicative of microbial activity. The position of VMP-2 (nearly midway between the two vent

wells) and its relatively higher elevation likely resulted in increased aeration and microbial activity at this point.

Figure 9 shows the respiration test results. The oxygen utilization within the first 24- hours is 5.8%. This value is essentially the same as the 6.1% oxygen utilization within the first 24-hours exhibited in the 2006 respiration test. Ideally, in the absence of additional hydrocarbon input from leaching residual hydrocarbons entrained in the soil of the original UFST source area, the oxygen utilization rate should decrease as a function of their being less and less mass to reduce over time.

Using the above assumptions, an oxygen utilization rate of 5.8% O₂/day would correspond to a biodegradation rate of approximately 3.4 mg/kg-day. Given that the initial soil concentration is 6,000 mg/kg, an estimate of cleanup time is calculated as follows:

$$6,000 \text{ mg/kg} = 1,764 \text{ days} = 4.8 \text{ years at } 3.4 \text{ mg/kg-day}$$

In-situ respiration testing should be used as the primary indicator for site closure. A good indication that the site is remediated and that final soil sampling can be conducted is when the in-situ respiration rate in the contaminated area is similar to that in the uncontaminated area. In-situ respiration testing to determine remediation success is preferable economically to relying on soil sampling as the sole indicator of site remediation, because it eliminates the high cost of intermediate soil sampling. A 2008 respiration test will be performed to evaluate changes in the apparent oxygen utilization rate.
