■ Subsurface Consultants, Inc.

ENVIRONMENTAL ENGINEERING SERVICES  
PLAZA CAR WASH  
400 SAN PABLO AVENUE  
ALBANY, CALIFORNIA  
SCI 549.001

November 7, 1989

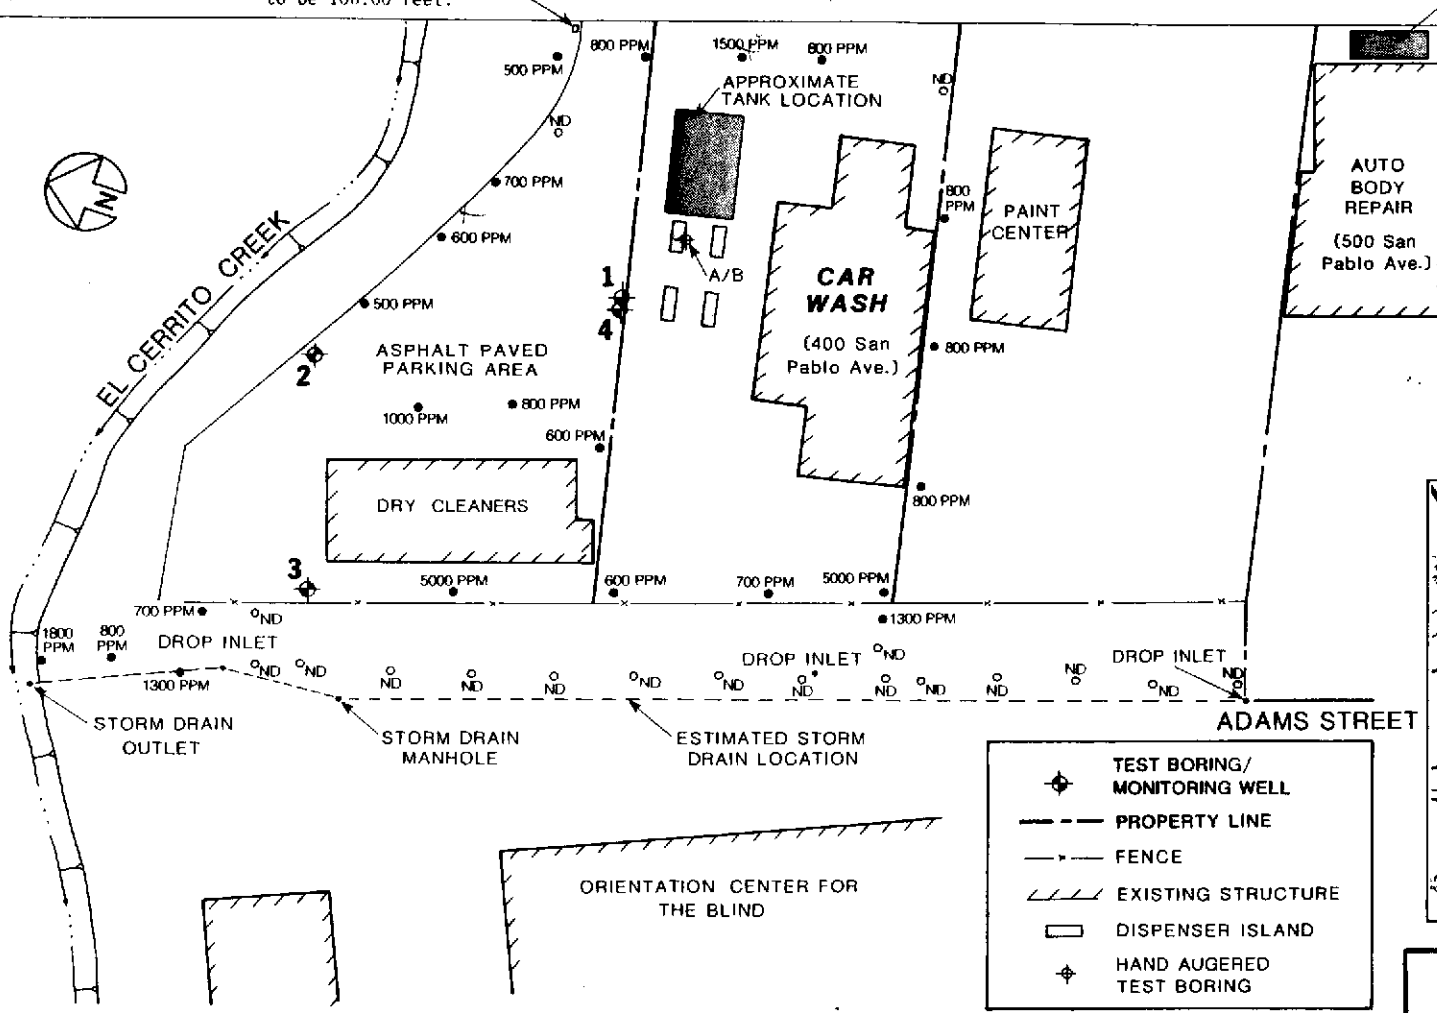
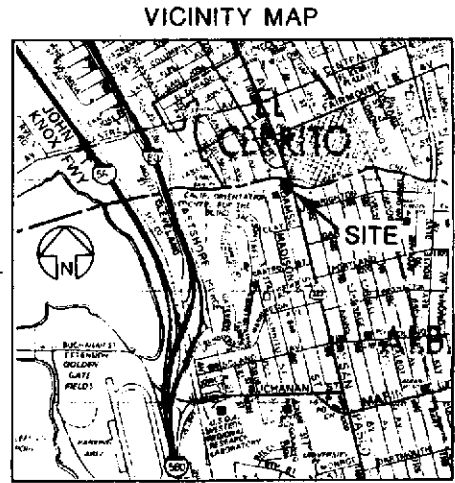
**SITE PLAN**

A soil vapor study was performed by SCI to evaluate the extent of hydrocarbon contamination. The study area included the Plaza Car Wash, Norge Cleaners and COCB properties. The vapor sampling locations are shown on the Site Plan.

The soil vapor study equipment consisted of hollow steel rods with slotted sampling tips, a rotohammer, vacuum pump and organic vapor meter (OVM). The rod was driven into the ground so that the tip was situated just above the groundwater level. Soil vapor was withdrawn from the rods using a vacuum pump. After a few minutes, the vacuum pump was disconnected and an organic vapor meter (OVM) was used to draw a sample of the vapor and analyze it for organic compounds. The OVM readings are shown on the Site Plan.

The soil vapor study results indicated contamination over almost the entire Norge cleaners and Plaza Car Wash sites. Because part of the contaminated area is upgradient of the

Along the storm drain on the COCB site, contamination was detected within about 60 feet of the creek. We recommend that at least one test boring/monitoring well be installed in areas situated more than 60 feet from the creek to confirm the soil vapor study findings.

unleaded gasoline tank distribution system, we conclude that it is possible that some of the contamination may originate from an off-premises source. We recommend that additional studies be performed to evaluate the extent of on-site and off-premises contamination. This should include an additional off-premises soil vapor study and test borings/monitoring wells both up and down gradient from the apparent on-site source.

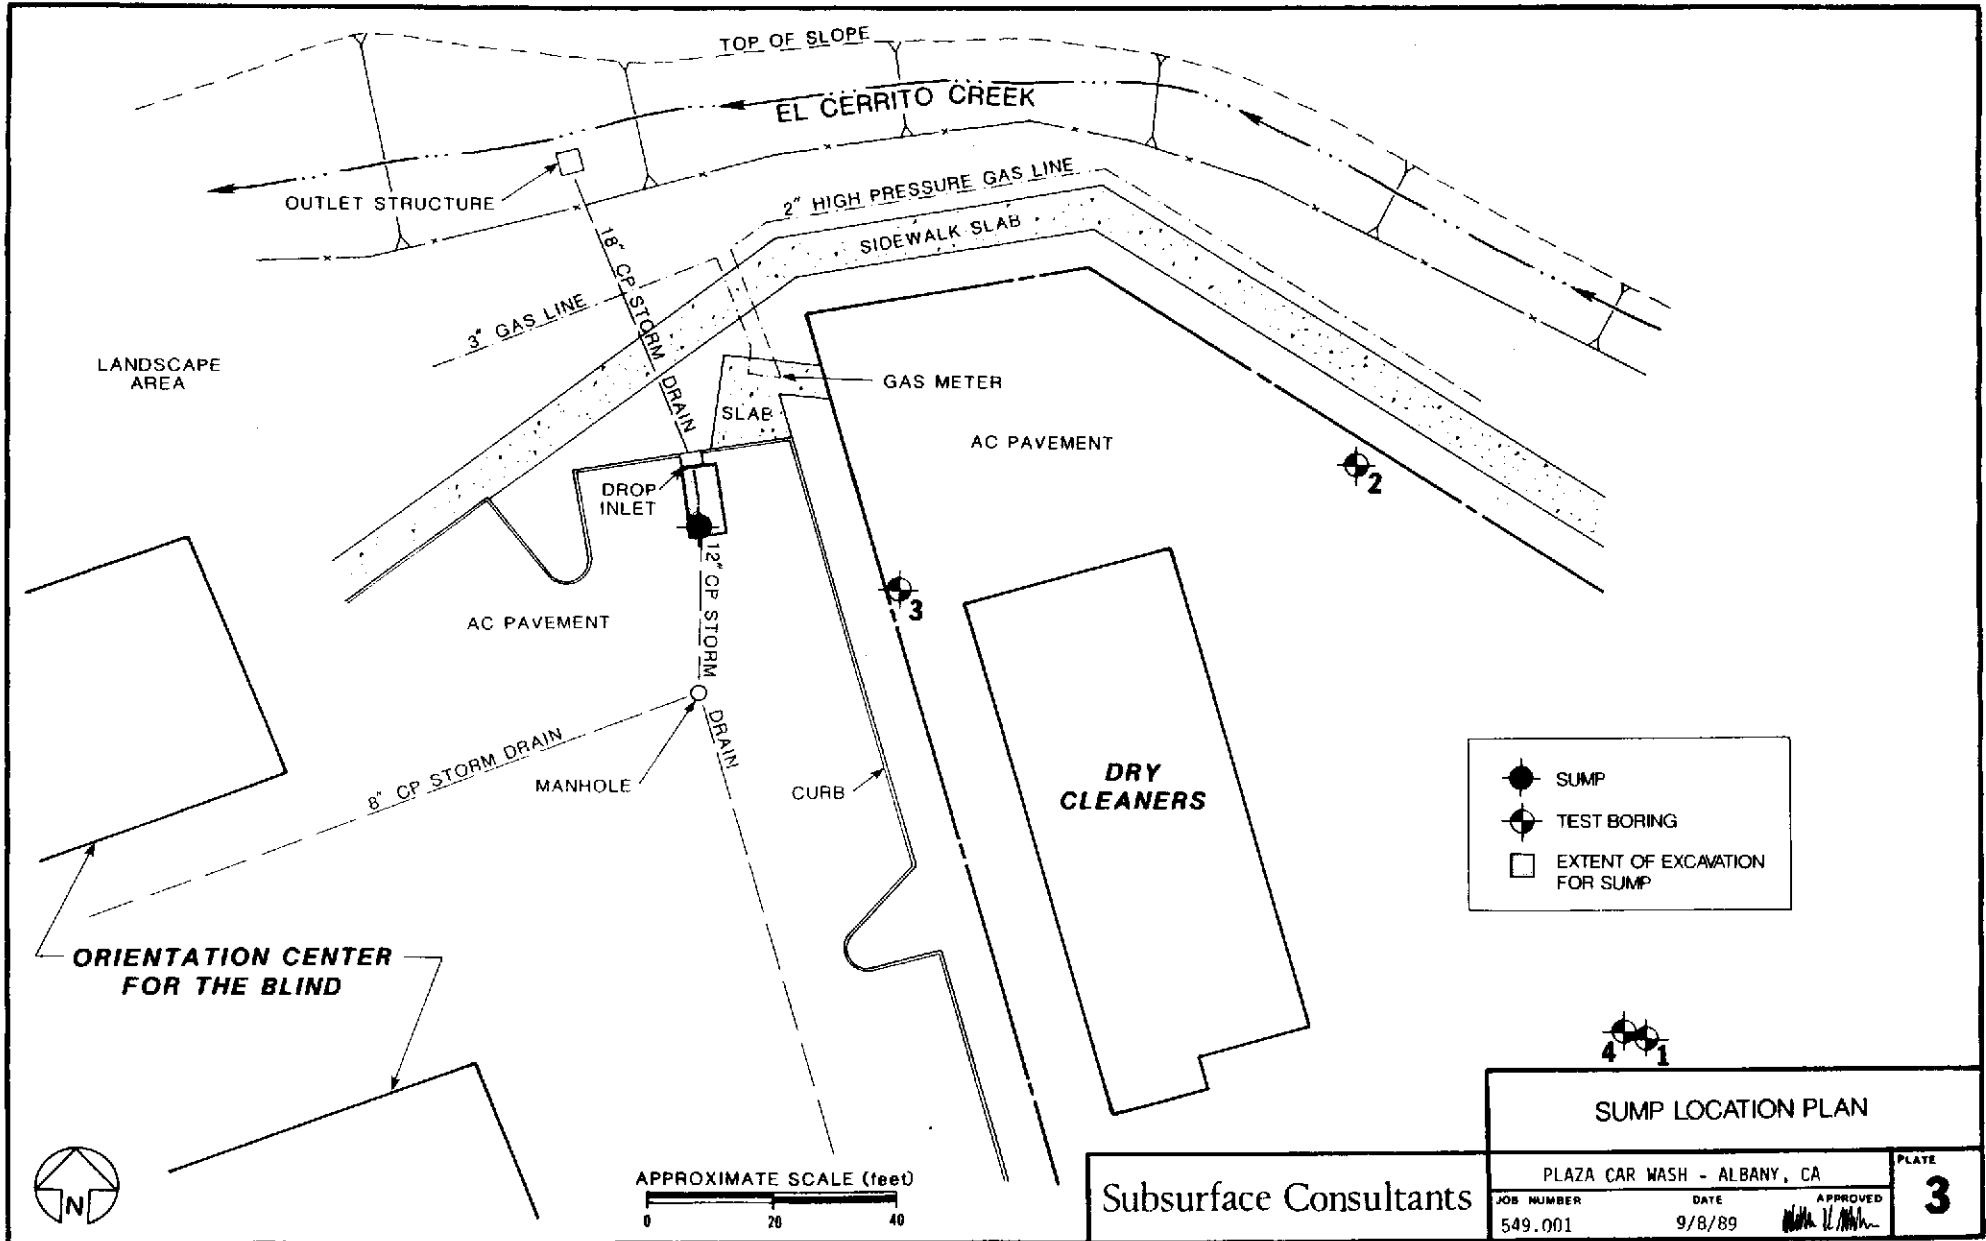
<b>SUMP LOCATION PLAN</b>		
PLAZA CAR WASH - ALBANY, CA		PLATE <b>3</b>
JOB NUMBER 549.001	DATE 9/8/89	APPROVED

On October 10 and 11, 1989, an excavation was made along the storm drain pipe in the area shown on the Sump Location Plan, Plate 3. Based upon OVM readings, about one half (5 cubic yards) of the soil removed was considered to be contaminated. The excavated soil was encapsulated in polyethylene sheeting and later aerated in accordance with BAAQMD guidelines, as reported in our letter dated October 16, 1989. The groundwater encountered in the trench contained a small amount of free product. It was removed and placed in steel drums for later disposal.

The excavation revealed a silty sand trench backfill of relatively high permeability. The clayey native soils have relatively low permeability. The 12-inch-diameter storm drain pipe was encountered at a depth of about 4.7 feet below surrounding grade. Of the three pipe joints exposed by the excavation, one was already sealed with mortar. Cracks were observed in one of the other joints and water was seeping out of the storm drain pipe, into the excavation. Mortar was placed over the unsealed joints. Trench backfill was encountered to a depth of about 6.7 feet, or about 1.0 foot below the pipe bottom. The excavation adjacent to the storm drain pipe was extended to a

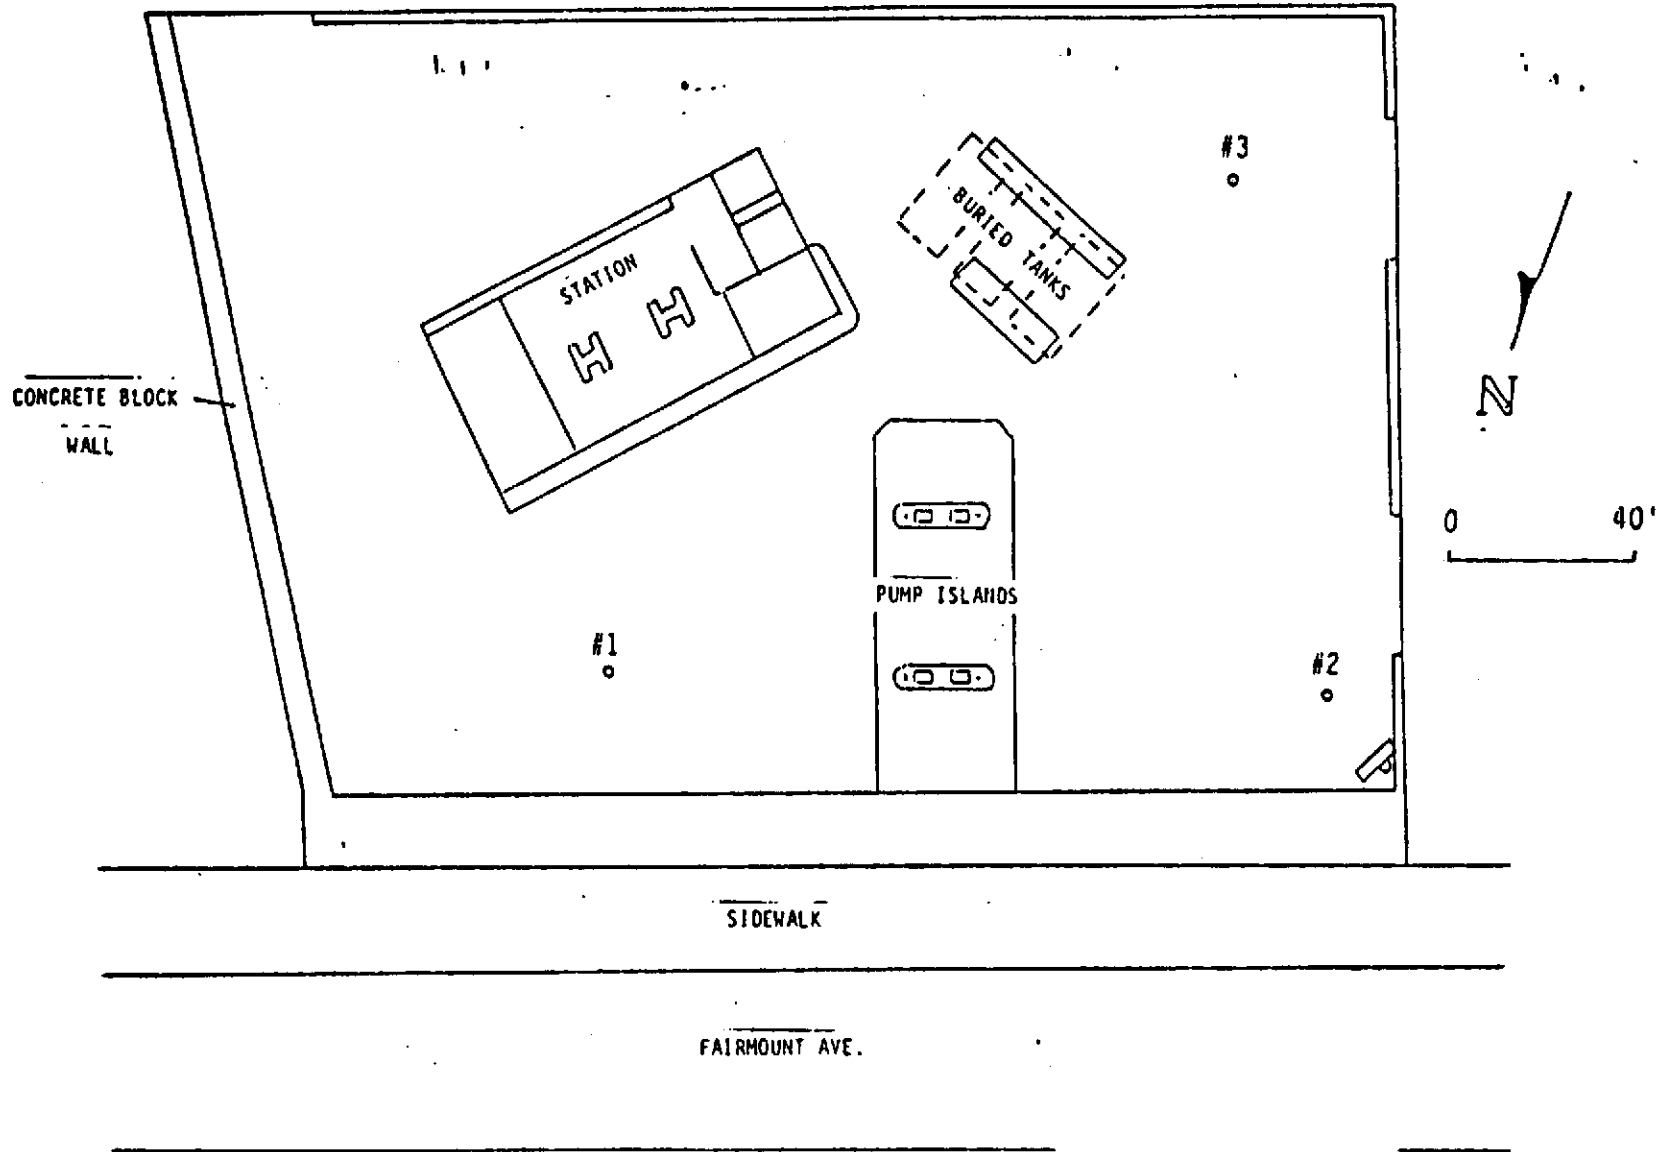
Figure 1. Location of monitoring wells on project site.

On July 8th, three monitoring wells were installed on the property (see Figure 1 for locations). During the drilling of these wells, split-spoon samples were taken to ascertain subsurface soil conditions and detectable hydrocarbon contamination. Geologic logs of these wells are given on Appendix A of this letter.
