August 22, 1989
SCI 549.001

Consultation re:
Gasoline Contamination
Plaza Car Wash
400 San Pablo Avenue
San Pablo, California

This letter presents preliminary results of our consultation regarding gasoline contamination at the subject site. Specifically, this letter records information regarding recent site history, temporary measures to mitigate the discharge of free product into the creek and proposed future investigation.

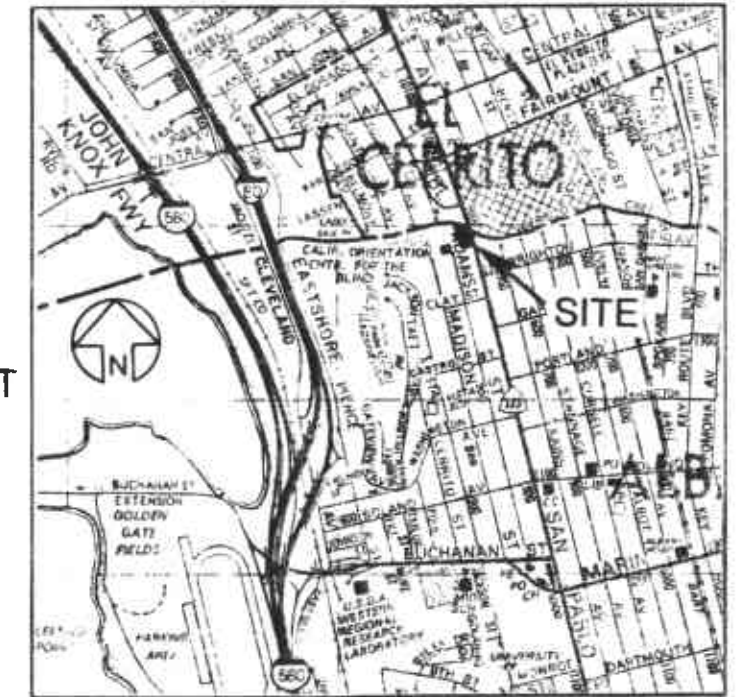
SITE PLAN			PLATE
PLAZA CAR WASH - ALBANY, CA			1
JOB NUMBER	DATE	APPROVED	
549.001	8/7/89

We understand that in early July 1989, a dark-brown liquid substance (free product) was observed floating on water in El Cerrito Creek, north of the Orientation Center for the Blind (OCB). The free product was exiting a storm drain pipe which terminates at the creek northwest of Norge Cleaners, as shown on the attached Site Plan (Plate 1). We understand that the storm drain only serves the OCB site. The Albany Fire Department (AFD) placed absorbent materials and booms in the creek to remove the free product, and inspected the storm drain pipe with a remote video camera. The camera was inserted into the pipe starting at the manhole located west of Norge Cleaners. Product was reportedly observed in the storm drain pipe north, but not south, of the manhole. The product was apparently entering the storm drain through the joints. The AFD determined that possible sources of the product were underground storage tanks located at Troxell's Auto Body (500 San Pablo Avenue) and Plaza Car Wash (400 San Pablo Avenue).

The test boring locations are shown on the Site Plan; the logs of the borings are presented on Plates 2 through 4. The soils are classified in accordance with the Unified Soil Classification System described on Plate 5. The test borings encountered clays, interbedded with relatively thin layers of gravel, to the depths drilled (12 to 20 feet). The clays, and gravels are likely to have relatively low and high permeabilities, respectively. An organic vapor meter (OVM) indicated the presence of organic vapors in soil samples from all of the test borings. Groundwater was encountered at depths of 4 to 7 feet. No free product was noted on the groundwater surface. Preliminary data suggests that the direction of groundwater flow, near the car wash, is to the west, toward the storm drain. However, additional water level readings are necessary to confirm that stabilized conditions have developed.

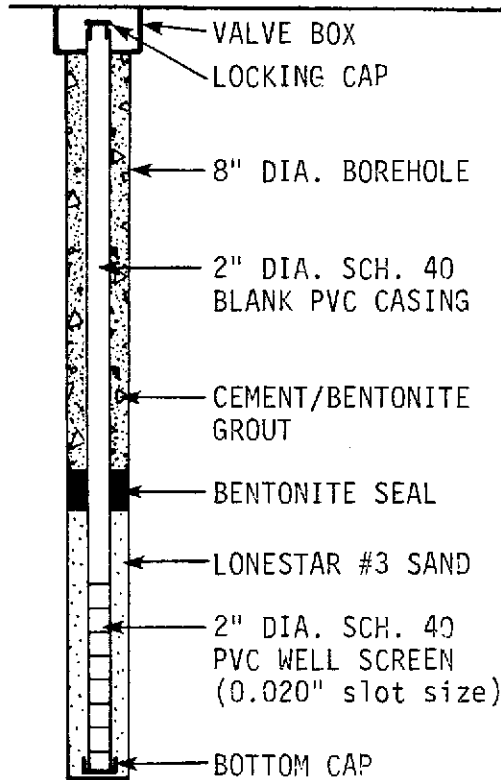
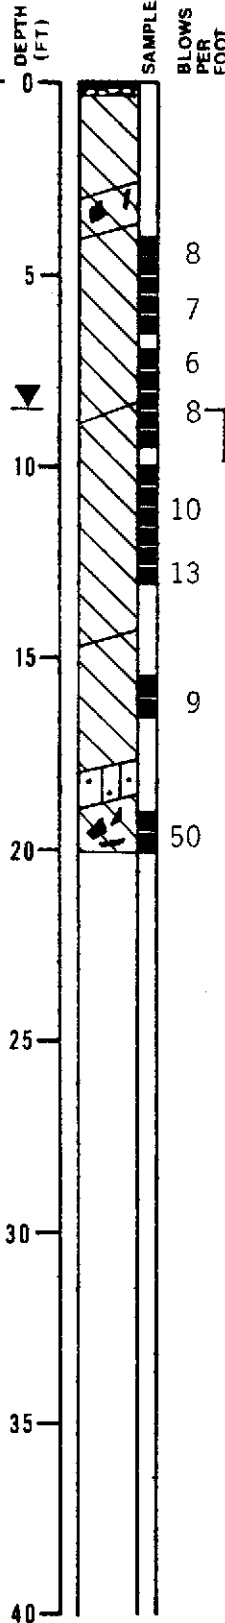
LOG OF TEST BORING 1

ASPHALTIC CONCRETE - 2" thick
 BASE ROCK - 2" thick
 BROWN SANDY CLAY (CL)
 stiff, moist, with gravel (fill)
 DARK GRAY CLAYEY GRAVEL (GC)
 medium dense, moist, with brick
 fragments (fill)
 BLACK SILTY CLAY (CL)
 medium stiff, moist
 BROWN-GRAY SILTY CLAY (CL)
 medium stiff, moist, with gravel
 GROUNDWATER LEVEL DURING DRILLING
 MOTTLED RED AND BROWN SANDY
 CLAY (CL)
 medium stiff, wet, fine grained
 sand
 BROWN SILTY SAND (SM)
 medium dense, wet
 BROWN CLAYEY GRAVEL (GC)
 very dense, wet, with sand

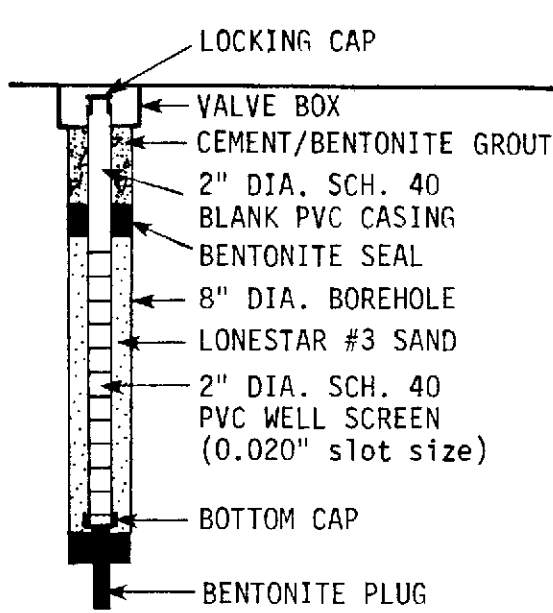
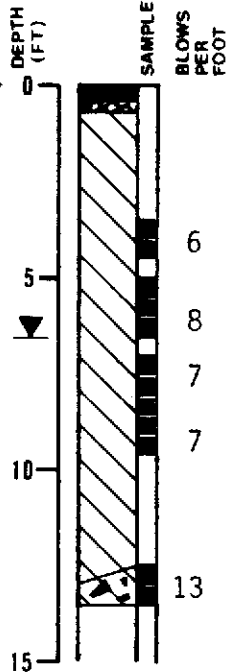
LOG OF TEST BORING 2

ASPHALTIC CONCRETE - 2" thick
 BASE ROCK - 3" thick
 DARK BROWN-GRAY SILTY CLAY (CL)
 medium stiff, moist

GROUNDWATER LEVEL DURING DRILLING

BROWN SANDY GRAVEL (GC)
 dense, wet

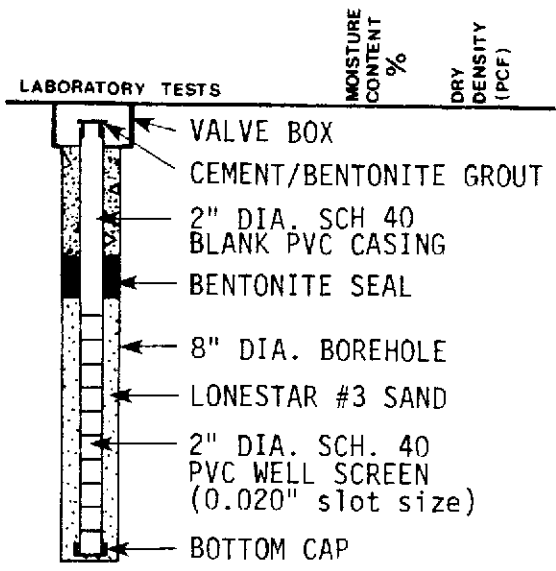
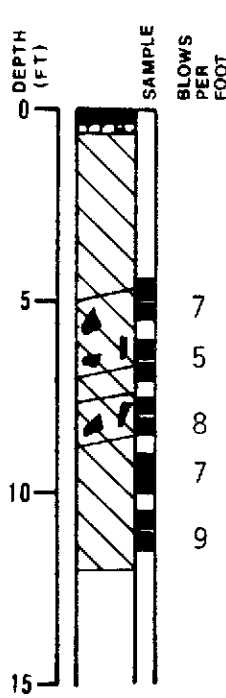
LOG OF TEST BORING 3

ASPHALTIC CONCRETE - 4" thick
 BASE ROCK - 3" thick
 BROWN SANDY CLAY (CL)
 medium stiff, moist, with gravel (fill)
 BROWN CLAYEY GRAVEL (GC)
 dense, wet
 DARK GRAY SILTY CLAY (CL)
 medium stiff, wet
 BROWN CLAYEY GRAVEL (GC)
 dense, wet
 DARK GRAY SILTY CLAY (CL)
 medium stiff, wet
 mottled gray and brown below 10 feet

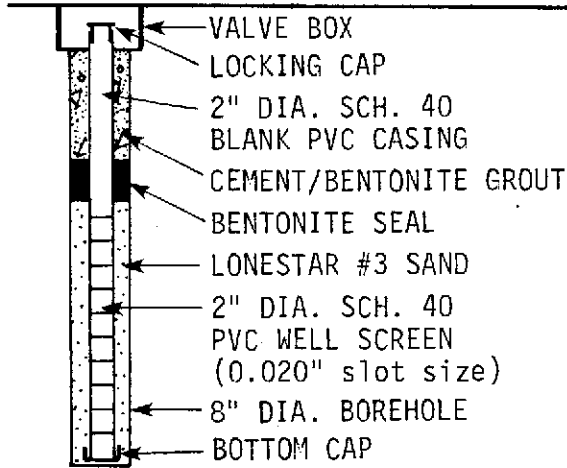
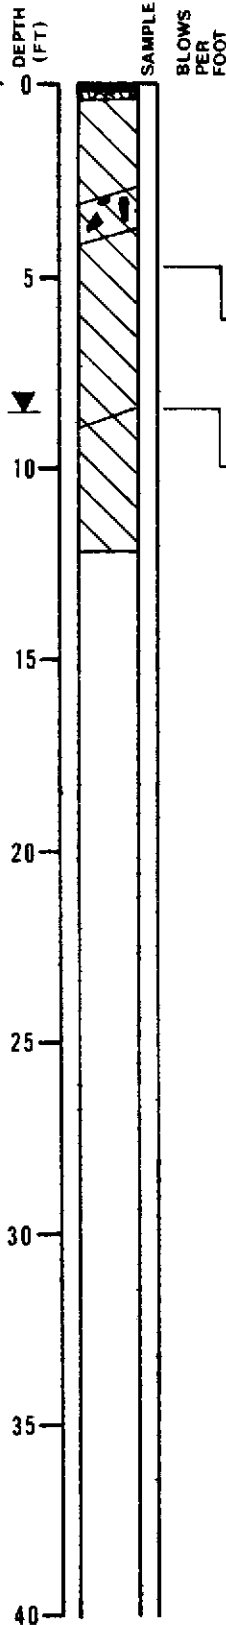
LOG OF TEST BORING 4

ASPHALTIC CONCRETE - 2" thick
 BASE ROCK - 2" thick
 BROWN SANDY CLAY (CL)
 stiff, moist, with gravel (fill)
 DARK GRAY CLAYEY GRAVEL (GC)
 medium dense, moist, with brick
 fragments (fill)
 BLACK SILTY CLAY (CL)
 medium stiff, moist
 BROWN-GRAY SILTY CLAY (CL)
 medium stiff, moist, with gravel
 GROUNDWATER LEVEL DURING DRILLING
