Subject: Site Conceptual Model
400 San Pablo Avenue, Albany, CA

**SITE CONCEPTUAL MODEL
FOR THE PROPERTIES
LOCATED AT 398 & 400 SAN PABLO AVENUE
ALBANY, CALIFORNIA
FEBRUARY 17, 2005**

SUBJECT: SITE CONCEPTUAL MODEL FOR THE PROPERTIES
Located at 398 and 400 San Pablo Avenue, in
Albany, California

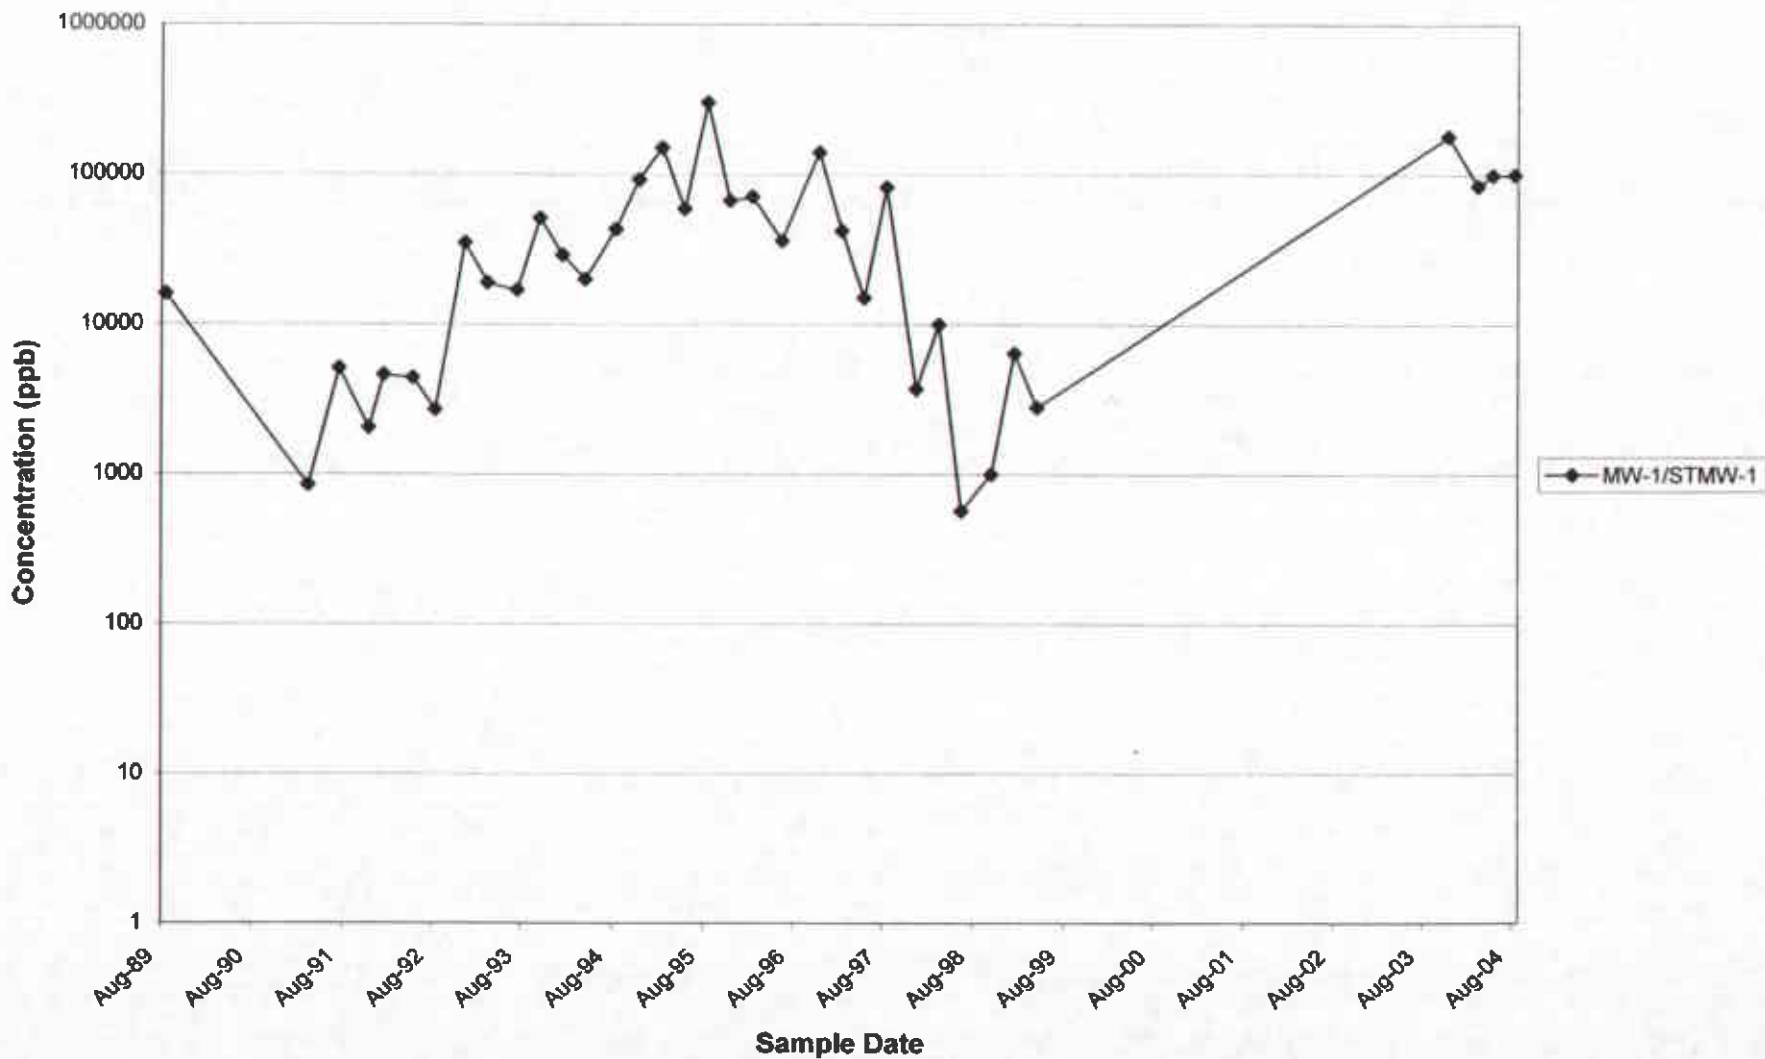
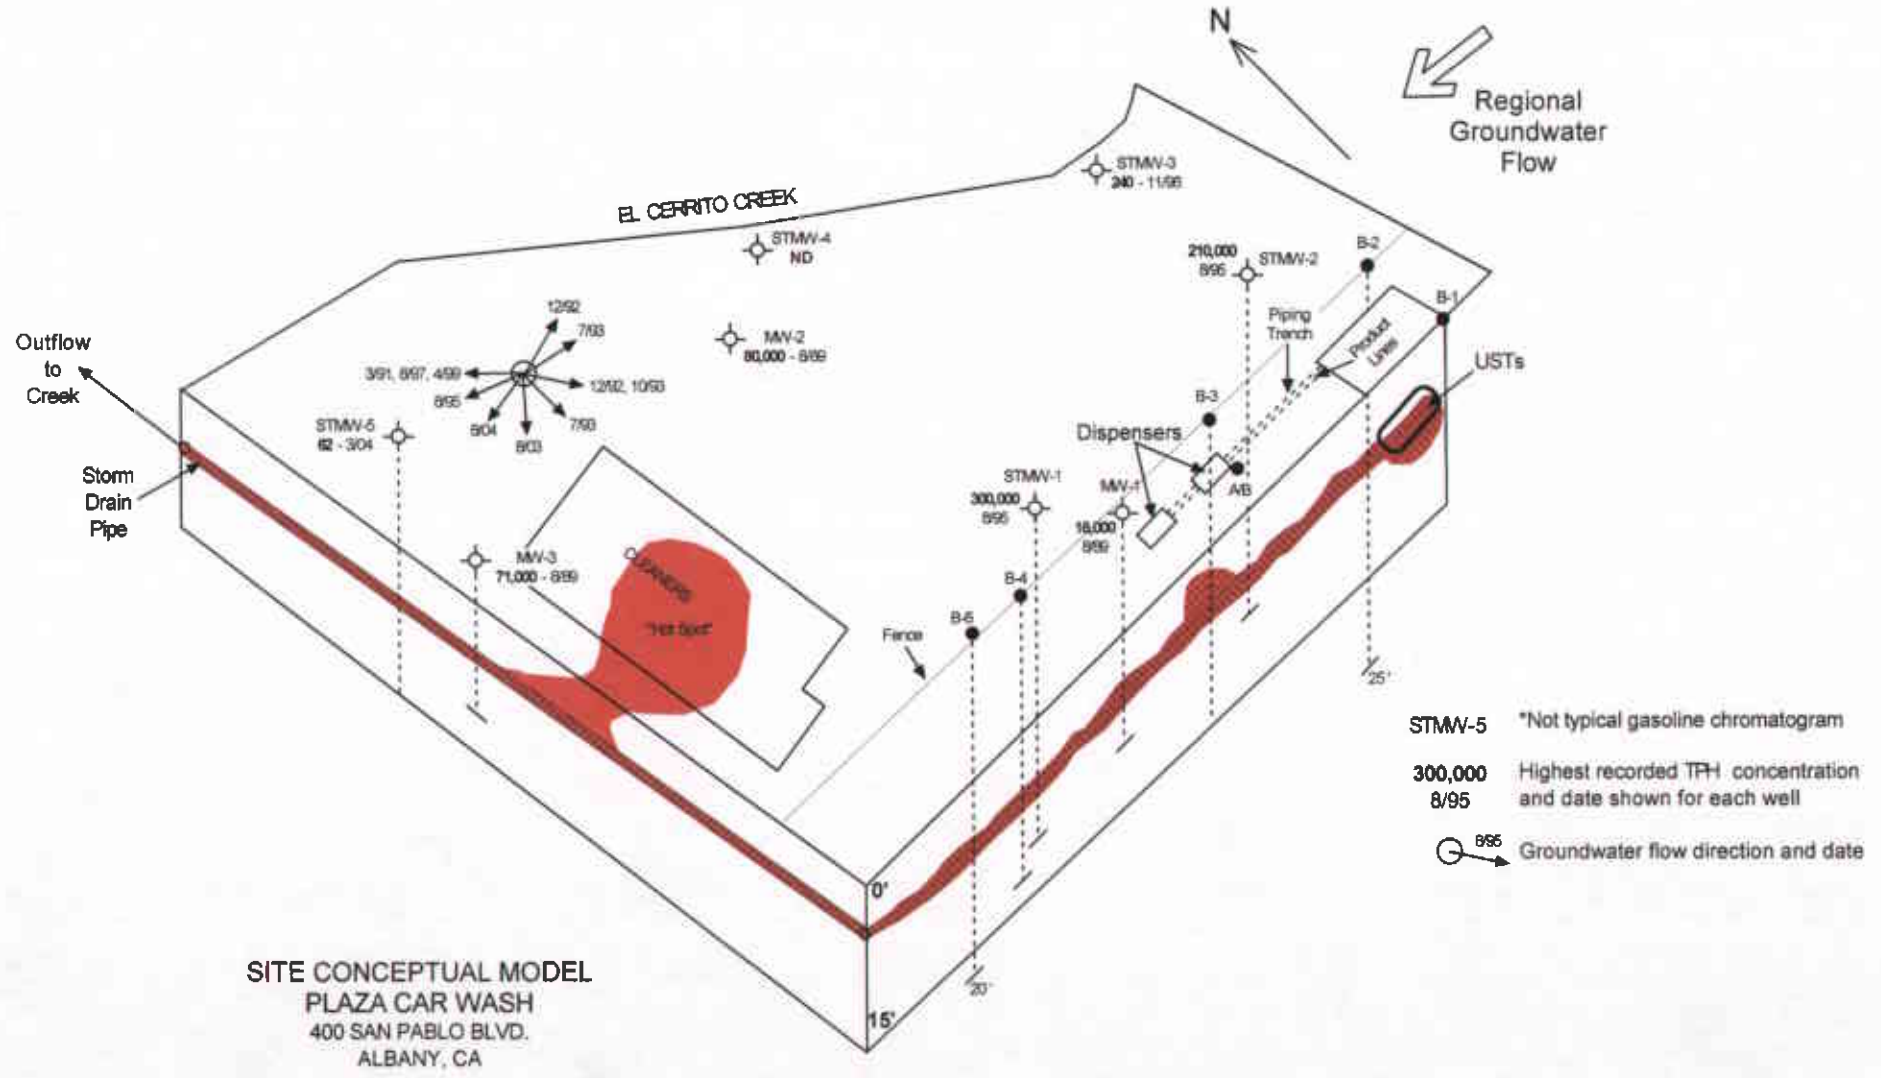
The foregoing discussions are summarized into a schematic block diagram of the site in Figure 8. The model predicts that under regional westward groundwater flow, petroleum and other hydrocarbons dissolved in shallow groundwater will migrate to the west, and that over time gasoline compounds will be detected in wells that are located west (downgradient) of the leak points. This situation will be modified by periodic shifts in the groundwater flow direction, which will vary depending on whether flow is toward or away from El Cerrito Creek. The small arrows in Figure 8 illustrate the variations in local groundwater flow that are documented in section 3.0 below.

In this scenario, any gasoline leaked from the dispensers will first impact monitoring well MW-1, which is located immediately west, and will subsequently migrate to STMW-1 and then along favorable flow paths to the southwest, west, or northwest. Fuel leaked from the UST's will follow a similar path, but may begin migrating more to the north because of the close proximity of El Cerrito Creek. In that case, STMW-2 would be impacted relatively early by a UST-derived plume of contaminated groundwater. The last wells to be impacted would be MW-2, MW-3, and
