Subject: Claim No. 7912
Site Address: 3609 International Blvd., Oakland, California

**INSTALLATION OF FRENCH DRAIN & GROUNDWATER
REMEDATION SYSTEM DETAILS**

**Tony's Express Auto Service
Oakland, California**

Project 99-2332

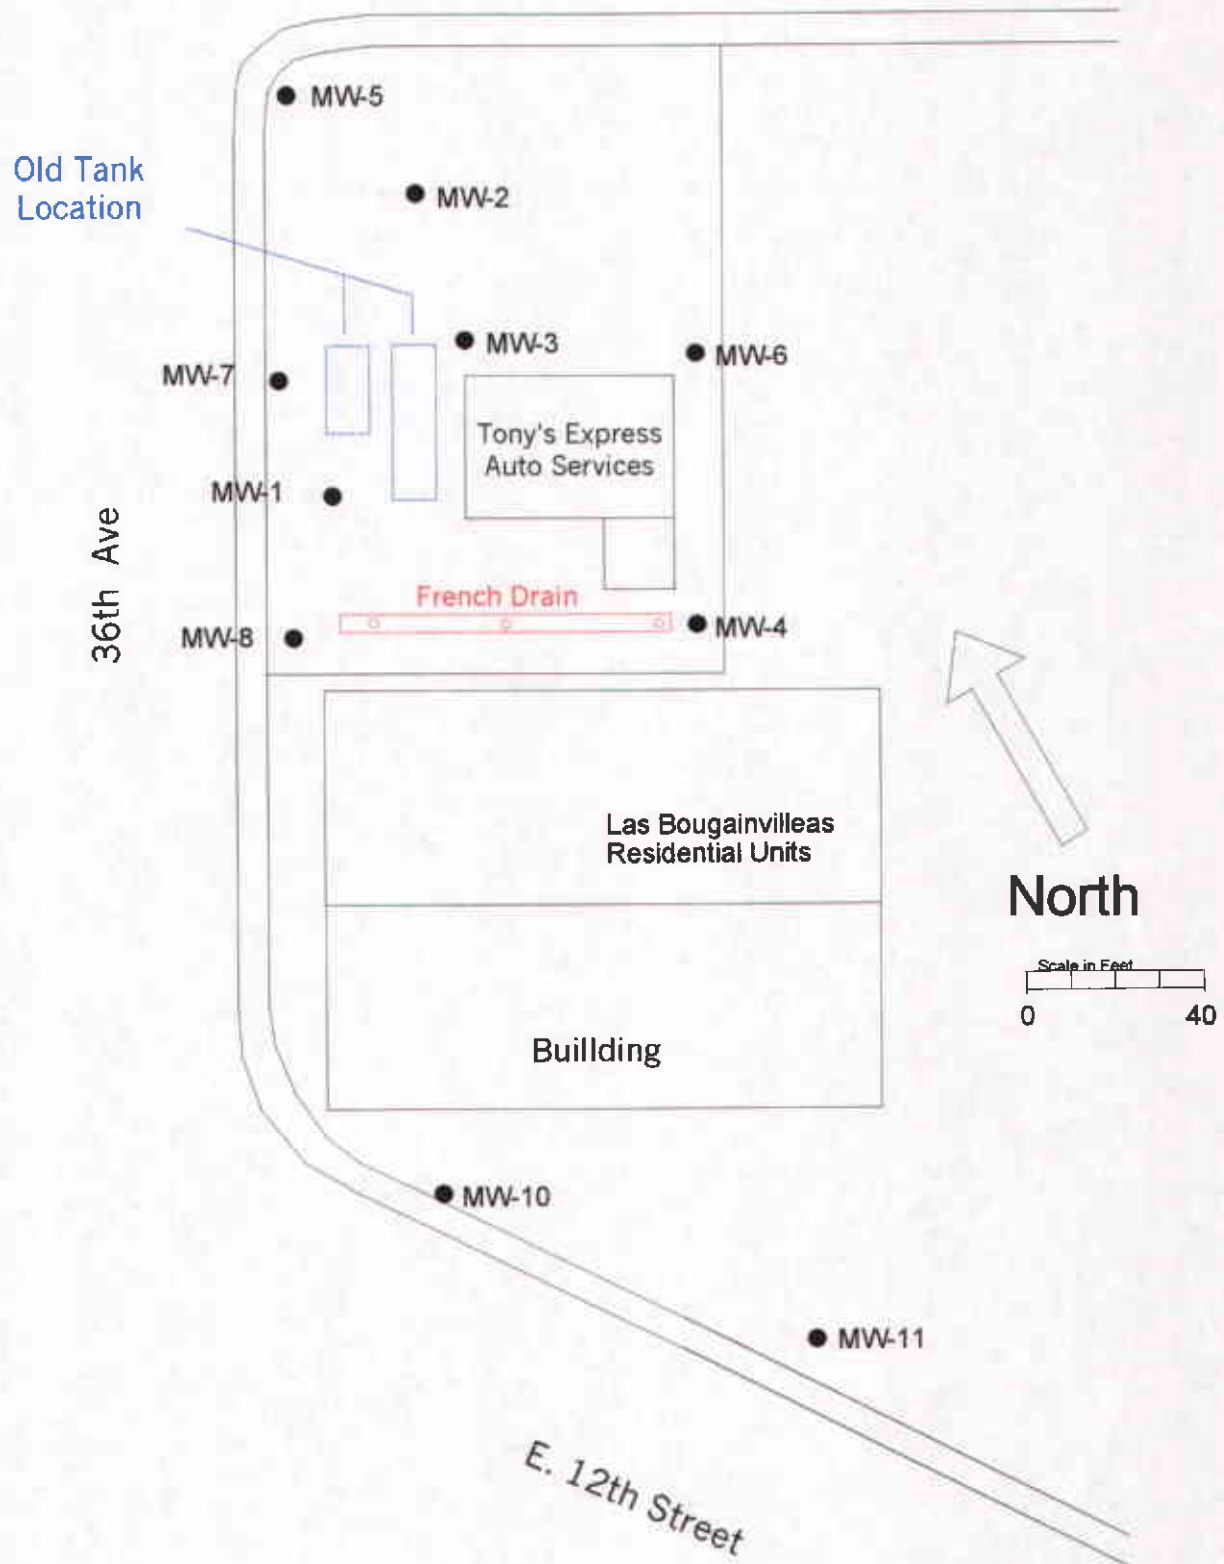
Figure 3: Site Map Showing Existing Well Locations and French Drain

In August 1999, SOMA retained DJK Construction (DJK) as a subcontractor to install the French Drain. On August 30, 1999 using an excavator equipped with a 3-foot wide bucket, DJK initiated removing the asphalt pavement for construction of the French drain. Figure-3 shows the location of the French drain. Near the surface, the soil type was light brown clay with no apparent staining or hydrocarbon odor. Below the 10-feet, the soil had some visible staining and a strong hydrocarbon odor was evident indicating a possible petroleum hydrocarbon contamination. The petroleum odor intensified as the depth of the excavation increased. Small sandy clay pockets existed below 12 feet and groundwater was encountered at approximately 16 feet below the ground surface.

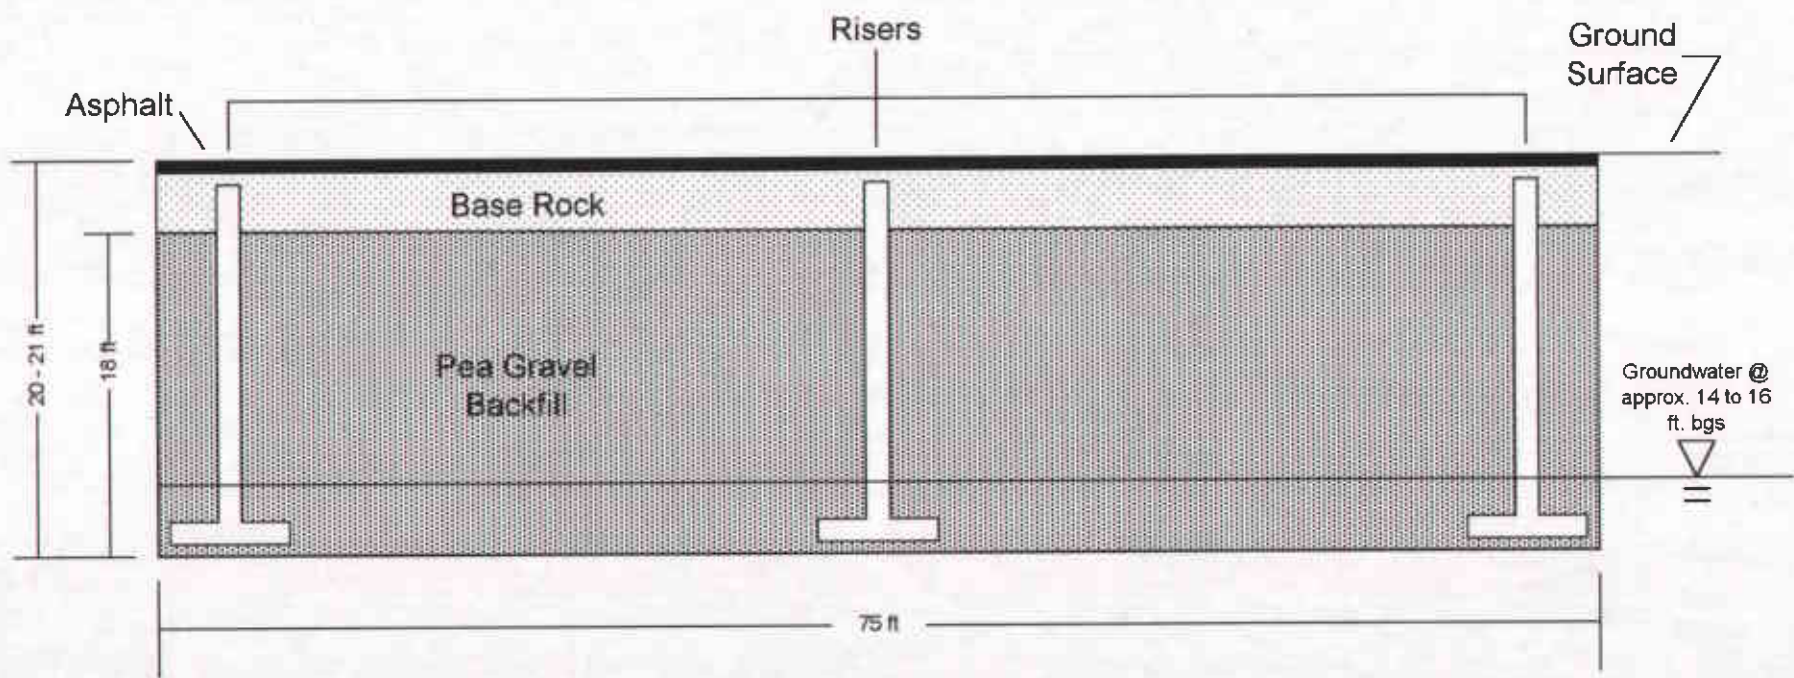
Figure 4: French Drain Details

The dimensions of the French drain are 3 to 4-feet wide, 75-feet long and 20 to 21-feet deep, see Figure-4. The center riser of the drain was about 1 foot deeper than the ends. The variation in depth was to allow water to flow to the center riser, which will be as an extraction point for the groundwater remediation

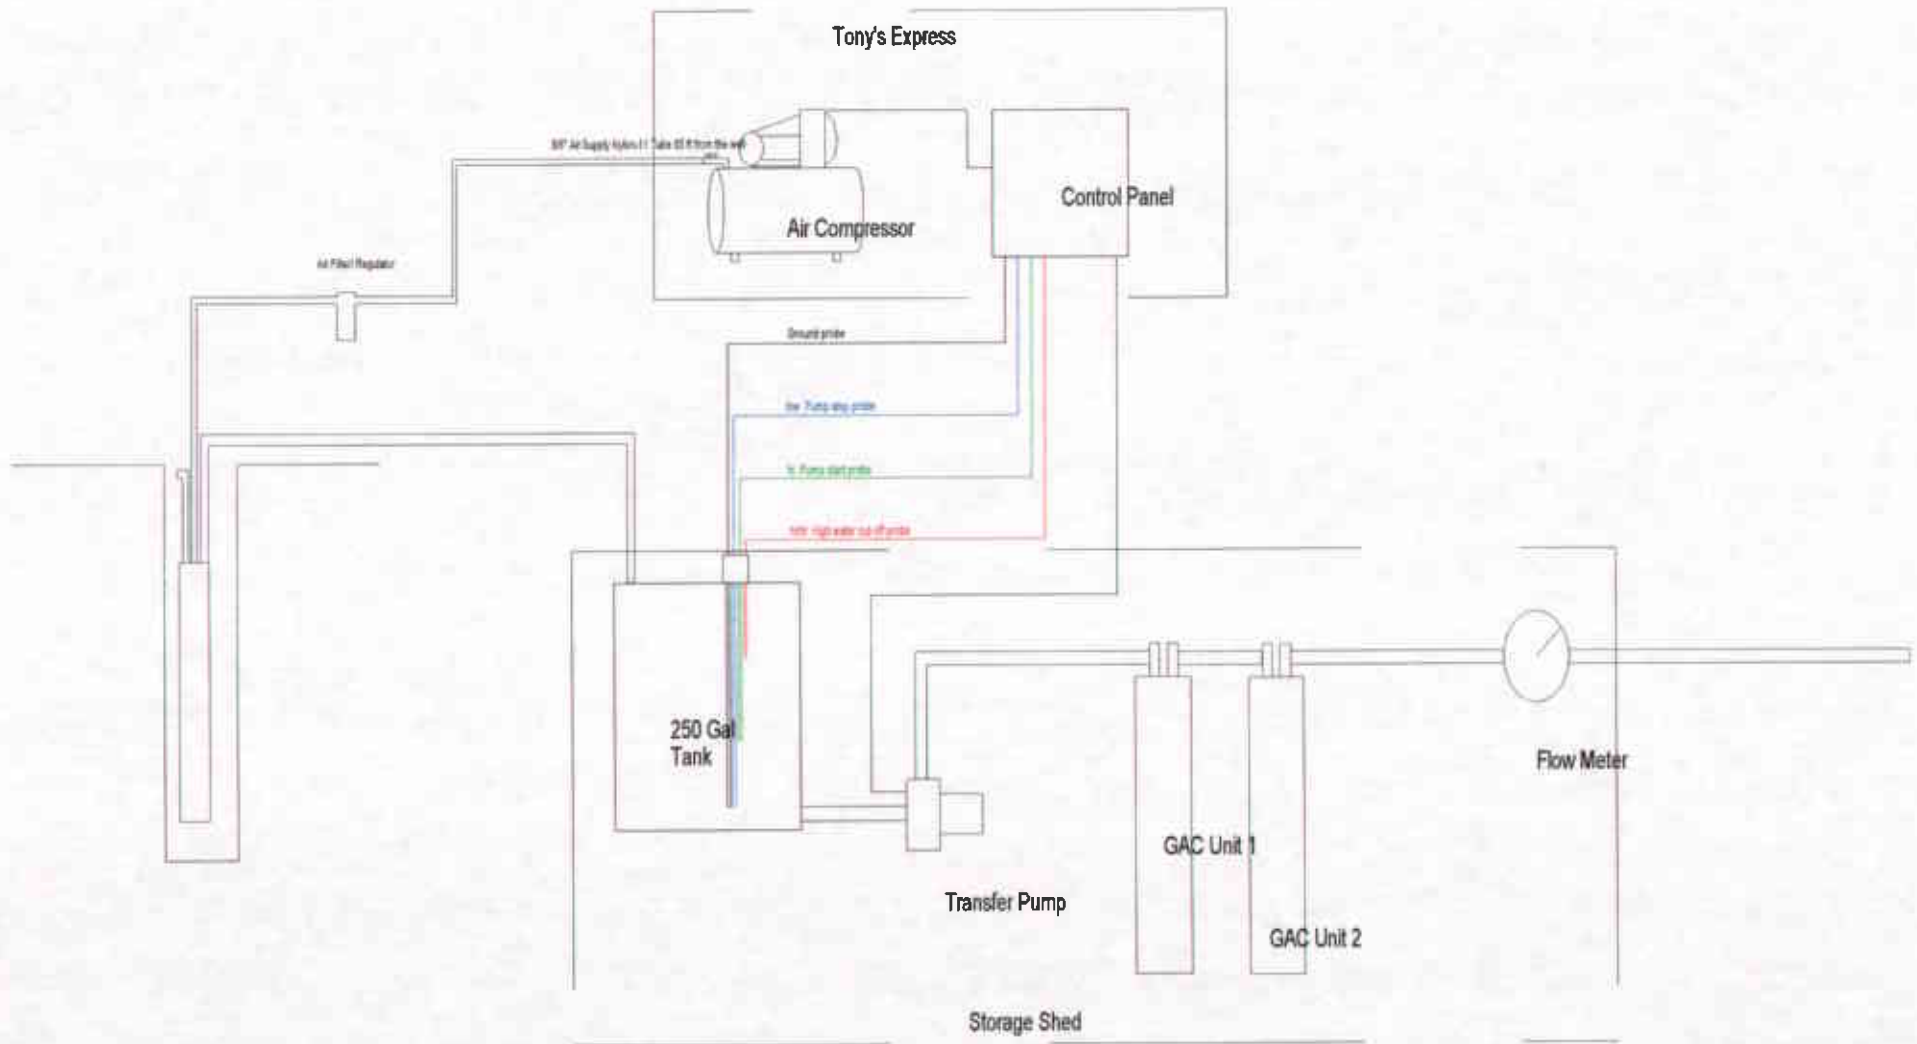
Figure 6: Groundwater Remediation System Details

After the installation of the French drain, work began on the groundwater remediation system. Figure-6 illustrates the details of the installed system. The

purpose of the groundwater remediation system is to remove all traces of petroleum hydrocarbons from the groundwater that is extracted from the trench. The system is also designed to prevent the continued off-site migration of petroleum hydrocarbon components. The system is composed of the following components:

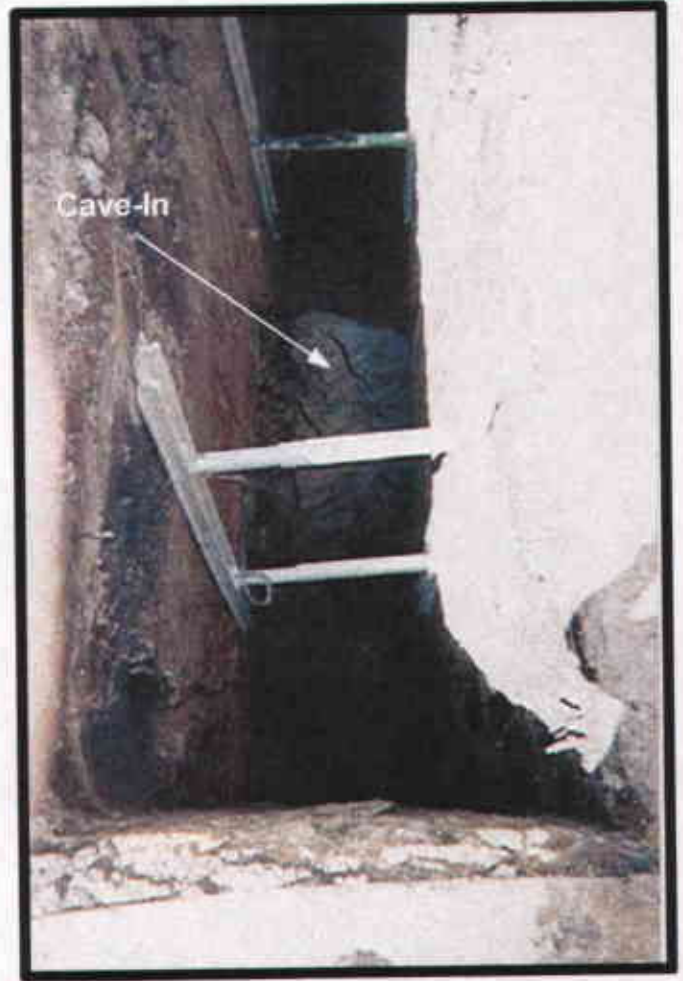
During the excavation procedure, several silty-sand pockets were encountered at the east end of the ditch where the excavation began. As the trench was exposed to a depth of 20 feet, the sandy layers began to flake off the sides of the trench. The soil flaking began to increase as preparations were being made to install the first riser. Excess material was removed to lower the bottom of the trench elevation again, due to the flaking material. By the time the riser was set in place, several cubic yards of material had flaked off and had to be removed. Nearby asphalt was also affected by the small cave-ins. Cracks became visible that required more asphalt than expected when the trench was re-paved.

A-2: Side Wall Cave-In

After the riser was set, backfilling began. The cave-ins continued until the backfill material had reached a stable depth in the trench. The original plan was to expose the entire ditch before setting the risers and backfilling, but due to the sandy pockets of soil, the methods for excavation had to be changed in the field. The new plan was to excavate in three smaller sections. This required that barricades be set near the end of each section to support the pea gravel backfill material. As each section of the trench was exposed, the barricade from the previous section was removed, allowing the pea gravel to flow down into the newly exposed trench. Some excavation was still required to bring the trench to the designed 20-foot depth. During the excavation process, some of the backfill material (pea gravel) had to be wasted. This allowed for a smooth transition between sections and allowed the total depth to remain constant at 20 to 21 feet below the ground surface. Following the excavation of each section, the barricade was set near the end of the open excavation and more backfill was placed to bring the entire trench up to a stable depth. This continued for the entire length of the trench and prevented further cave-ins or flakes from occurring. Out of scope work was conducted by DJK, due to the numerous obstacles that were encountered during the excavation.

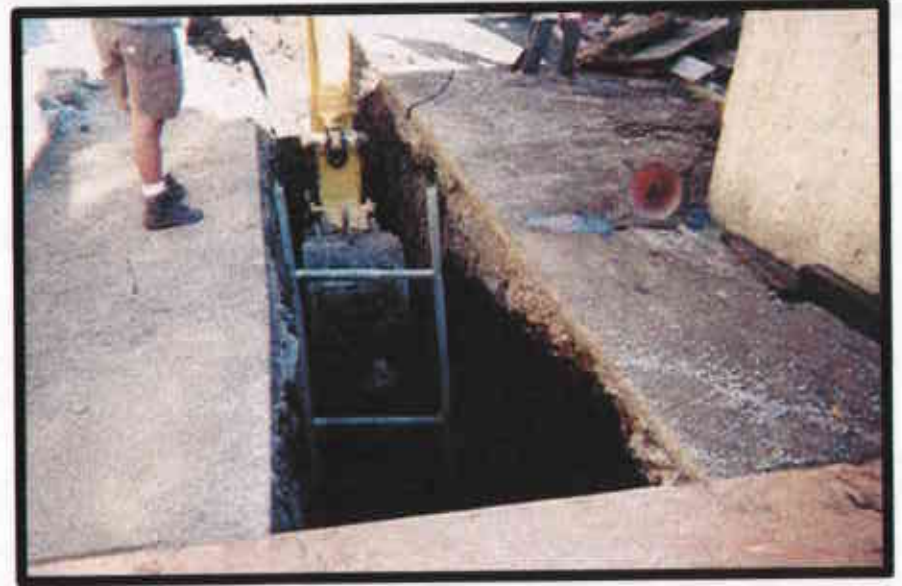
A-5: Excavating Soil After Cave-In

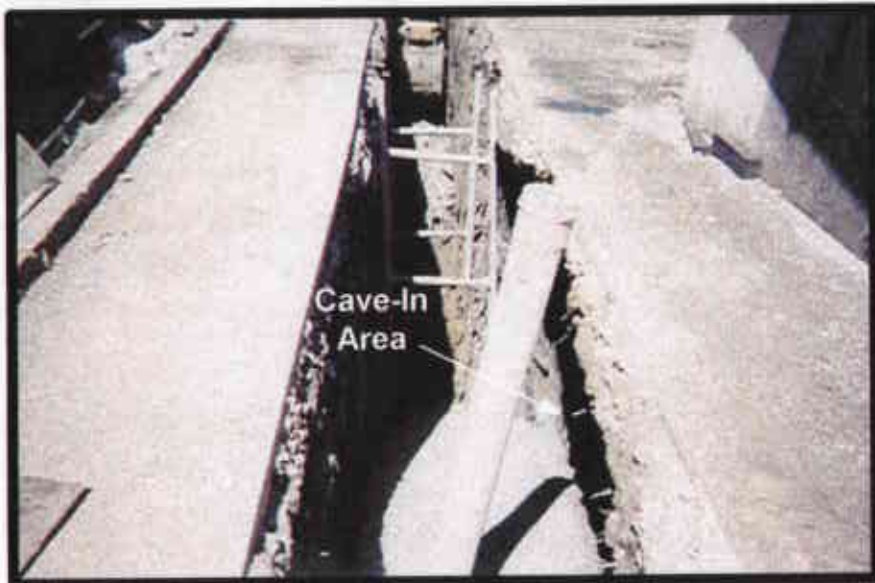
A-8: Cave-In at the East End

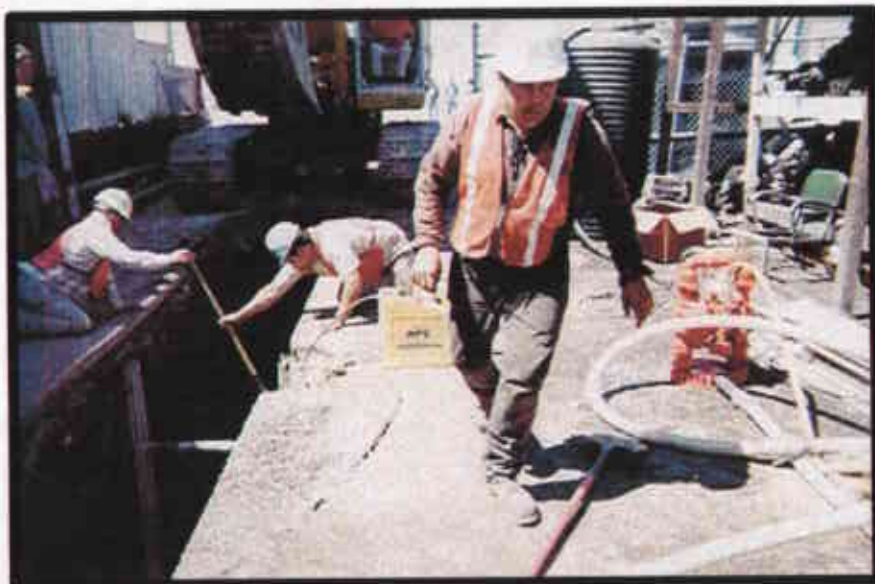
A-10: Setting the Trench Shoring

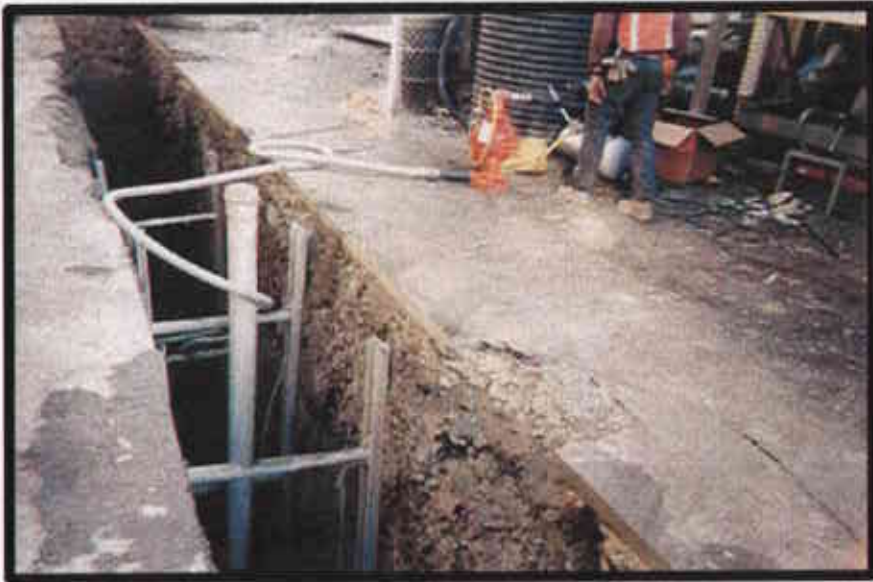
A-12: Pumping Water from the Excavation
