Re: Site Closure Report
P&D 23rd Avenue Associates
1125 Miller Avenue, Oakland, CA
Clearwater Project No. CB018
ACEH Fuel Case Leak No. RO0000294

SITE CLOSURE REPORT

23rd Avenue Partners
1125 Miller Ave.
Oakland, California

October 3, 2002

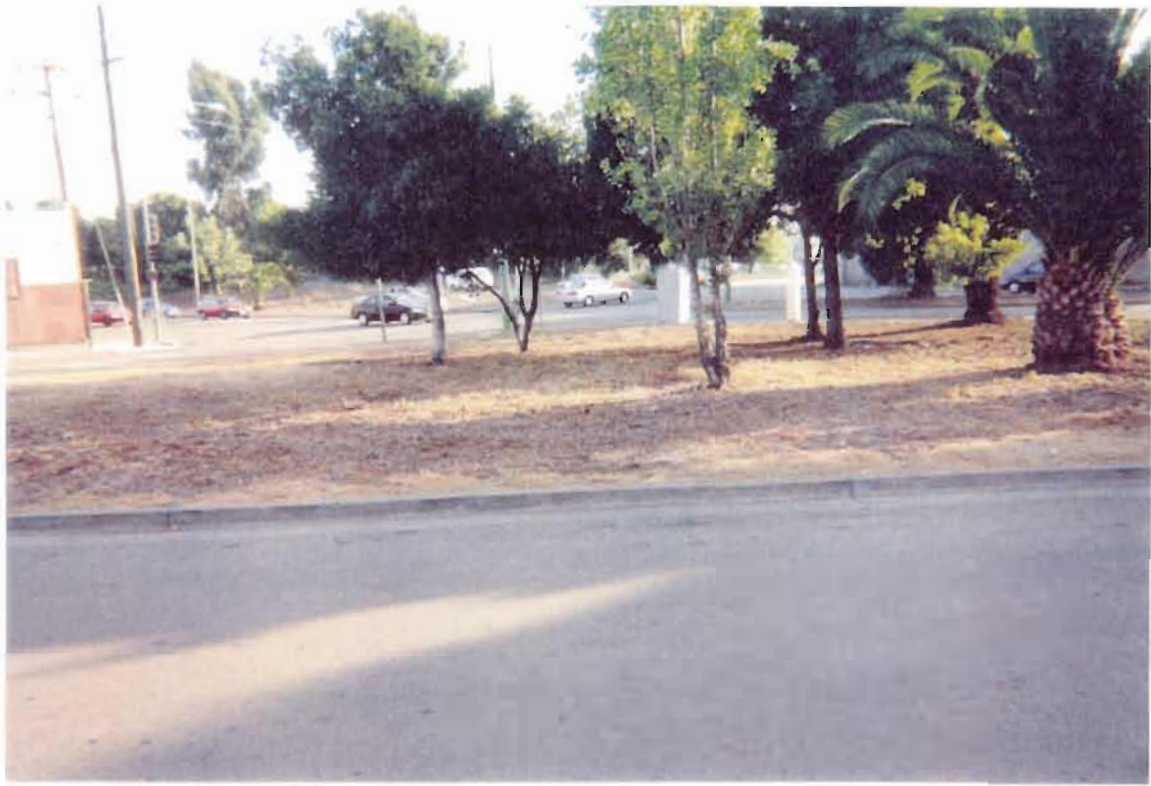
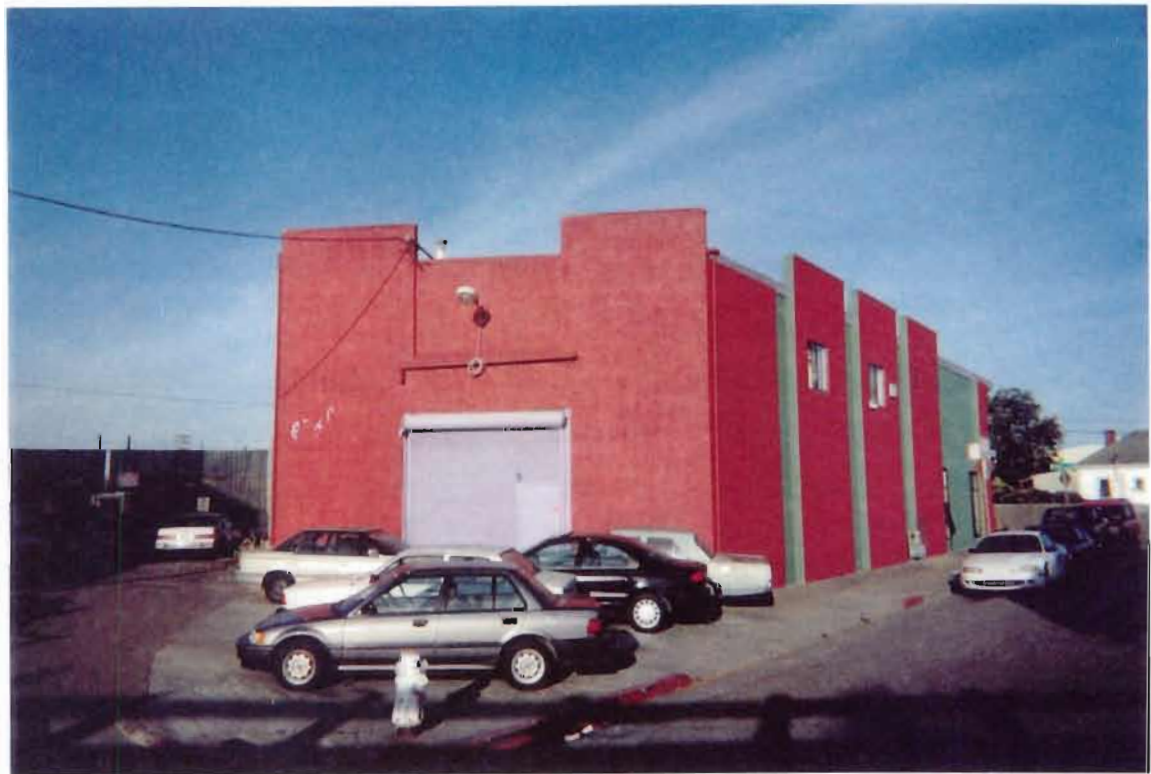
Site Closure Report Photos 6/12/02

Top Photo: Looking southwest
Mini-park across East 11th Ave.
23rd Avenue in background (red cars)
Bottom Photo: Looking east
Hydrant and storm drain at bottom

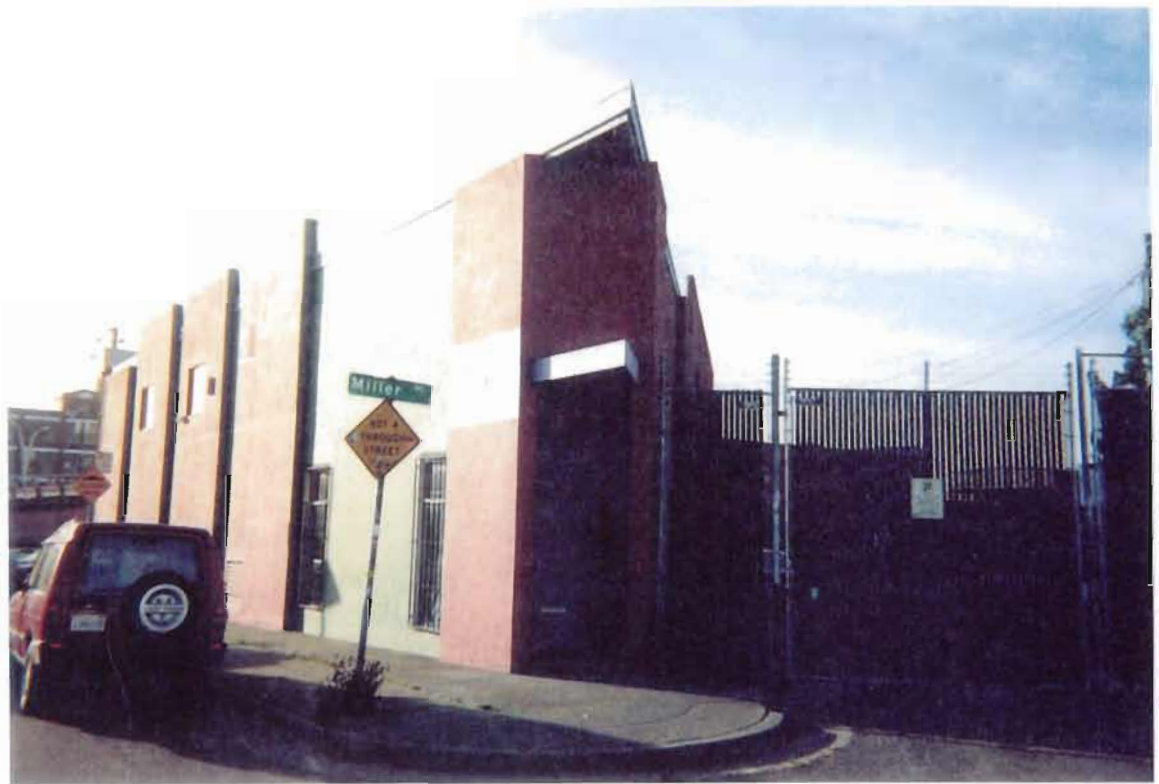
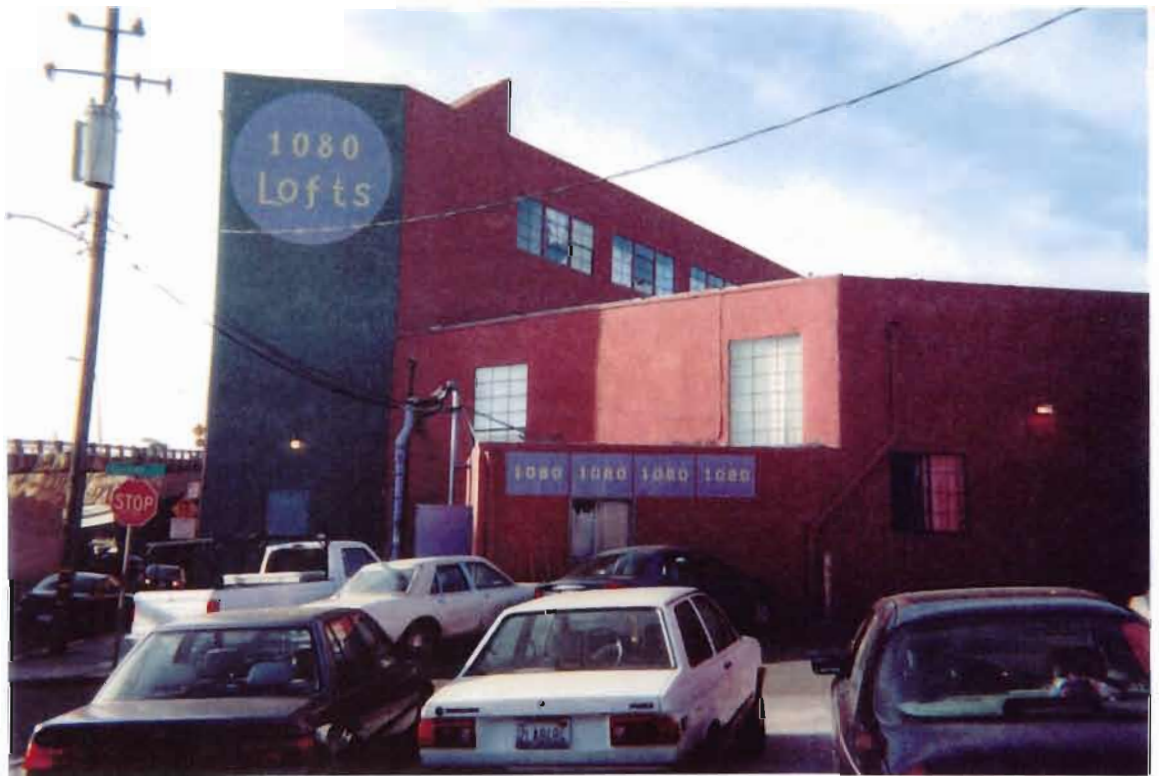
Site Closure Report Photos 6/12/02

Top Photo: Left on E. 13th
right street: Miller Ave.
Building in center of photo.
Bottom Photo: Looking NE
across Miller Place to Lofts

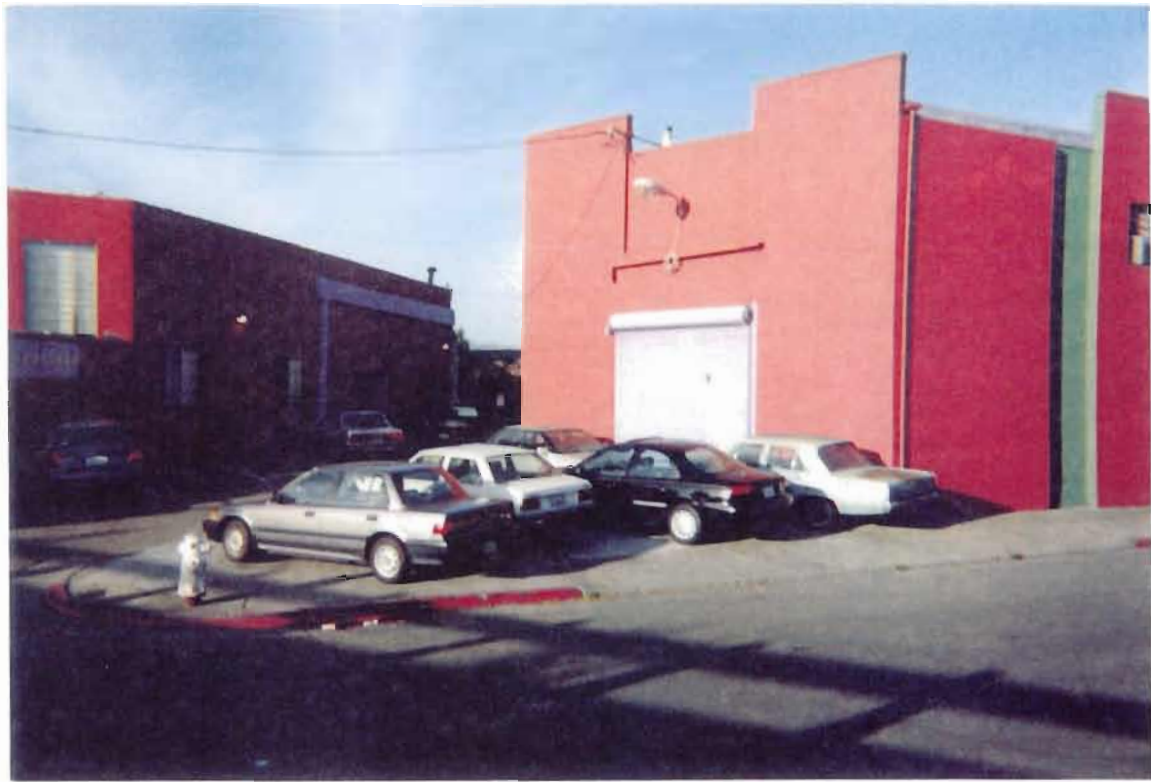
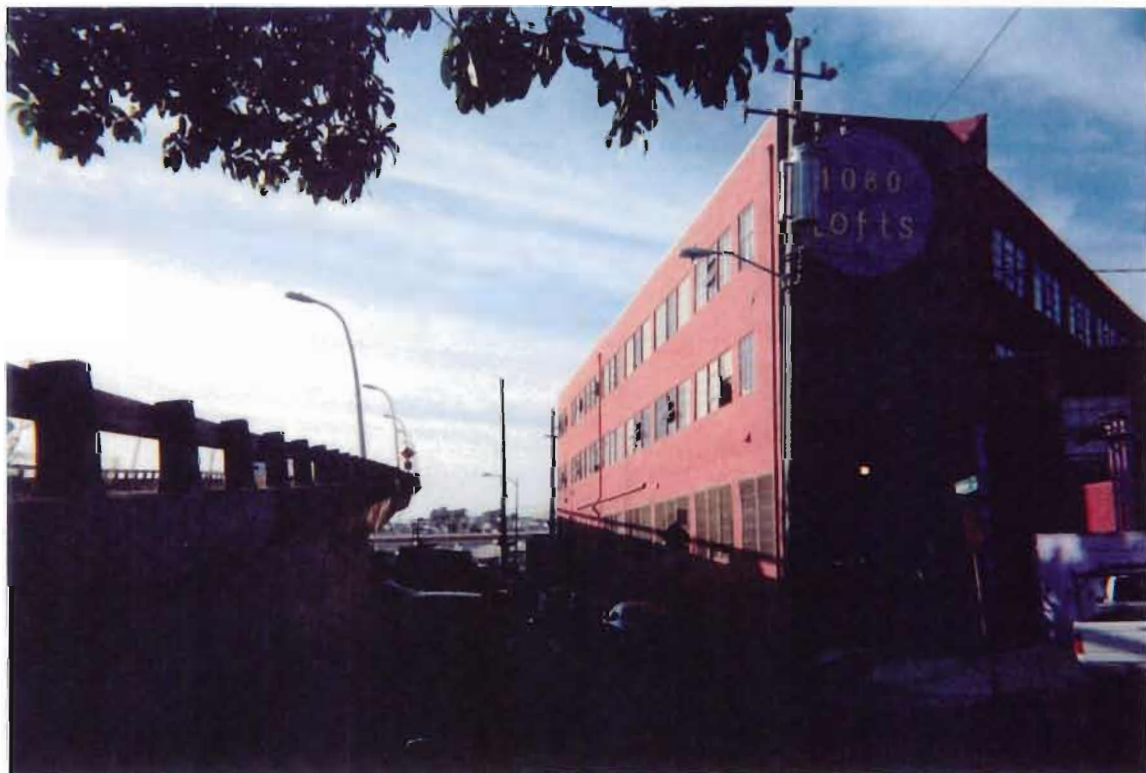
Site Closure Report Photos 6/12/02
Photographs taken by J. Jacobs
Site Closure Report Photos
23rd Avenue Properties
Oakland, California

Top Photo: Looking southeast
Note white hydrant and storm drain.
Building in right of photo.
Bottom Photo: Looking north
23rd Ave. freeway ramp on left

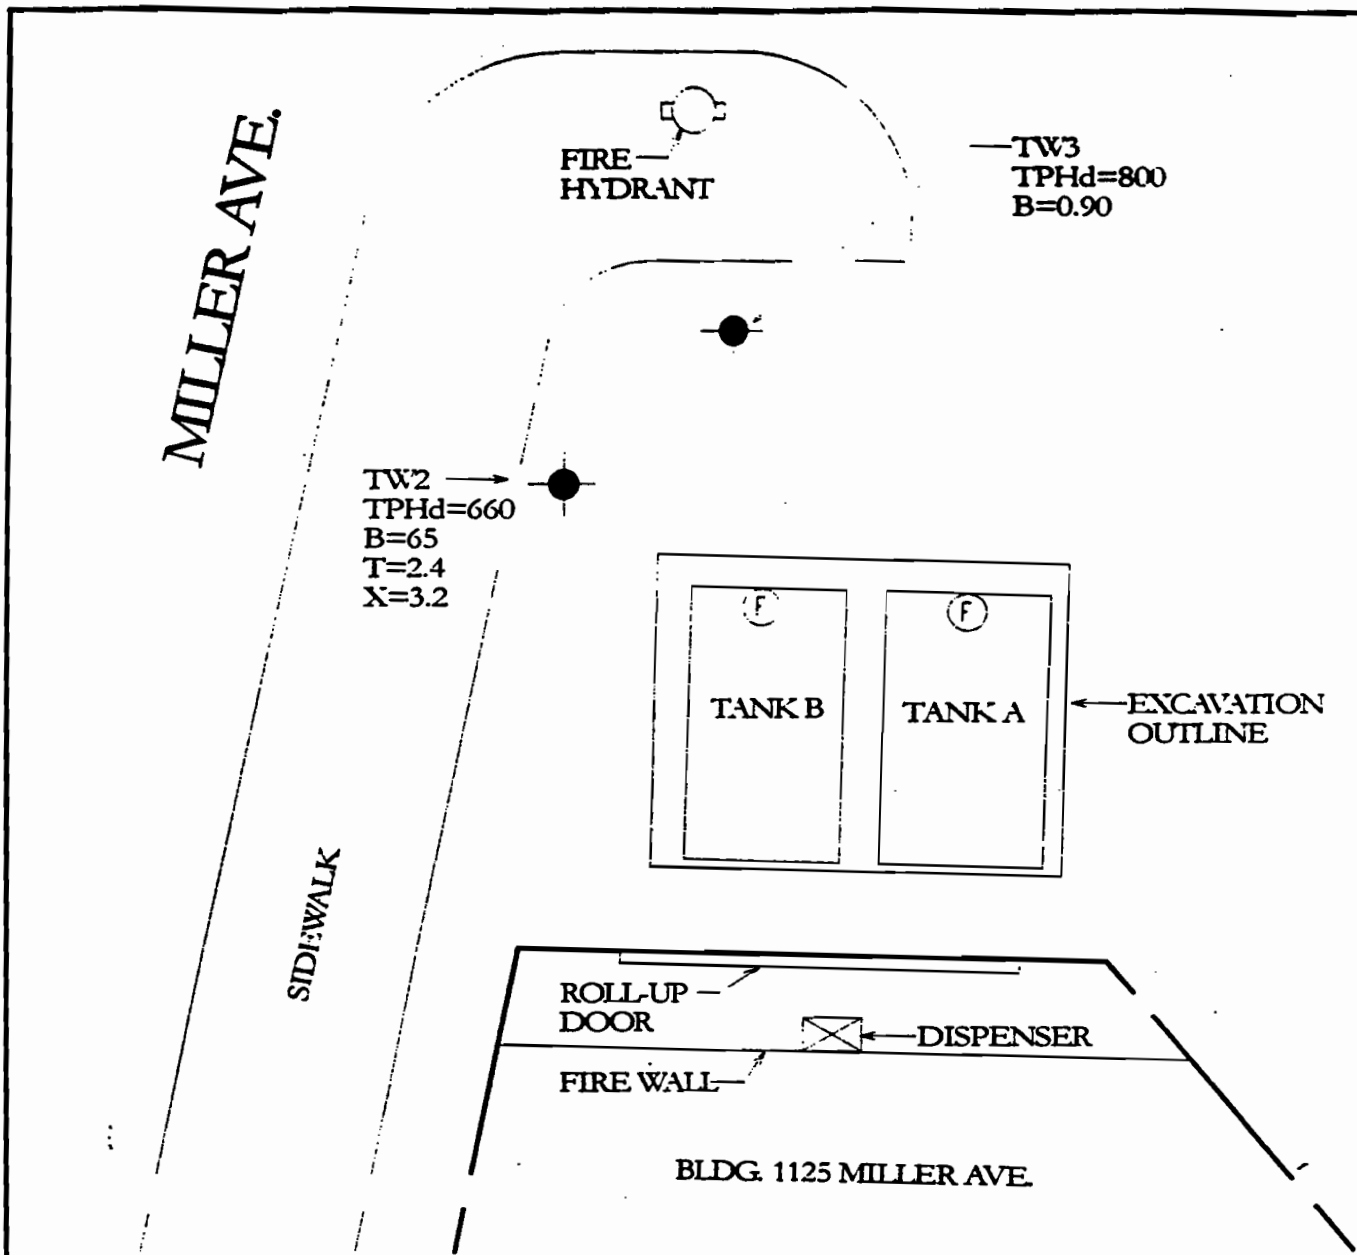
TW2
 TPHd=660
 B=65
 T=2.4
 X=3.2

TW3
 TPHd=800
 B=0.90
