**RE: BP OIL FACILITY #11117
7210 Bancroft Avenue
Oakland, CA 94621**

Attached please find our **SITE ASSESSMENT REPORT DATED MARCH 9, 1995**
for the above referenced facility.

PHASE II ENVIRONMENTAL AUDIT

**EASTMONT MALL PROPERTY
OAKLAND, ALAMEDA COUNTY, CALIFORNIA**

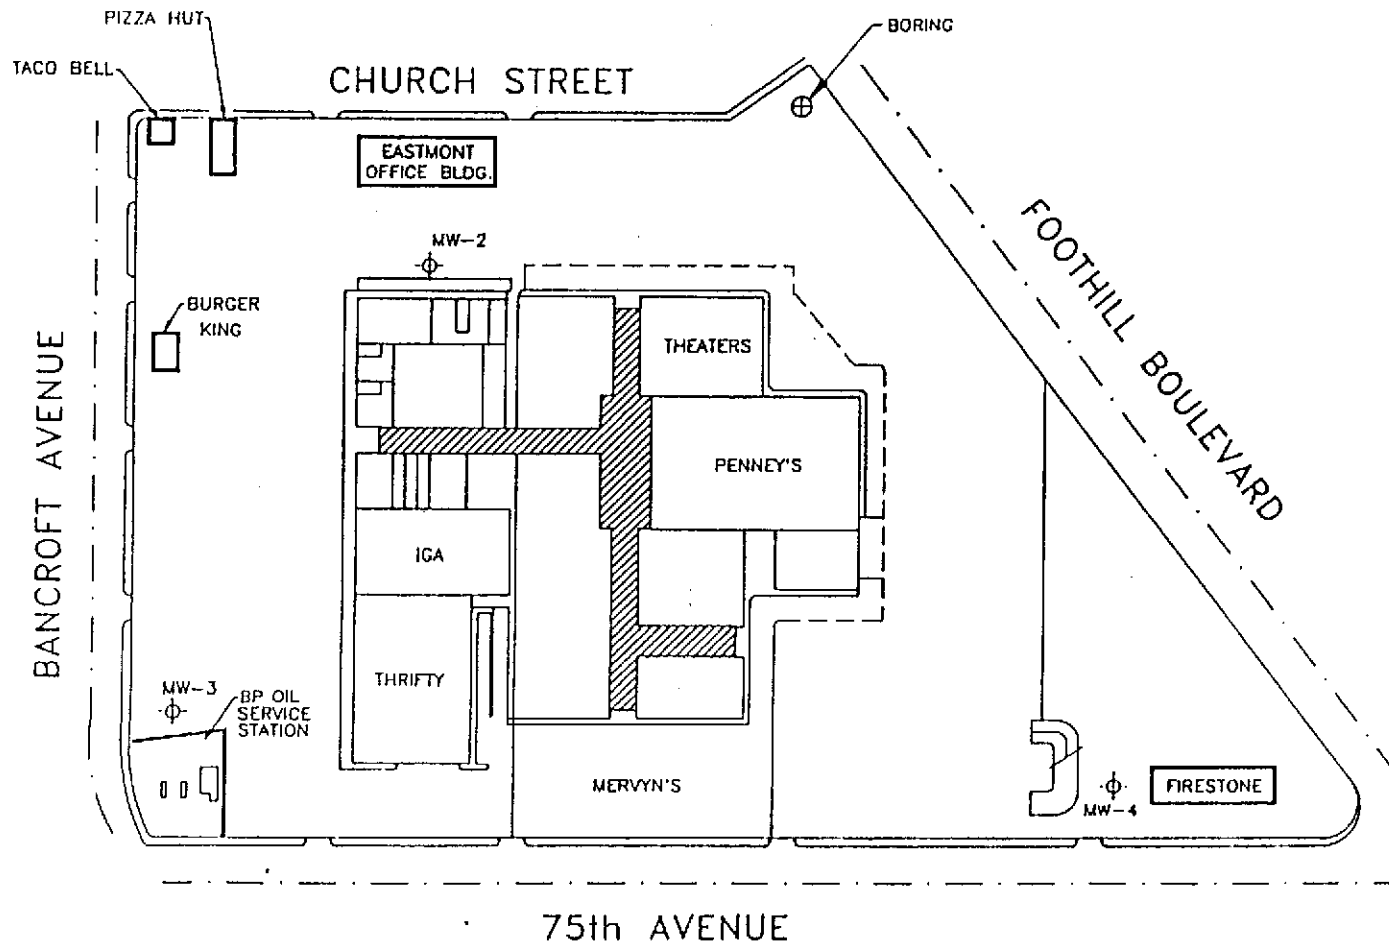
Hunter	EASTMONT MALL OAKLAND, CA.
FIGURE 2 SITE MAP	
12/88	02-401-002

On December 5 and 6, 1989, one soil boring (B-1, designated as MW-1 for laboratory analyses), and three ground-water monitoring wells, MW-2, MW-3, and MW-4, were completed at the locations shown on Figure 2 - Site Plan. The wells and soil boring were completed using a truck mounted Mobile Drill B-53 hollow-stem auger drill rig. The drilling and sampling procedures are included in Appendix B -Drilling and Sampling Procedures.
