GROUNDWATER SAMPLING & ANALYSIS
AND
COMPREHENSIVE ASBESTOS SURVEY
15563 WASHINGTON AVE.
SAN LORENZO, CALIFORNIA
FOR
MR. DON CALLAHAN

JOB NO. EC-517/E316-02
AUGUST 23, 1993

SUBJECT: Groundwater Sampling and Comprehensive Asbestos Survey, 15563
Washington Boulevard, San Lorenzo, California

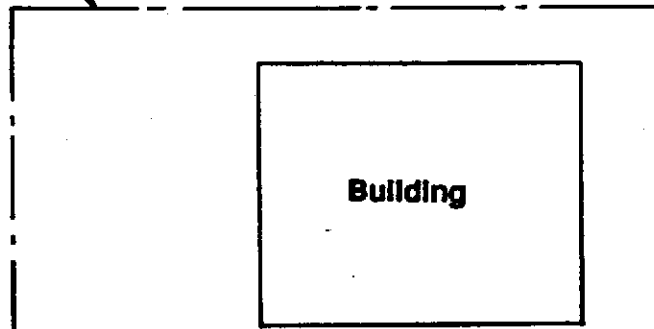
FIGURE NO.
2
REV NO.

The results of the groundwater analysis show that TPH-gasoline contamination of the groundwater beneath the subject property has occurred. The concentrations of TPH-gasoline range from 50 parts per billion (ppb) at location B-1, closest to Washington Boulevard (Figure 2), to Not Detected at B-2, to 4,500 ppb at B-1, the western-most sample. BTEX were detected in B-1 and B-3. TPH - diesel was not detected in any of the samples. Laboratory data are presented in Table 2 and laboratory data sheets are included in Appendix D.

Contamination of the groundwater is most likely caused by sub-surface migration of gasoline onto the subject property from the neighboring Shell service station. The highest concentration of contaminants was detected in B-3 at the southwest corner of the subject

property. The detected levels of TPH-gasoline and BTEX are all above action limits dictated by the state and county regulatory agencies.

B-3
4900/18

B-2
ND/0.7

B-1
50/0.5

A copy of this report should be sent to the Alameda County Health Care Services Agency which has local enforcement jurisdiction for leaking UST's in Alameda County.
