Harding Lawson Associates

PHASE I
PRELIMINARY HAZARDOUS MATERIALS
SITE ASSESSMENT
2855 CYPRESS STREET
OAKLAND, CALIFORNIA

HLA Job No. 18452,038.02

September 25, 1990

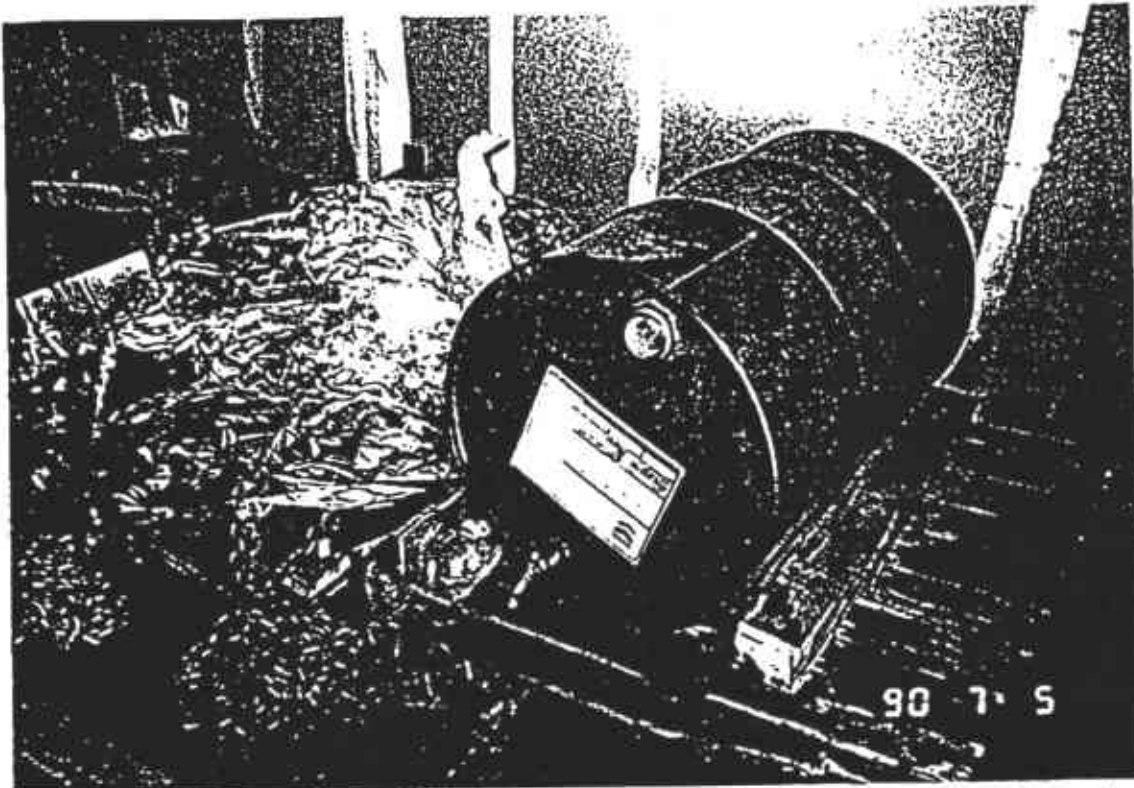
Photo One

oil per month to operate machinery. A supplier picks up empty cylinders and drums and recycles them. The three cylinders of liquified petroleum were stored properly and there was no evidence of leakage. A 50-gallon drum of motor oil was lying on its side atop two unstable wooden pallets and was leaking onto the floor (Photo 1). The drum is stored in violation of fire marshall codes. There was no evidence of the heavy staining which was observed in the 1989 aerial photograph.

Southland Packaging
Leaking motor oil

- o Leaking containers of various chemicals were observed in Space 10, and oil was observed leaking from a drum onto a concrete slab in Space 8. HLA recommends that storage of these containers be corrected by disposing of the leaking chemical containers and their contents and uprighting the drum.

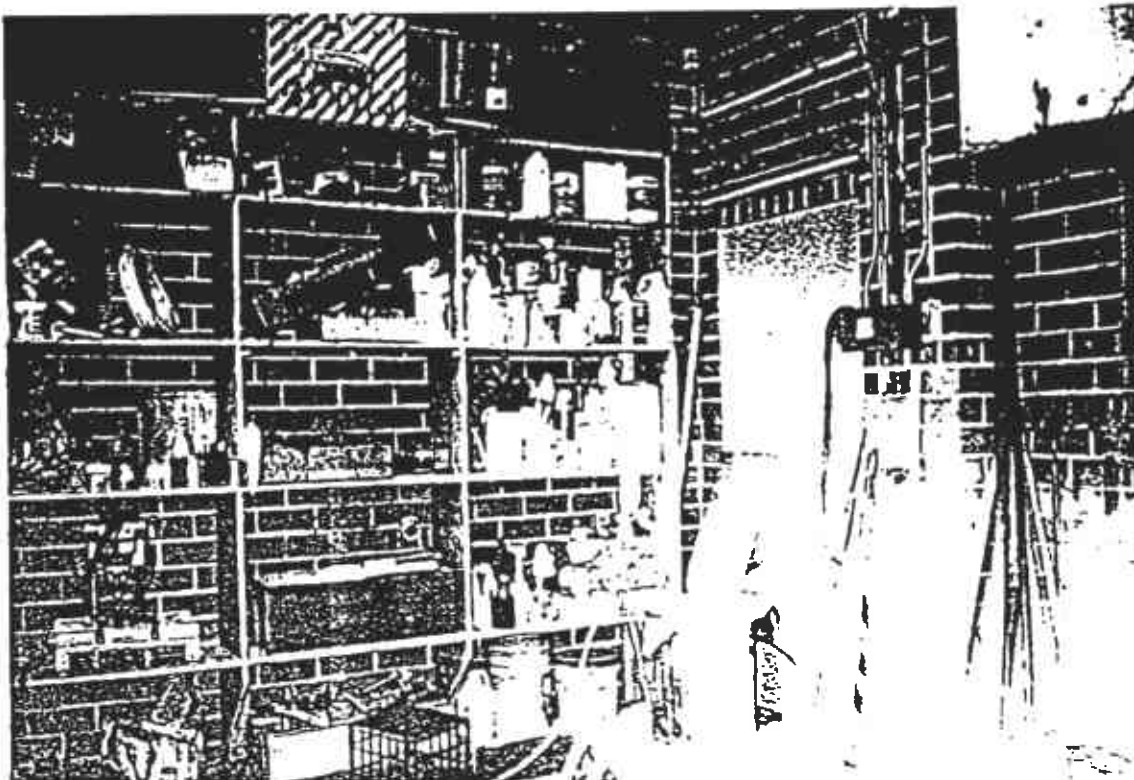
Photo Two

Joinery Structures, a woodworking company, currently occupies Space 10, approximately 5,400 square feet. Several household- and industrial-type paints, thinners, oils, and wood stains were observed on a shelf in the rear of the shop. The containers were in poor condition and the materials have been allowed to leak and contact other containers. Some of the containers were not labeled or could not be identified (Photograph 2).

Many unsorted, miscellaneous and
hazardous materials stored
