# QUARTERLY GROUNDWATER MONITORING REPORT

May 20, 1996

Peralta Maintenance Yard 501 5th Avenue Oakland, California

ACC Project No. 6045-14

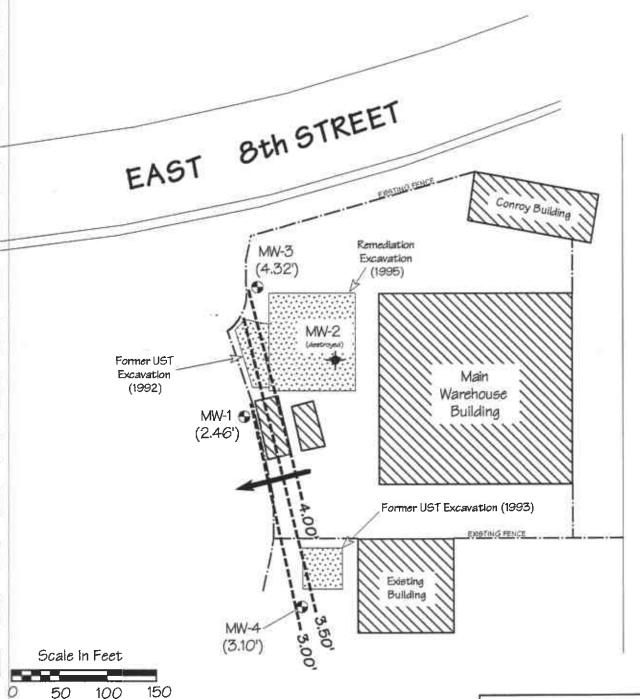
Figure Number: 3.0 Scale: 1" = 100'

Groundwater elevations were calculated from water level measurements collected in the wells on March 27, 1996. Groundwater gradient was calculated using this data. The gradient was evaluated by triangulation using the elevation of the potentiometric surface measured with respect to mean sea level datum. As shown in Figure 3, general direction of groundwater flow is west-northwest at a

gradient of 0.033 foot/foot. Historic groundwater flow direction on site is summarized in Table 2. The groundwater gradient has increased slightly and flow direction is toward the west compared with previous sampling periods.

NOTE: Groundwater Elevations Measured in Feet Above Mean Sea-Level on 3/27/96
