GROUNDWATER MONITORING REPORT

August 21, 1998

Peralta Maintenance Yard
501 5th Avenue
Oakland, California

ACC Project No. 6045-014.00

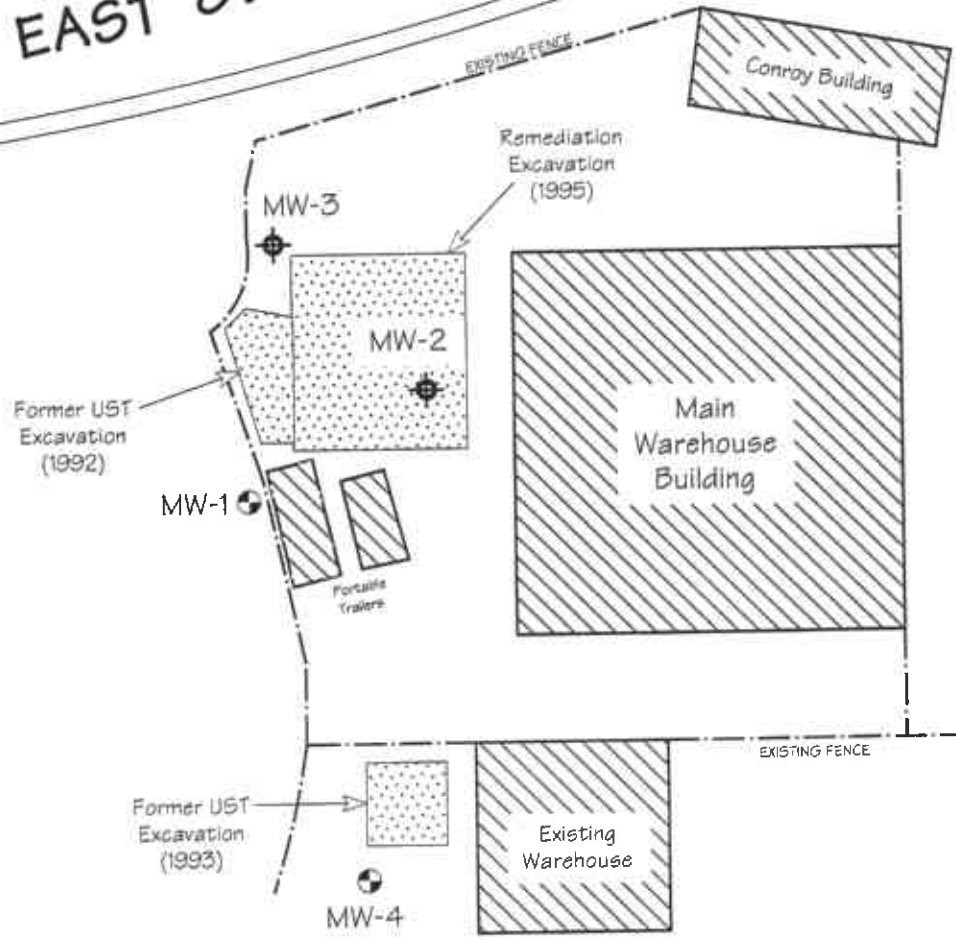
In February 1994, four additional borings were drilled on site and converted into 2-inch-diameter monitoring wells (MW-1, MW-2, MW-3, and MW-4). The monitoring wells were used to evaluate the extent of groundwater impact from the two former excavations (Figure 2). Laboratory analysis of the groundwater samples collected in February 1994 from monitoring wells MW-1 and MW-4 (downgradient from the tank excavations) indicated no detectable levels of the constituents evaluated. The groundwater results from monitoring well MW-1 indicated a downgradient extent of groundwater impact. Laboratory analysis of groundwater samples collected from monitoring wells MW-2 and MW-3 (upgradient of the former tank excavations) indicated detectable levels of constituents. Groundwater samples collected from borings MW-2 and MW-3 indicated detectable levels of TPHd, TPHg, and benzene, toluene, ethylbenzene, and total xylenes (BTEX). Motor oil was reported in the soil sample collected from boring MW-2. However, motor oil was not detected in the groundwater sample collected from monitoring well MW-2. A concentration of TPHd was detected only in the soil sample from boring MW-2.
