Subject: 6121 Hollis Street
Emeryville, California

**Interim Report on the Delineation of the Extent of PCBs
Contamination and Workplan for Further investigation at the
Heritage Square Property Located at
6121 Hollis Street, Emeryville, California**

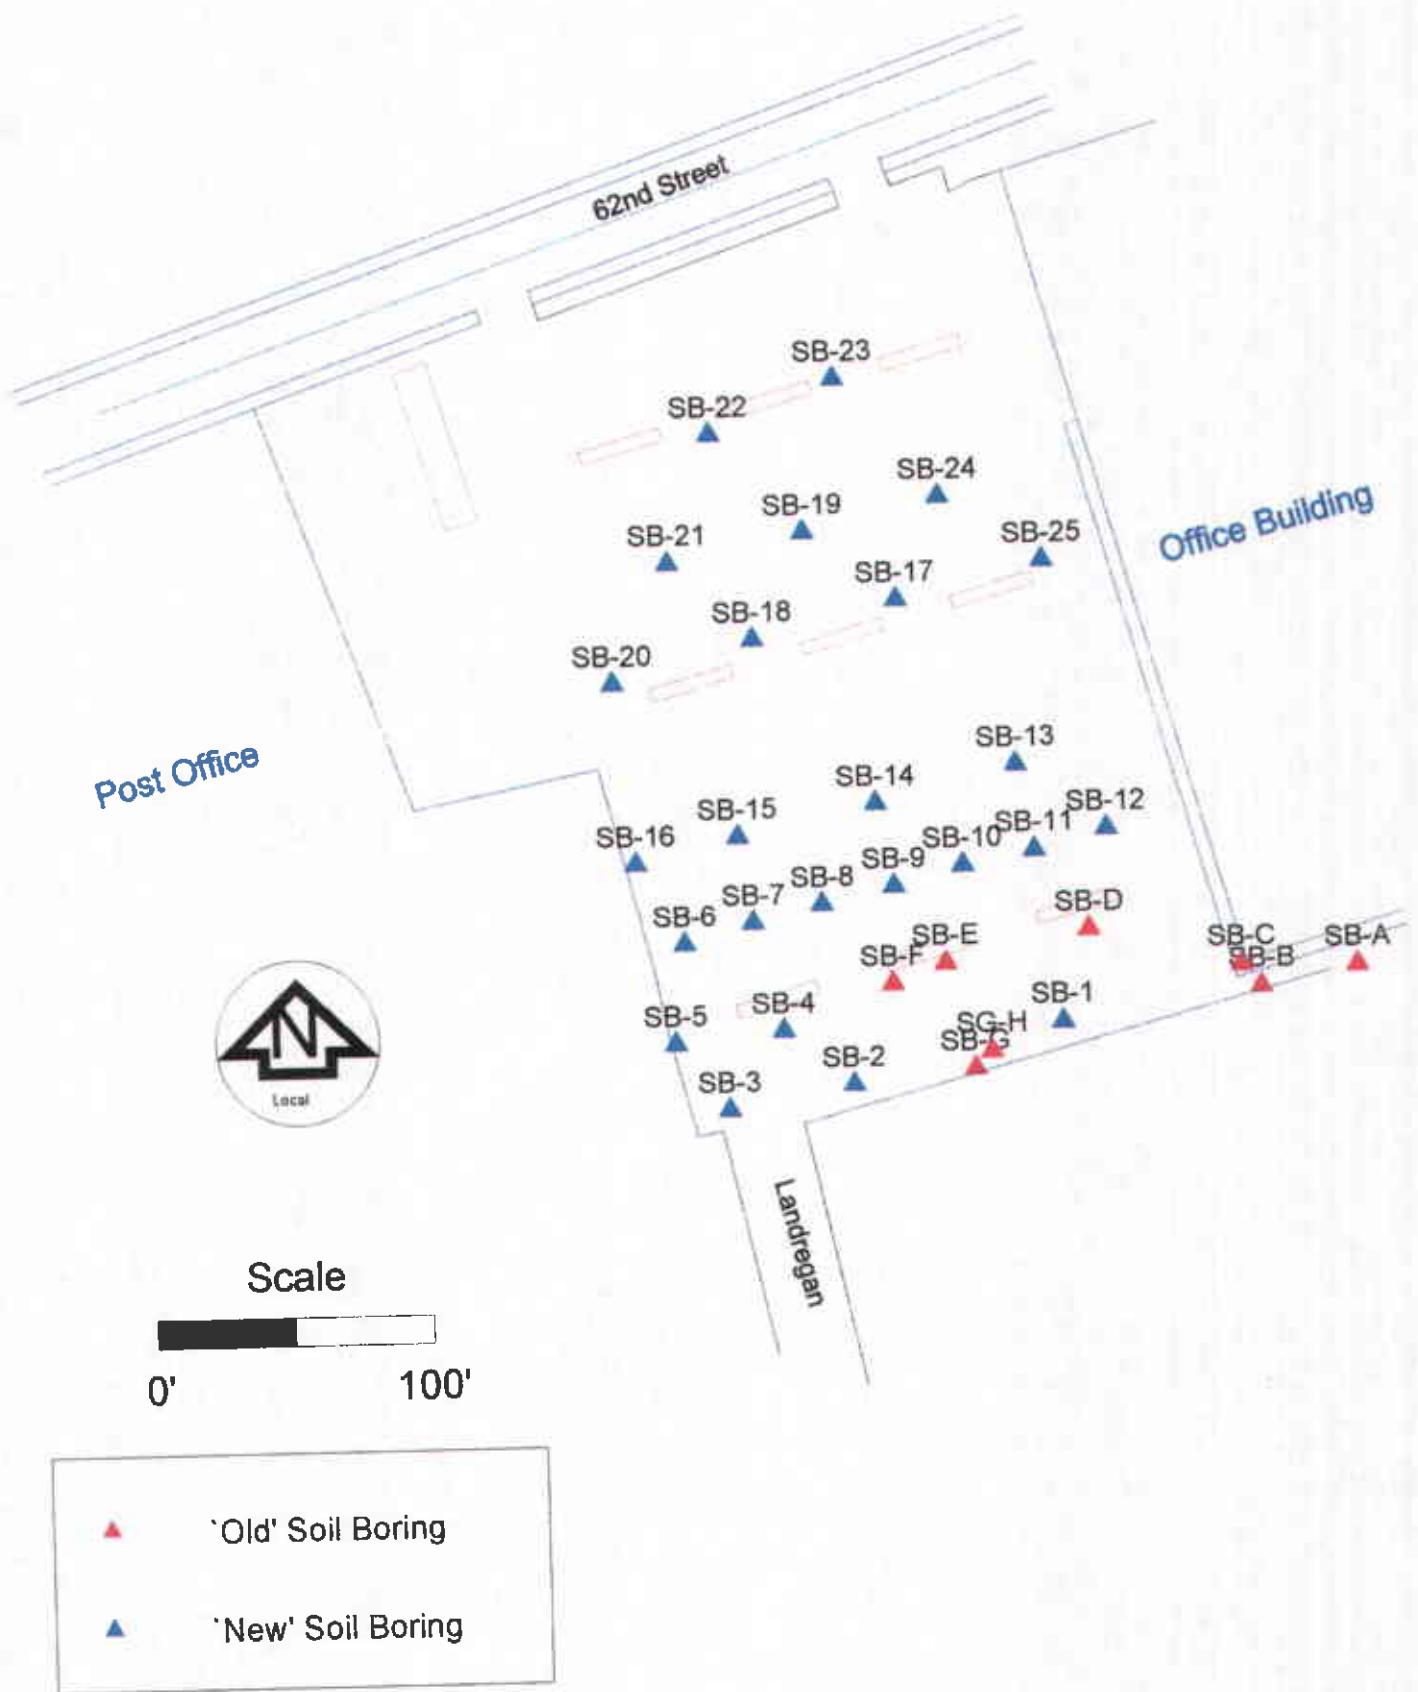
Figure 2: Soil Boring Locations

Figure-2 shows the location of the soil borings. The borings were drilled by the hollow stem auger to a total depth of 4-feet below the ground surface (bgs). Two soil samples were collected from each soil boring. One sample was collected immediately below the asphalt pavement, while the other was collected at 3.5-4 feet bgs. The drilling and sampling operation was conducted under the supervision of SOMA's Senior Field Engineer. To avoid cross contamination, the sampling tools were decontaminated after drilling and sampling of each soil boring. A total of 50 soil samples were collected during this investigation.

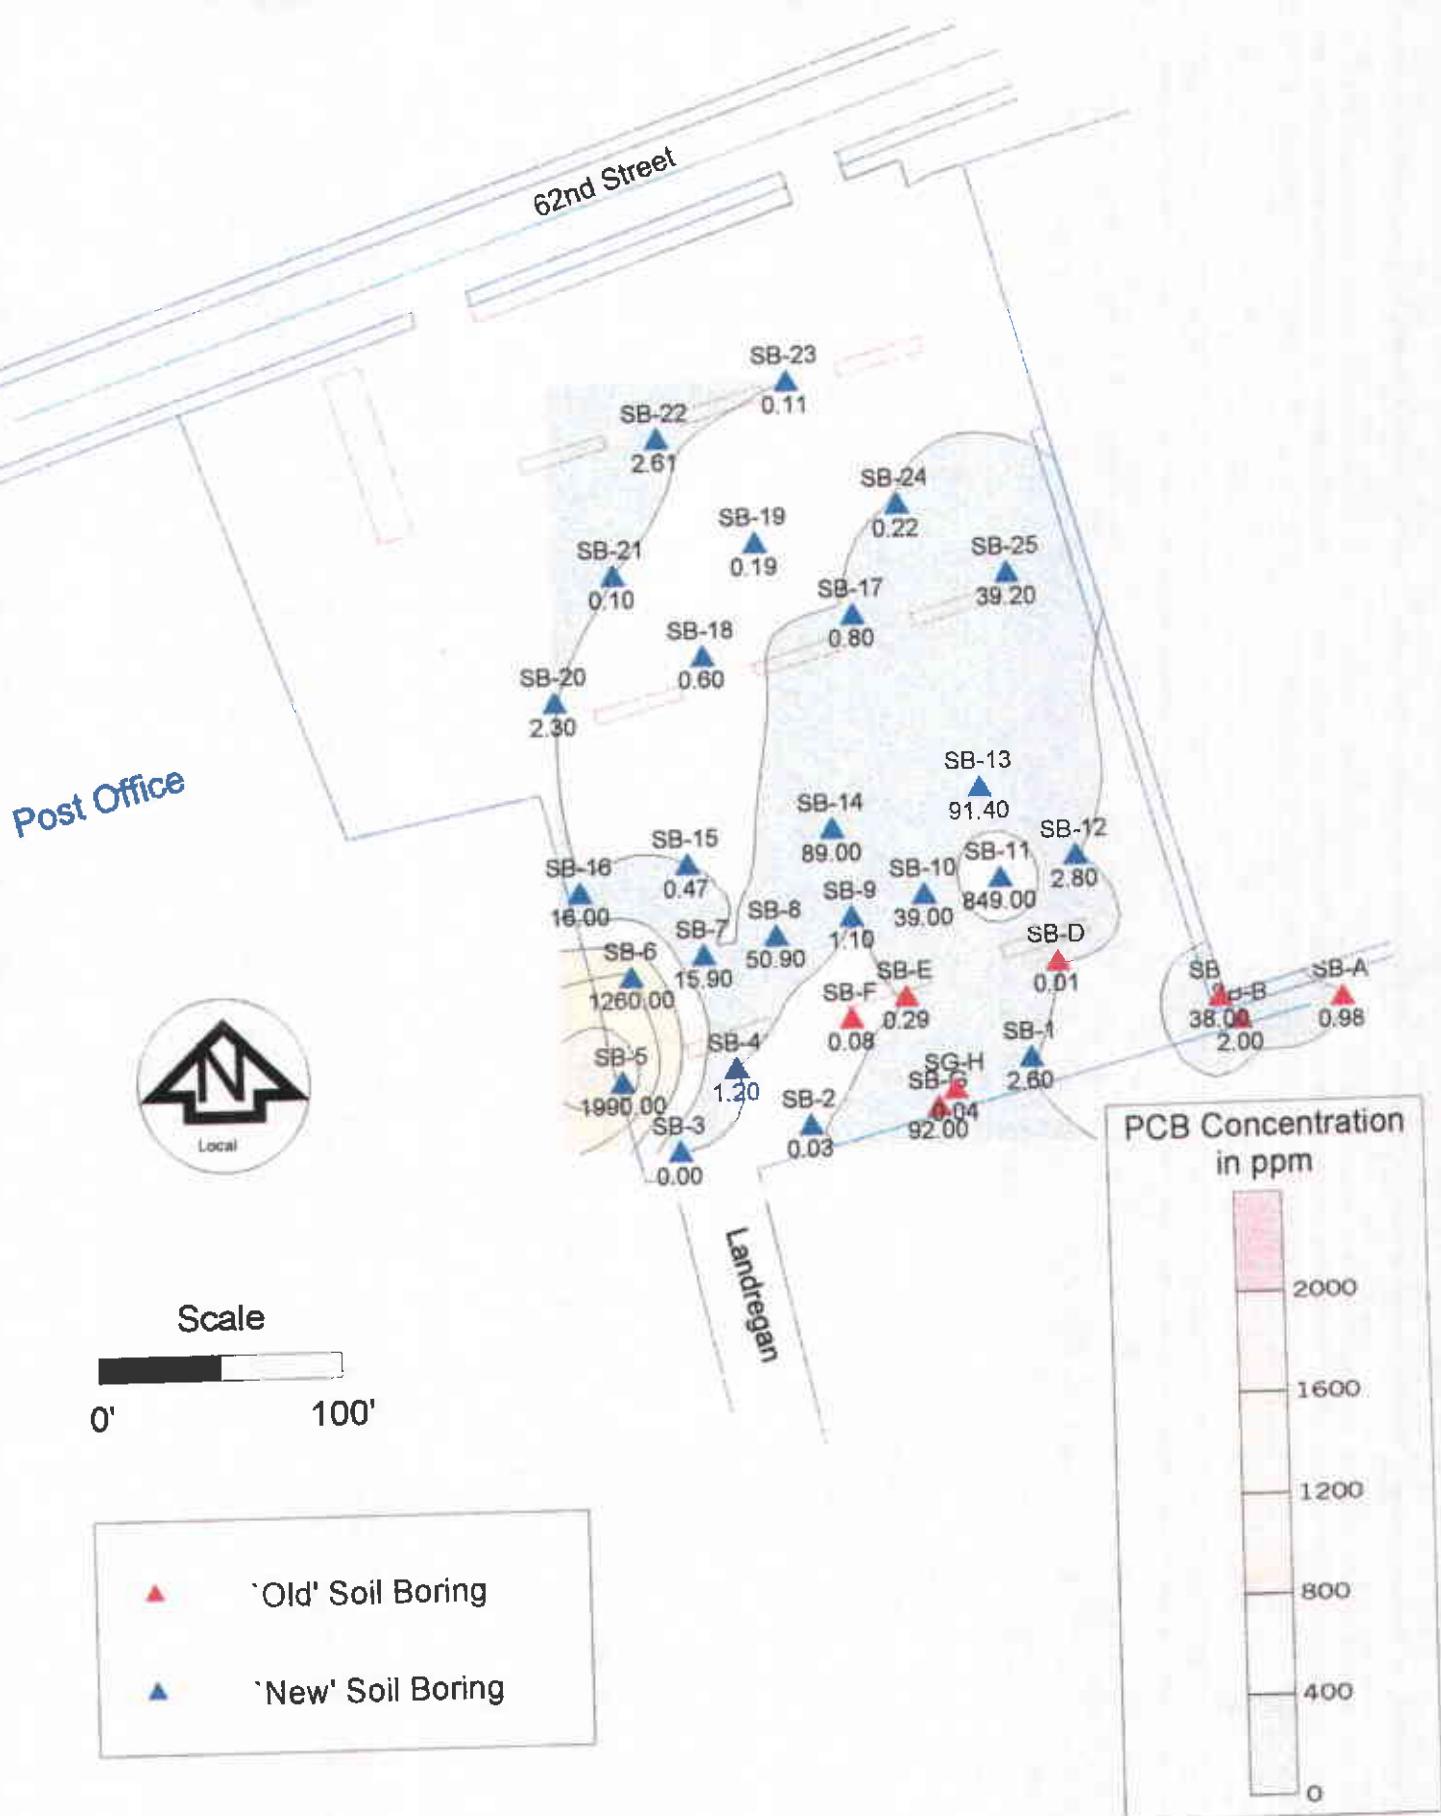
Figure 4: Contour Map of PCB Concentration in Soil at 4' Depth

Figure-3 shows the PCB concentrations at 0.5-foot depth. Figure-4 shows the PCB concentrations at 4-foot depth. A three-dimensional representation of PCB concentration beneath the Property has been shown on Figure 5. As Figure 3 shows, significant concentrations of PCB at 0.5-foot depth was detected at the

As Figure-6 shows, in general, concentration of PCB significantly decreases by depth. The PCB concentrations were detected in limited areas at a 4-foot depth. For instance, the high concentration of PCB at a 4-foot depth was only detected at three soil boring locations of SB-11, SB-5 and SB-6. The SB-11 is located toward the eastern side of the Property, while SB-5 and SB-6 are located at the western Property boundary adjacent to the U.S. Post Office site.
