REMEDIAL INVESTIGATION SERVICES
FOR SUSPECTED SOIL CONTAMINATION
AND UST SITES

PARKS RESERVE FORCES TRAINING AREA

DUBLIN, CALIFORNIA

September 1994

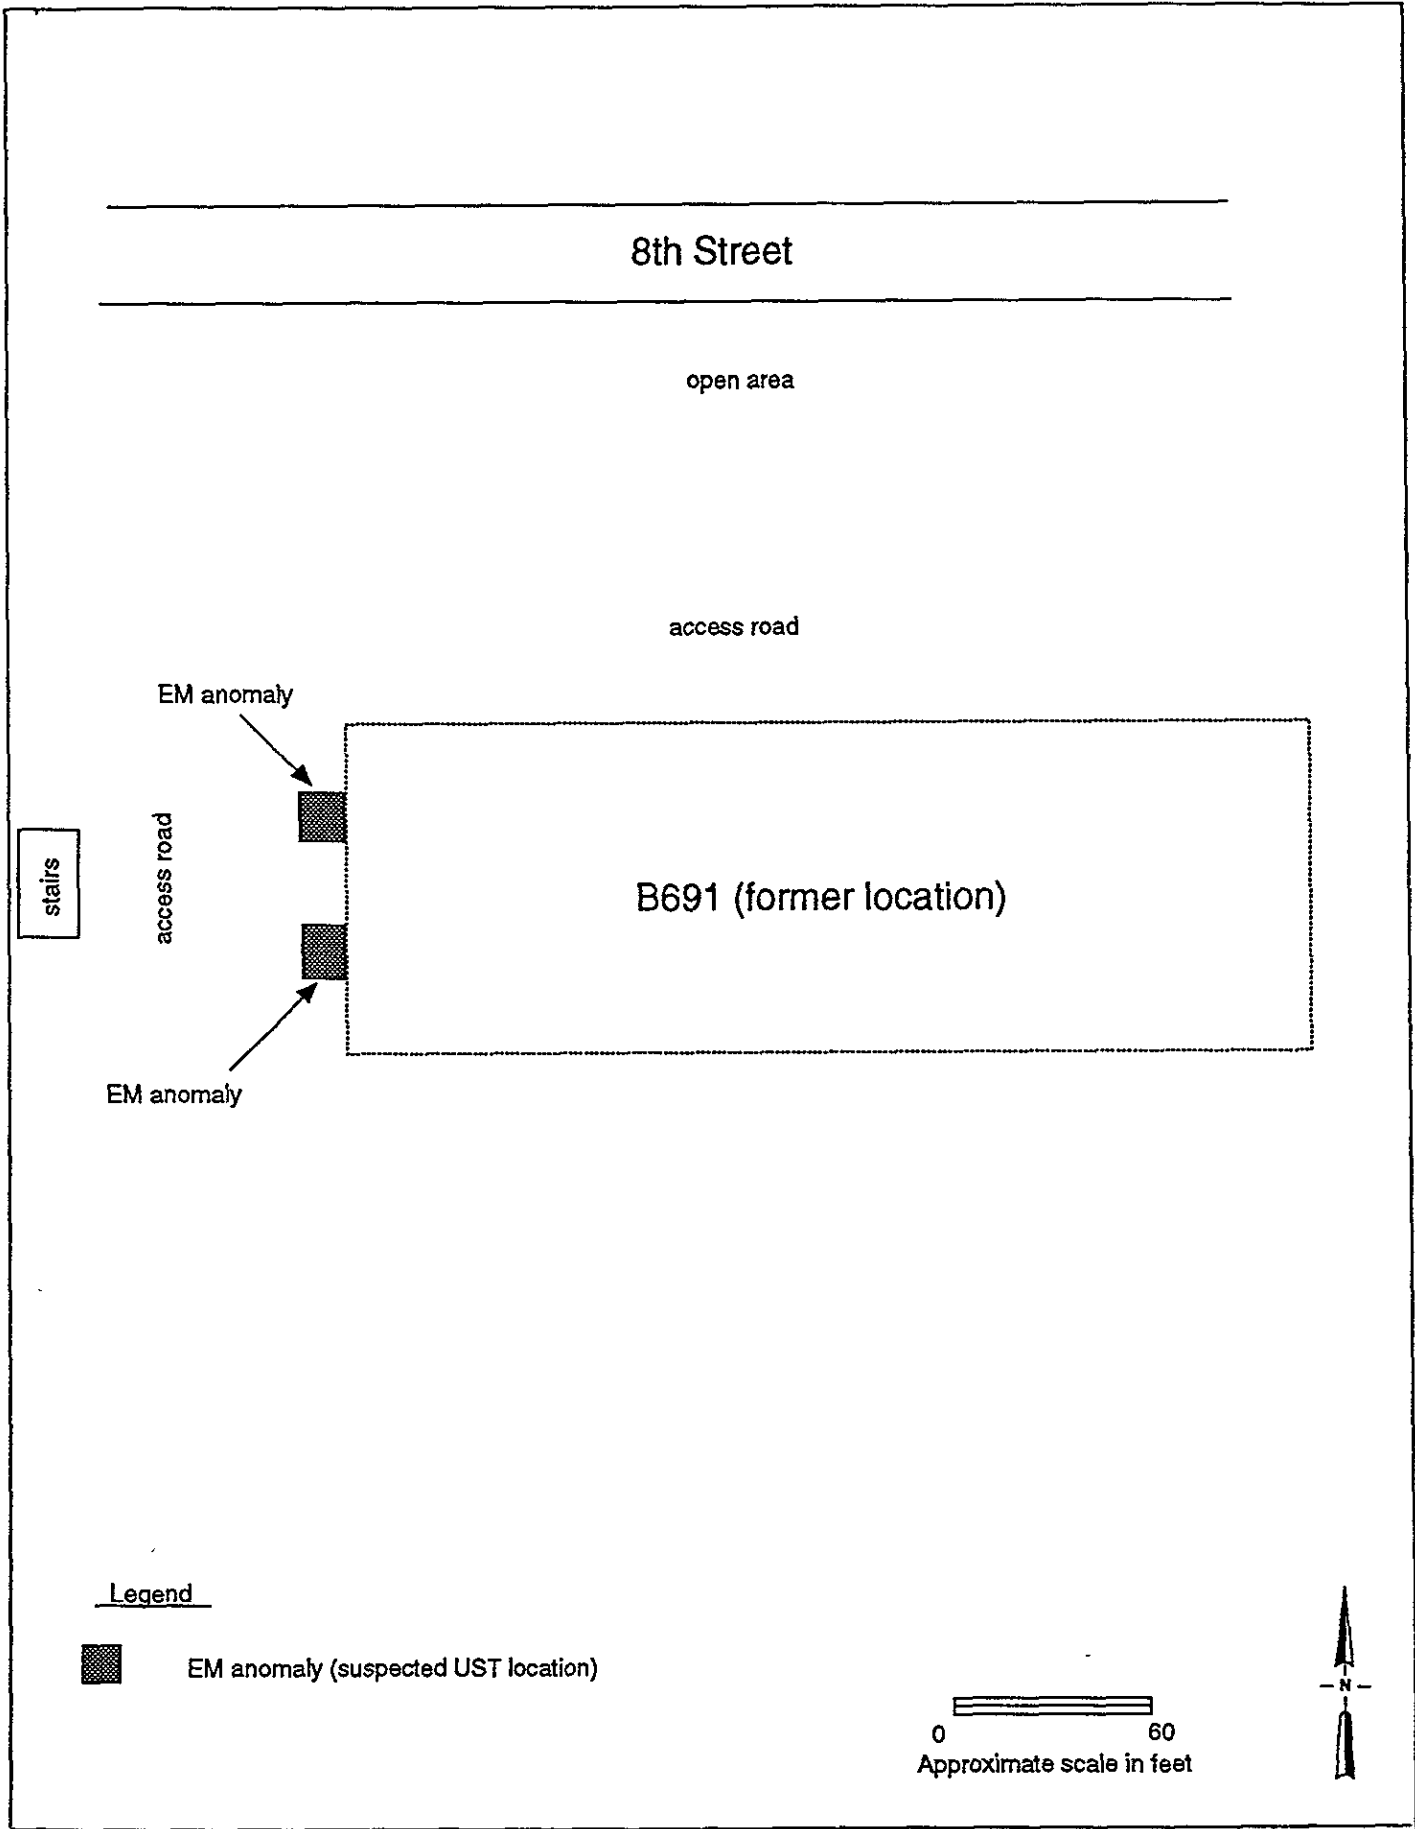
**SITE LOCATION MAP FOR
SUSPECTED UST SITE AT BUILDING 691**

WCFS conducted an electromagnetic search within the area of the suspected USTs at each mess hall. Two anomalies were located at the former location of Building 691 where the excavation crew unearthed the UST (Figure 3). Anomalies suggesting the presence of underground pipelines or utilities were observed at B691. However, neither anomaly appeared to enter the footprint of the original structure. Anomalies suggestive of the

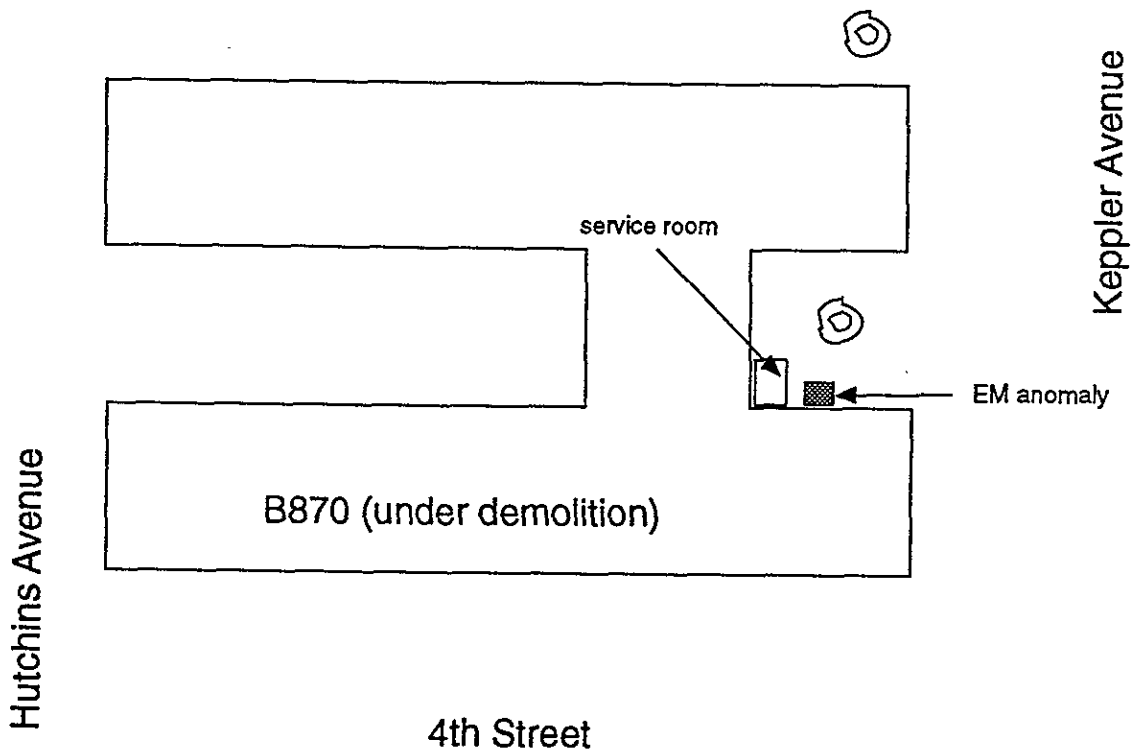
**Figure
5**

During the July 1994 site investigation, Building 870, an abandoned building, was under demolition. However, previously during the February 1994 site reconnaissance activities for the PA, WCFS personnel observed piping associated with a boiler room that indicated the possible presence of a UST. In this investigation an electromagnetic search was conducted to evaluate the piping. An electromagnetic anomaly was identified in the southwest corner of the eastern open area of Building 870. This anomaly was identified just east of the footprint of a small service room. Although the anomaly was not as strong as that caused by other USTs in the area, the possibility of a buried tank at this location cannot be precluded. The location of this anomaly is shown in Figure 5. The presence of extensive

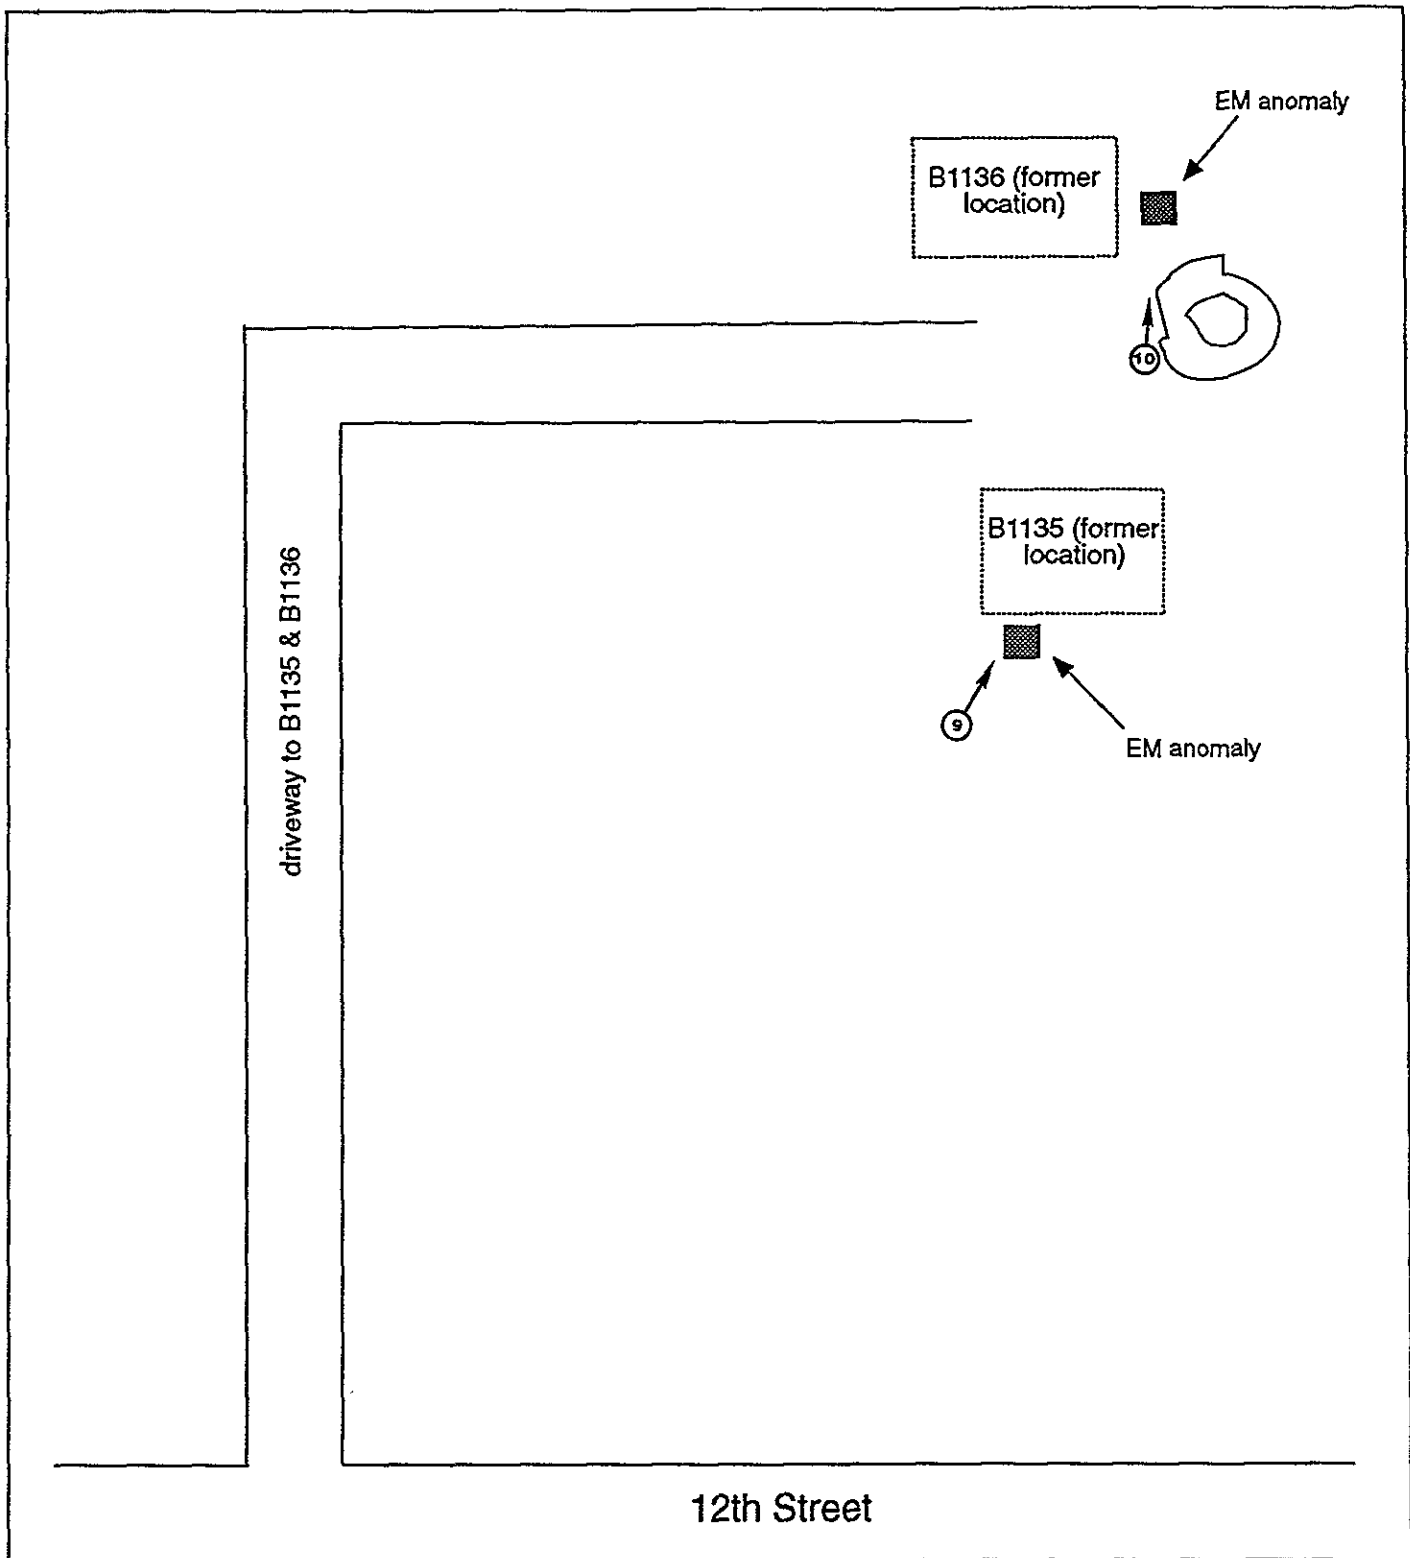
| Project No. 7127 | Parks Reserve Forces Training Area Dublin, California | SITE LOCATION MAP FOR UST SITES AT BUILDINGS 1135 AND 1136 | Figure 6 |

the north side of the original garage area was used as a reference marker to locate the tanks. Relative to this marker, the EM search showed that the UST at Building 1135 was found to be 94 feet on a bearing of 176 degrees True and the UST at Building 1136 was found to be 22 feet on a bearing of 357 degrees True.

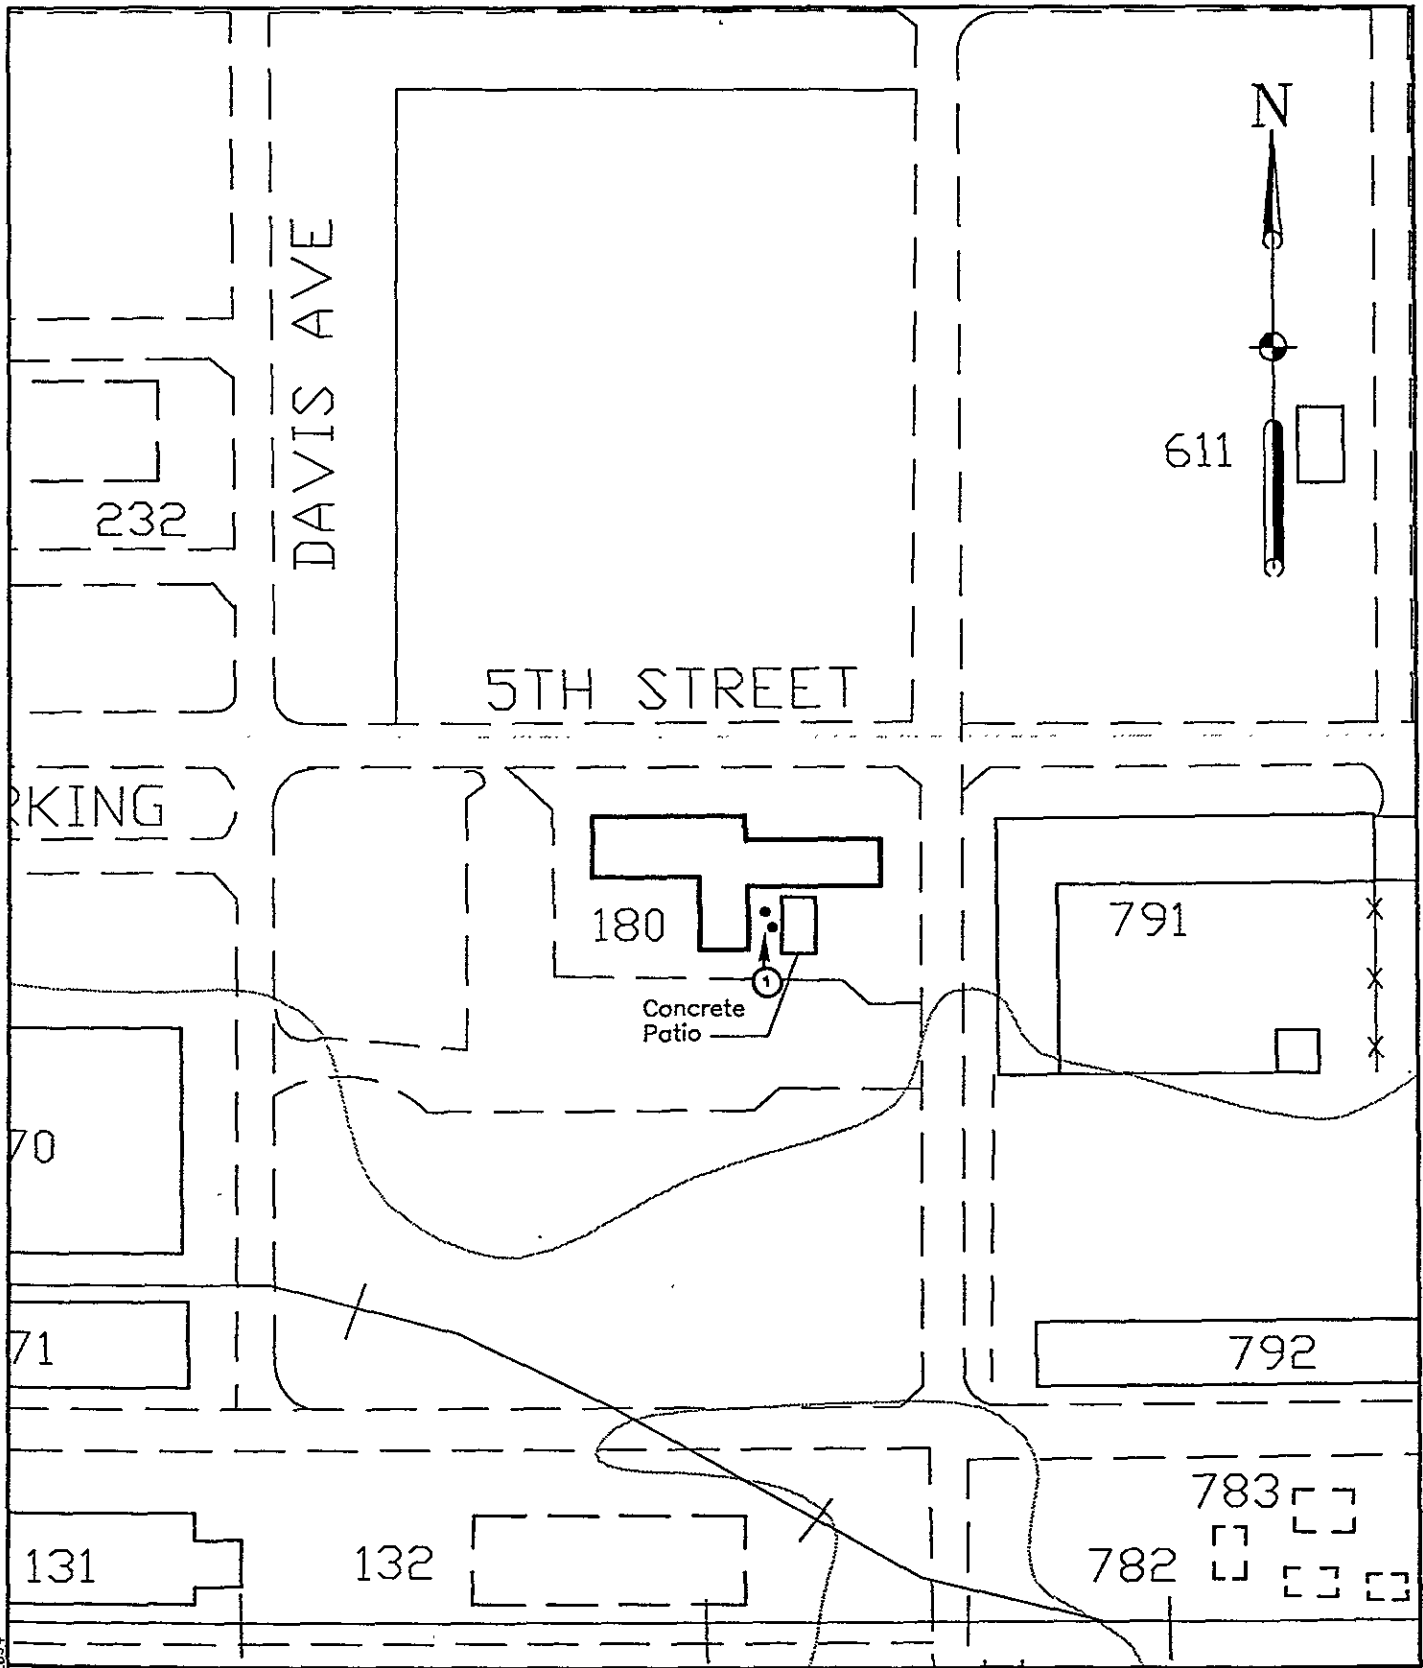
| Project No. 7127 | Parks Reserve Forces Training Area Dublin, California | SITE LOCATION MAP FOR BUILDING 180 | Figure 7 |

During the site investigation activities on July 13, 1994, WCFS collected five soil samples at the location of the previously identified soil stained area west of the concrete slab at Building 180. To collect the soil samples, two hand auger borings (boring SB-1 and boring SB-2) were advanced to depths of 1.5 and 0.5 feet below ground surface (bgs), respectively. The location of the hand auger borings are shown on Figure 7.

During field screening of the soil samples, up to 90 ppm of VOCs were measured using the HNu in boring SB-1 at a depth of 0.9 feet bgs (sample 180-2). However, less than 15 ppm of total petroleum hydrocarbons (TPH) as diesel were detected in sample 180-2 using the Petro RISC soil test. Field screening of boring SB-2 using the HNu detected up to 40 ppm of VOCs at the ground surface (sample 180-3), but no VOCs were detected at a depth of 0.5 feet bgs (sample 180-4). Soil staining was noted at the ground surface in the area of boring SB-2. Petroleum odors were not noted in the soil samples collected during the investigation. The subsurface soil was silty clay to a depth of approximately 1.0 feet bgs, underlain by a sandy layer. Due to the localized nature of the VOC readings and the < 15 ppm TPH-diesel value in the sample analyzed, the area was not staked. A summary of the screening results is presented below in Table 4.

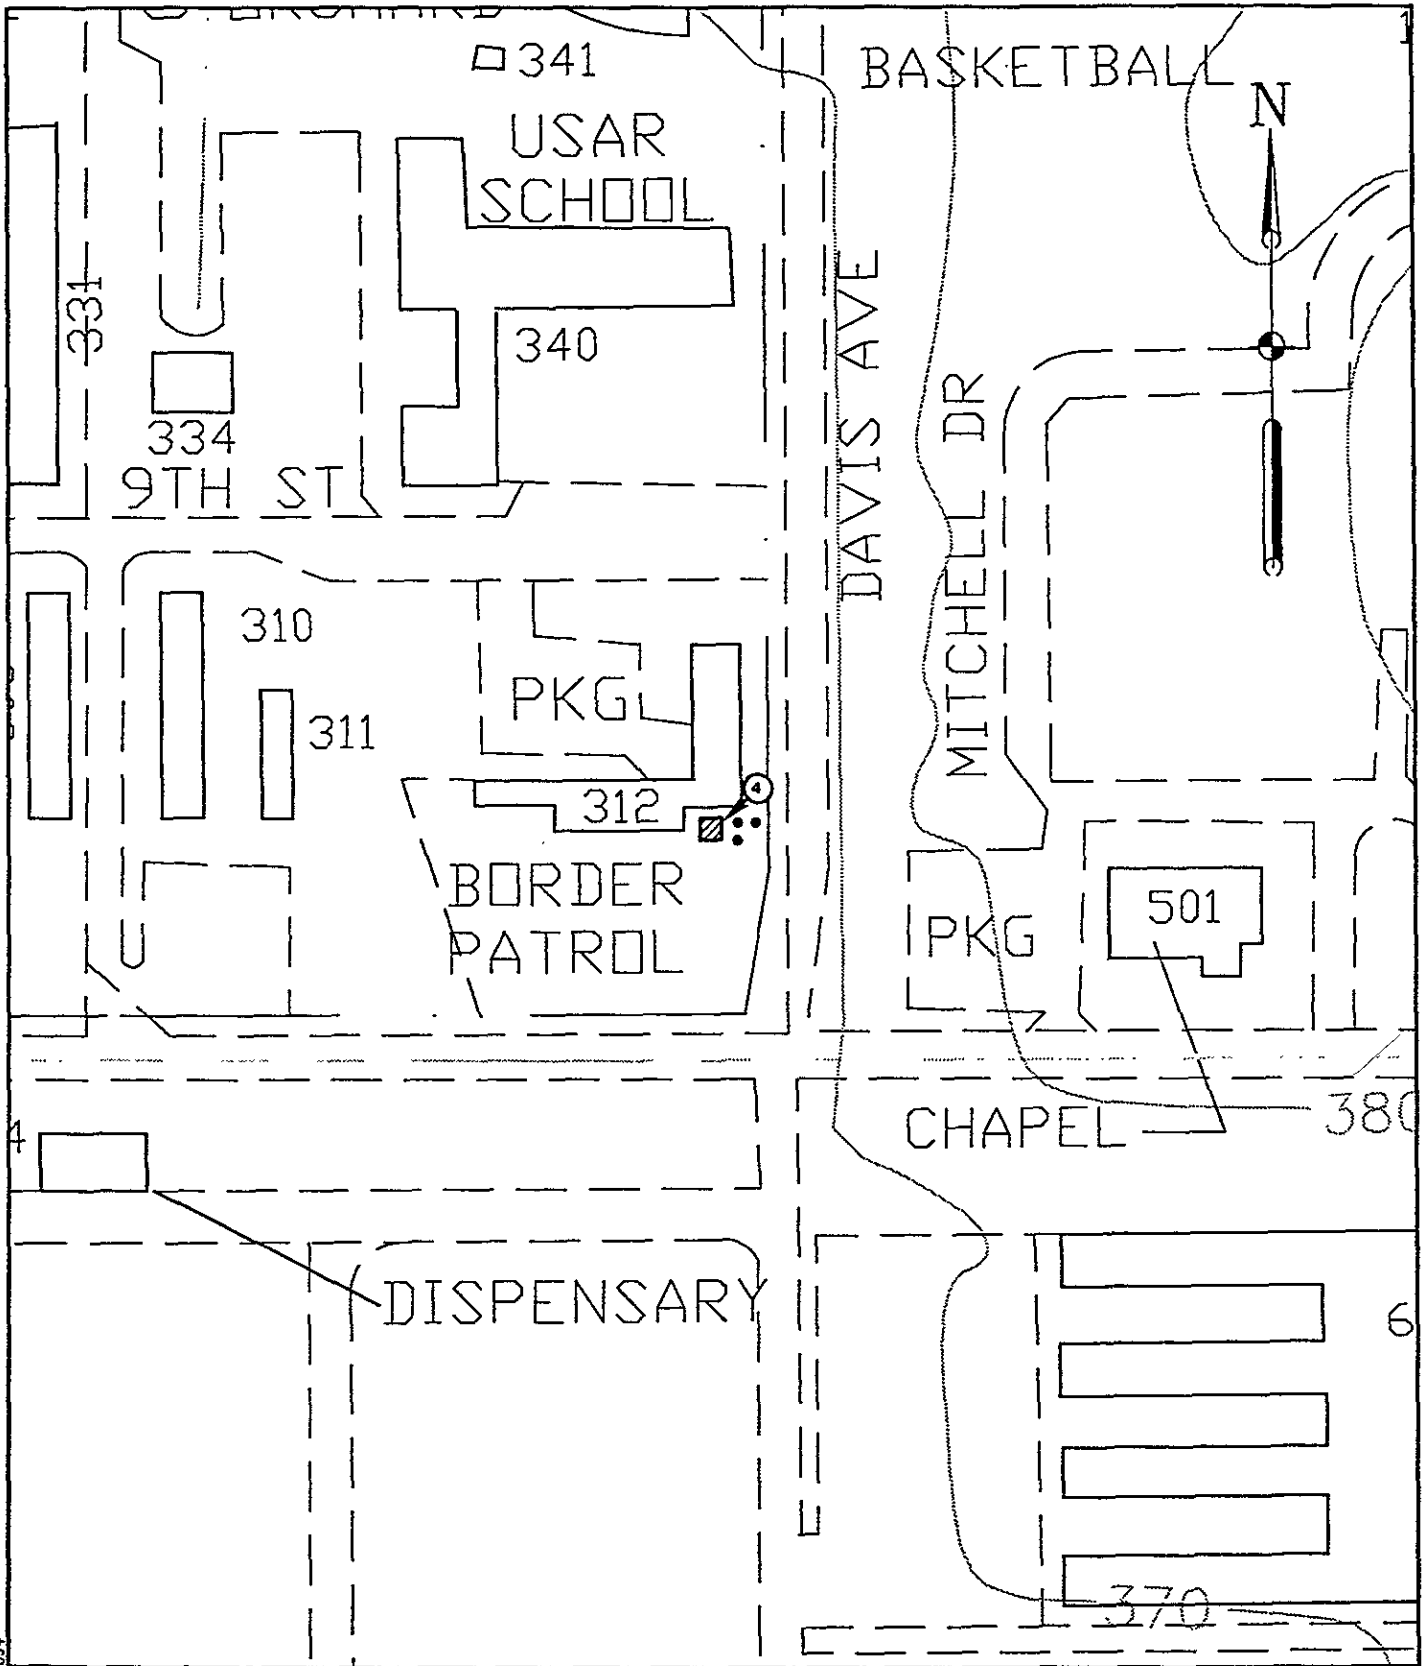
| Project No. 7127 | Parks Reserve Forces Training Area Dublin, California | SITE LOCATION MAP FOR BUILDING 312 AST | Figure 8 |

Building 312 is occupied by the U.S. Border Patrol and consists of offices, a detention facility, and a vehicle storage area enclosed by a chain-link fence. A 50-gallon diesel aboveground storage tank (AST) used for fueling an emergency generator was observed outside Building 312 near the southeast corner. During site reconnaissance activities in February 1994 for the PA, WCFS personnel observed a 1 to 2-foot diameter dark and oily stain on the concrete pad underneath the AST and on the surface of the soil next to the eastern edge of the pad.

During the site investigation activities on July 13, 1994, WCFS collected six soil samples in the previously identified soil stained area east of the concrete pad and AST at Building 312. To collect the soil samples, three hand auger borings (borings SB-1, SB-2, SB-3) were advanced to depths of 0.7, 1.6, and 0.1 feet below the top of the concrete pad, respectively. The locations of the hand auger borings are shown on Figure 8.

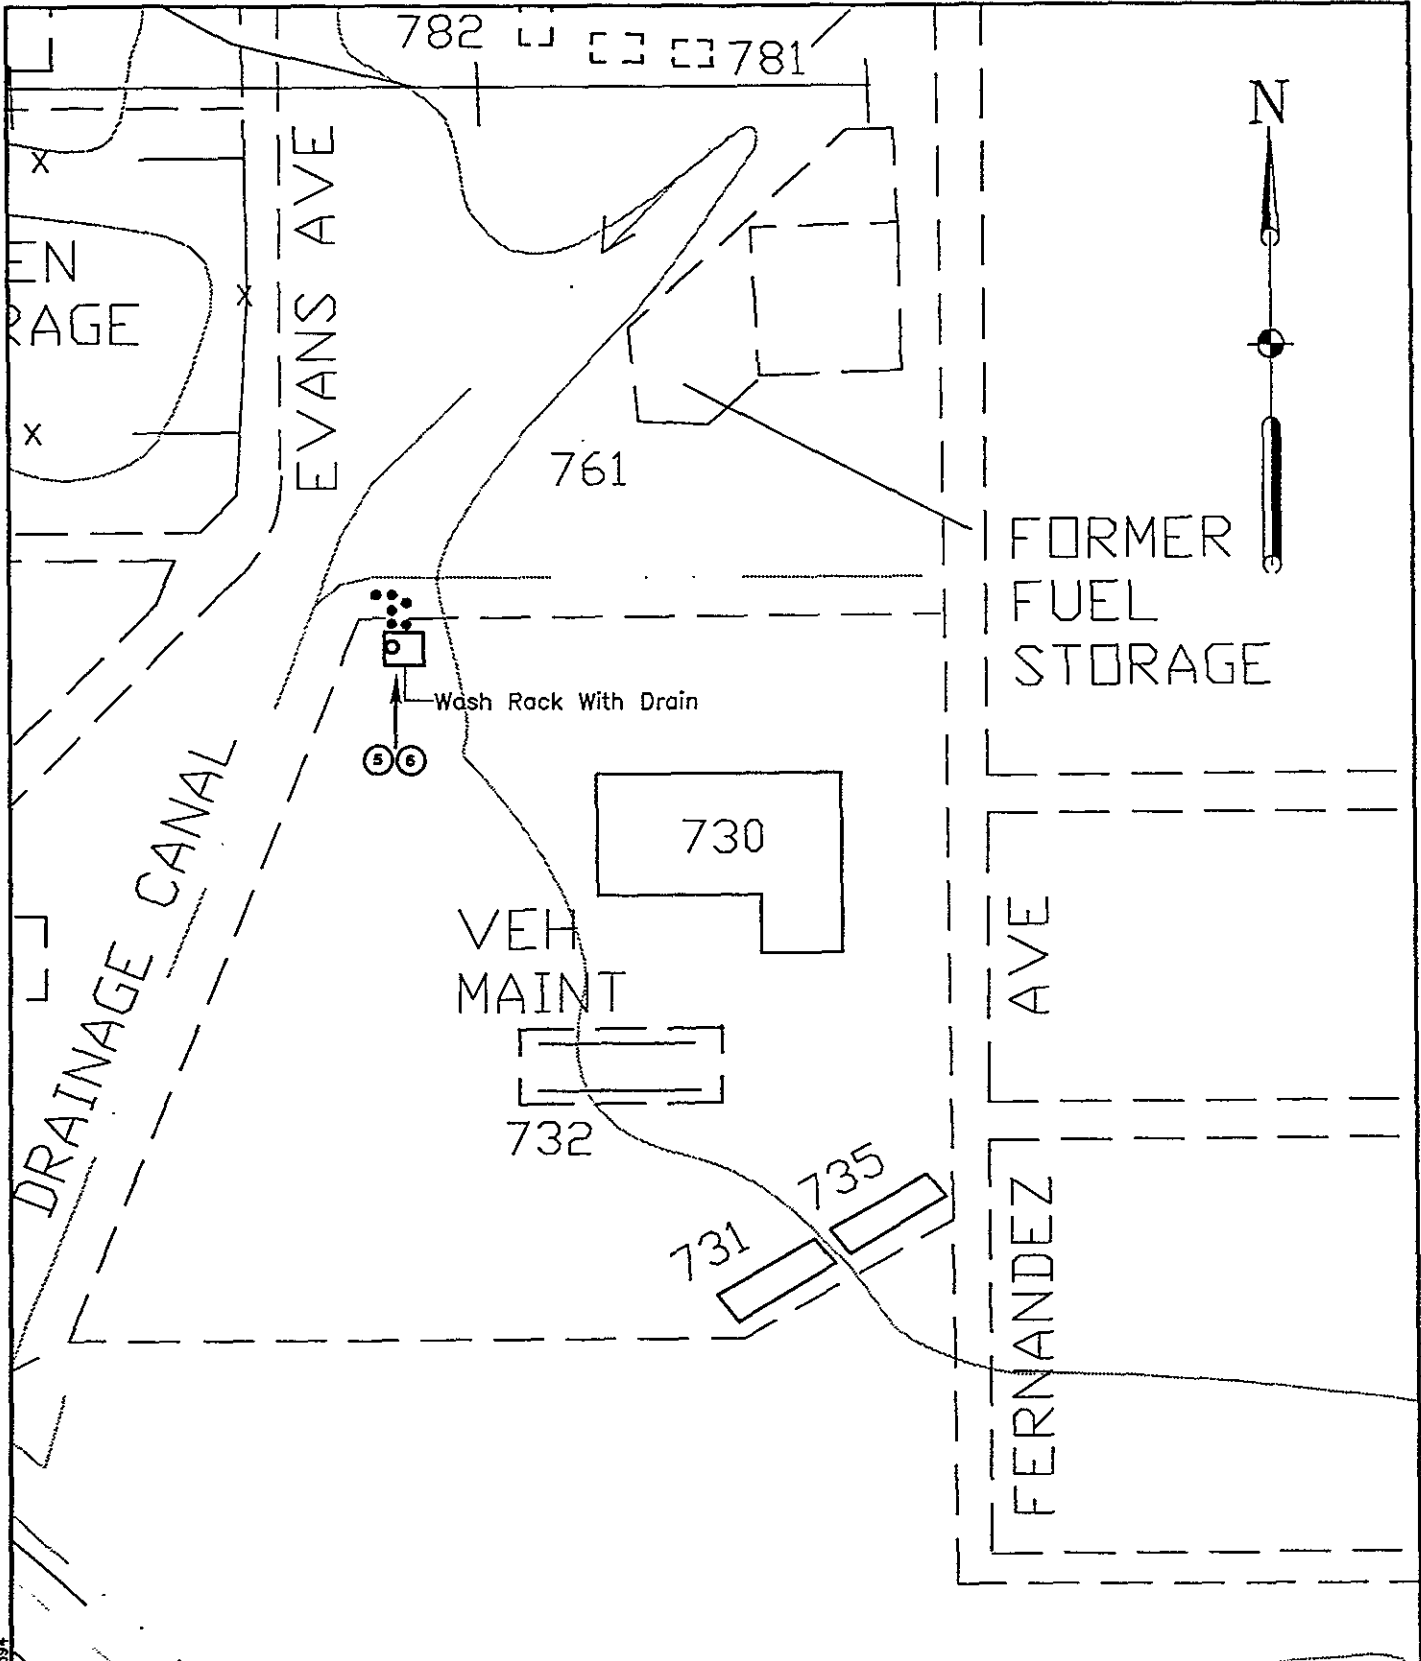
| Project No. 7127 | Parks Reserve Forces Training Area Dublin, California | SITE LOCATION MAP FOR BUILDING 730 WASH RACK | Figure 9 |

Building 730 is occupied by the 124th Army Command (ARCOM) ECS 30G and is utilized as a motor and track vehicle maintenance and storage area. During site reconnaissance activities in February 1994 for the PA, WCFS personnel observed a wash rack northwest of Building 730. According to ECS 30G personnel, vehicle wash water from the rack emptied in to the adjacent unlined surface water drainage ditch north of the wash rack. The ground surface at the wash rack outfall slopes down toward the bottom of the drainage ditch with a change in elevation of approximately 3 feet.

Soil staining or odors were not observed in the soil samples collected during field screening. The subsurface soil was varied from silt to clayey silt. The subsurface soil in the bottom of the drainage ditch was hard pan at a depth of 0.5 feet bgs. The perimeter of the area

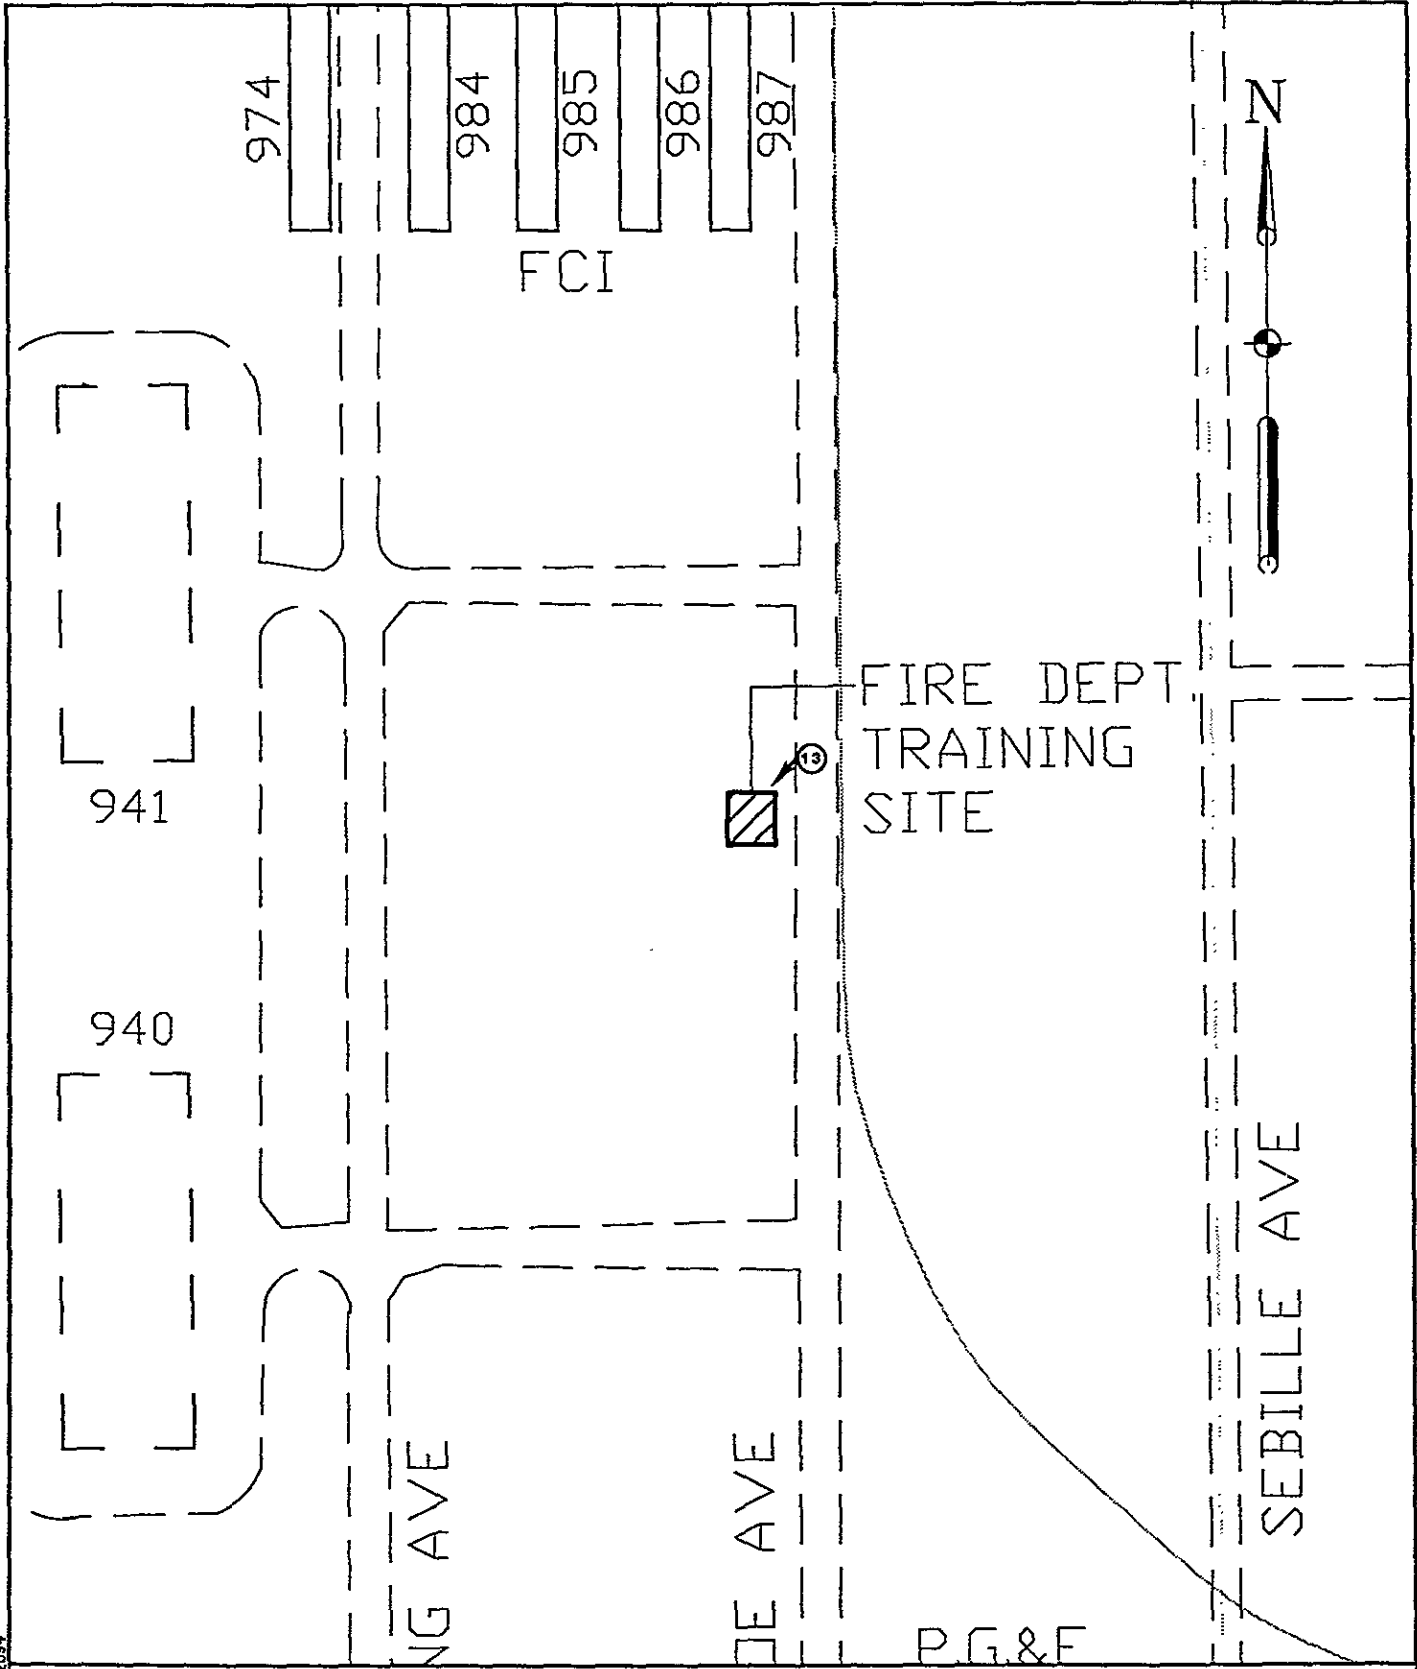
The fire training area (FTA) is an open field located between 6th and 7th Streets and Loring and Monroe Avenues (Figure 10). This area was used by the PRFTA Fire Department for fire suppression training. Between 1979 and 1992, a burn pit in the fire training area was used for fire suppression exercises on wood fuels. Gasoline was reportedly used to ignite the wood material. During site reconnaissance activities in February 1994 for the PA, Captain Woolson and Captain Wallace, with the PRFTA Fire Department, informed WCFS personnel that ninety-nine percent of the time water was used as the method of suppression and on rare occasions aqueous film forming foam (light water) was used for training. Light water is a flammable liquid fire-suppression agent. Both Captain Woolson and Captain Wallace stated that the burn pit was never filled with flammable liquids during fire training exercises.

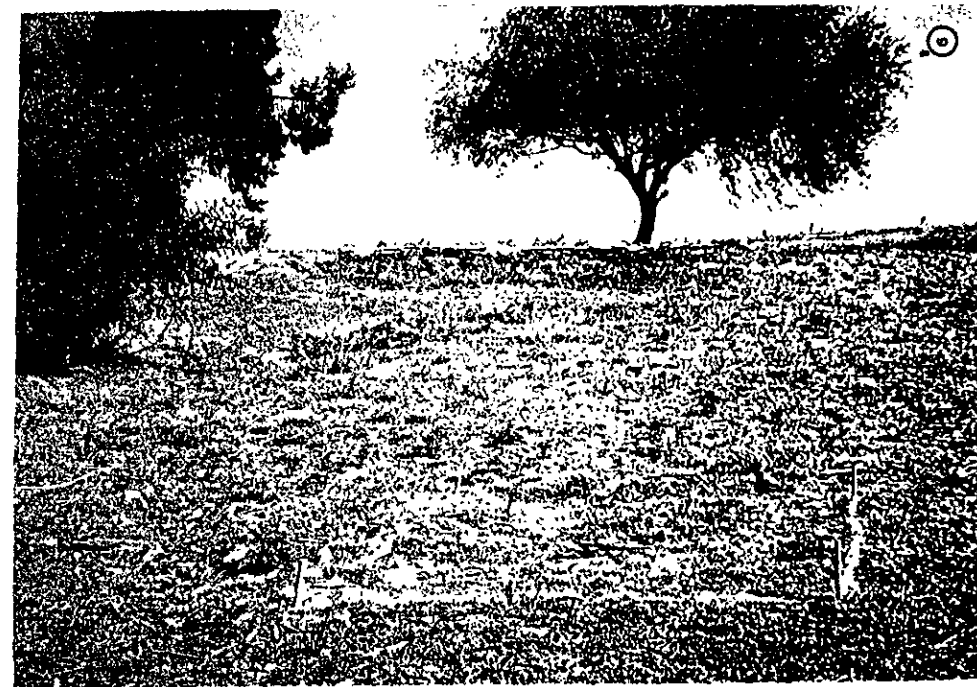
- Photo 10 - UST identified with wooden stakes at the former location of B1136. View to the north.
- Photo 11 - Wash rack and associated oil/water separator at Area 1160. View to the west.
