May 23, 1994
SCI 820.001

Ms. Susan Hugo
Alameda County Health Care Services Agency
80 Swan Way, Room 200
Oakland, California 94621

**Summary of Environmental
Investigation/Remediation
6707 Bay Street
Emeryville, California**

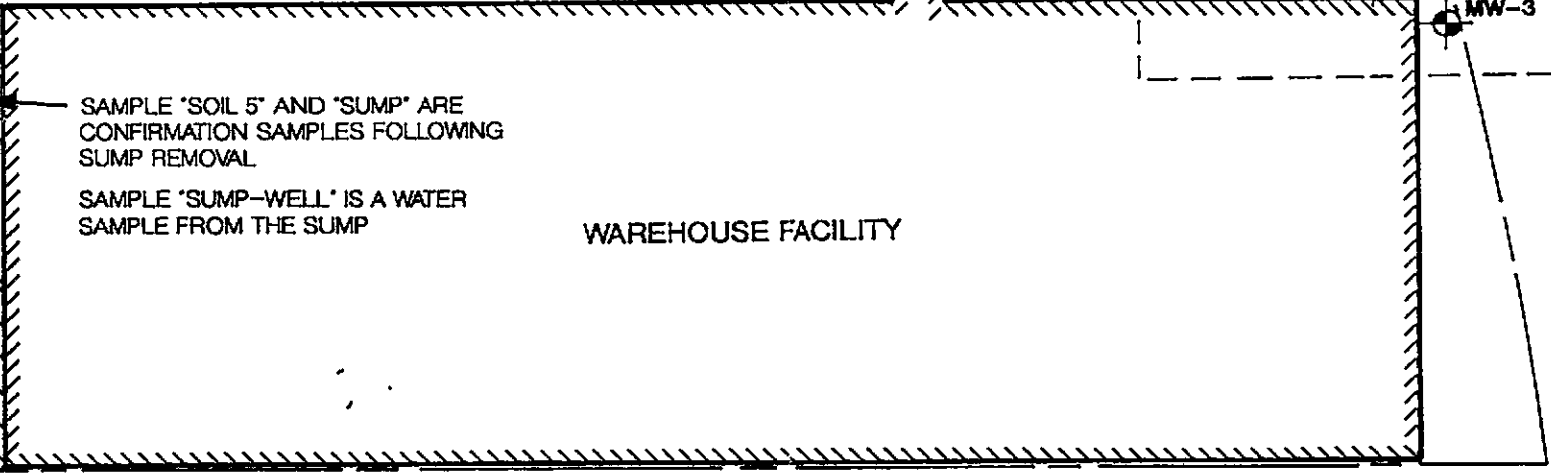
SITE PLAN

This letter presents a summary prepared by Subsurface Consultants, Inc. (SCI) of the results of environmental investigation/remediation at the referenced site. The site consists of a 2.2 acre parcel which is currently occupied by two buildings; a 15,000-square foot office building and a 55,000-square foot warehouse. The buildings and site layout are shown on the attached Site Plan, Plate 1.

Groundwater currently exists approximately 8 to 12 feet below the ground surface. This corresponds to groundwater elevations varying from 8 to 12 feet mean sea level datum. The groundwater elevations indicate that groundwater in the tank area generally flows toward the northwest at a gradient of approximately 3.0 percent. Groundwater in the west portion of the site flows in a westerly direction. The most recent groundwater gradient is presented on Plate 1.

An exterior concrete sump was located outside the northwest corner of the warehouse. A liquid sample obtained from the sump in 1989 contained low levels of oil and grease, TEH and some heavy metals. The sump was removed in 1989. Soil samples "Soil 5" and "Sump", were obtained from the sump excavation. The soil samples contained oil and grease, some heavy metals and PCBs at concentrations typical of those found throughout the landfill. Hence, the sump is not judged to represent a source of contamination at the site.

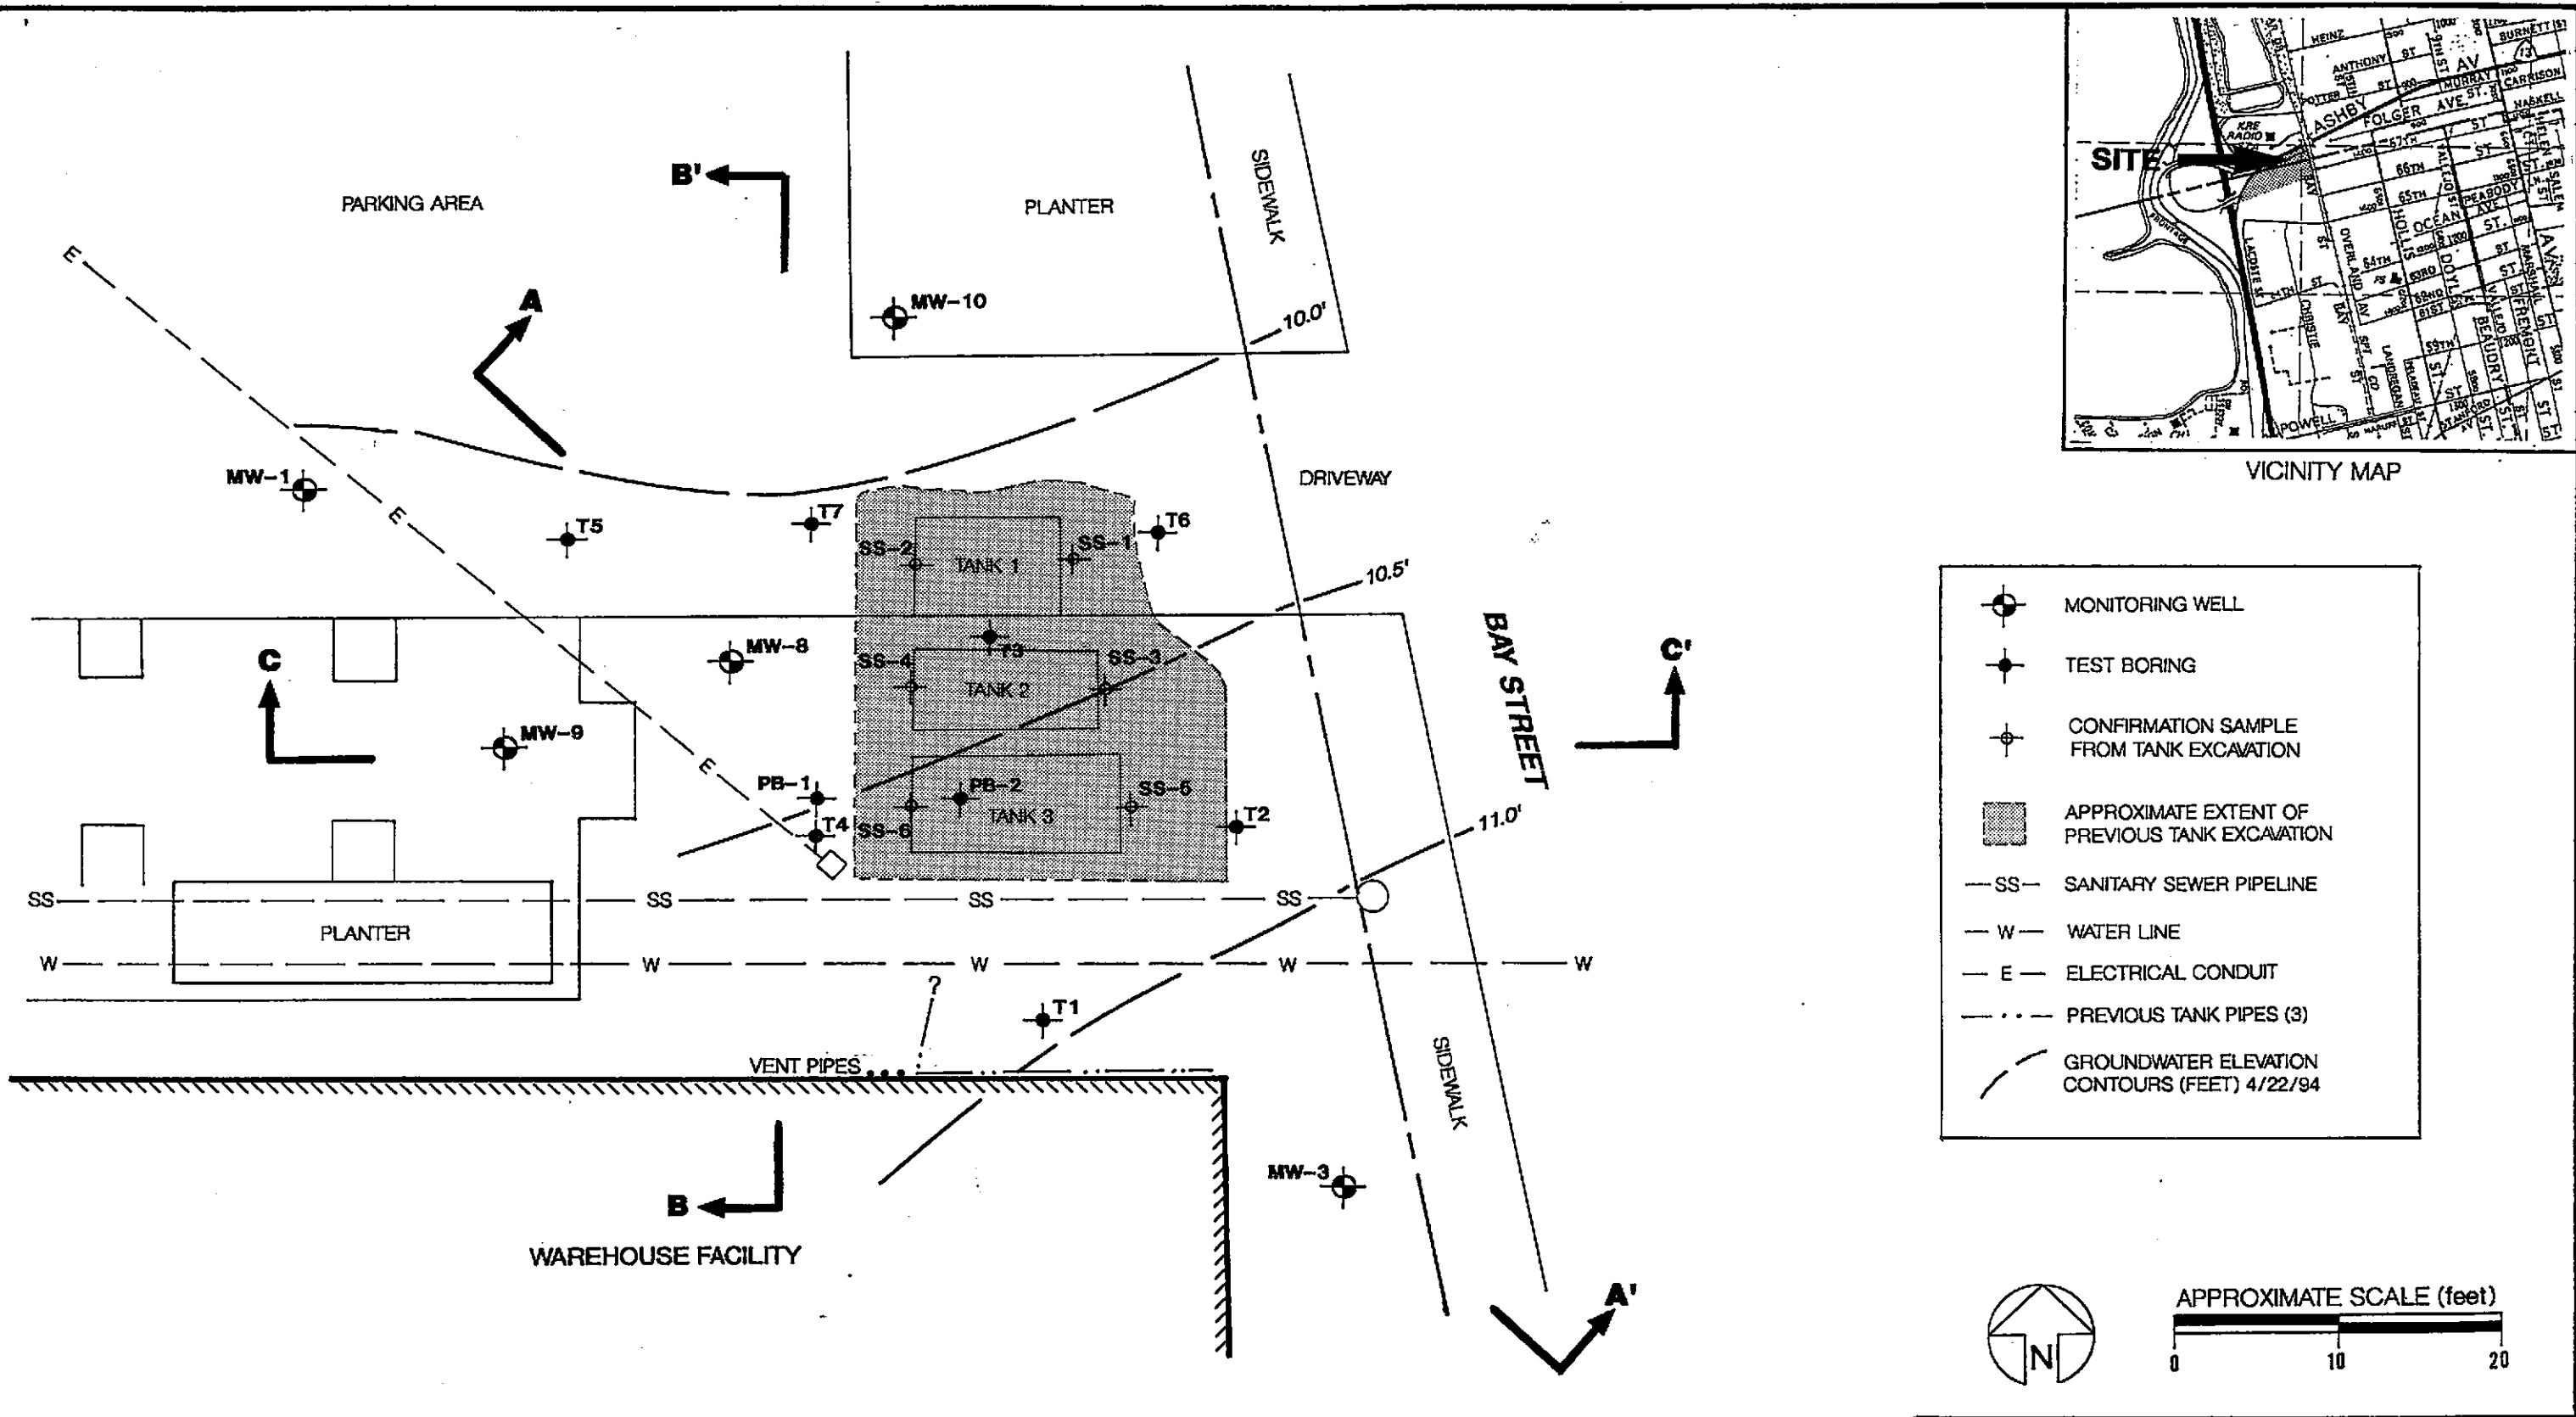
TANK AREA PLAN

From 1963 to 1979, Dymo Industries, Inc., a label tape and label tape puncher manufacturer owned by Esselte Pendeflex Corporation, operated on-site. Dymo reportedly used virgin methyl isobutyl ketone (MIBK, or 4-methyl-2-pentanone) and methyl ethyl ketone (MEK or 2-butanone) in their processing. Chemicals used in Dymos process were stored on-site in underground storage tanks (UST) at the approximate location shown on Plate 2.

In October 1989, three (3) UST's (one 2,000-gallon, one 1,650-gallon, and one-3,200-gallon) were removed from the site. Analytical test results following tank removal, indicated that soils in the tank area contained significantly elevated levels of MIBK, benzene, xylene and dichlorobenzene, and low levels of TEH, TVH, ethylbenzene and toluene, and semi-volatile organics.

Analytical data indicates that after operation of the system, MIBK concentrations, as well as other contaminant concentrations, were significantly reduced. However, elevated levels of MIBK remain predominately within clayey landfill materials situated downgradient of the tank area.

Significant groundwater impact appears to be limited to the previous underground tank area where MIBK concentrations up to 19,000 ug/l currently exist. Petroleum hydrocarbons, volatile and semi-volatile organics and heavy metals have been detected at significantly lower concentrations. In our opinion, other than the MIBK, the low level groundwater contaminants are associated with contaminants in the fill rather than on-site uses.

SCI is currently assessing remedial alternatives for the tank area. Within the tank area, the extent of soil and groundwater

contamination is well defined. The most appropriate remedial alternative will be negotiated with the ACHCSA and the Regional water Quality Control Board.
