Subject: Cap Status Assessment Report
September 2016
64th Street Properties, Emeryville, California
(EKI 990016.08)

**PHOTOGRAPHS TAKEN FOR THE CAP
STATUS ASSESSMENT
(ON 29 AUGUST 2016)**

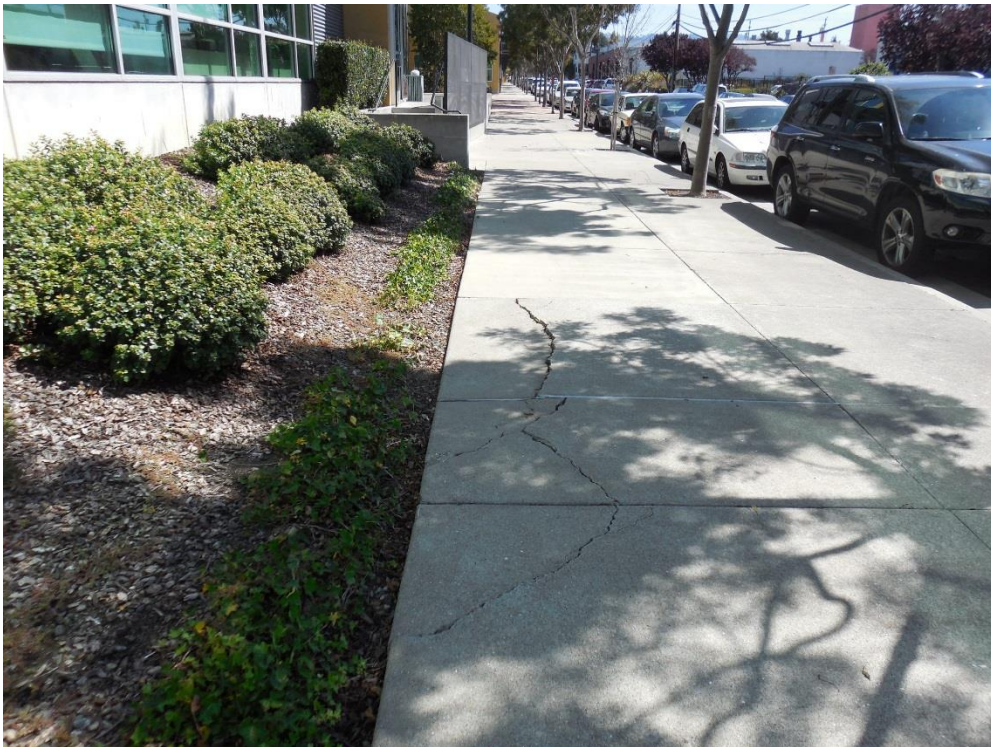
Photo 26

In summary, based on our visual assessment of the cap, the cap appears to be in a similar condition to that after repairs were made in 2013, except for some cracks in the sidewalk along the southern edge of Area A (Photo 26, Attachment C). Ms. Wells informed EKI through email, on 12 September 2016, that planned replacement of the cracked sidewalk will occur in 2017. The sidewalk replacement will be observed and reported on in the next Cap Status Assessment Report in 2018.
