RE: 4800 San Pablo Ave.

# HydroSolutions of California, Inc.

November 17, 1993

SUBJECT: SOIL-GAS SURVEY  
4800 SAN PABLO AVENUE  
EMERYVILLE, CALIFORNIA

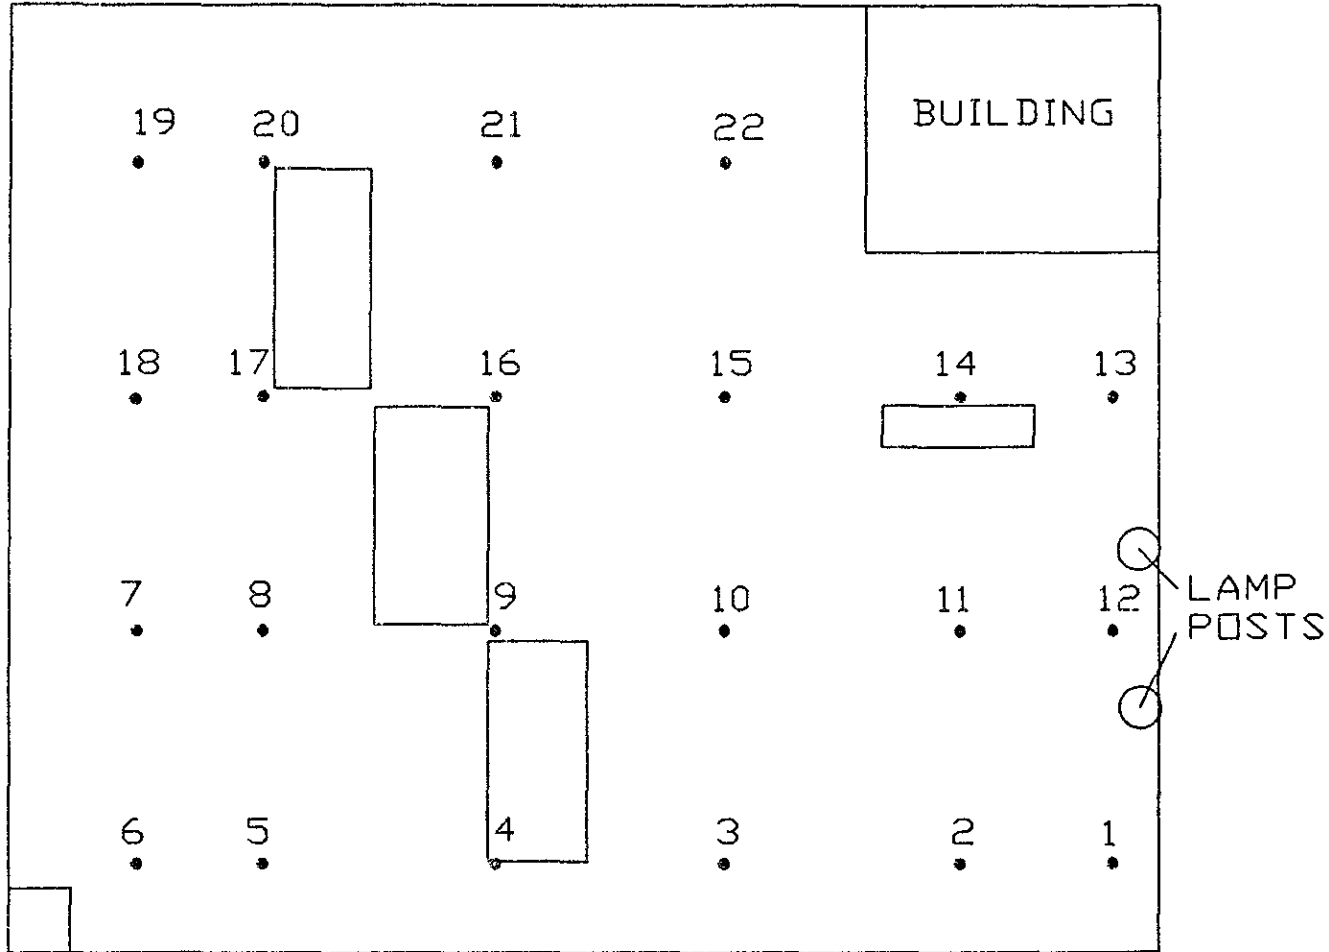
SOIL-GAS PROBE LOCATIONS

Information obtained from the above maps and aerial photographs were compared with the current asphalt and concrete patches noted on-site. Concrete patches are illustrated in figure 2 as unnamed rectangles. The three north trending concrete slabs are broken in the center (3-4 foot wide break) which may represent the location of an old dispenser island. Furthermore, the area surrounding soil probe 14 appears to have been patched with concrete. Probe 14 penetrated the subsurface easily to a 2.5 foot depth and required very little vacuum to collect a soil-gas sample. These conditions may indicate a sand backfill existing in this area.

Insertion of probe 3 encountered an impermeable layer which prevented penetration beyond the 5.0 foot depth. This area also appears to be patched with asphalt which may represent an old tank excavation.

Probe 22 penetrated the groundsurface very easily and required very little vacuum to collect a soil-gas sample. The groundsurface in this area was concrete. A large portion of the concrete had previously been damaged.

All soil-gas samples contained  
2.2ppmv or less organic vapor.  
No indications of petroleum  
were noted in the field.
