**REPORT OF
SUBSURFACE INVESTIGATION**

**VINCENT ROOFING COMPANY
2181 Dunn Road
Hayward, CA**

July 12, 1995

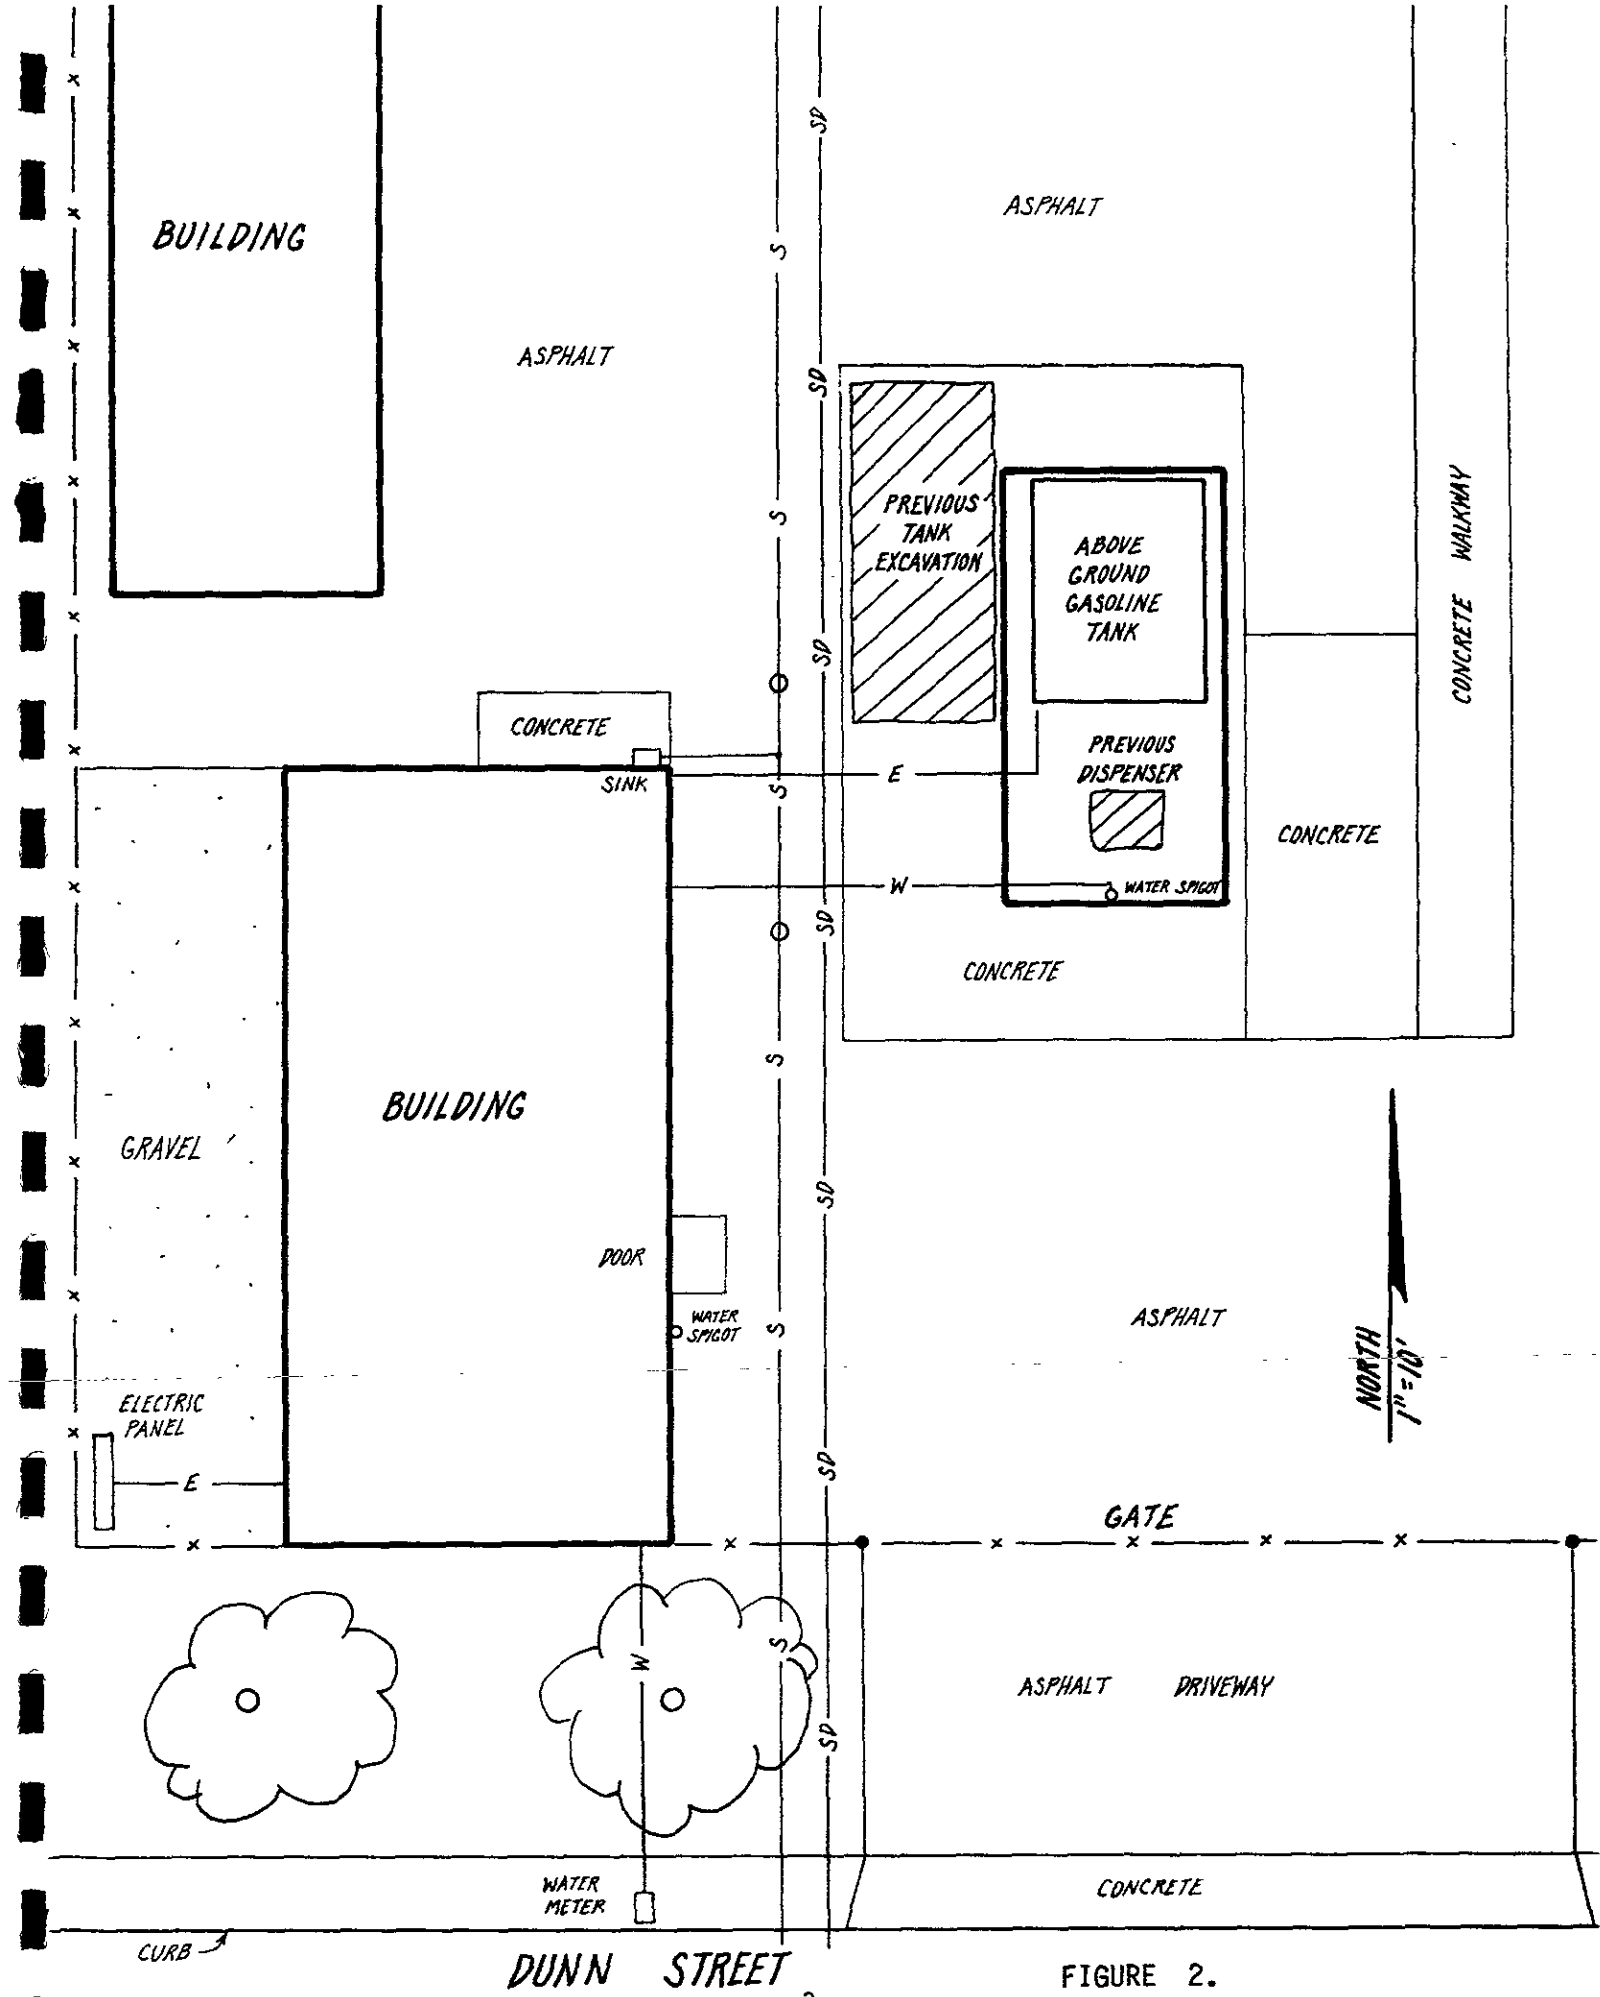
FIGURE 2.
Site Map.

A map of the site showing the layout of the facility, along with the location of the previous underground tank excavation is shown in Figure 2. At the time of the removal, Gasoline was found to be present in the native soil beneath the tank at concentrations of up to 260 mg/Kg (ppm). In addition, trace amounts of Ethylbenzene, Xylenes and Lead were discovered to be present in the native soil at this same location.

A map of the site is shown in Figure 2. This map shows the layout of the facility, along with the locations of the previous tank excavation. At the present time, approximately one-half of the site is paved with asphalt or concrete. Imported gravel covers the remainder of the site. The former tank excavation location is capped with concrete pavement and an above-ground fuel storage tank with spill containment wall.

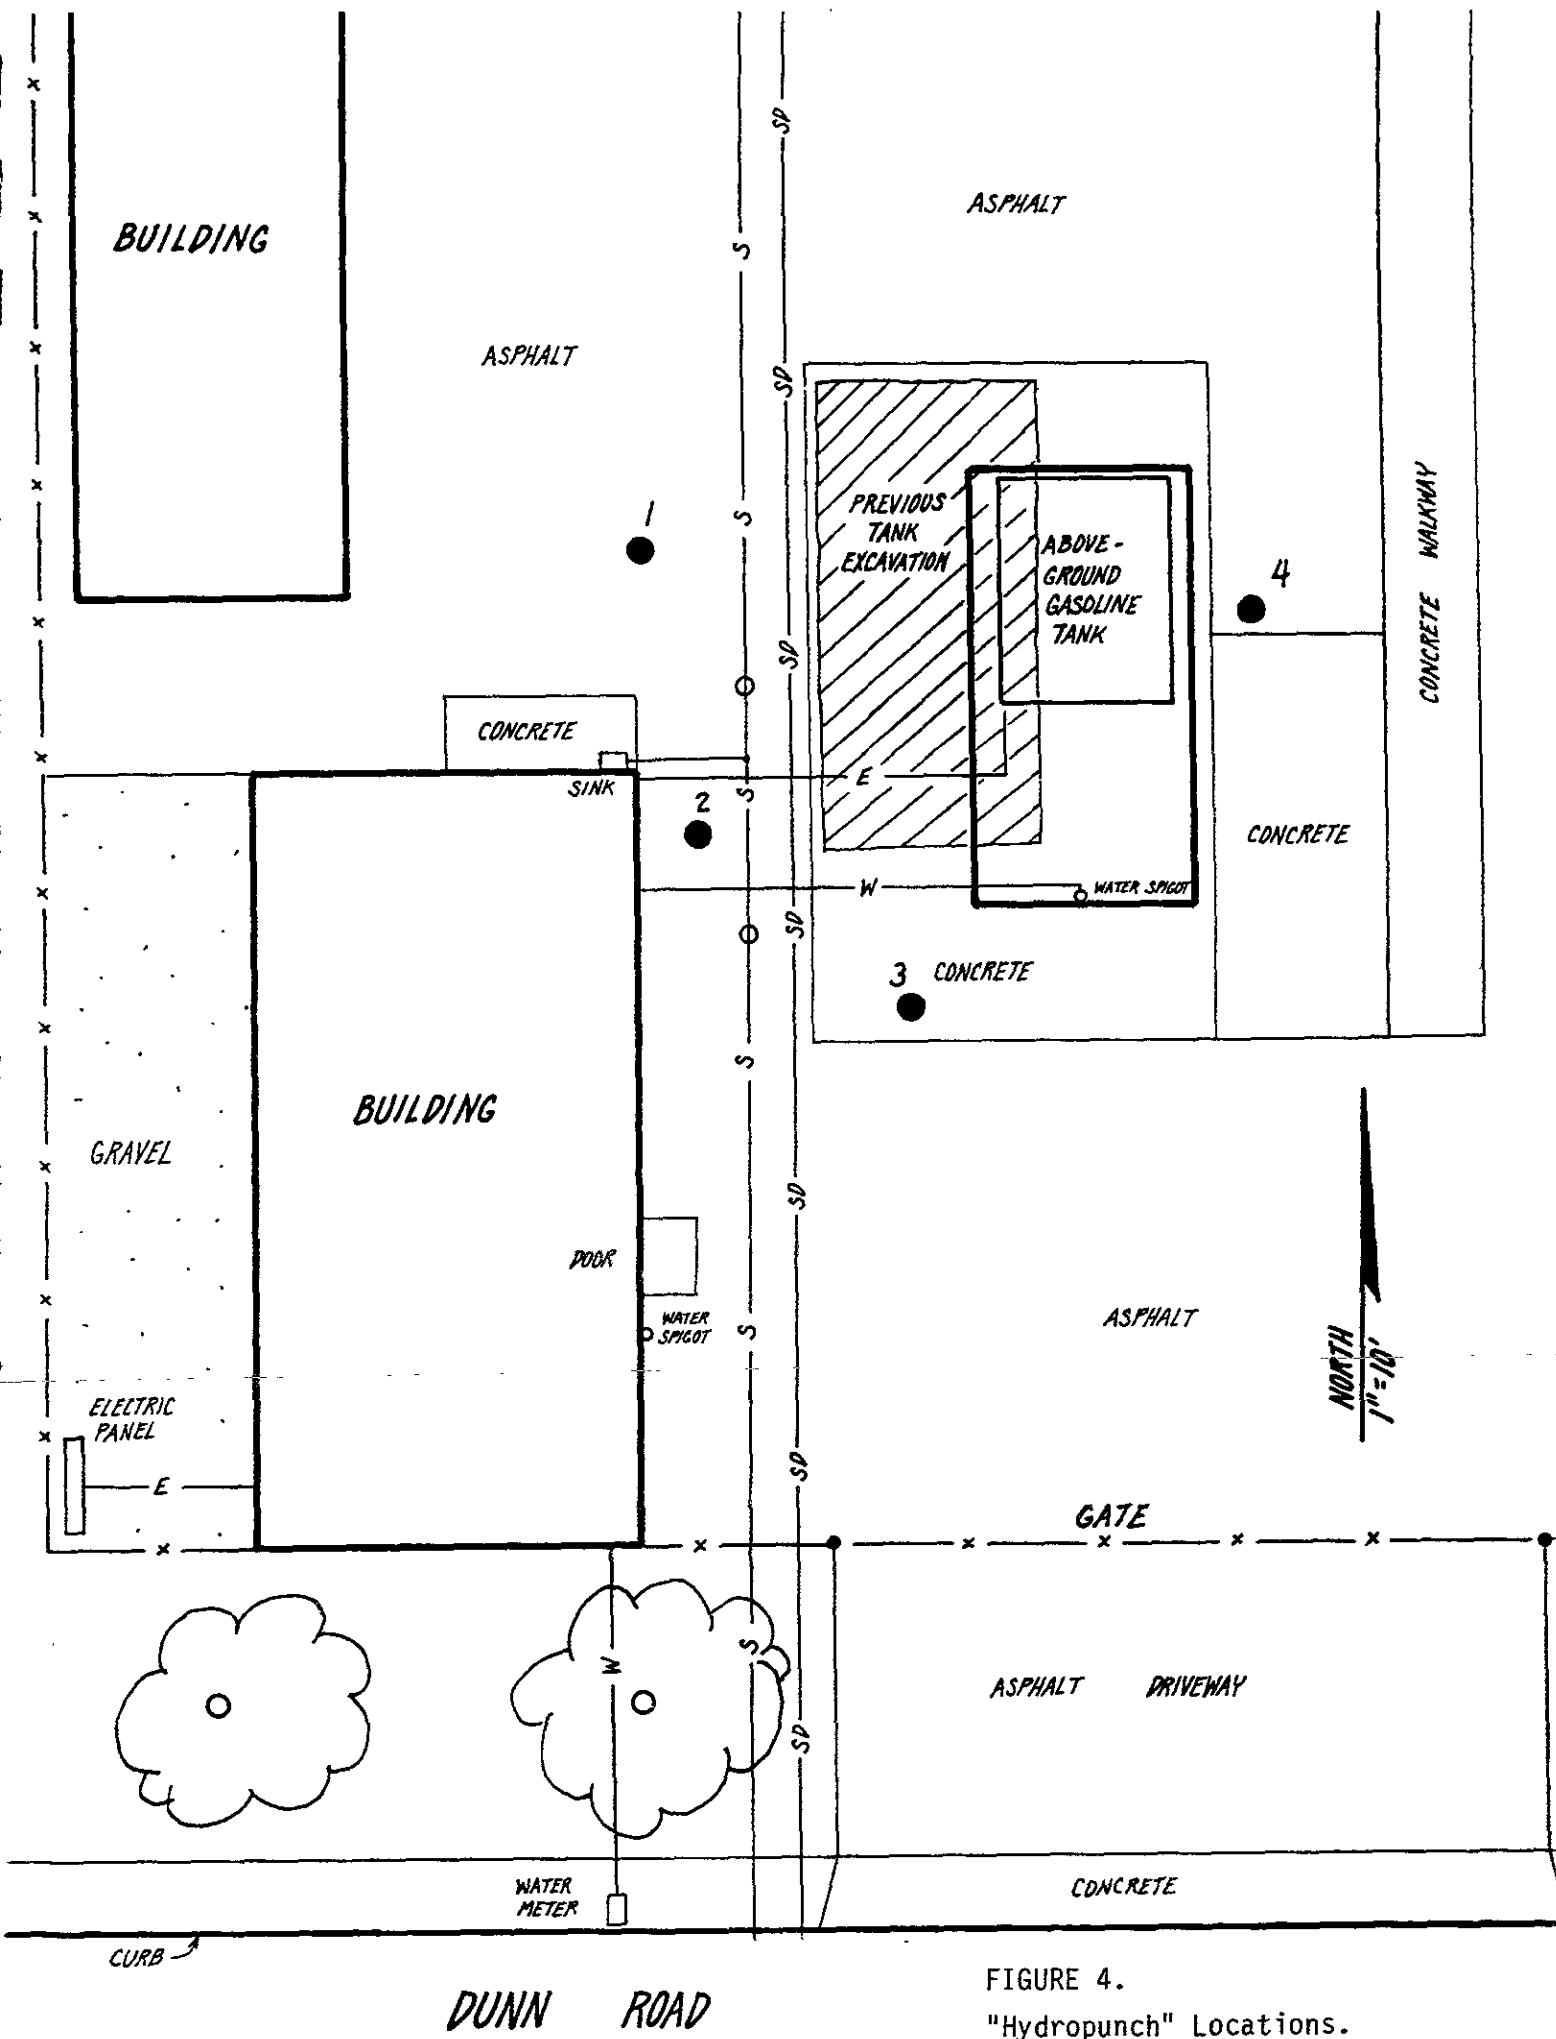
FIGURE 4.
"Hydropunch" Locations.

The actual "hydropunch" groundwater sampling locations are shown in Figure 4. The locations were selected based upon 1) the presumed shallow groundwater flow direction, 2) estimated locations of the previous underground tank and associated product dispenser, and 3) what was believed to be good spacing between data points in order to achieve reasonable plume definitions of any contaminants that may be present in the shallow groundwater.

It should be noted that "hydropunch" probe HP-4 was installed only for the collection of water elevation data.

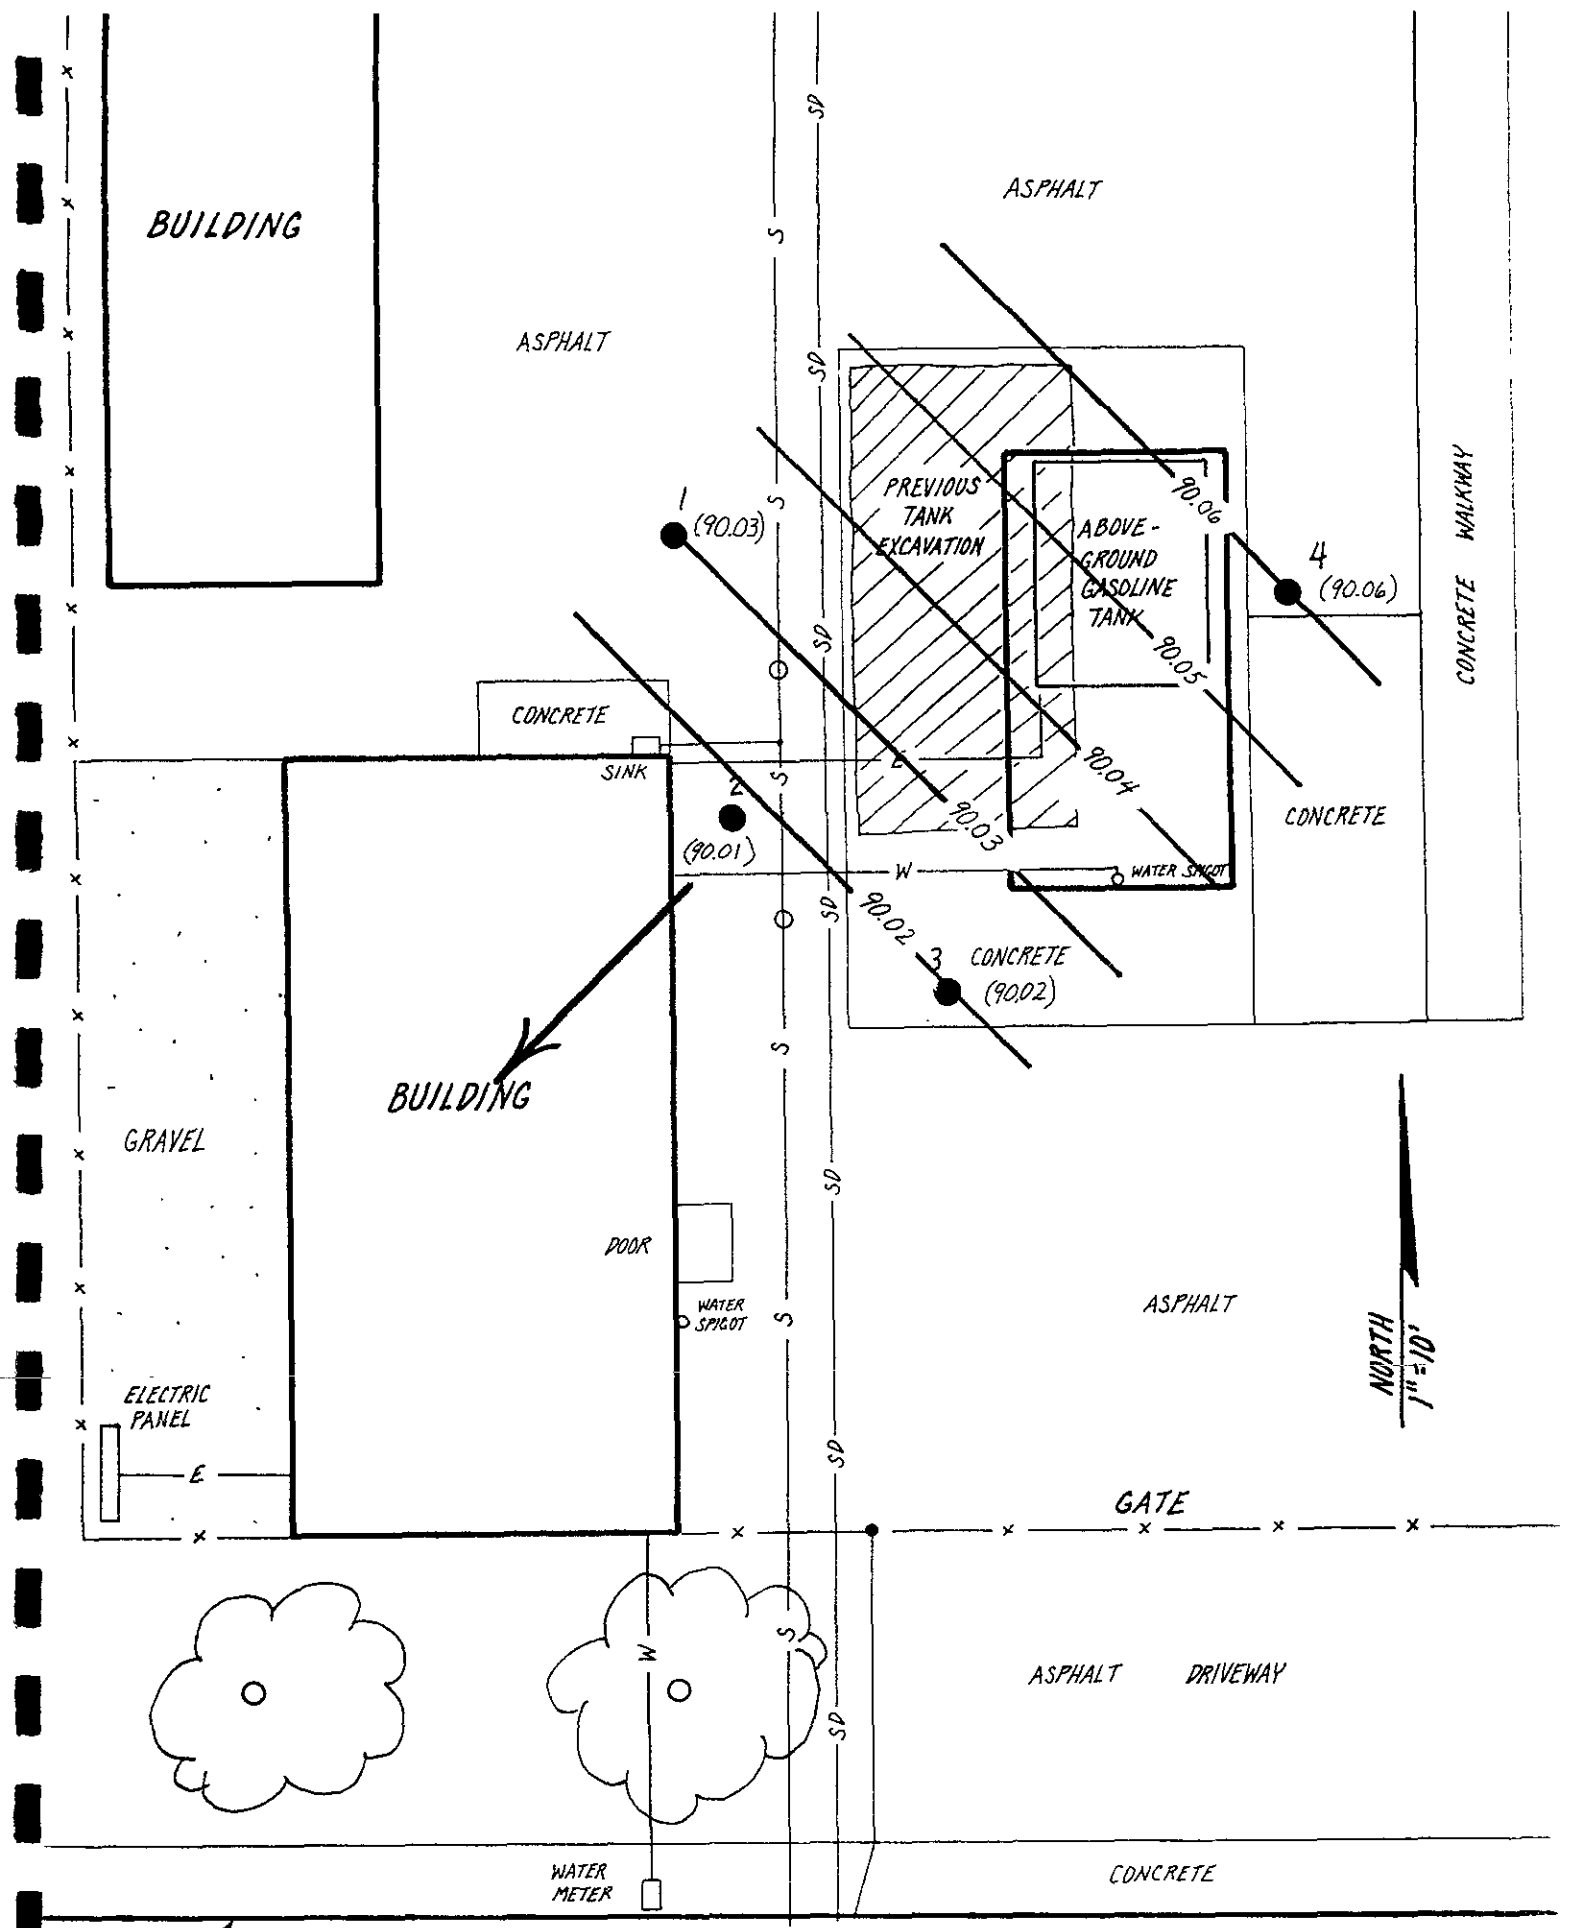
FIGURE 5. Shallow Groundwater Table Contour Map, measured June 26, 1995.

The shallow water table elevation measurements for June 26, 1995, are shown in Table 1. Figure 5 presents a contour map for the shallow groundwater table beneath the site. As shown in this figure, the shallow groundwater beneath the site appears to flow in a southwesterly direction.

Figure 5 presents the contour map for the shallow groundwater table beneath the site. As shown in this figure, the shallow groundwater table beneath the site appears to be relatively flat, with a calculated hydraulic gradient of $dH/dL = 0.01'/6.8' = 0.0014$.
