16501 Ashland Ave, San Lorenzo 11/30/89

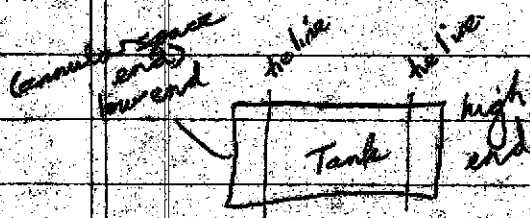
11:34 Tank in ground. Tank sloped $\frac{1}{8}$ " per foot to northwest. Tie lines replaced w/ plastic strip beneath cable + cable holder.
