Challenge Dairy Products

Summary Report:

Soil and Groundwater

Investigation and Remediation

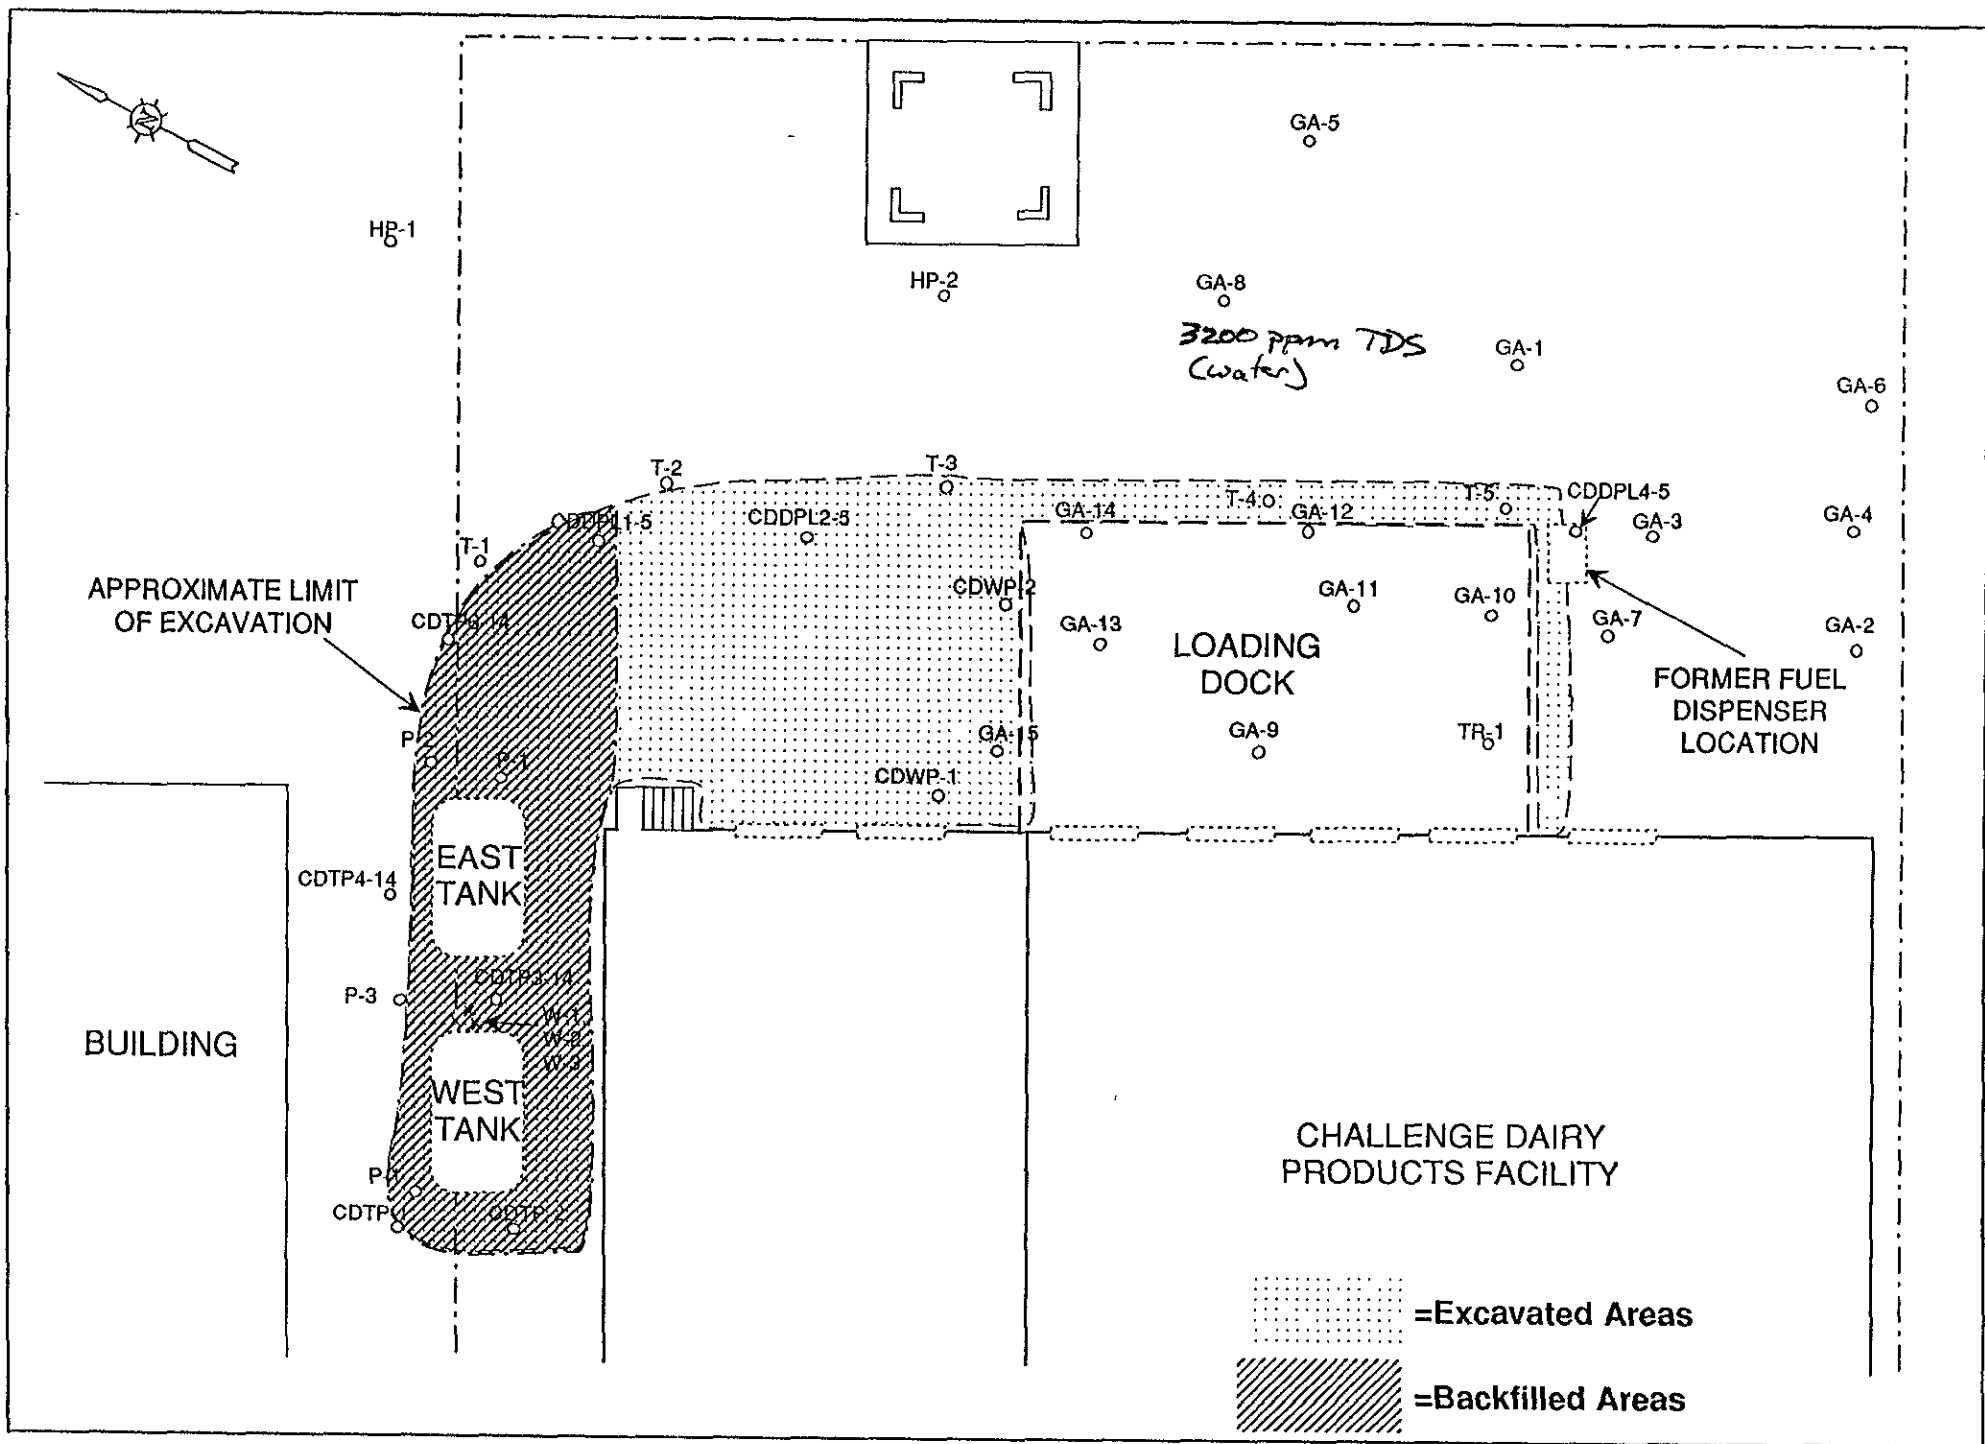
Figure 1-3: Excavated and Backfilled Areas

The area where the tanks were removed was excavated to approximately 14 feet. Eight feet of soil was excavated from the north loading dock area and the pipeline corridor. Additional sampling occurred in January, February, and May around the excavated areas as well as in other areas of the site. Groundwater collecting in the excavated pit is pumped out and treated before being discharged.

In December 1990, following telephone communications with the Alameda County Health Department, the excavated area (north of the building) where the tanks had been as well as in the vicinity of the pipeline was backfilled with clean off-site material to prevent damage to the structural integrity of the building. Figure 1-3 shows areas which have been backfilled. Figure 1-4 provides a color photograph of the backfilled area where the tanks were removed, as well as a photograph of the excavation where the fuel dispenser pumps were located.

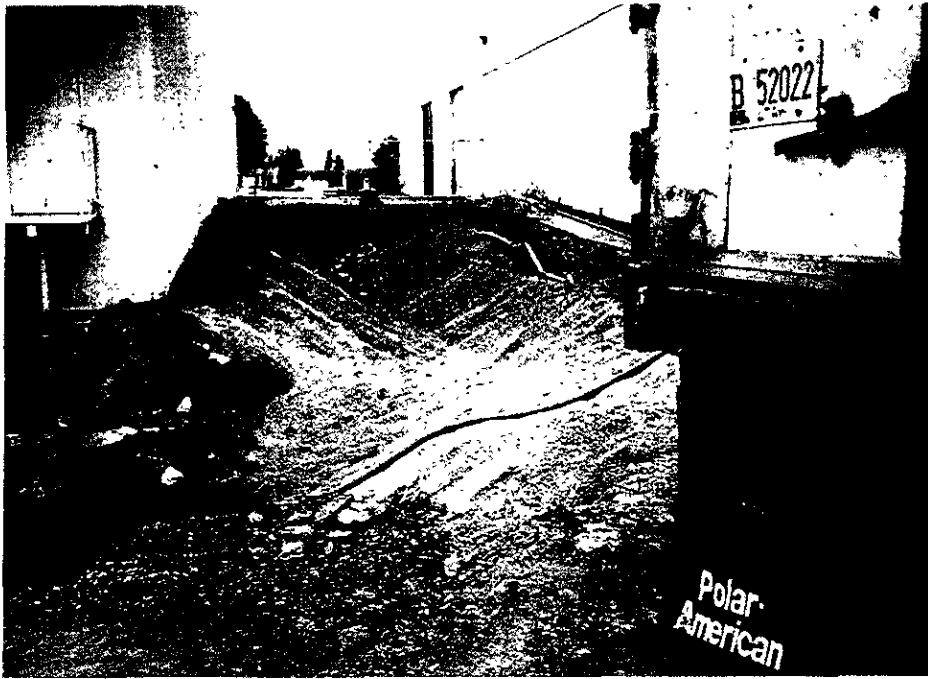
Location of Excavated Tanks Showing Partial Backfill
(Photo Facing West)

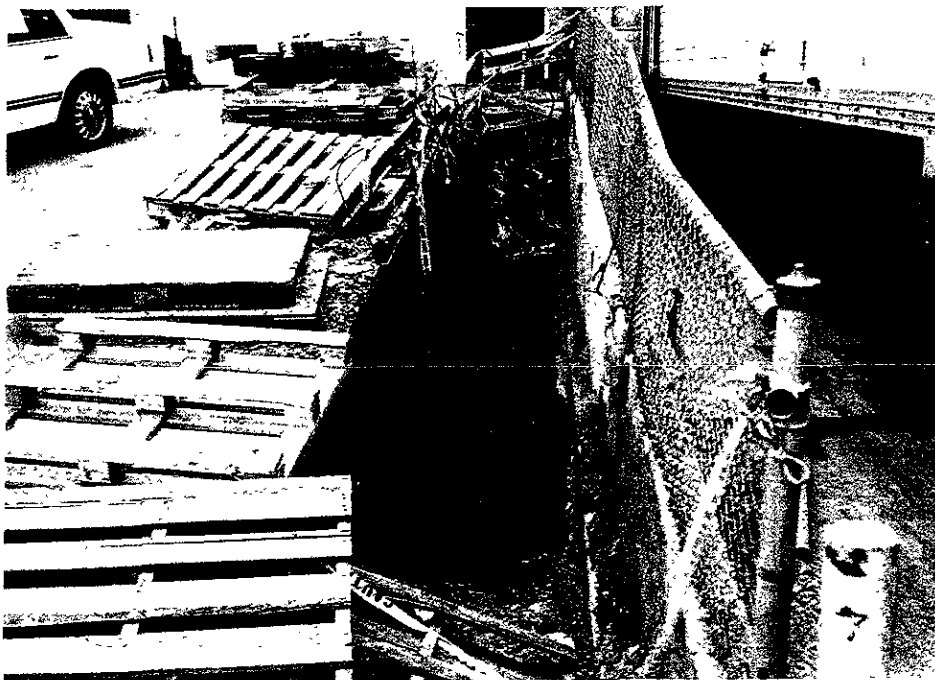
Location of Excavated Fuel Pumps
(Photo Facing West)

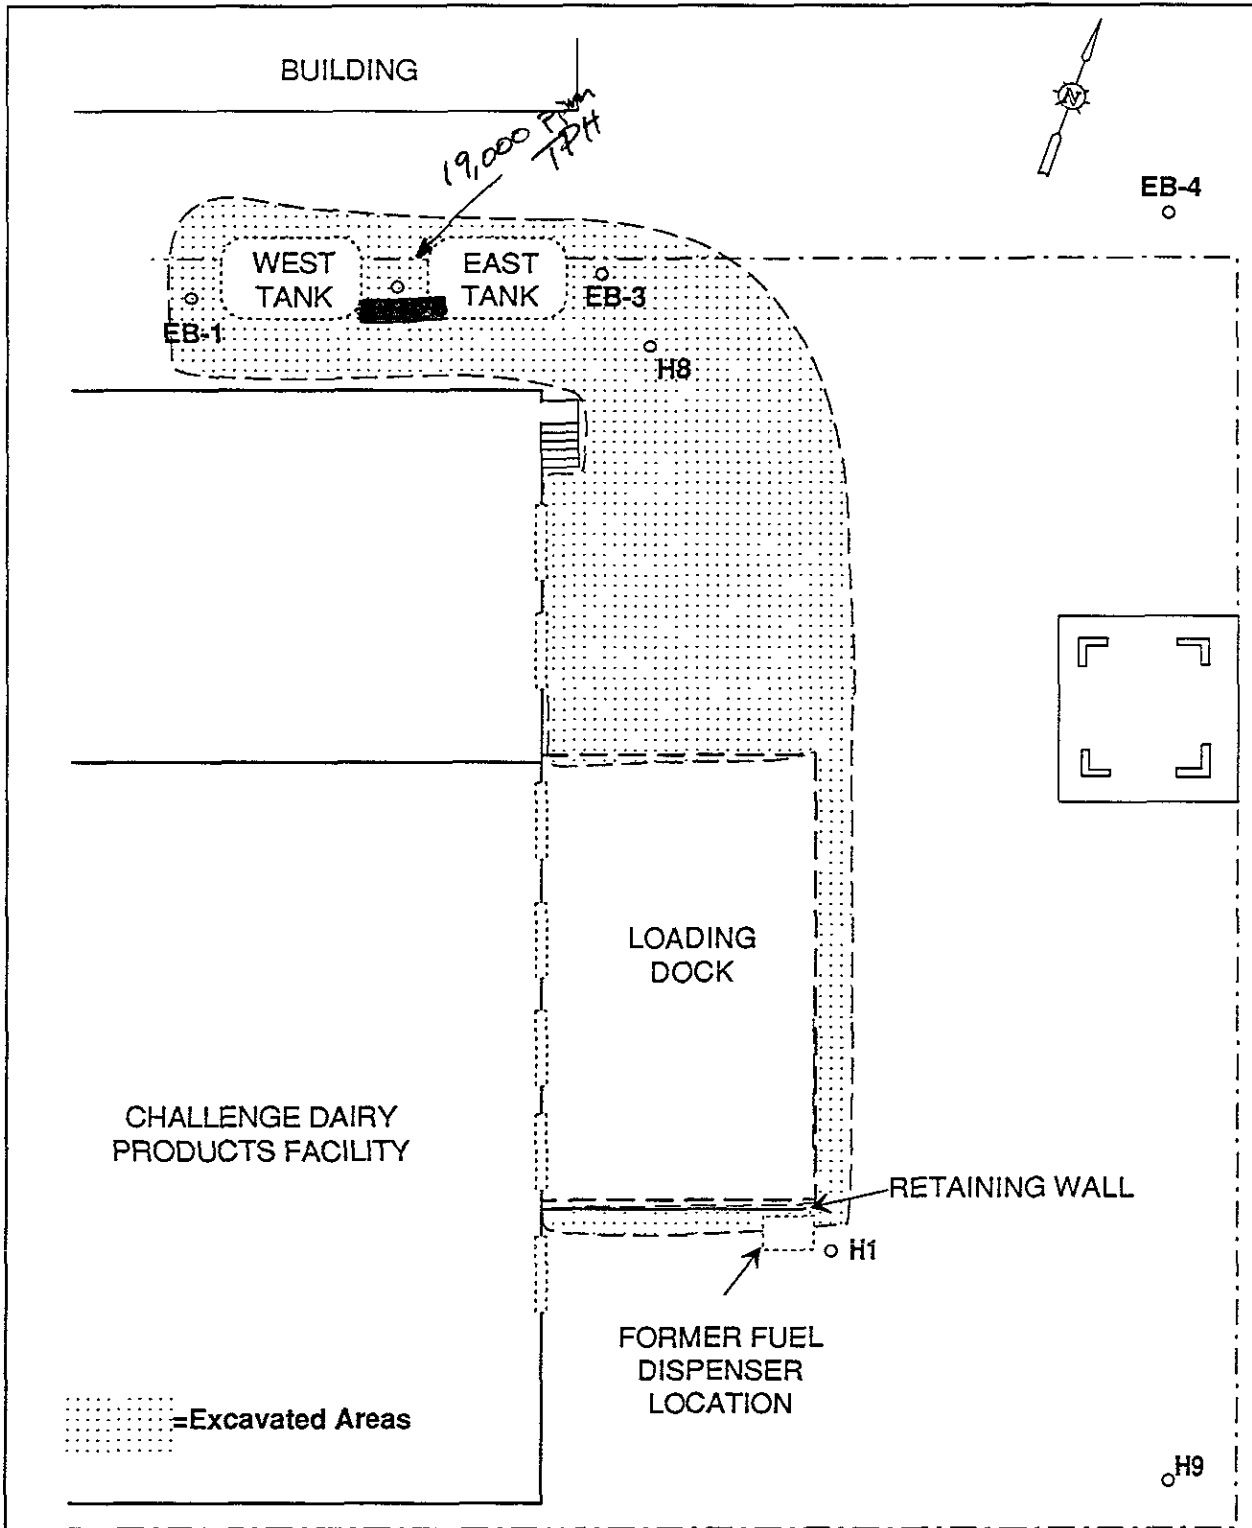
Figure 3-1	Uribe & Associates
SOIL AND GROUNDWATER SAMPLE LOCATIONS FROM SELDITCH REF. #1	CHALLENGE DAIRY PRODUCTS FACILITY UNDERGROUND TANK REMOVAL
Modified from Golder Associates Inc., Ref. #2

During this program, seven sampling locations were drilled on the Challenge Dairy facility (see Figure 3-1). The results showed high TPH (19,900 mg/kg) at sampling location EB-2 near the Challenge Dairy underground fuel tanks. The Selditch report recommended that, "a probable solution would be removal of both tanks." (Selditch, Ref. #1).

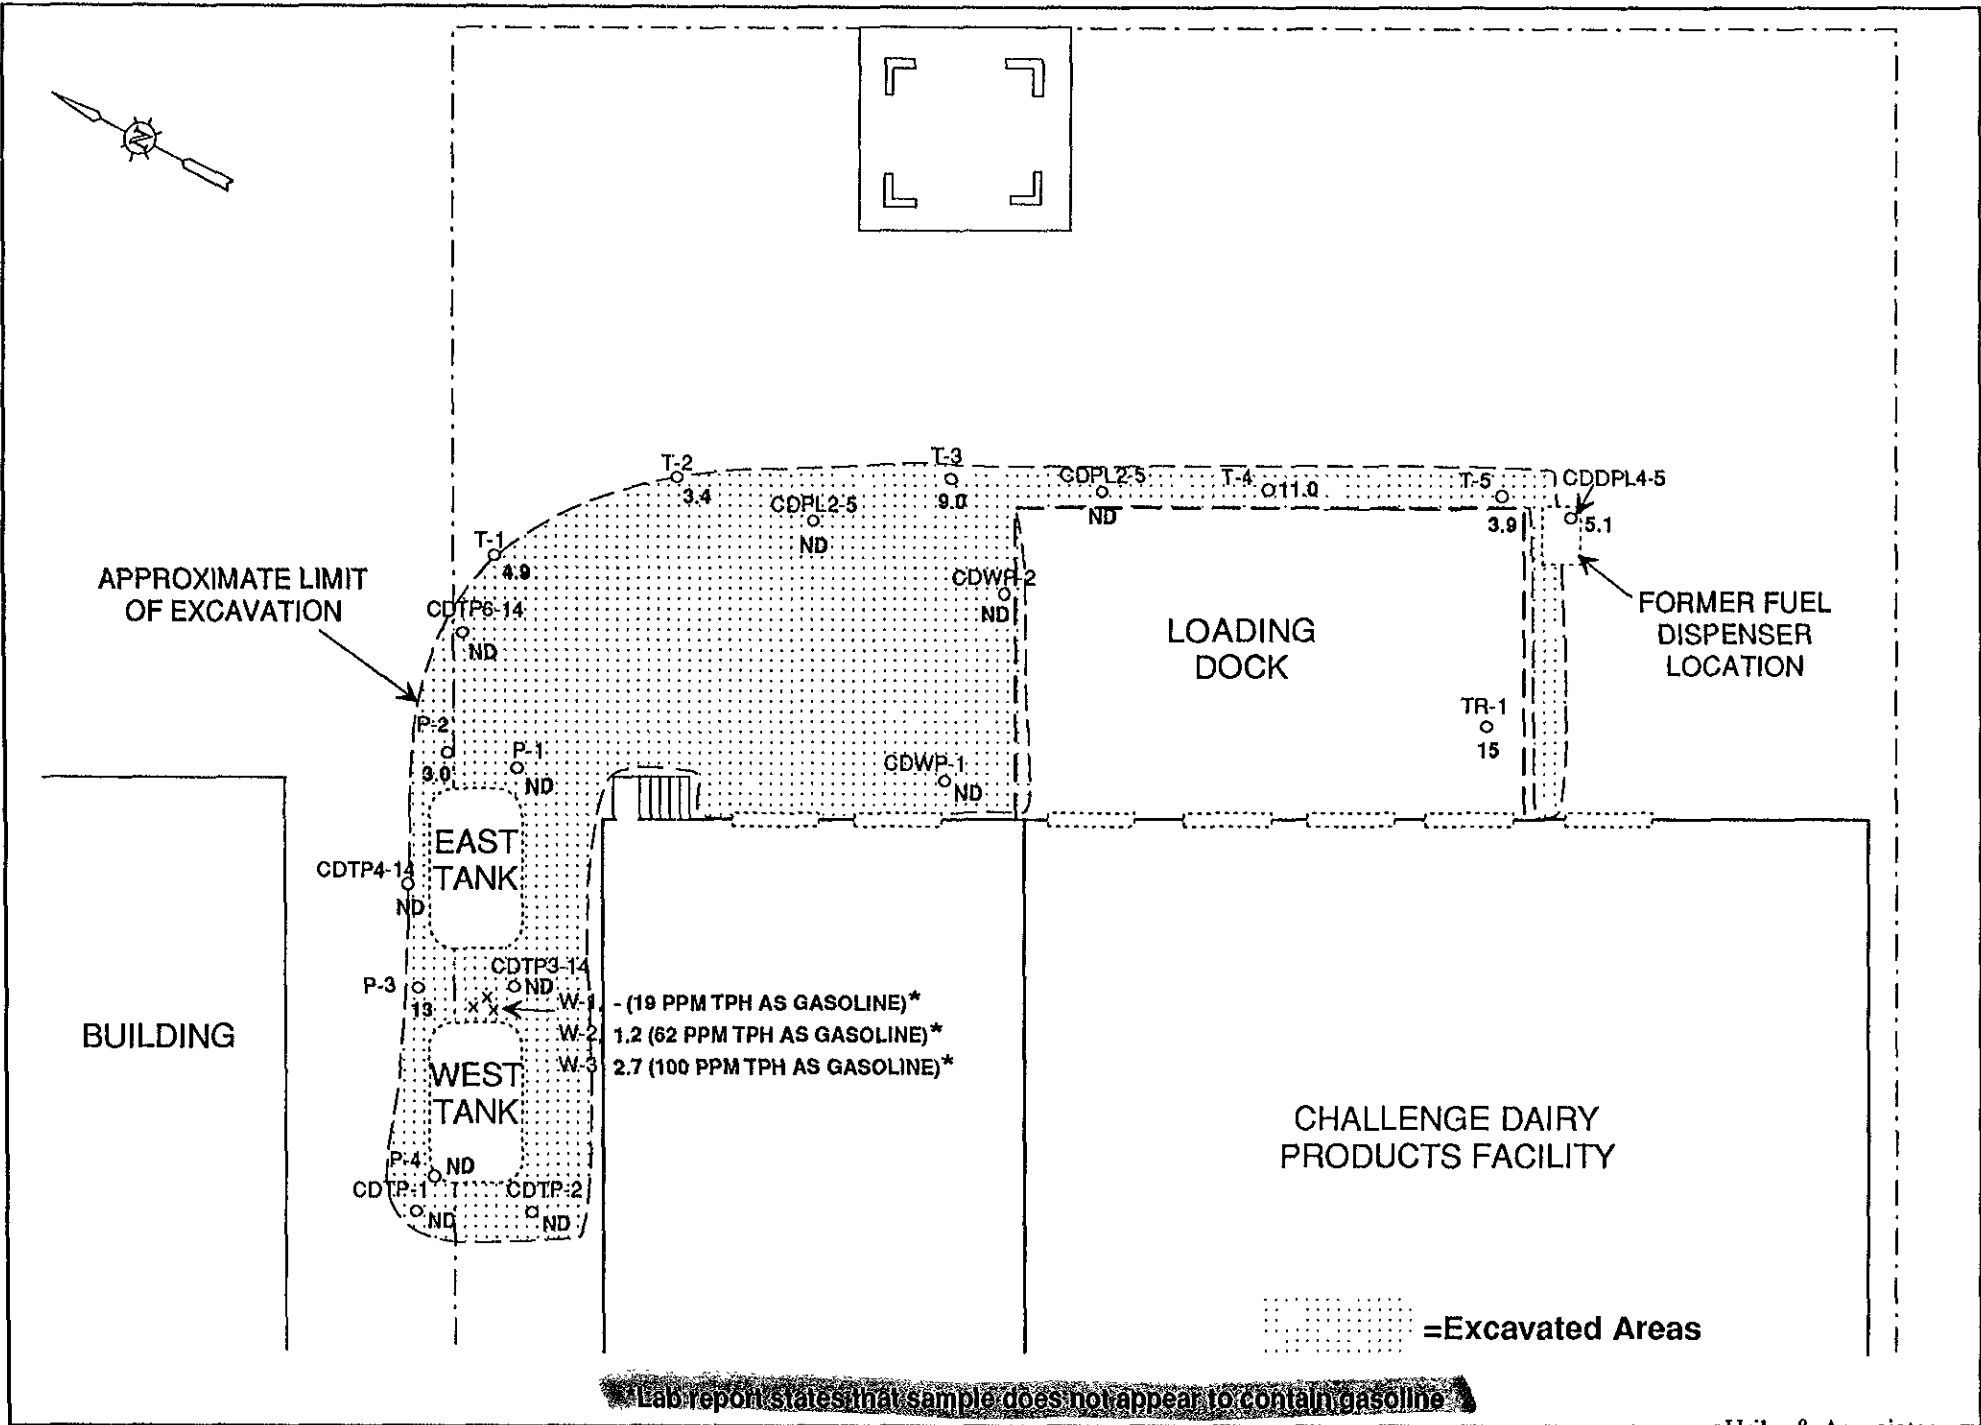
Figure 4.3-A: TPH as Diesel (Method 8015) in Excavated Areas (ppm)

TPH as Diesel concentrations in soil samples ranged from below the detection limit to 13 ppm. The laboratory noted that the two samples with detectable levels of TPH as Diesel appeared to actually contain diesel. TPH as Gasoline concentrations in soil samples ranged from the detection limit to 8.6 ppm. The laboratory noted that the one Method 8015 sample with a detectable TPH concentration did not appear to contain gasoline.
