Challenge Dairy Products

Summary Report:

Soil and Groundwater

Investigation and Remediation

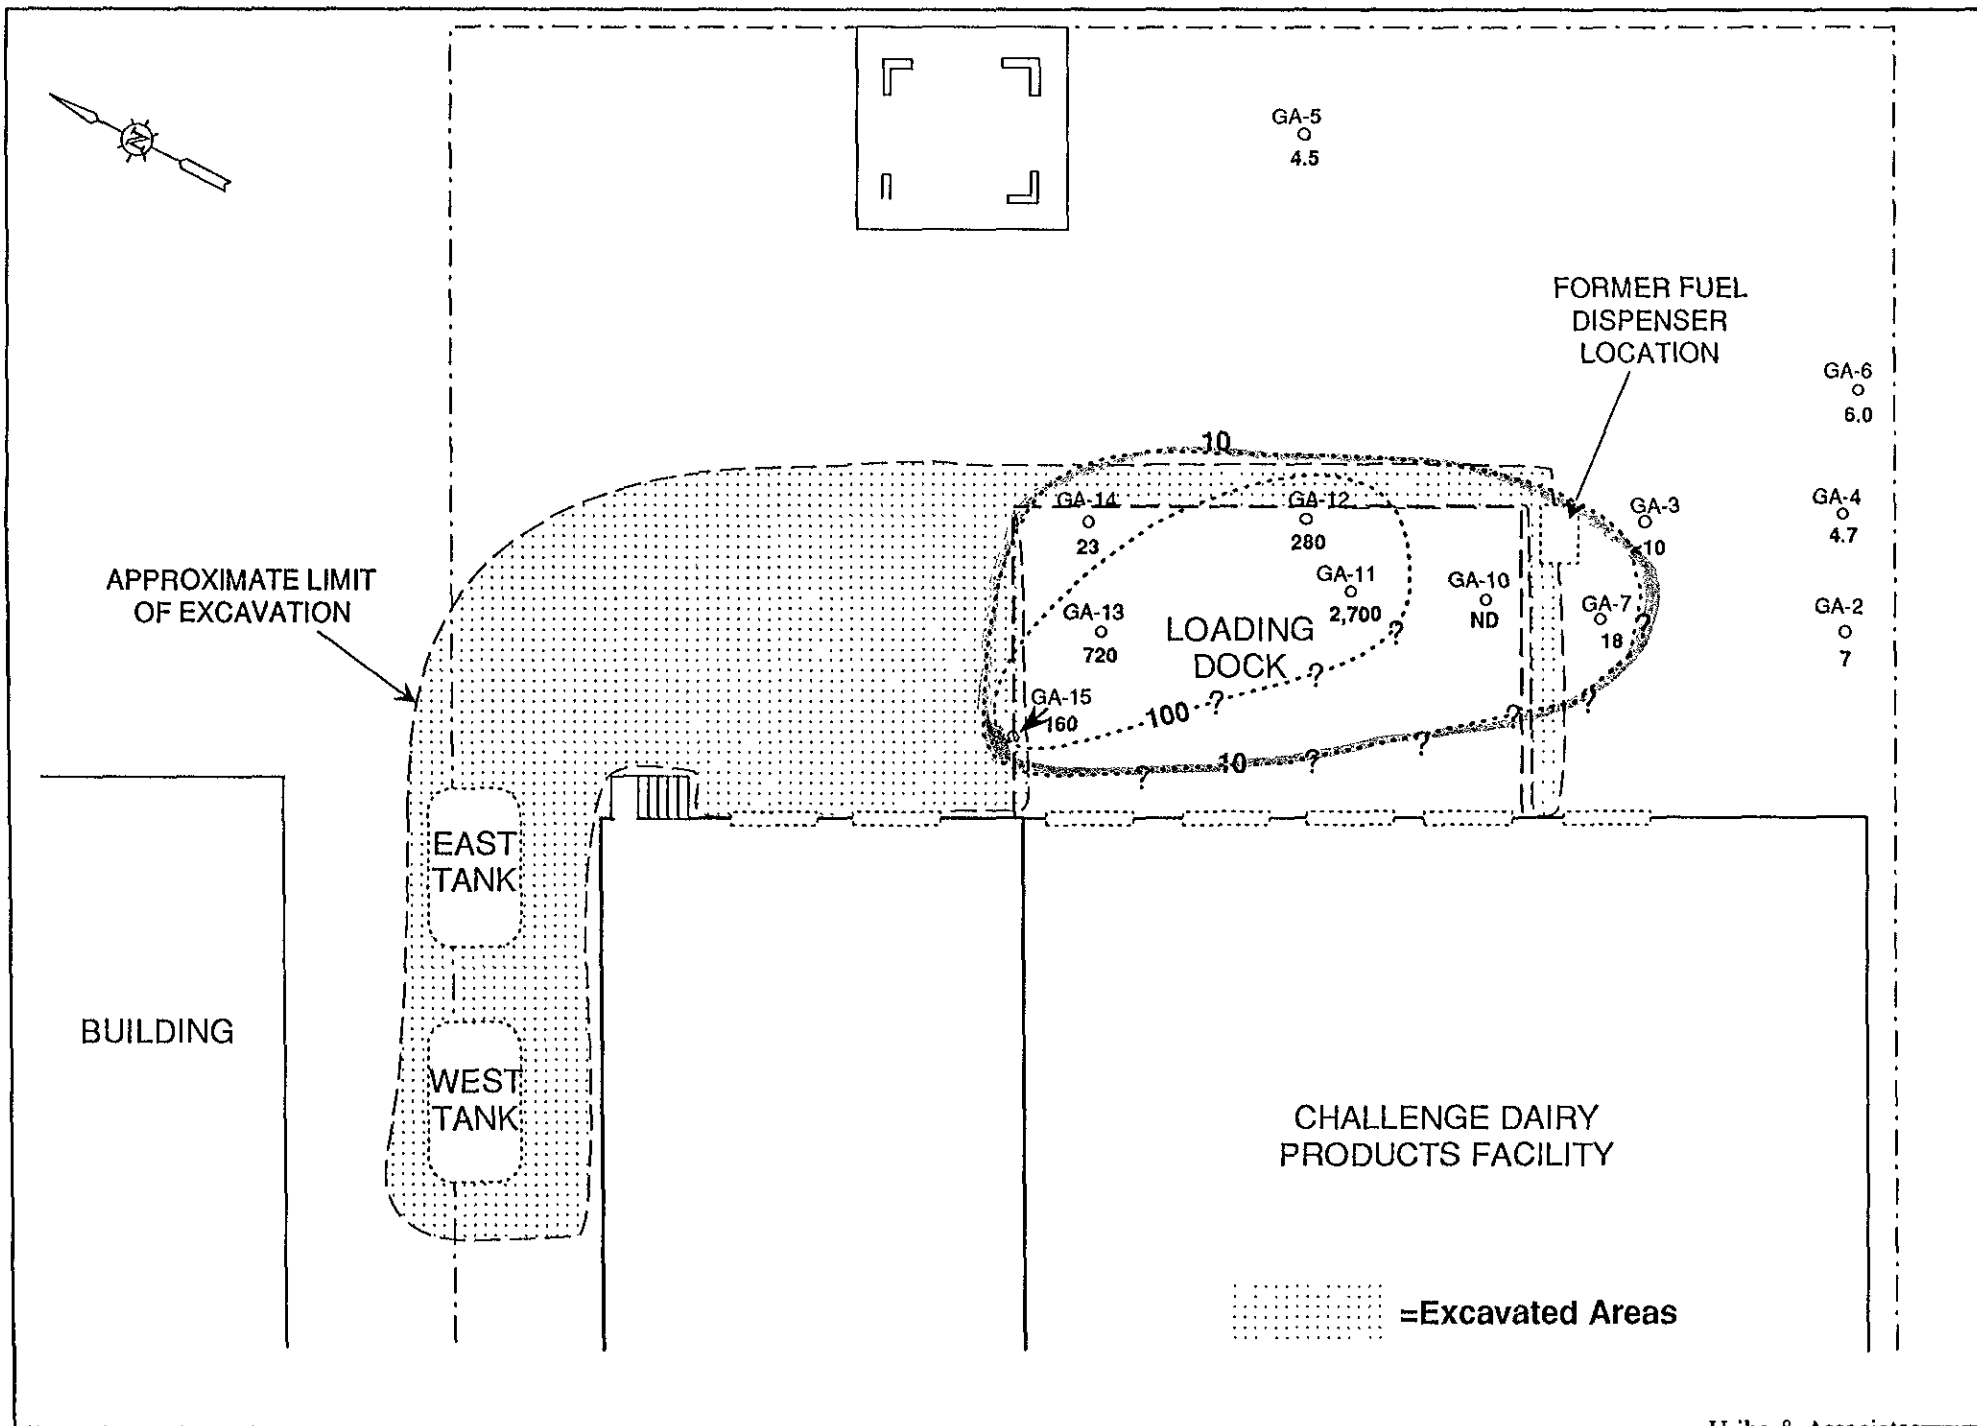
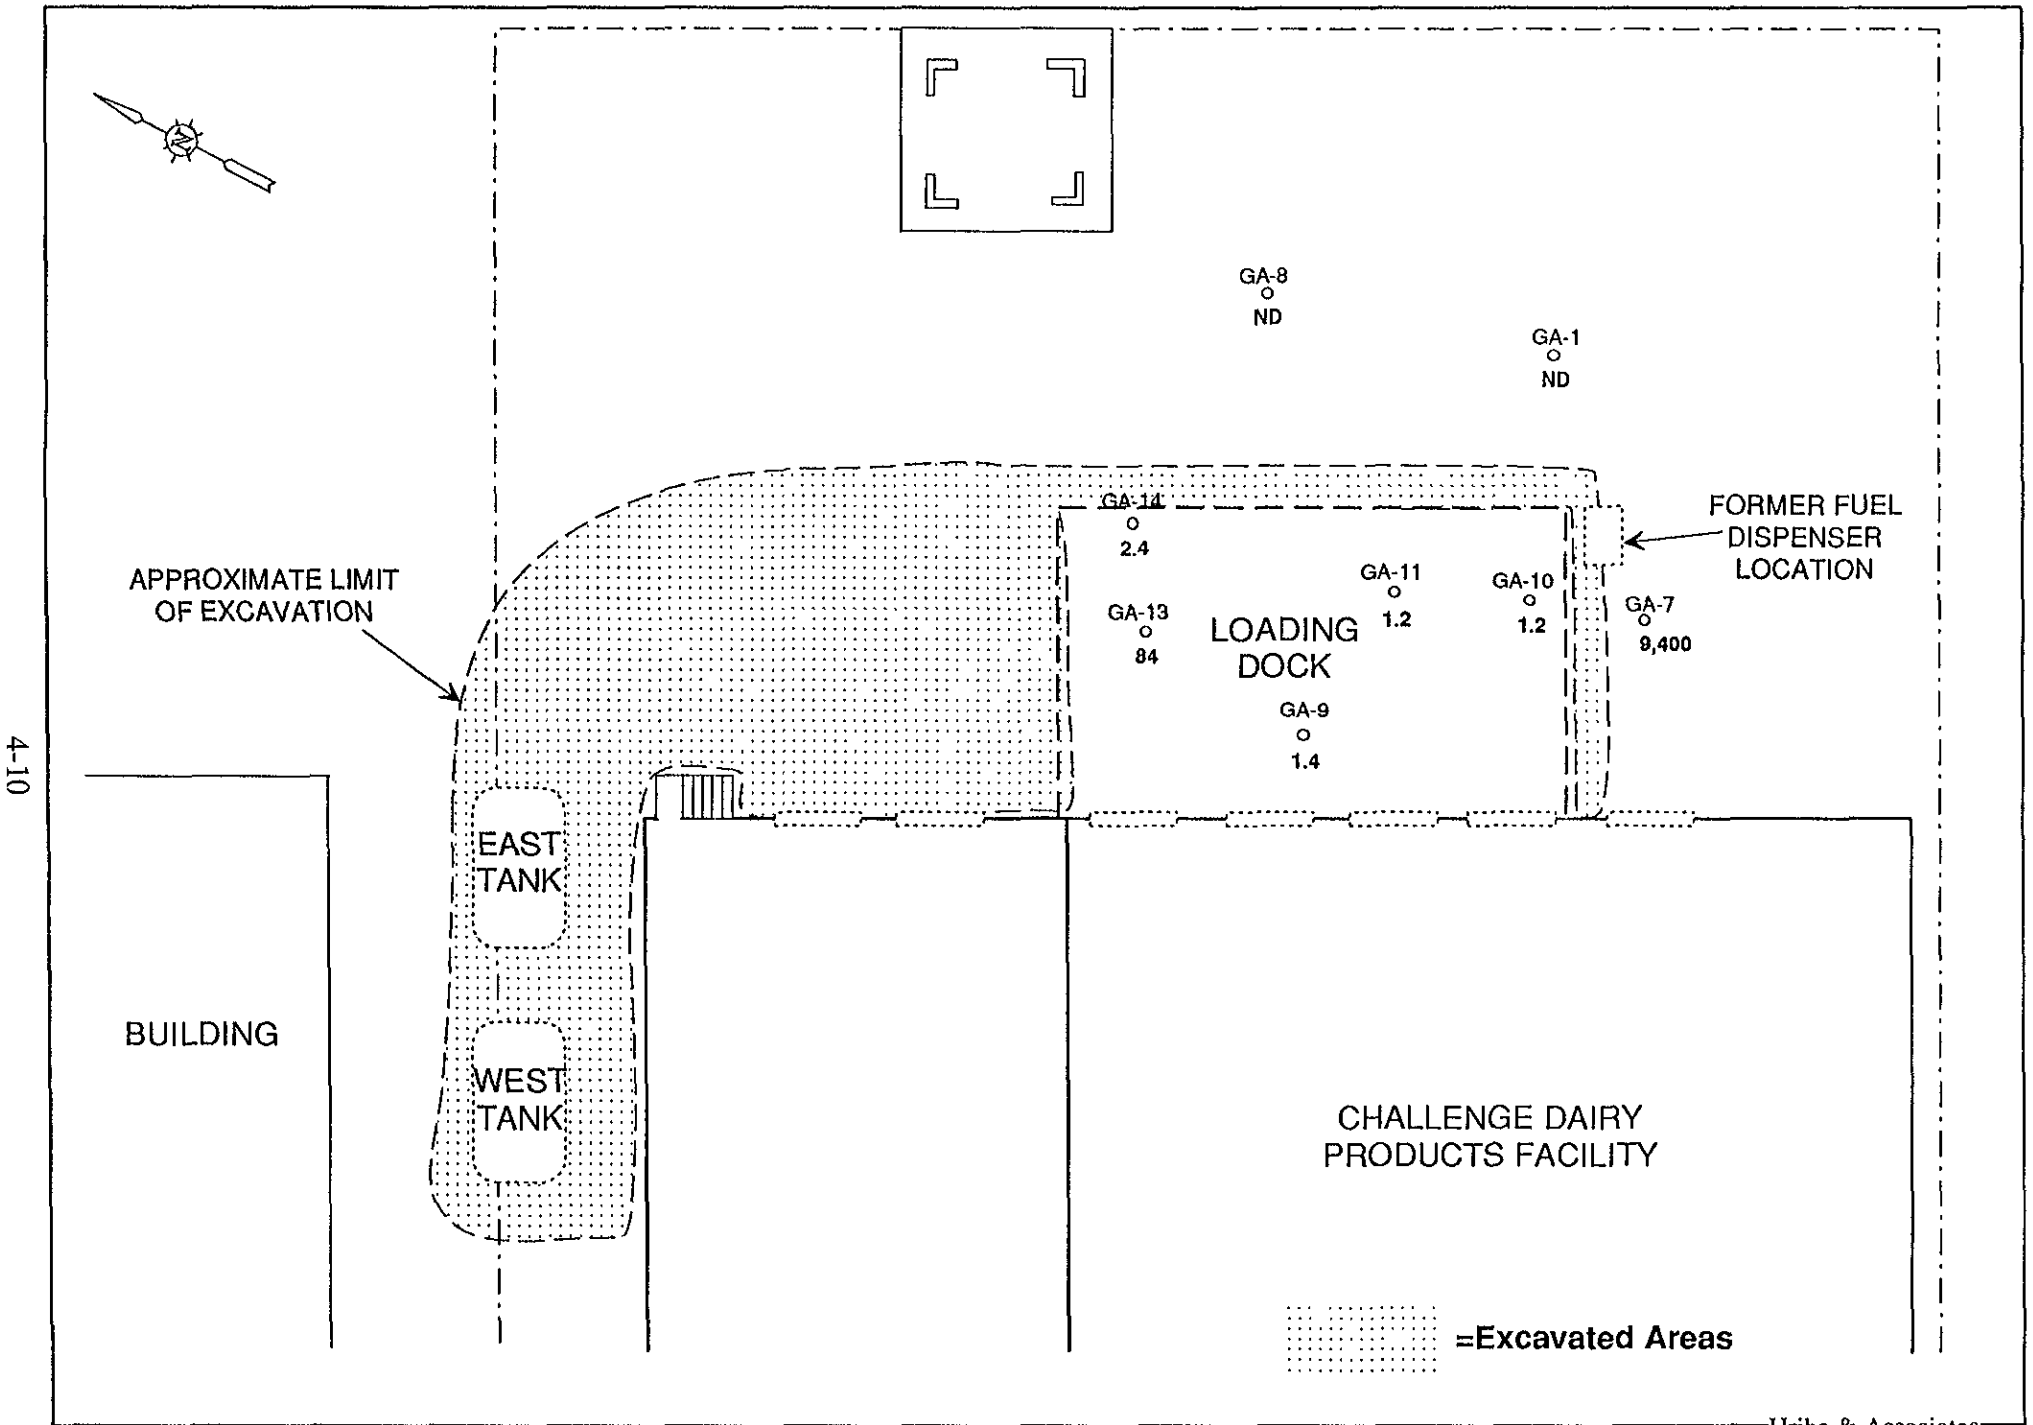
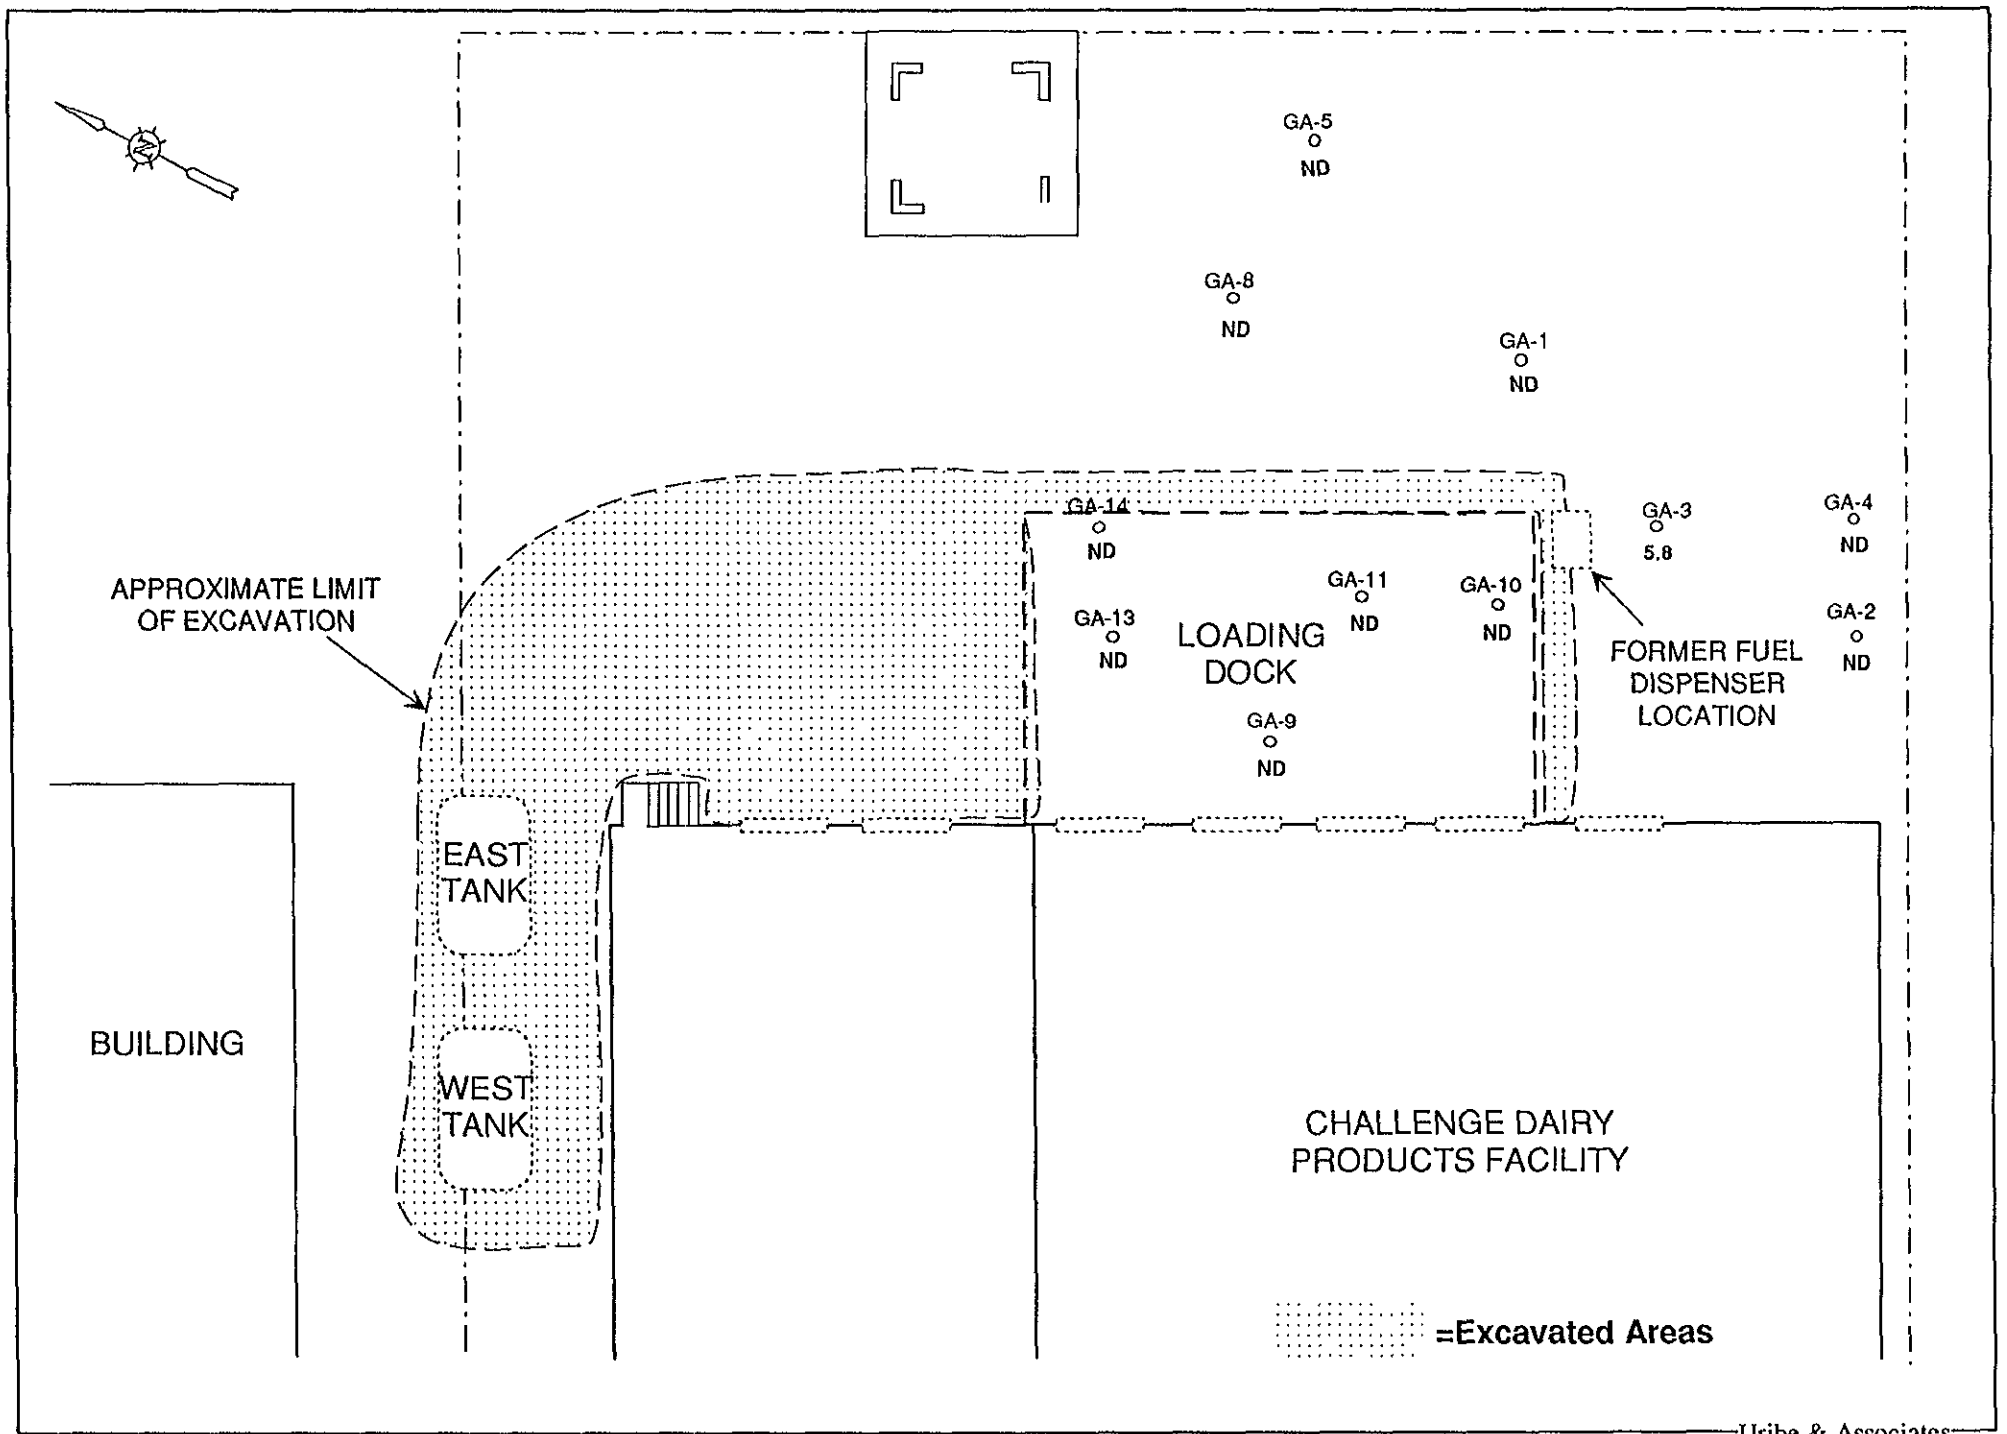
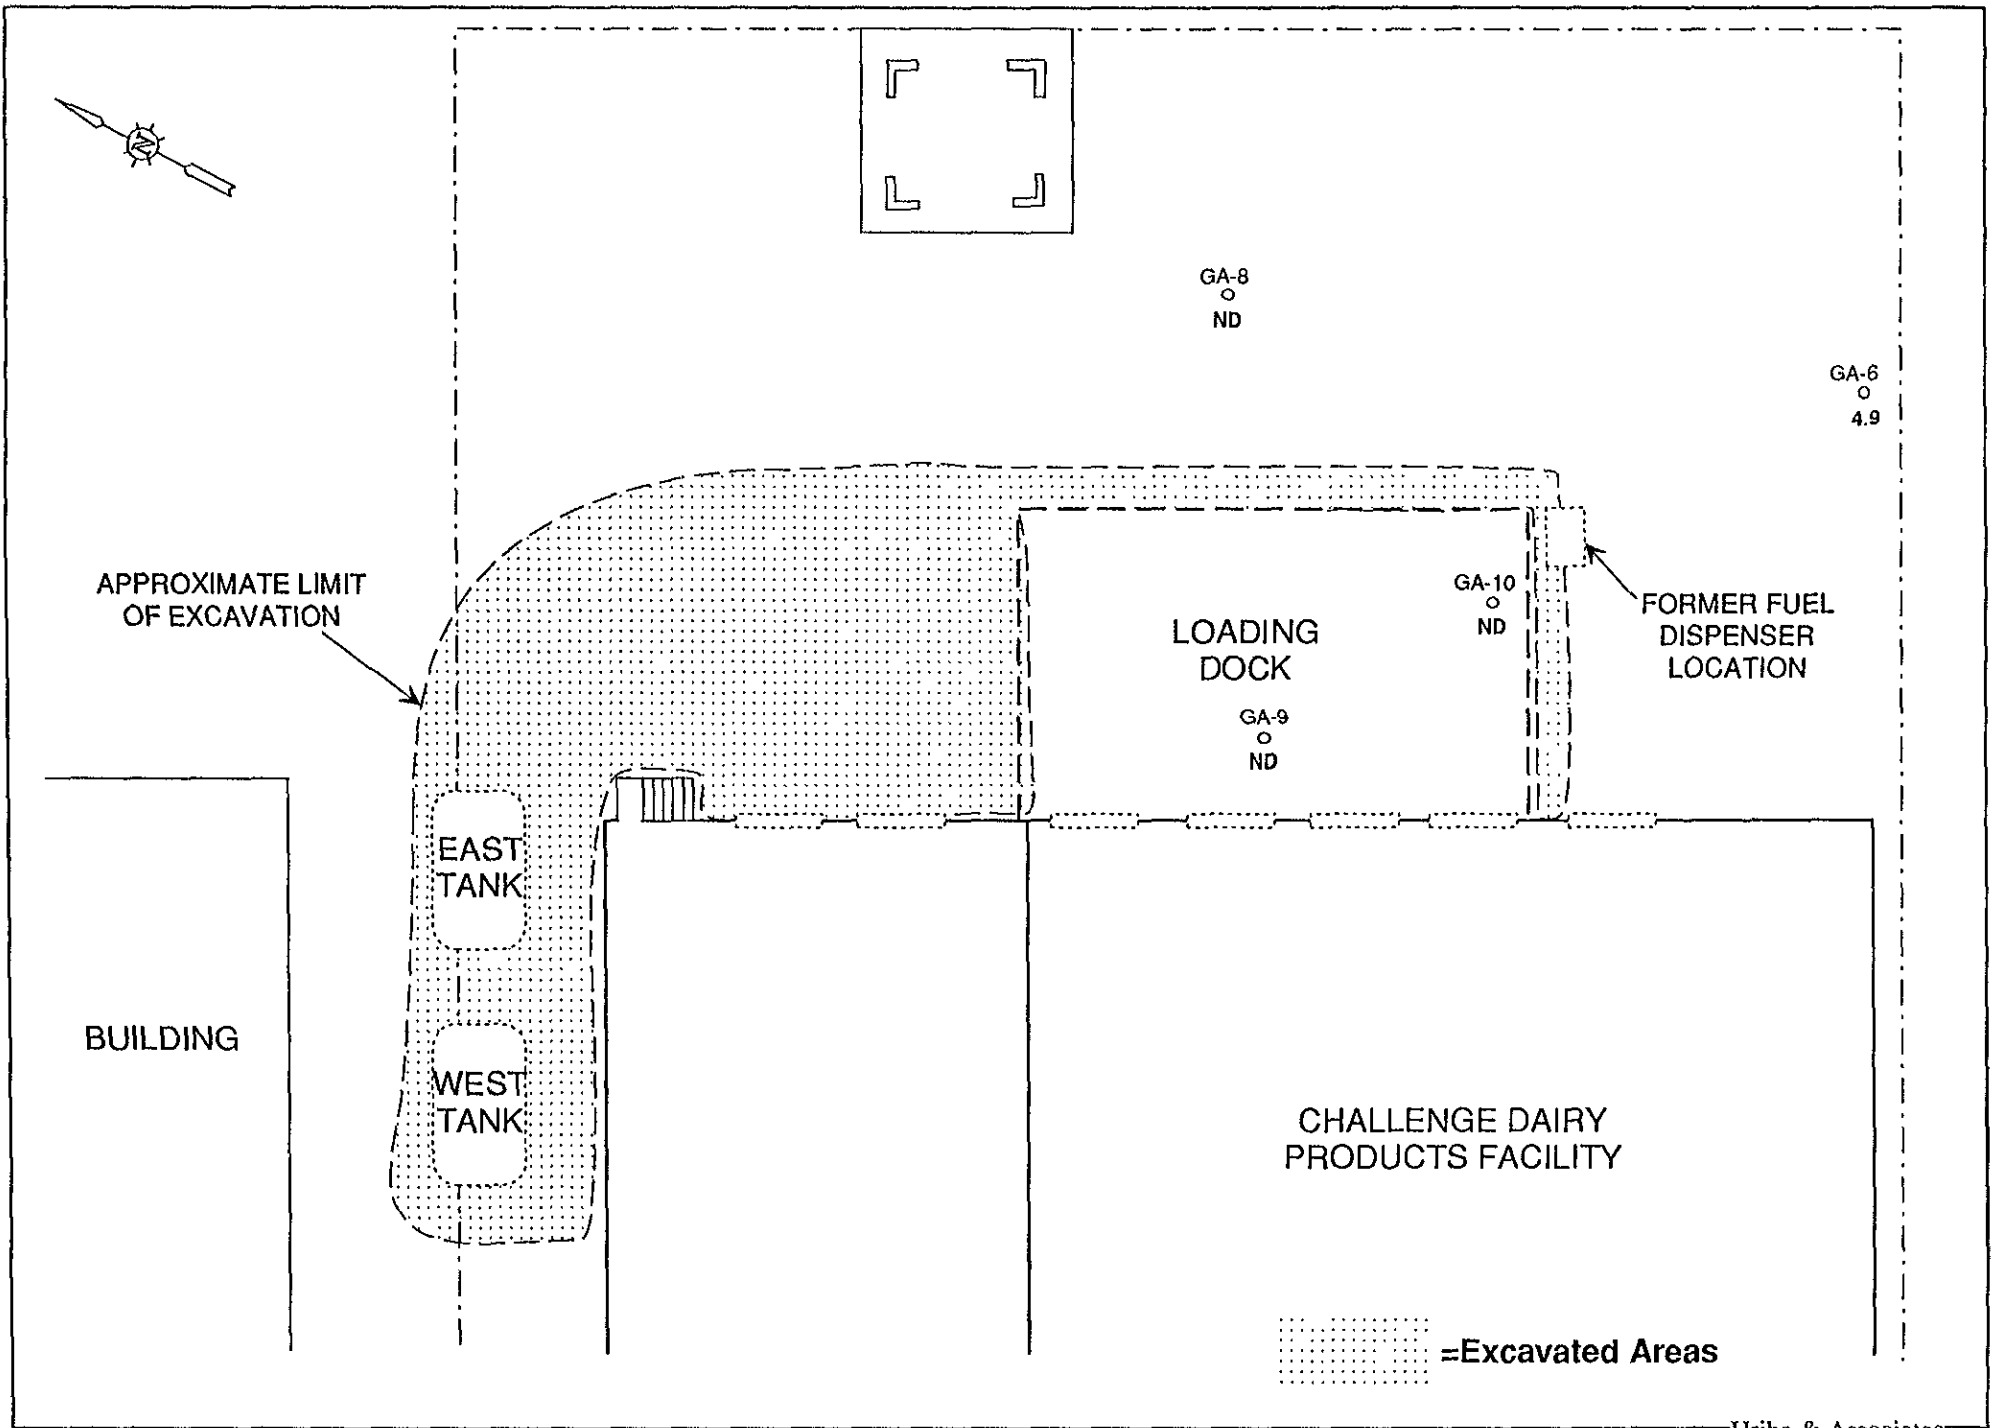
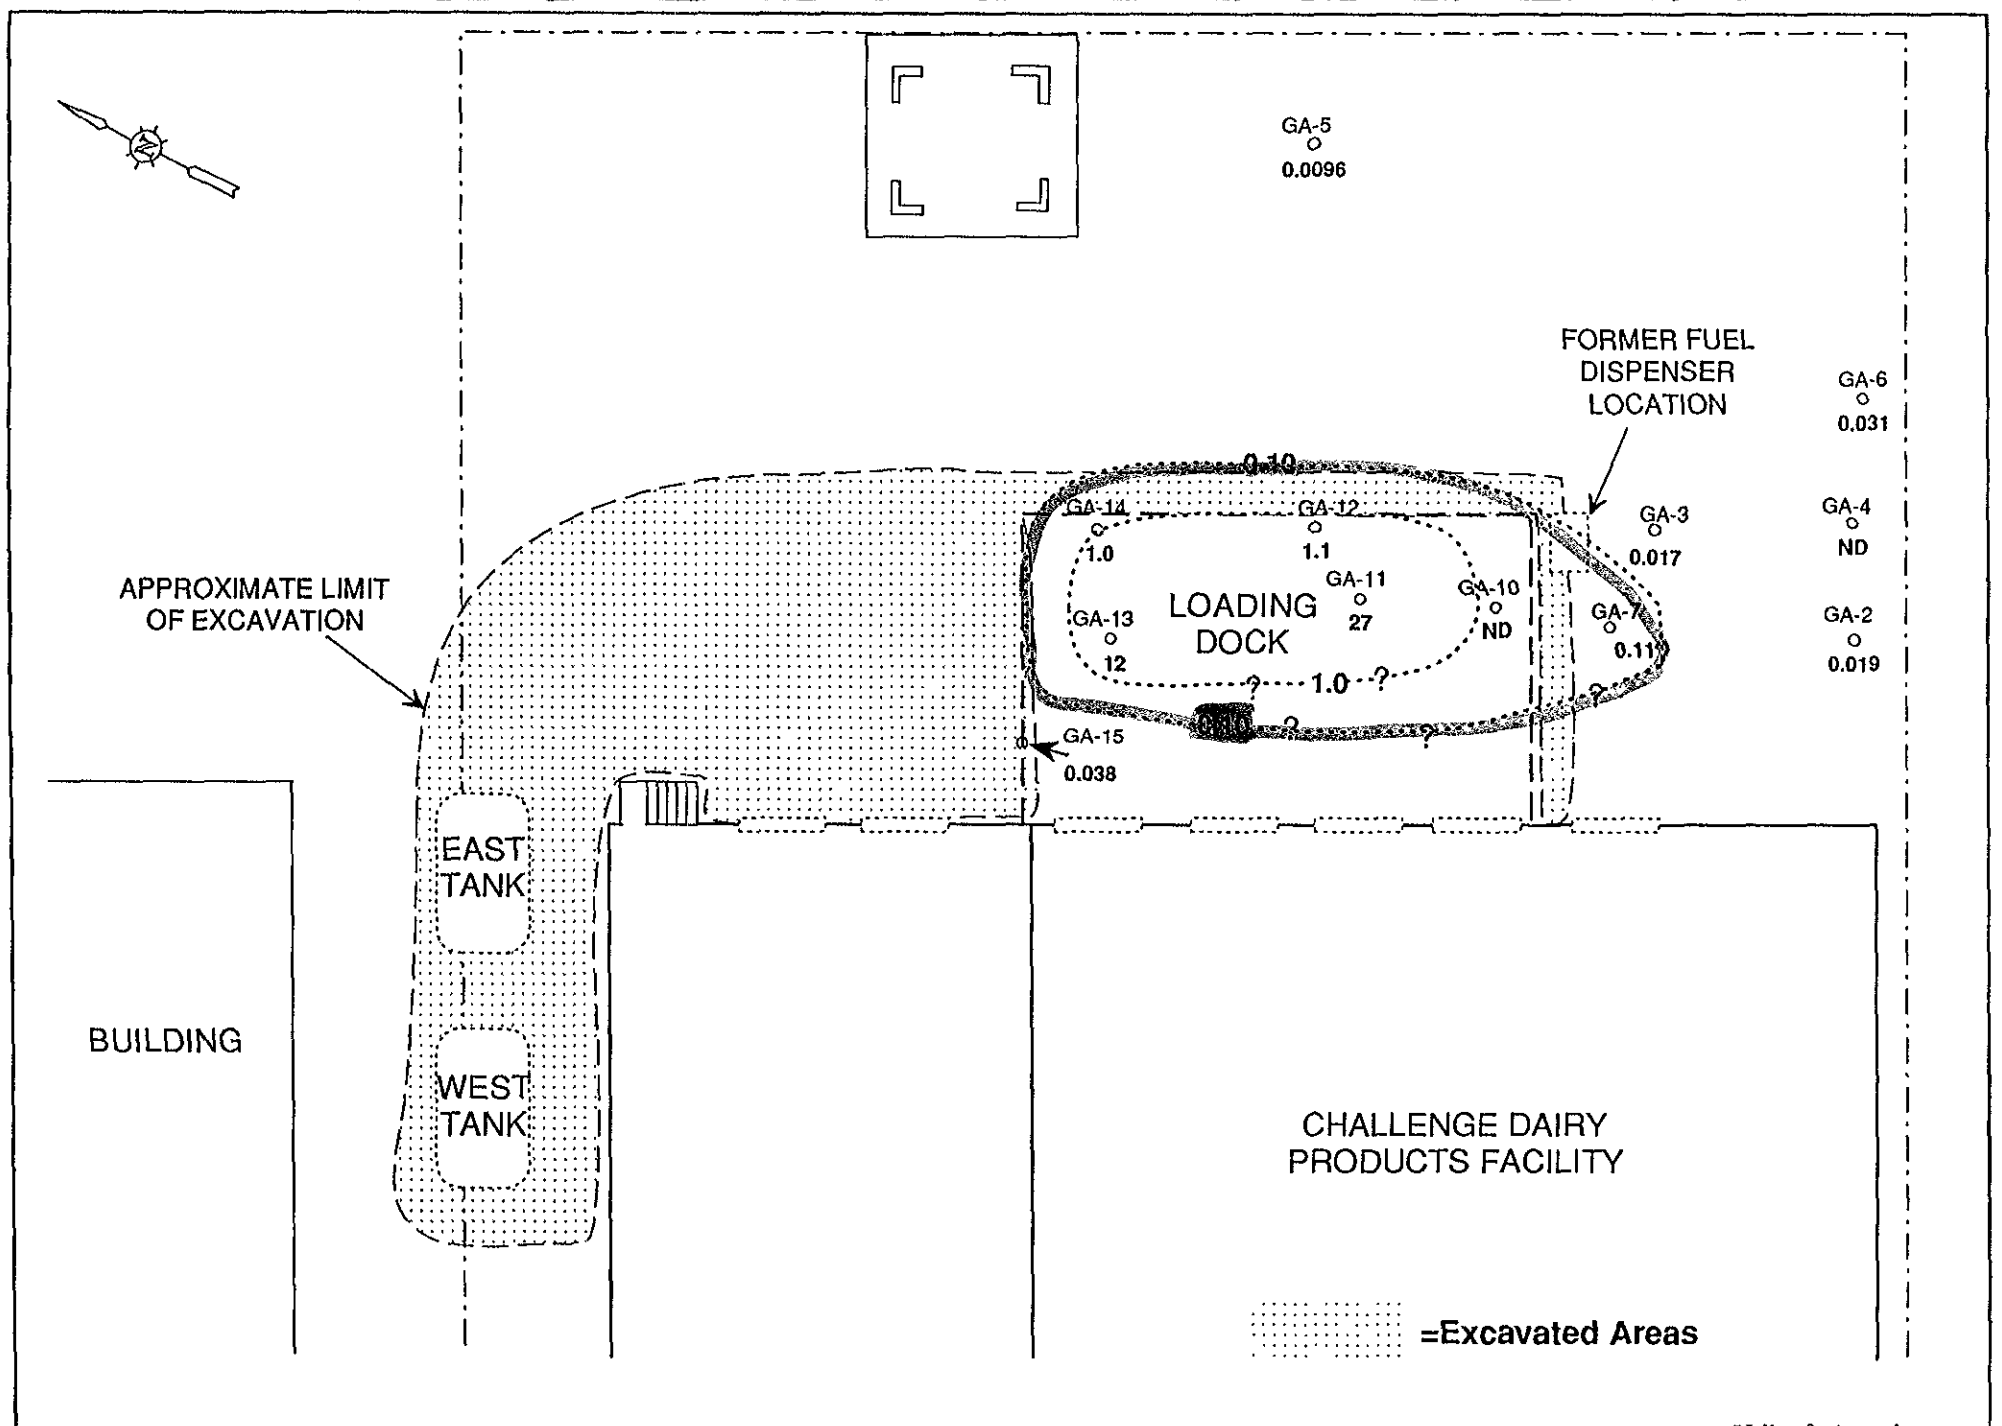
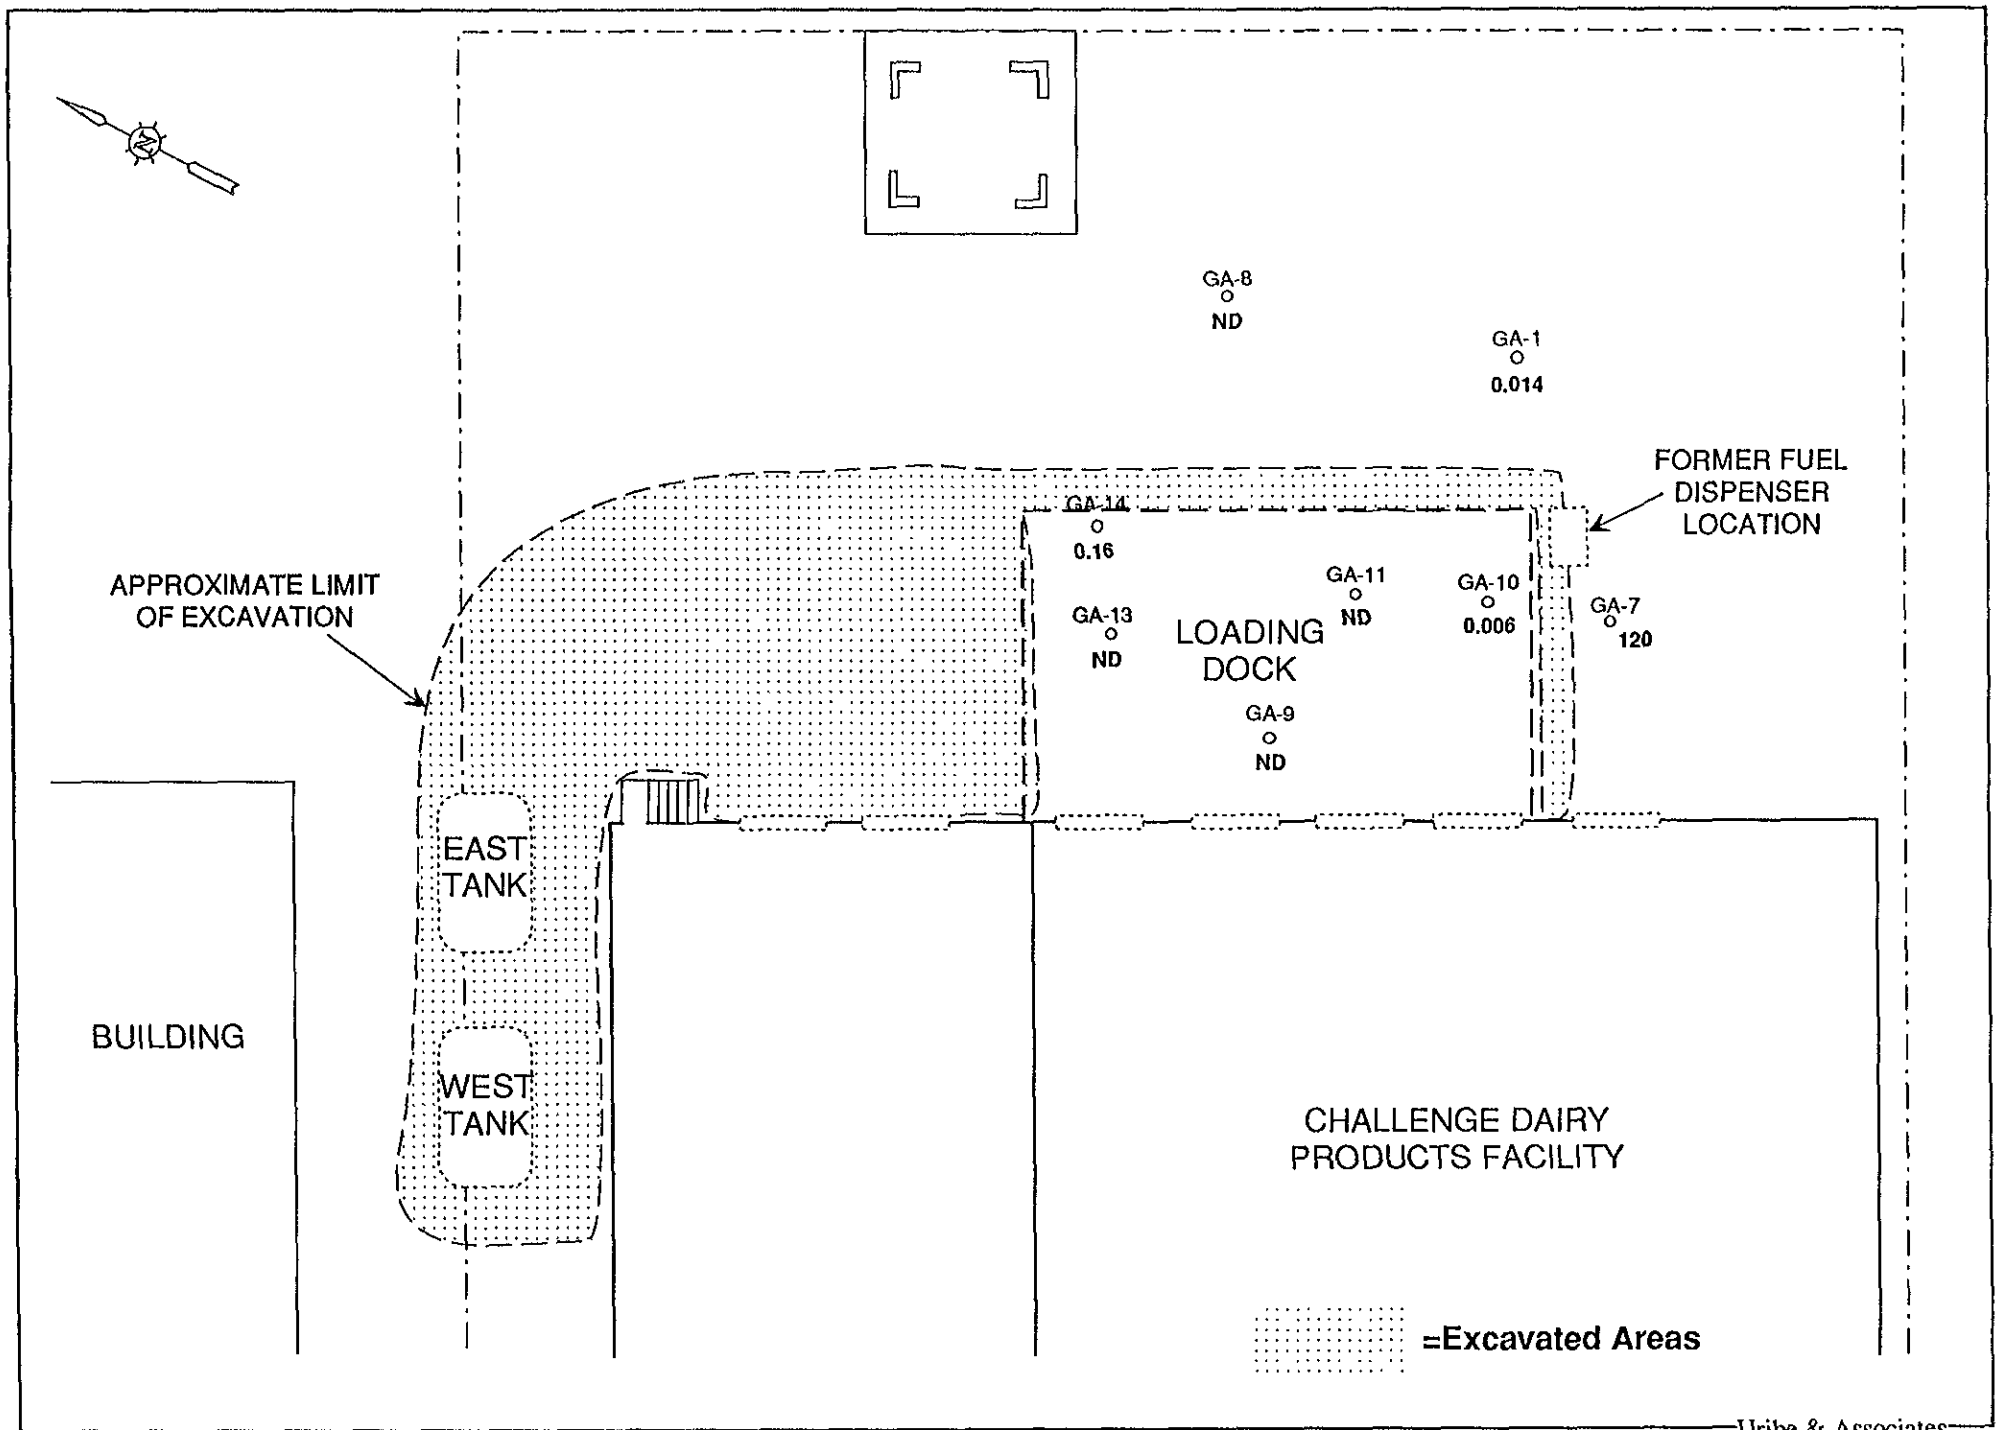
includes iso-concentration lines at 0.10 ppm and 1.0 ppm benzene. As can be seen from the figures, the highest TPH and benzene levels found on the site were in a sample from the shallow depths beneath the loading dock and a sample collected adjacent to the former fuel dispenser. The site-maximum TPH and benzene levels of 9,400 ppm and 120 ppm, respectively, were found in the sample collected adjacent to the fuel dispenser. With the exception of one TPH analysis, detected levels of TPH and benzene were at least one order of magnitude lower than the site maximum values.
