**REPORT ON
LIMITED SUBSURFACE ENVIRONMENTAL
INVESTIGATION AND
REMEDICATION OF CONTAMINATED SOIL**

**SITE LOCATION:
2915 BROADWAY, OAKLAND, CALIFORNIA**

MEC Project No. 90-1006

April 2, 1990

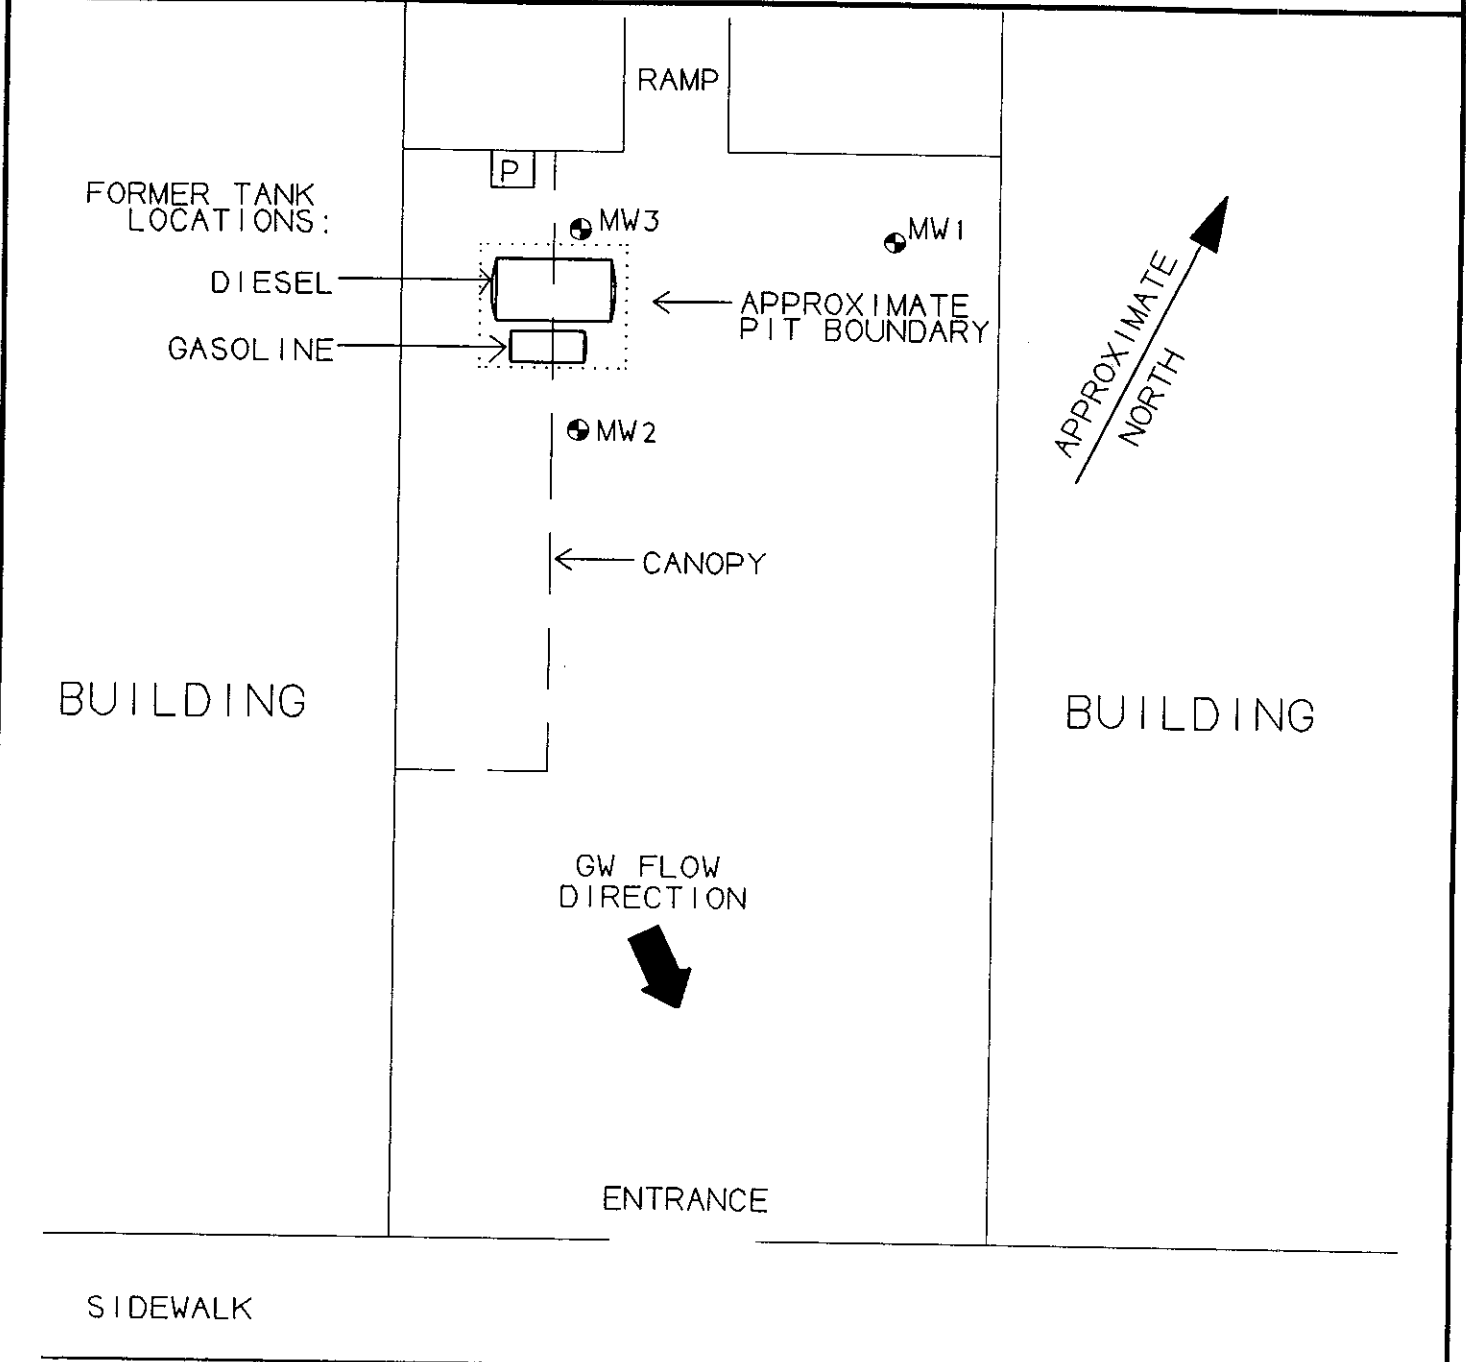
FIGURE 2: SITE PLAN FOR EUROPEAN MOTORS LTD.

Three borings were drilled to describe the geology, locate the water table, and install the monitoring wells. The site plan (Figure 2) shows the location of the wells in relation to the site. Each of the borings was drilled into the water table with hollow stem augers, logged and sampled.
