11 December 1990
SA10-111P

Subject: Phase I Site Assessment for 2244 Santa Clara Avenue, Alameda, California

**PHASE I
SITE ASSESSMENT REPORT
2244 SANTA CLARA AVENUE
ALAMEDA, CALIFORNIA**

**Krater and Wilson Mortuaries
24th Street and Barrett Avenue
Richmond, California**

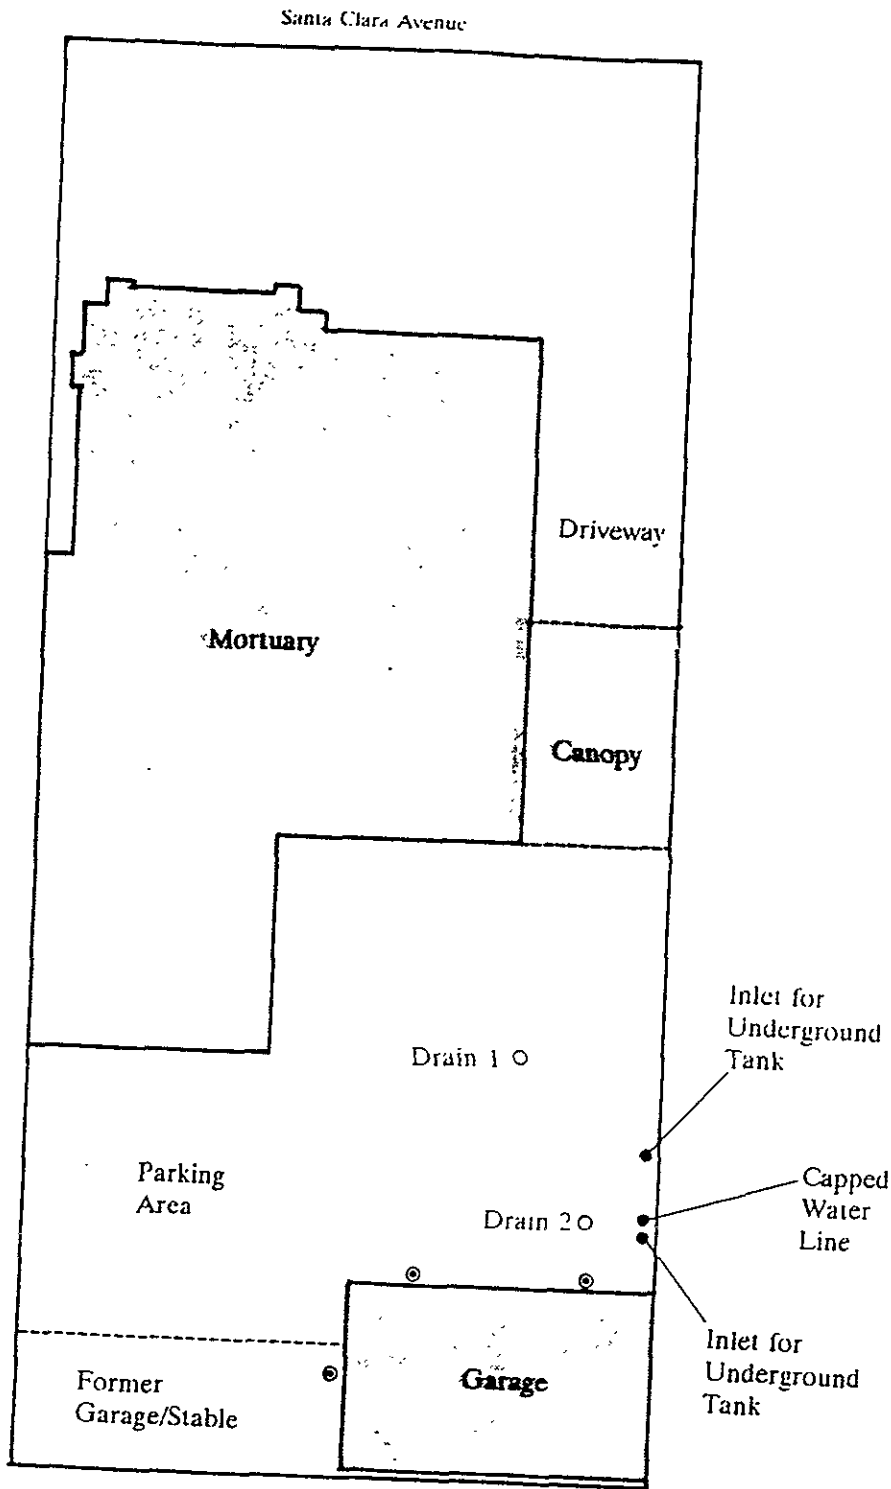
Figure 2

Adjacent to and northeast of the garage, two 2-inch steel pipe caps were observed protruding from the asphalt surface (Figure 2). BASELINE was informed that the caps were associated with an underground fuel tank (Anderson 1990) (Figure 7B). The northernmost cap was carefully removed by BASELINE and a clean wood dowel was lowered into the pipe for the purposes of determining the tank depth and contents, if any. The dowel was inserted to a depth of 50 inches below the ground surface when a solid bottom was encountered. When the dowel was removed, 4 inches of an oily substance with a hydrocarbon odor was observed on the bottom of the dowel. The same procedure was used on the more southern 2-inch steel pipe cap. When the southern cap was removed, a pressure or vacuum release sound was heard. The total depth the dowel could be inserted into the tank was 15.5 inches and, when it was removed, 4 inches of an oily substance was observed on the dowel. A 1-inch cap was located between the two 2-inch caps. The 1-inch cap was loosened and water under pressure was observed to leak out.

Two drains were observed in the parking area in the southern portion of the site. Drain 1 (Figure 2) had a solid bottom, contained no standing water, and appeared to have an outlet; the destination of the outlet is unknown. Drain 2 had a solid bottom at a depth of 2 feet, and was filled with soil and water to a depth of 7 inches below the ground surface. It is unknown whether Drain 2 has an outlet.

- Remove underground storage tanks, associated piping, and Drain 2 located in the southern portion of the property. This work should be performed in accordance with a permit from the City of Alameda by a qualified contractor.

- Collect soil samples from three locations adjacent to the former auto repair building (Figure 7 includes proposed sampling locations). The samples should be analyzed for total petroleum hydrocarbons as gasoline and diesel, oil and grease, volatile organic compounds, and pesticides.

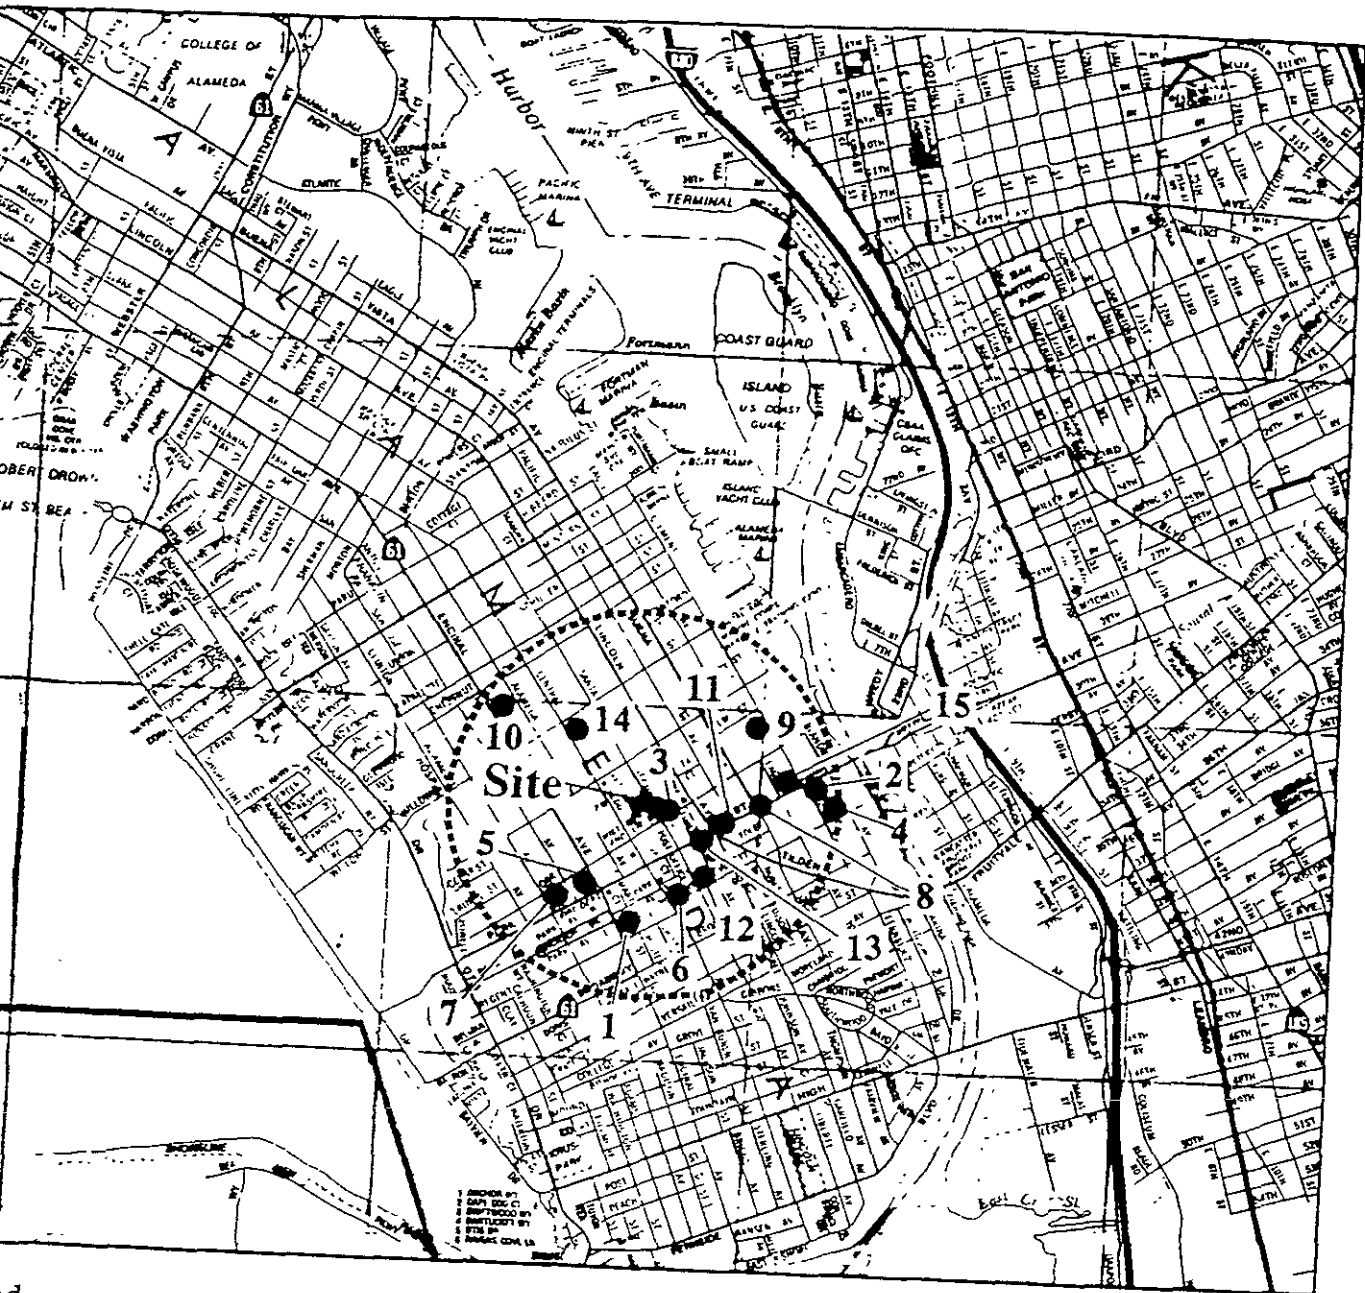
Figure 6

Based on available information, it is unknown whether migration of contamination from off-site sources has reached the project site from the south (Sources 1, 5, and 7 on Figure 6) or east (fuel dispenser and tank on adjacent property). Potential on-site sources of subsurface contamination include underground fuel tanks, the former auto repair shop, and subsurface drains.
