**Subject: Results of Pipeline Investigation  
Former American National Can Company Facility/Super Kmart  
Oakland, California**

This letter report has been prepared by PES Environmental, Inc. ("PES") to present the results of field investigations regarding the existence and condition of a former fire suppression water pipeline located at the former American National Can Company ("ANC") Oakland, California facility (Plate 1).

**Site Location Map**  
Utility Survey / Fire Suppression  
Pipeline Investigation  
Former ANC / Super Kmart Center  
Oakland, California

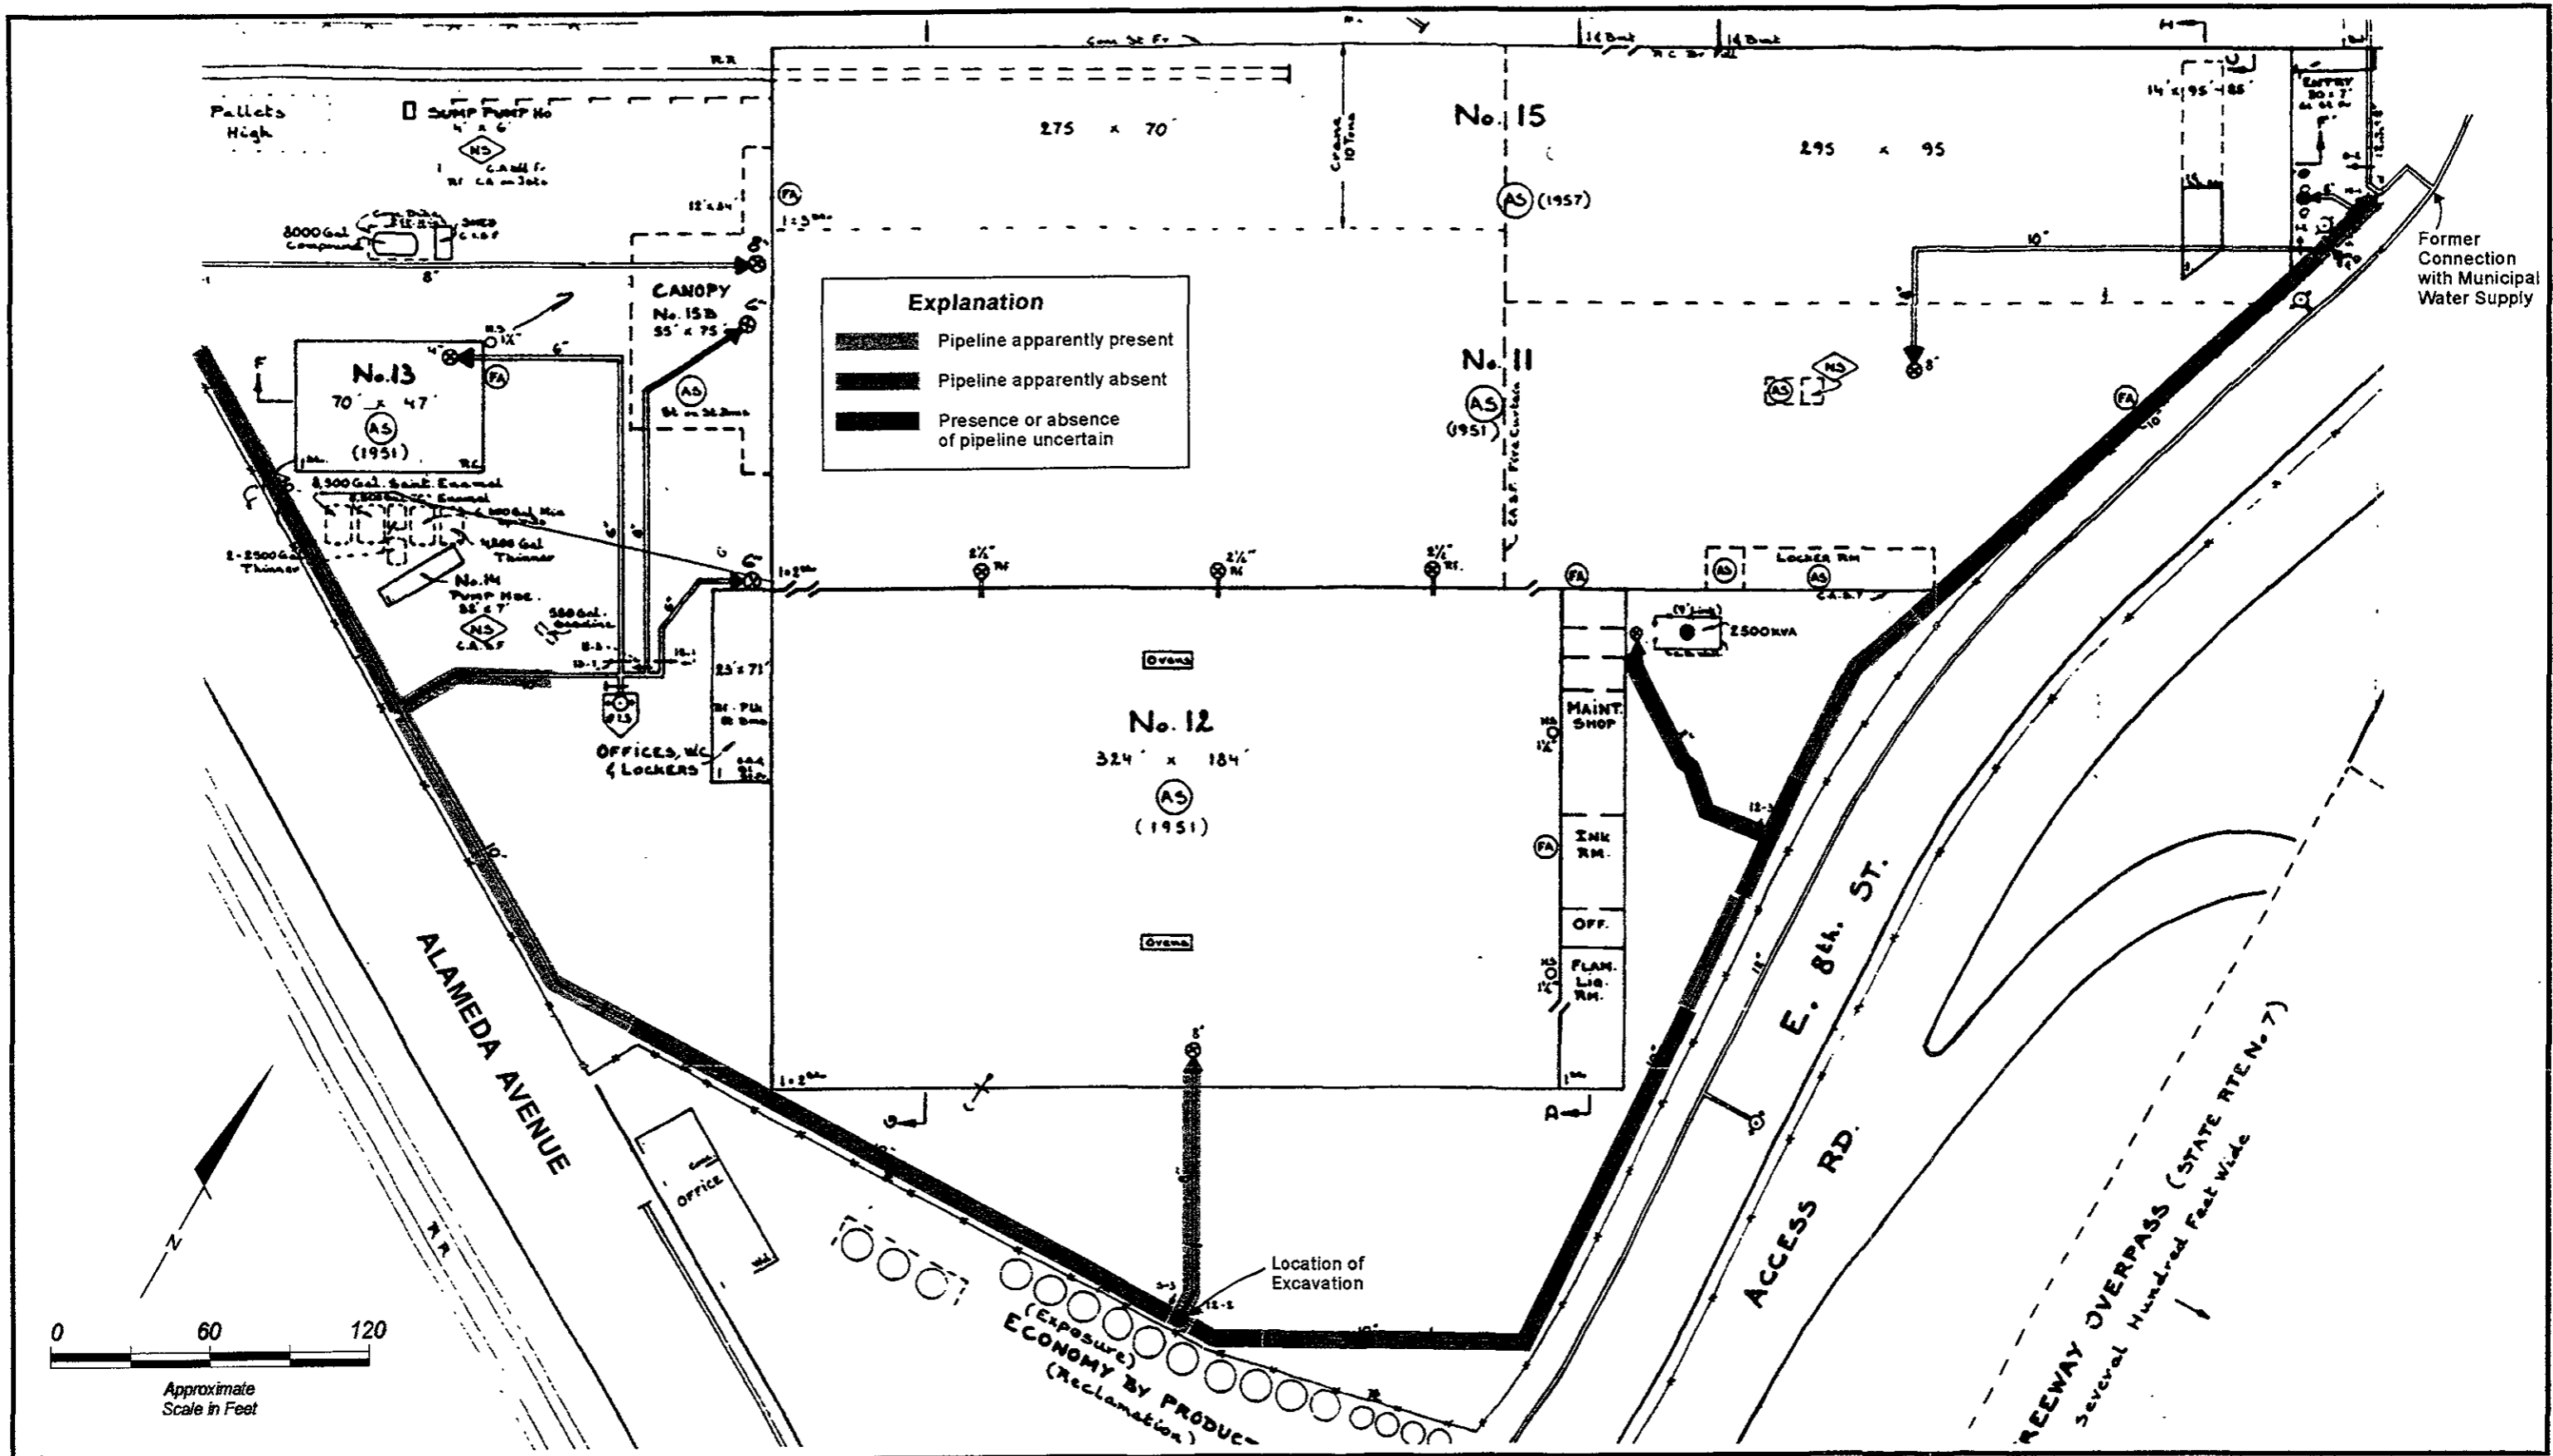
Attached as Plate 2 is a portion of a historical map<sup>(1)</sup> showing the historical alignment of the pipeline around the southern perimeter of the site. The utility survey focused on the southern boundary of the subject property based on discussions with Plant Reclamation and plans of the fire suppression piping for the former ANC facility. Plate 2 also shows the location, along East 8th Street, where the fire suppression pipeline was connected to the municipal water supply system.

The results of the fire suppression pipeline survey are indicated on the attached historical map. Sections of the pipeline have been color coded to indicate: (1) pipeline sections apparently present as indicated by the utility locating methods (highlighted in blue); (2) pipeline sections apparently absent as indicated by the utility locating methods (highlighted in green); and (3) inconclusive as to the presence or absence of the piping sections due to interferences or other limitations of the utility locating equipment and methods (highlighted in pink).

1. Segments of the fire suppression pipeline appear to remain in place;
2. Interferences and other limitations of the utility locating equipment precluded reliable determination of the existence of other segments, including the pipe segment located along the property line shared by the subject site and the former Ekotek Lube property; and
3. Segments of the pipeline have been removed. The removed segments isolate the existing pipeline segments from the municipal water supply source. *how so?*

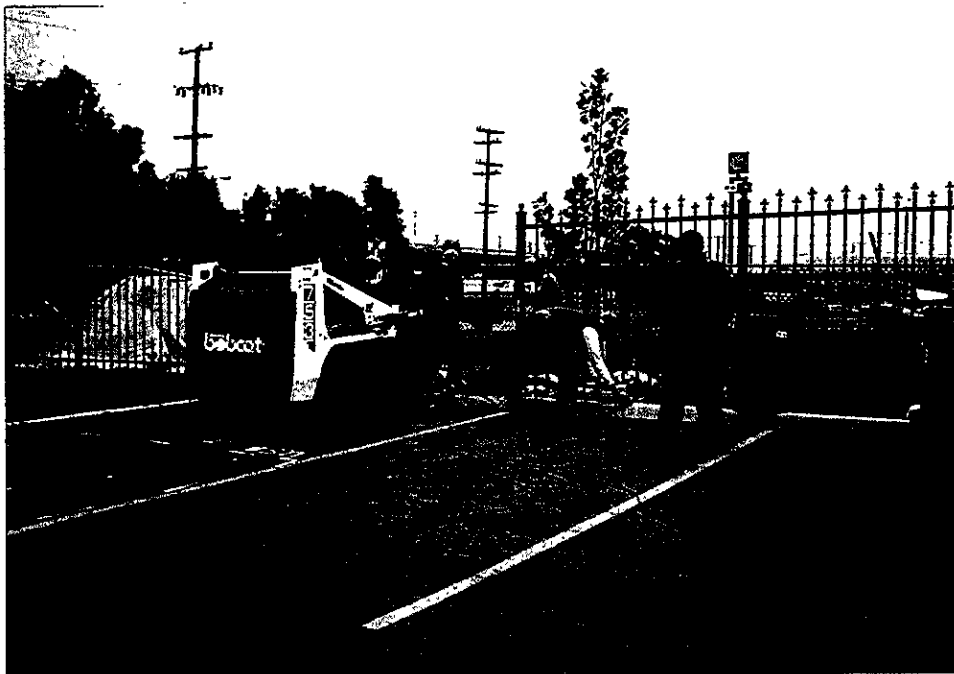
On October 23, 1996, PES and Plant Reclamation exposed the fire suppression piping at the location identified on Plate 2. Using hand tools and a small backhoe attachment to a Bobcat (see Photograph 1, Plate 3), soil was excavated to a depth of approximately 4.5 feet below ground surface ("bgs"). Excavation spoils were stockpiled adjacent to the excavation on plastic tarping (Photograph 2, Plate 3). At 4.5 feet bgs, a cast iron pipe measuring 10 inches in diameter was exposed. The piping material and size were consistent with the fire suppression piping identified on the plans.

Photo 1. View of excavation activities south of parking area.

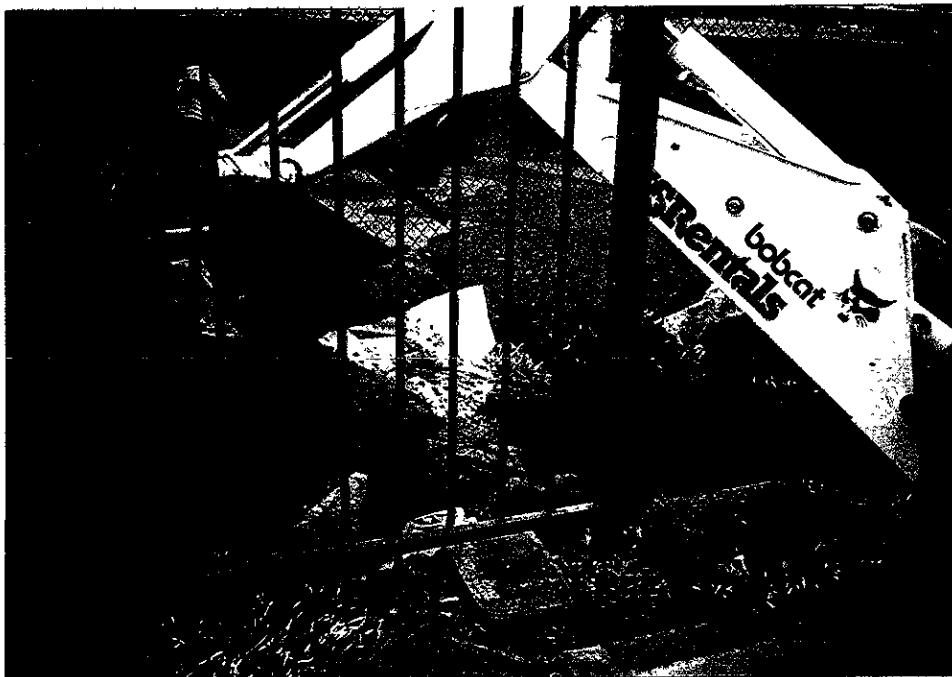
Photo 2. View of limits of excavation.
