ENVIRONMENTAL RISK ASSESSMENT
THE HARBOR TUG AND BARGE COMPANY
GRAND STREET FUEL TERMINAL
ALAMEDA, CALIFORNIA

Versar Job No. 6721.4

June 6, 1990

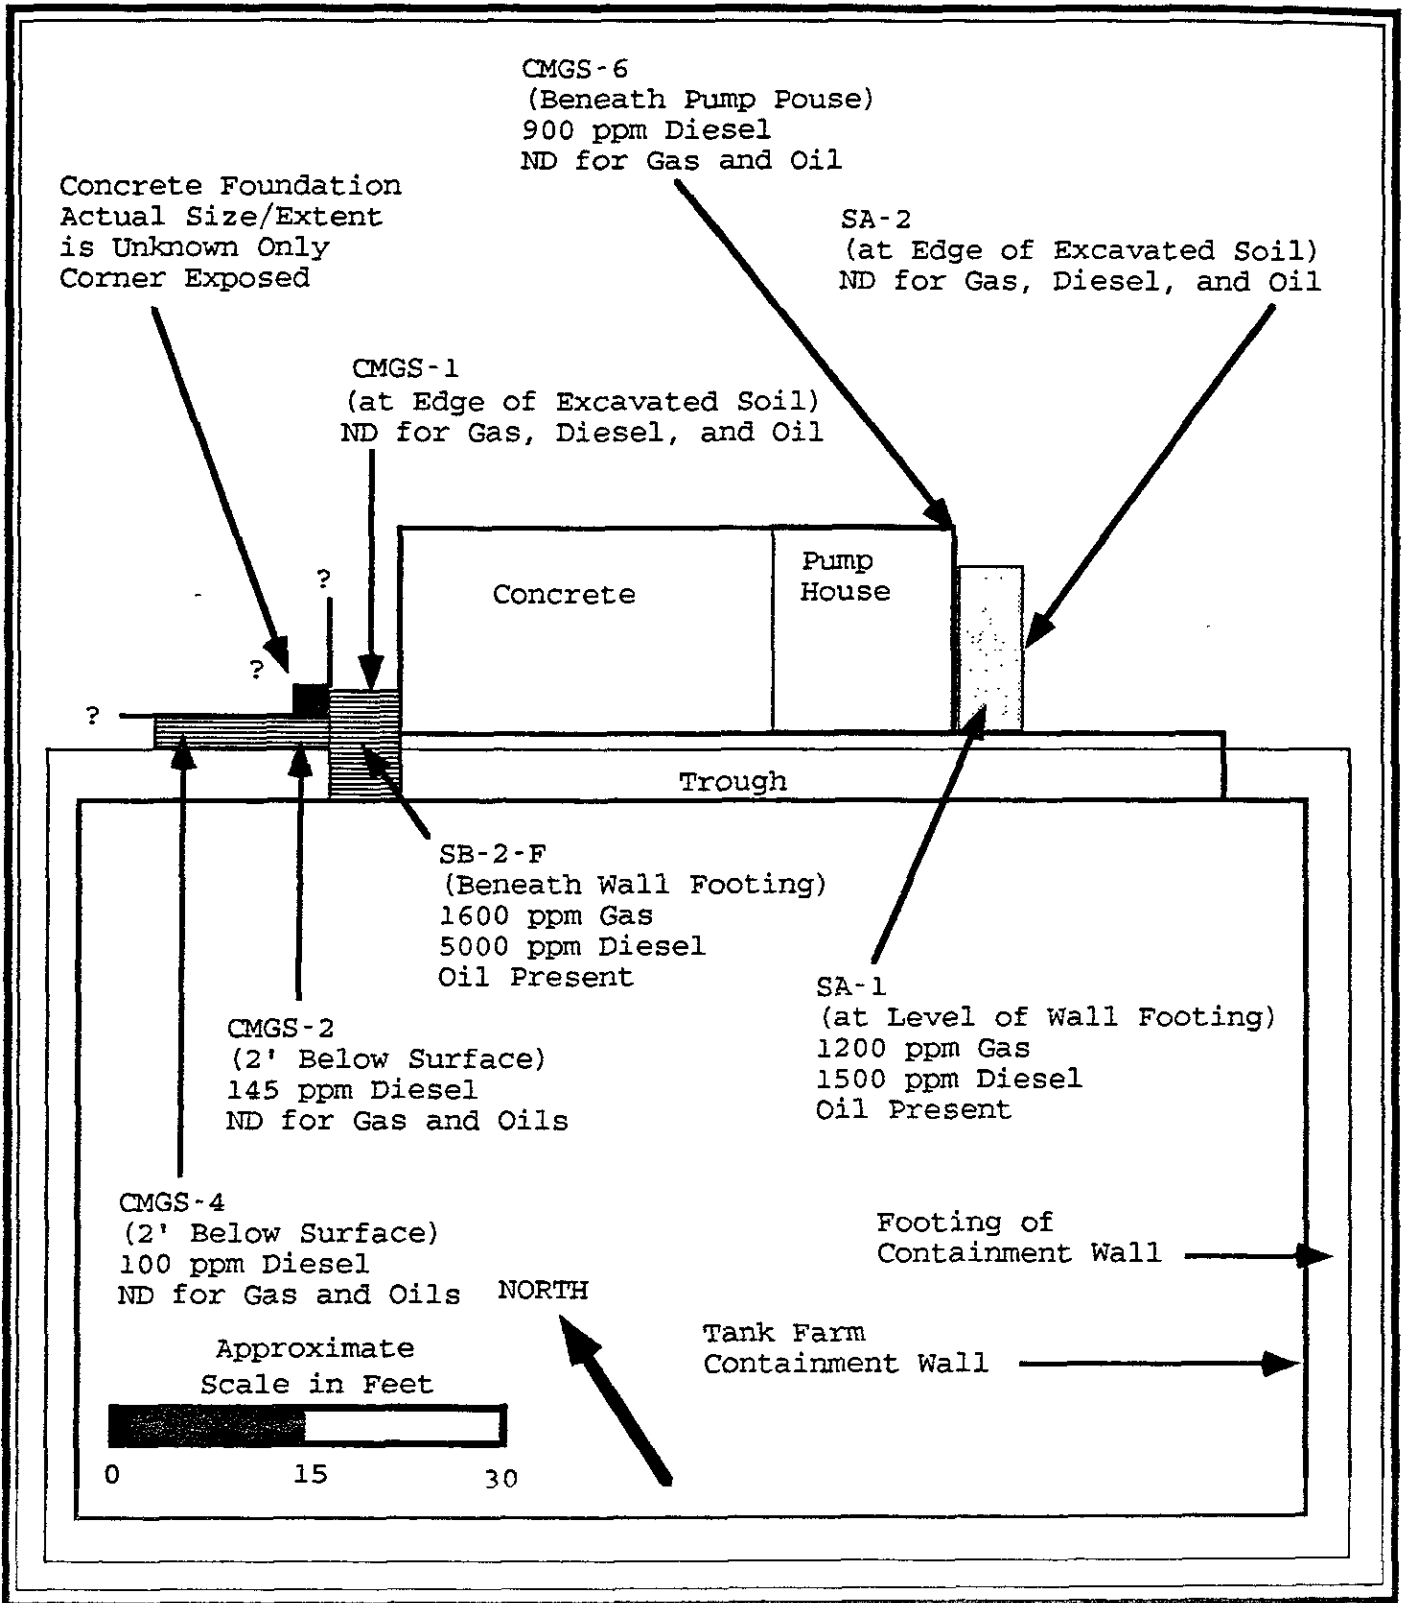
Figure 6-1. Sampling Locations and Analytical Results

Following the excavation of the contaminated soil, sampling was conducted following the procedures described in Section 5.2. Sample locations and results are presented in Figure 6-1. An examination of the excavation wall showed that the contaminated soil extended under the tank farm and the pump house, and that some residual contamination was present under clean soil in the zone of tidally-induced ground water fluctuation. The laboratory report indicated the following sample results. Samples collected from the clean soil above the zone of fluctuation (i.e., samples SA-2 and CMGS-1) contained no detectable concentrations of petroleum hydrocarbons. Soils within the zone (i.e., samples CMGS-2 and CMGS-4) contained between 100 mg/kg (i.e., parts per million or ppm) and 145 mg/kg of diesel. Soil sampled under the pump house (i.e., sample CMGS-6) contained 900 mg/kg of diesel. Soil sampled under the tank farm (i.e., sample SB-2-F) contained 1,600 mg/kg of

gasoline and 5,000 mg/kg of diesel. Soil sampled at approximately the same horizon as the wall footing (i.e., sample SA-1) contained 1,200 ppm gasoline and 1,500 ppm diesel.

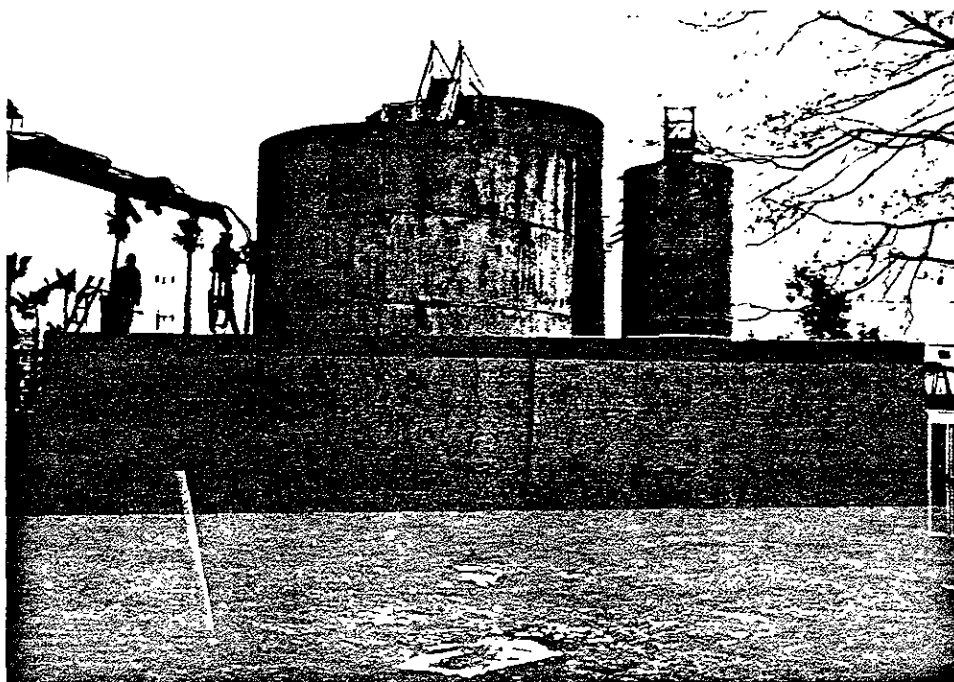
surrounded by a containment wall approximately 11 feet high and six-inches thick. Several cracks were observed in the containment wall (see Photos 2 and 3, Appendix A). Some of the cracks were reportedly caused by an earthquake (Richter Magnitude 7.0) which occurred in the San Francisco Bay area on October 17, 1989. Cracks which were present before the earthquake were enlarged by the ground motion. Since the storage tanks were empty at the time of the earthquake, there is no concern that petroleum was released into the environment through the cracks in the wall. Several cracks were also observed in the tank farm foundation (see Photo 4, Appendix A). The cracks in the foundation did not appear to penetrate through to the underlying soil.

Photograph 2. Cracks in the Fuel Storage Facility Containment Wall

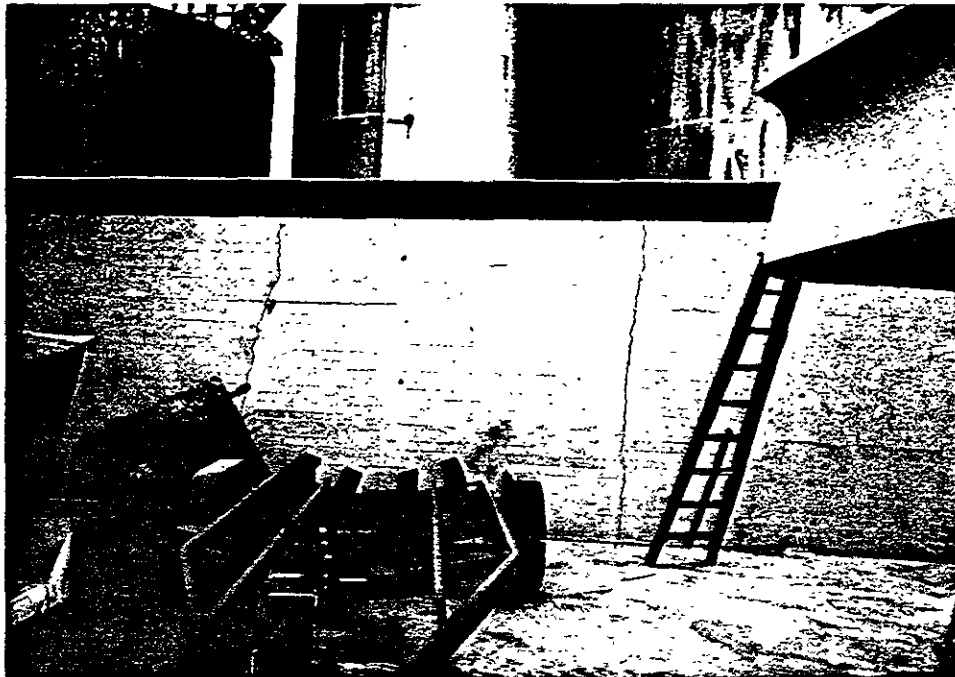
Photograph 3. Cracks in the Fuel Storage Facility Containment Wall

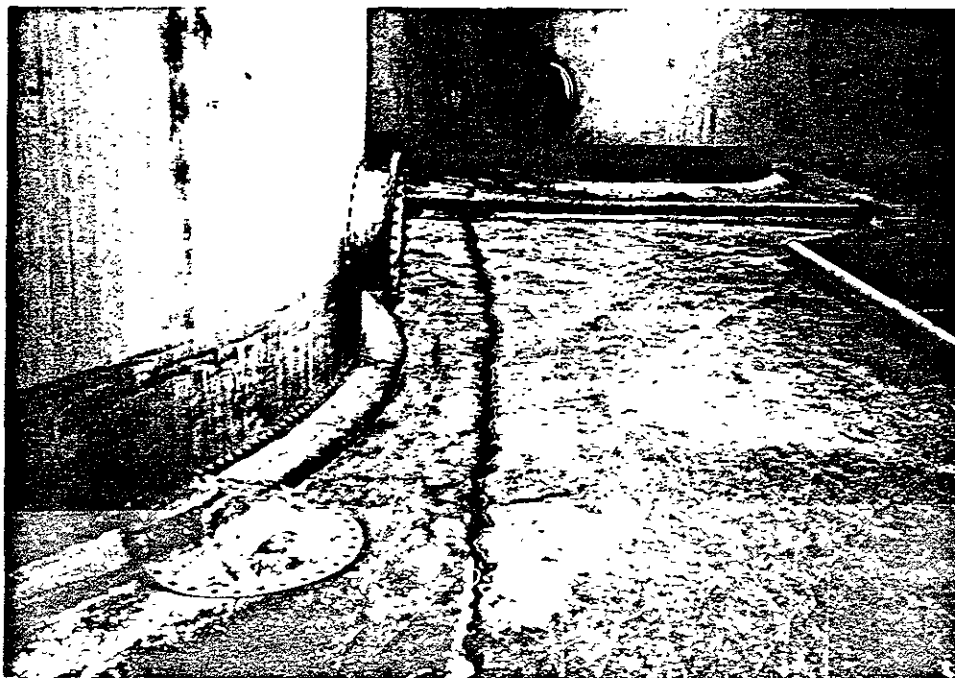
Photograph 4. Cracks in the Fuel Storage Facility Foundation

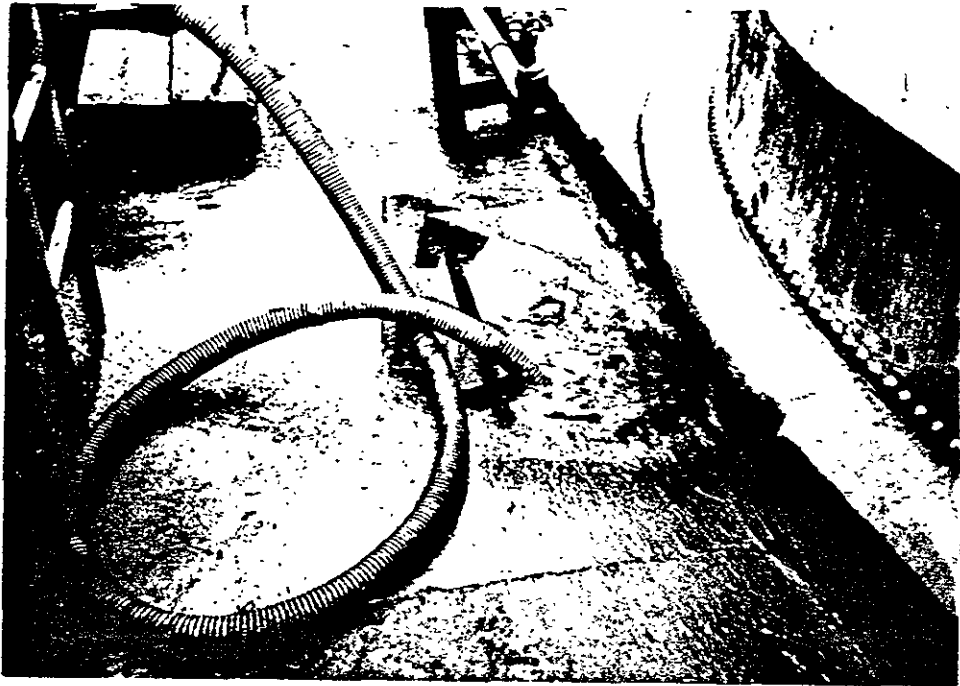
A sump located inside the tank farm was filled with ground water at the time of the inspection (see Photo 5, Appendix A). The level of water fluctuates within the sump as a result of tidal action. The sump was constructed to allow ground water to be pumped during extremely high tides to prevent structural damage to the tank farm foundation. Liquid from the sump was pumped during the collection of samples (see Photo 6, Appendix A). When evacuated, the sump was observed to have steel on the sides and bottom, and an opening two inches in diameter near the bottom which permitted ground water to flow into the sump. A sludge consisting of a mixture of sediment and oil was observed at the bottom of the sump (see Photo 7, Appendix A).

Photograph 5. Tank Farm Sump

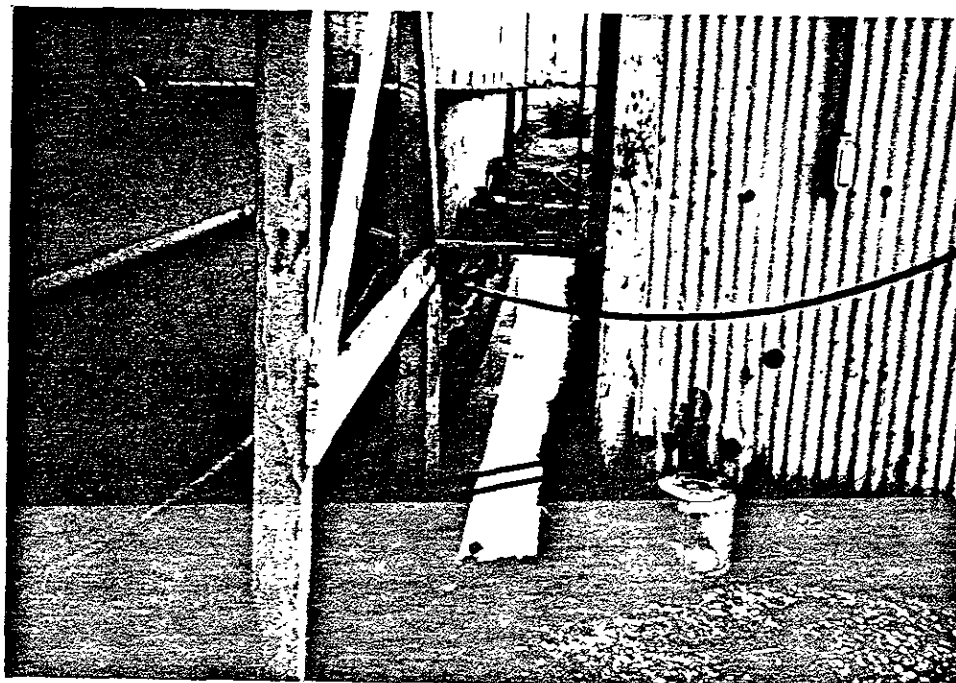
On the northeast side of the tank farm, outside the containment wall, is a concrete trough (see Photo 8, Appendix A). This may have been constructed to contain spills and leaks during filling and emptying operations. The concrete trough is broken near the southeast end (see Photo 9, Appendix A), and drain pipes penetrate the northwest end of the trough (see Photo 10, Appendix A).

Photograph 8. Concrete Trough at the North End of the Tank Farm

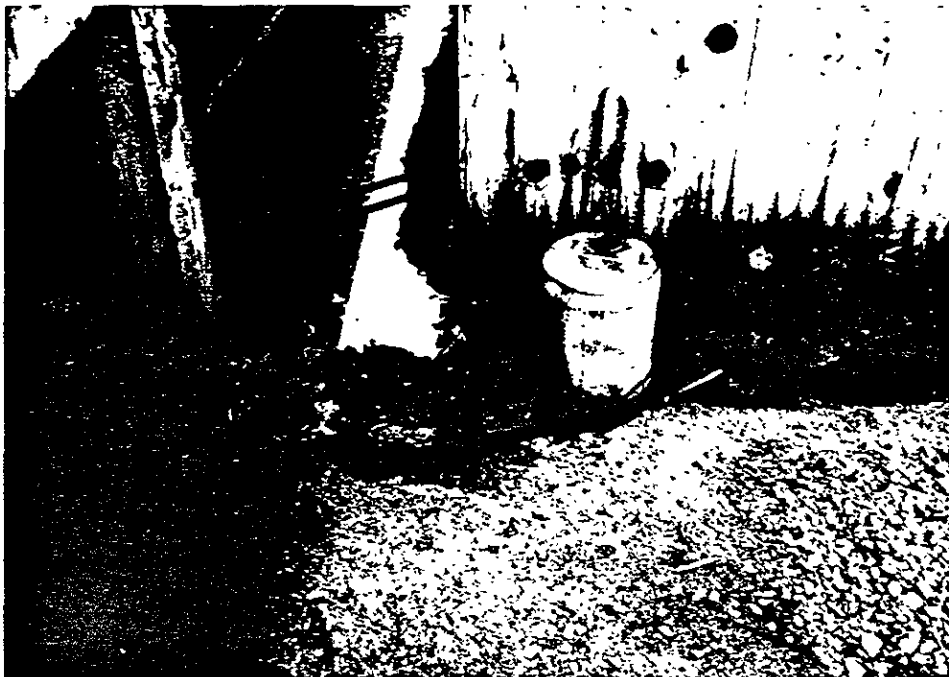
Photograph 9. Breaks in the Concrete Trough

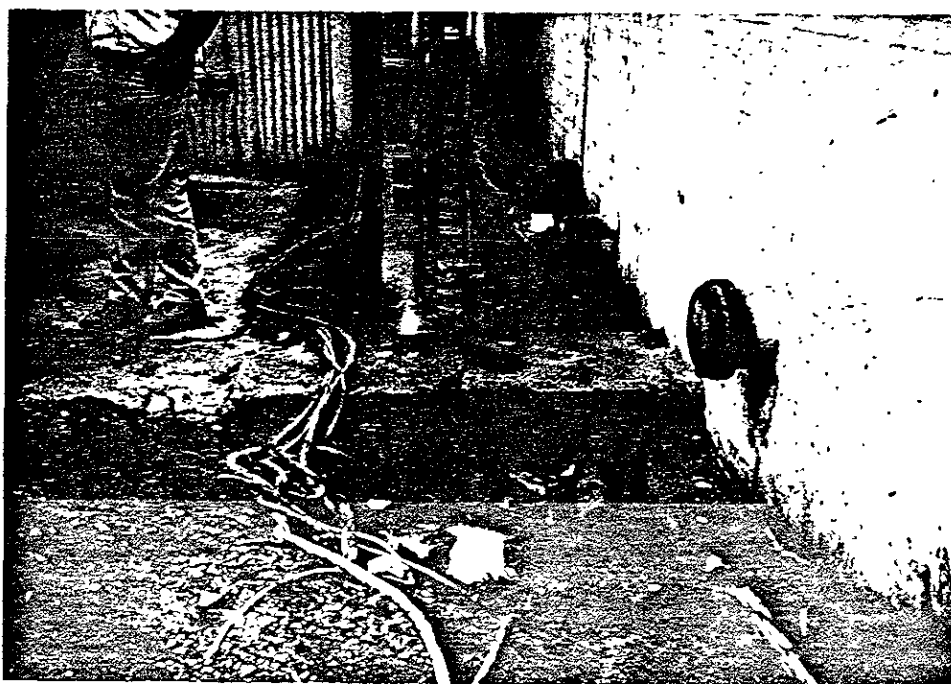
Photograph 10. Drain Pipes Penetrating Trough

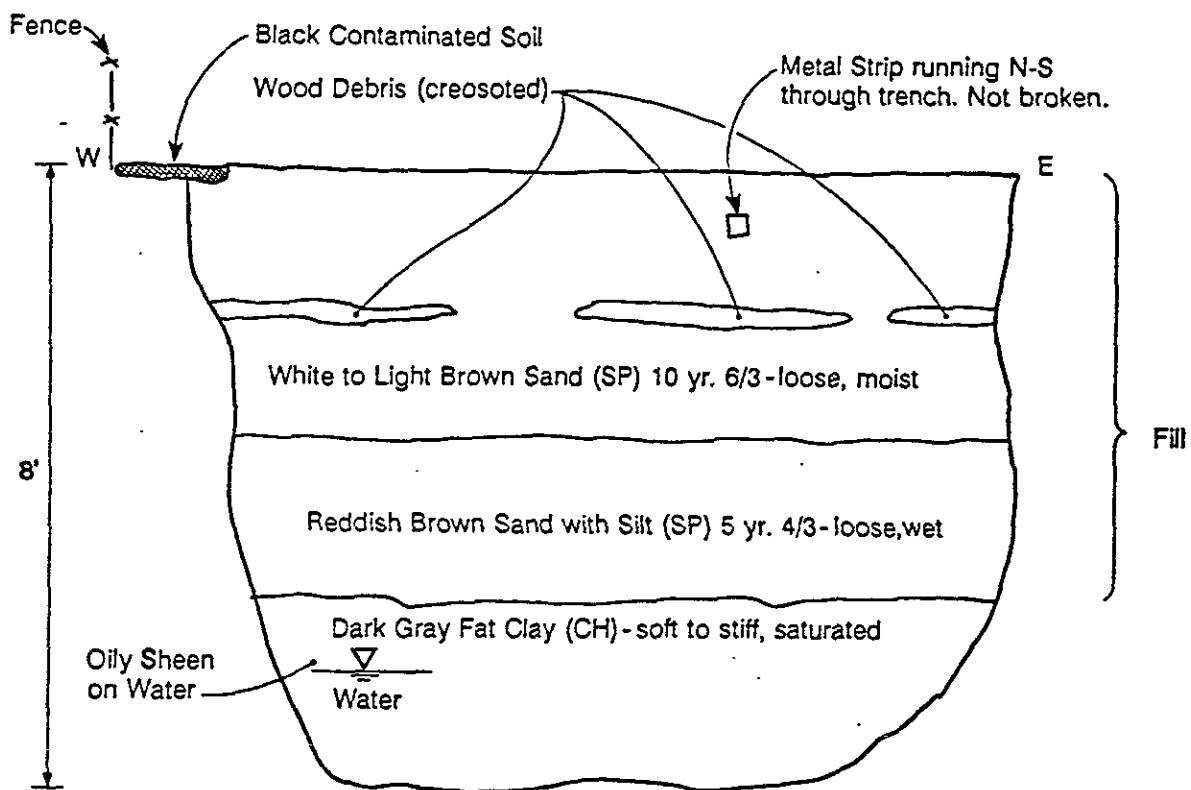
Log of Trench 3
 Environmental Assessment
 Proposed Encinal Marina
 Alameda, California

Elevated levels of lead were observed in soils from Test Trench 3, although the value did not exceed the Total Threshold Limit Concentration that characterizes a hazardous waste pursuant to Section 66699 of the California Administrative Code. The presence of abundant wood fragments at the ground surface and at a depth of 1.5 to 2 feet may have resulted from the dismantling of a tugboat in that area, which reportedly took place in 1986.

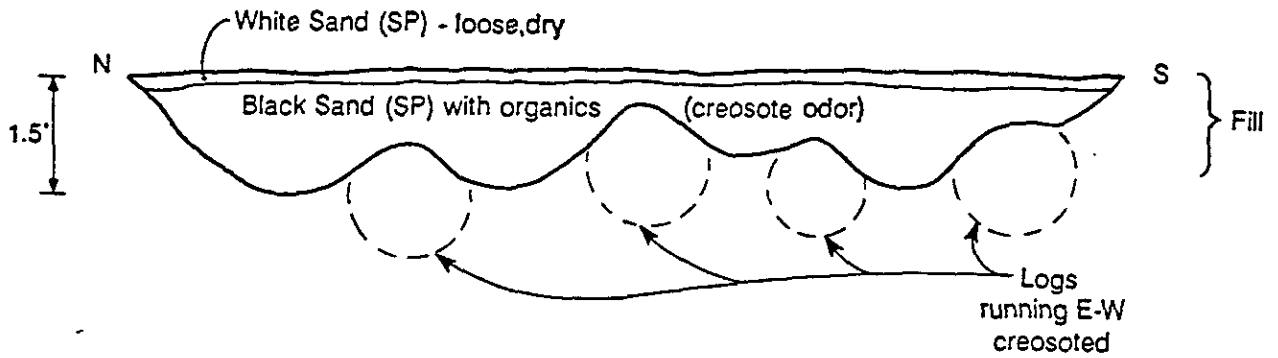
TRENCH 4

The creosoted poles or timbers encountered in this area are of concern because differential settlement may occur as the poles decay. Although this area was the location of the Alaska Packers boat building shed and wharf, and later a marine railway, the purpose of the poles or timbers is unknown.

Contaminated soil and creosoted timbers should be removed from this area around Trench 4. Contaminated soils should be transported to a permitted hazardous waste facility for disposal. A suitable disposal site for the creosoted timbers will have to be located.
